7 CONCLUSIONS AND RECOMMENDATIONS

Proposed Residential Conversion
of first and second floors
110 East Street Bedminster Bristol

Client	Structural Soils
Site	110 – 112 East Street, Bristol
Report Reference	S1RA-1044
Date	20/01/2025
Author	Will Hunnisett

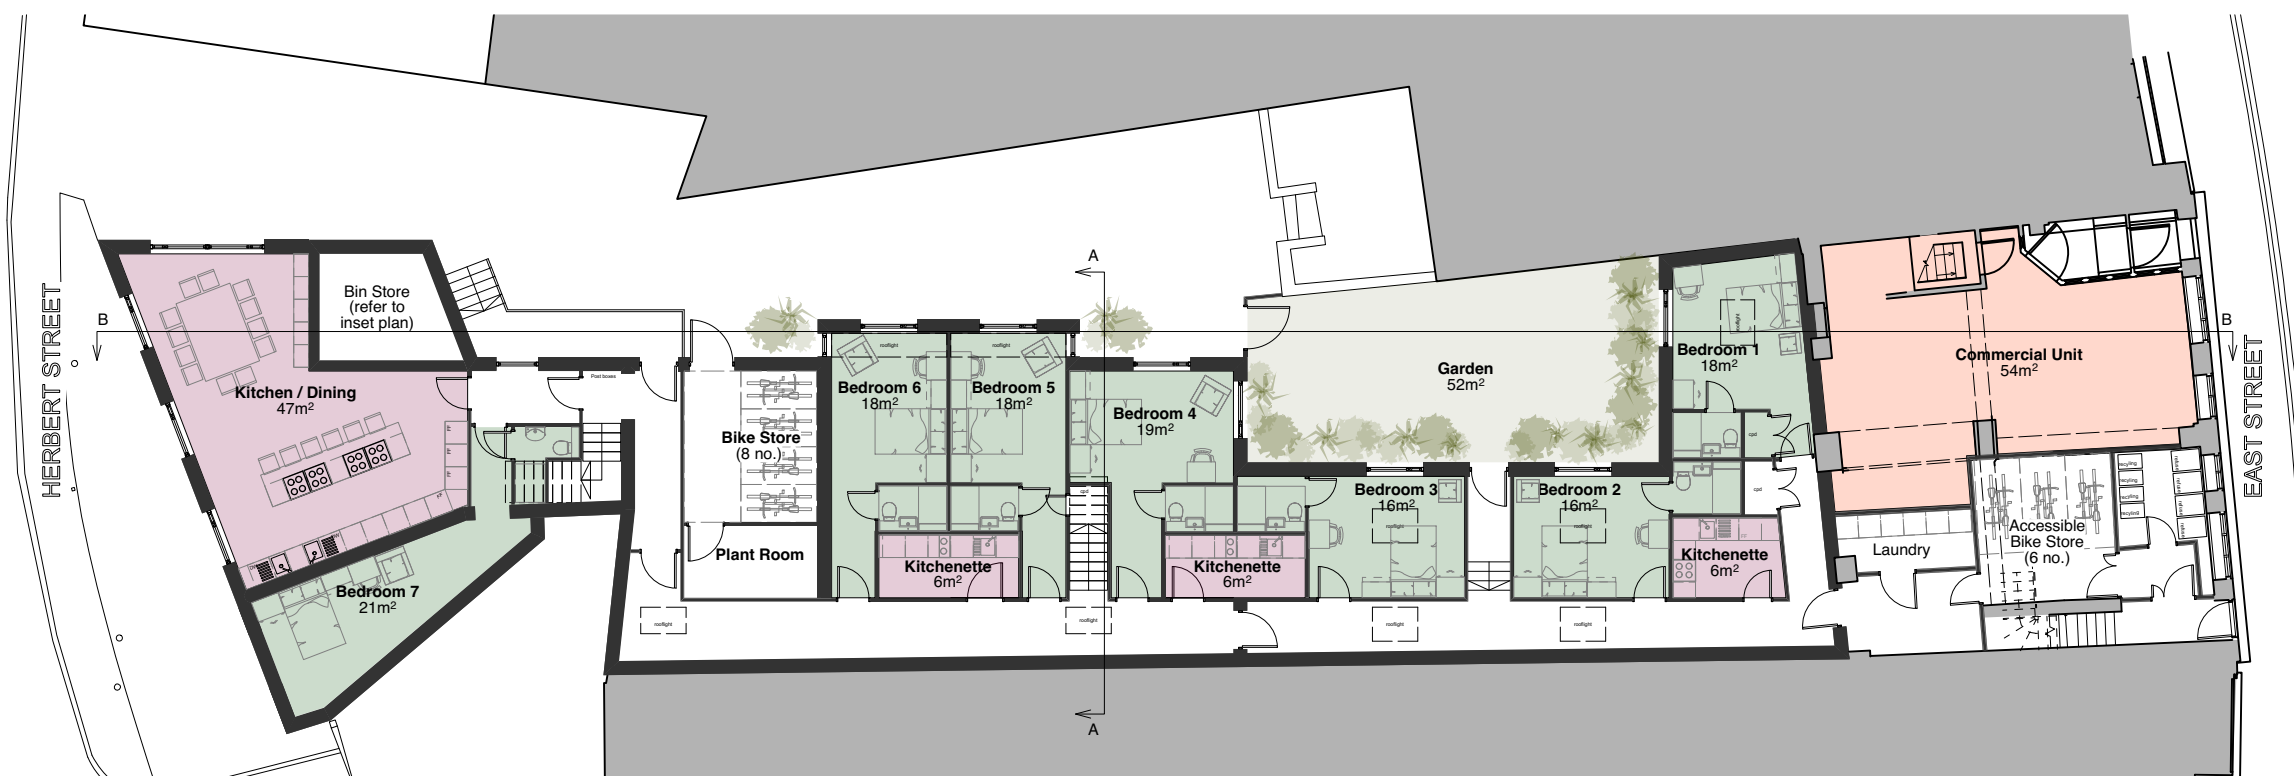
Proposed Ground Floor Plan

The two risk linkages identified above relate solely to the proposed landscaping. The plan of the proposed development in Appendix A shows a small grassed area about 10 m by 5 m lined with shrubs or small trees on two sides and two other small trees.
