Department
for Education

Managing Older Buildings:

A guide for estates maintenance staff

December 2025

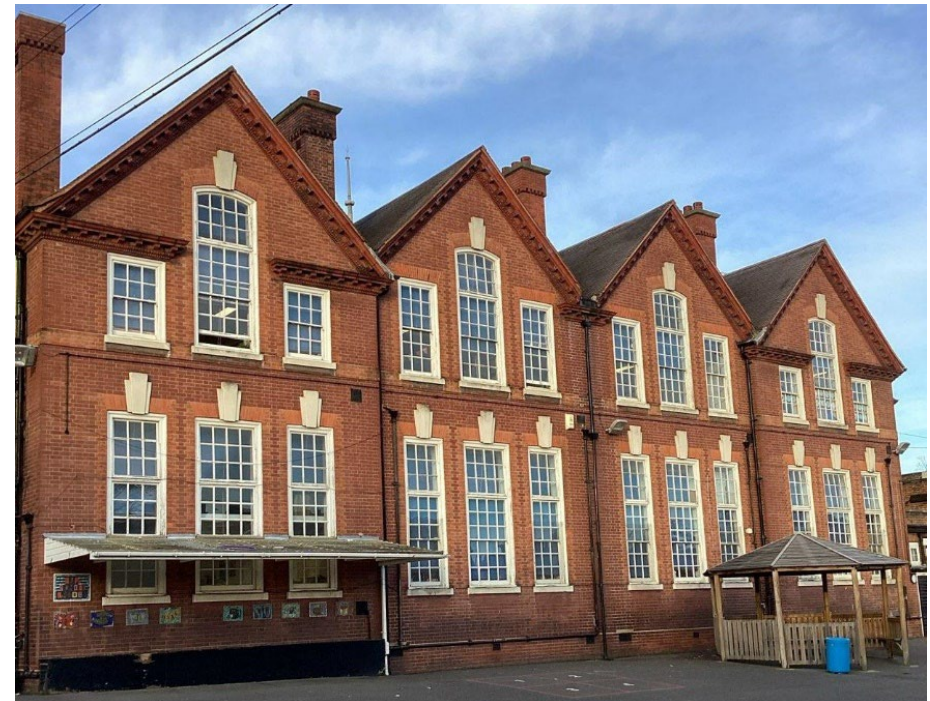
Figure 1: Example of pre-war traditional school construction

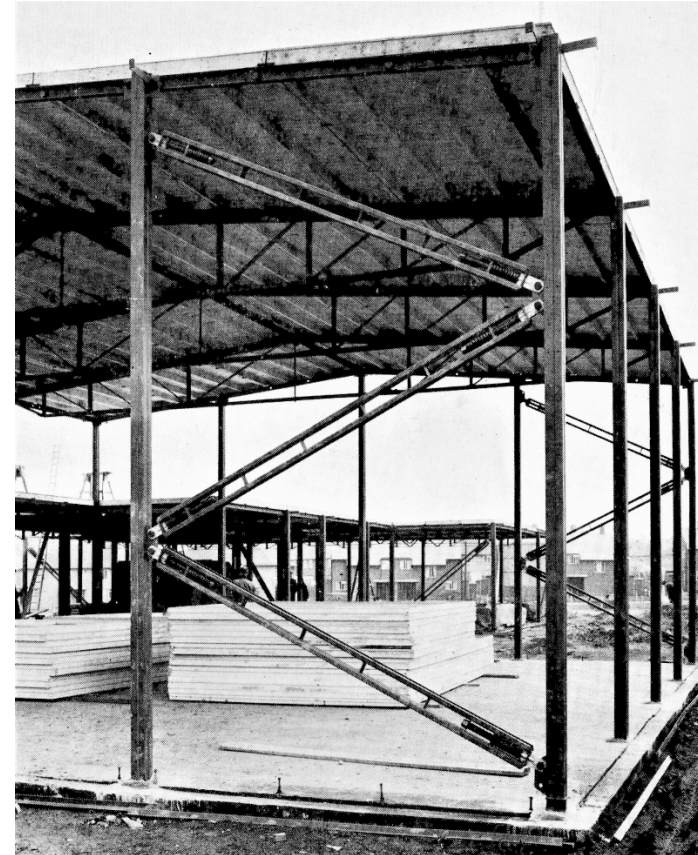
Figure 3: Example of a post-war system build (CLASP)

In some cases, the consortia developed a single system, for example CLASP (with its distinctive bracing design). In other cases, they developed a range of solutions using different materials, for example SEAC (steel, concrete and masonry systems). Private suppliers included Orlit and Derwent (also known as Vic Hallam). Further details of these systems are provided in Appendix A.

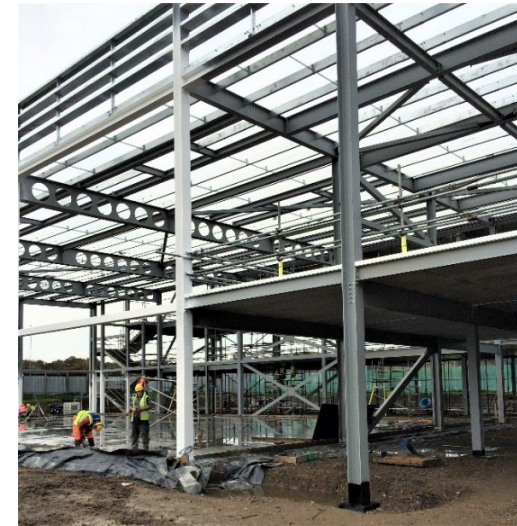
Figure 4: Example of steel framed construction

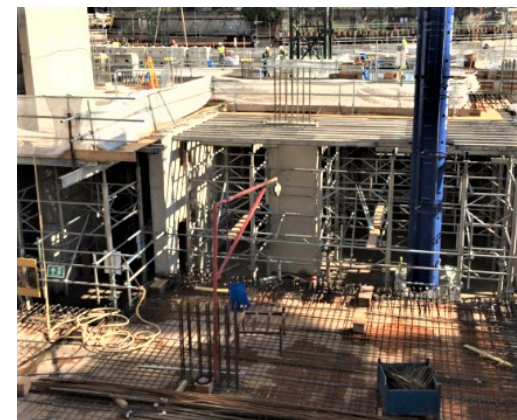
Figure 5: Example of concrete framed construction

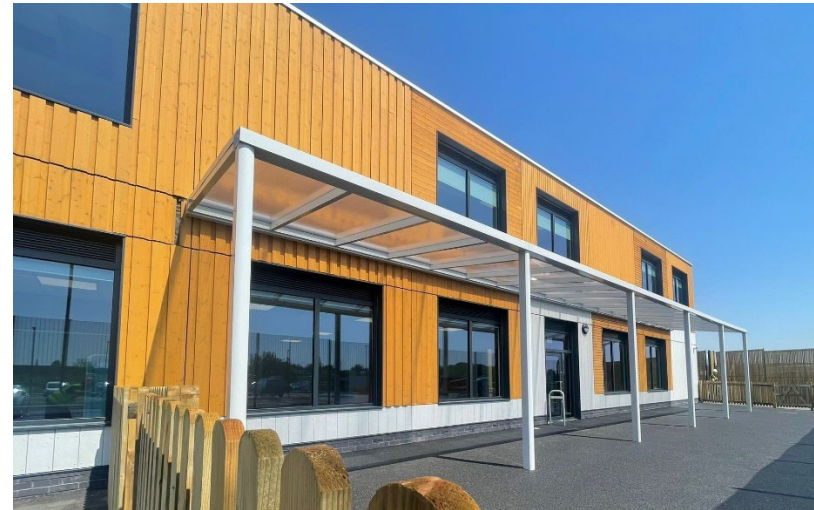
Figure 6: Example of a completed school using MMC/DfMA

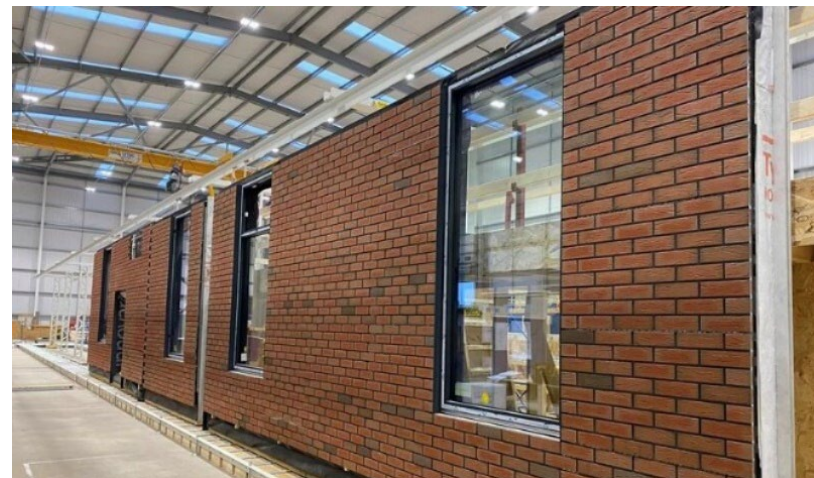
Figure 7: Example of MMC/DfMA off-site manufacture

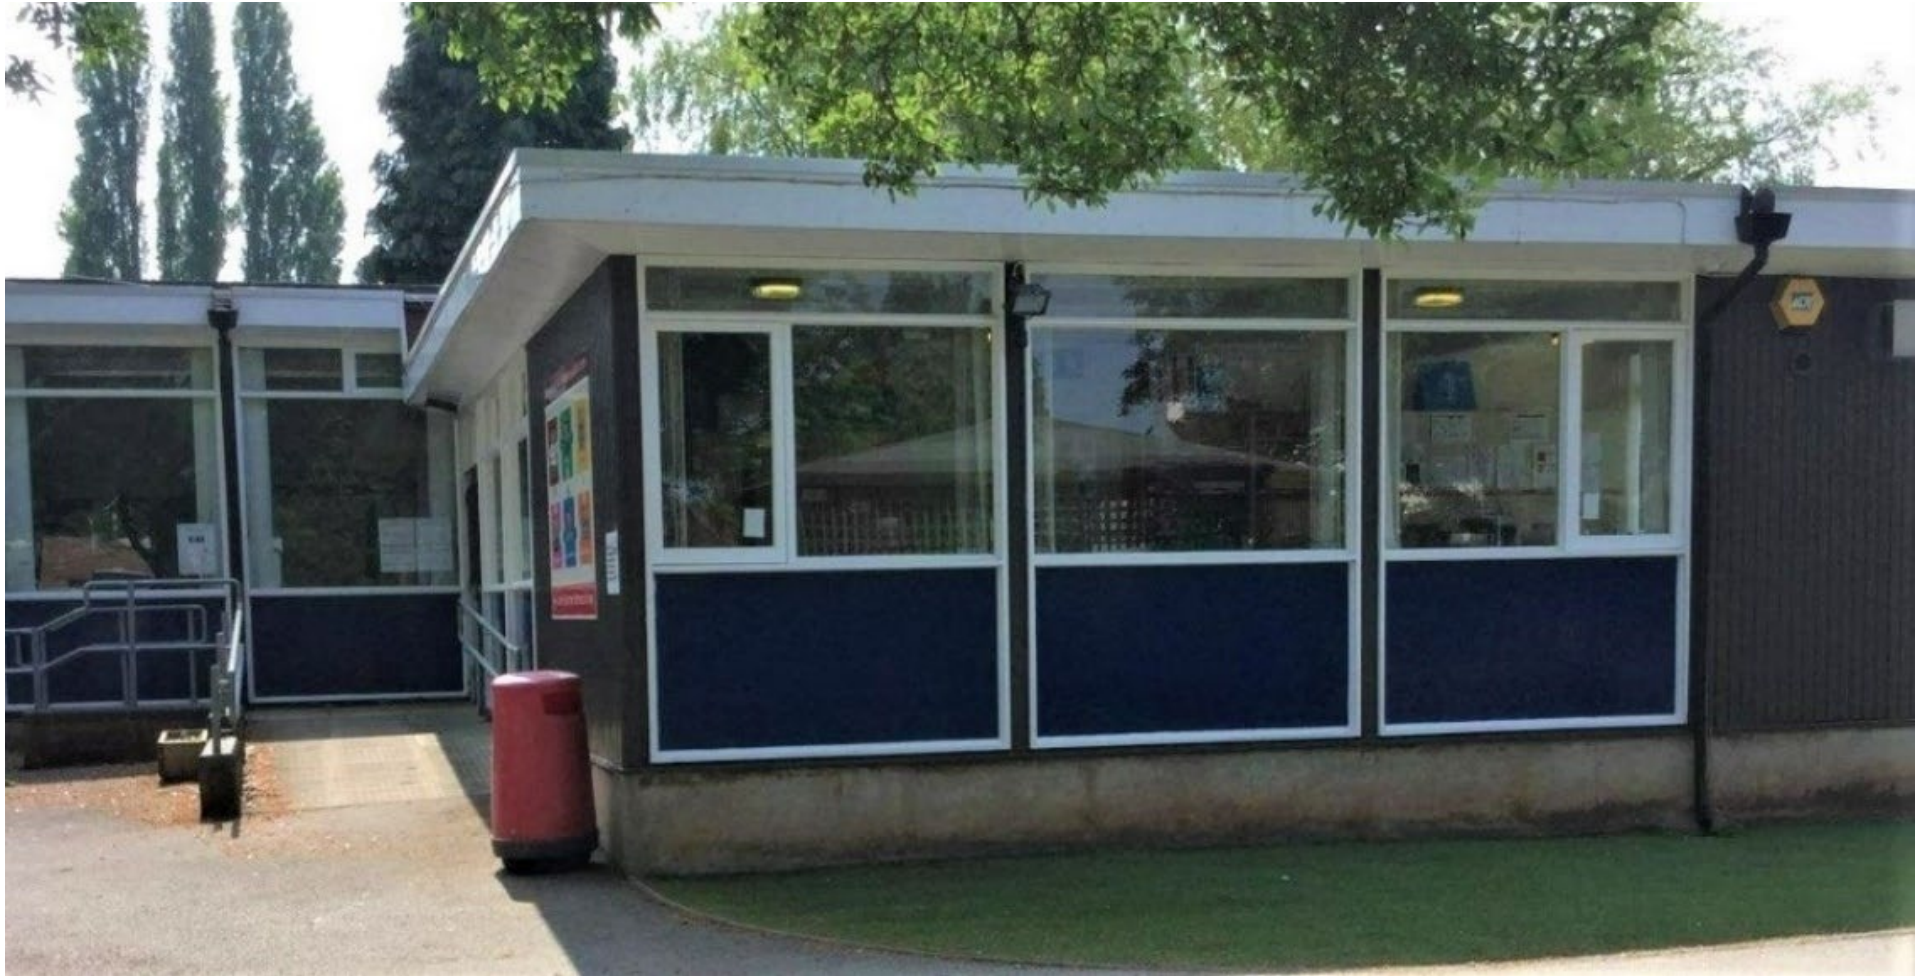
Figure 8: Example of Derwent school accommodation

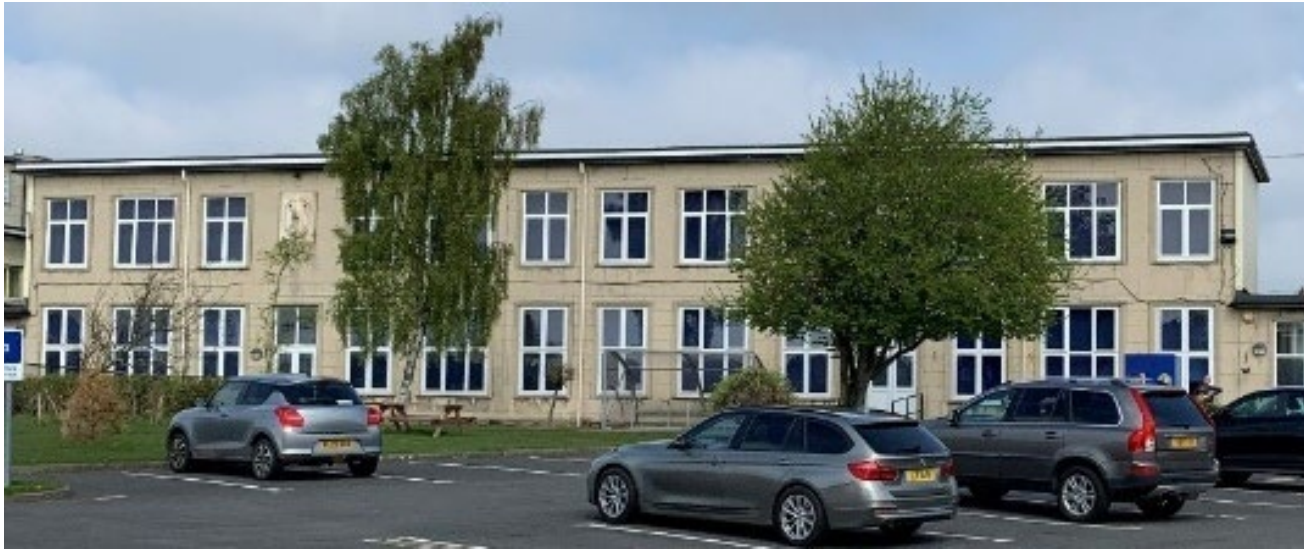
Figure 15: Example of Orlit school accommodation

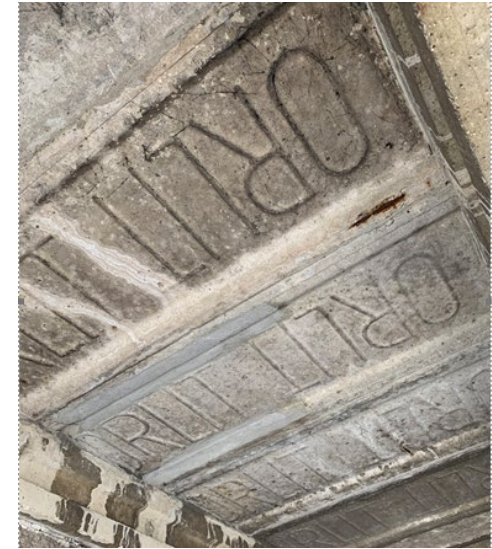
Figure 16: Orlit soffit

Note: Slabs are not always imprinted with 'Orlit'.

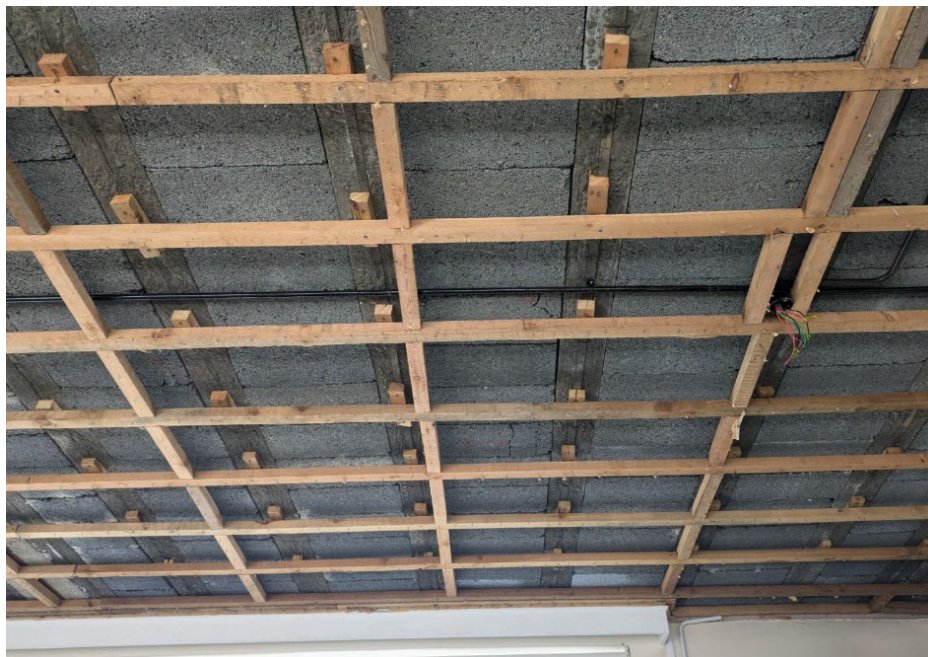
Figure 22: Example of soffit to beam and hollow pot floor

Beam and hollow concrete pot floor systems are typically constructed from precast concrete beams or 'ribs' at regular spacings with hollow concrete blocks or 'pots' placed on site to infill between the beams. A concrete topping or screed may also be laid over the beams and pots to complete the floor structure. These floor and roof systems have less steel reinforcement in them than would be expected in modern buildings.

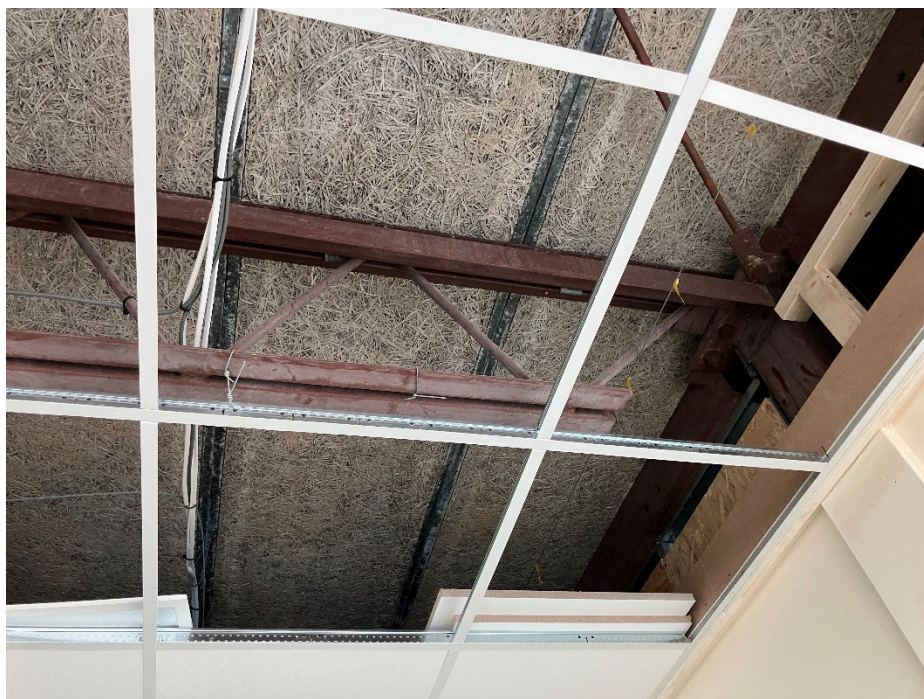
Figure 28 - Woodwool roof slab supported by steel trusses
