7 CONCLUSIONS AND RECOMMENDATIONS

Proposed Residential Conversion of first and second floors
110 East Street Bedminster Bristol

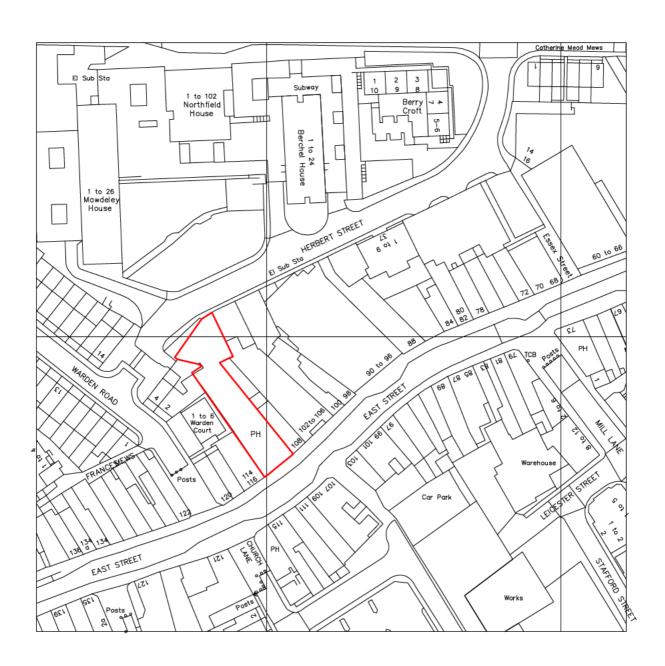
Scale 1: 1250 Date : Sept 2022

Drwg No 3568/6
David Cahill Design Consultant

- (i) Site Location Plan
- (ii) Existing Site Plan
- (iii) Proposed Development Plan

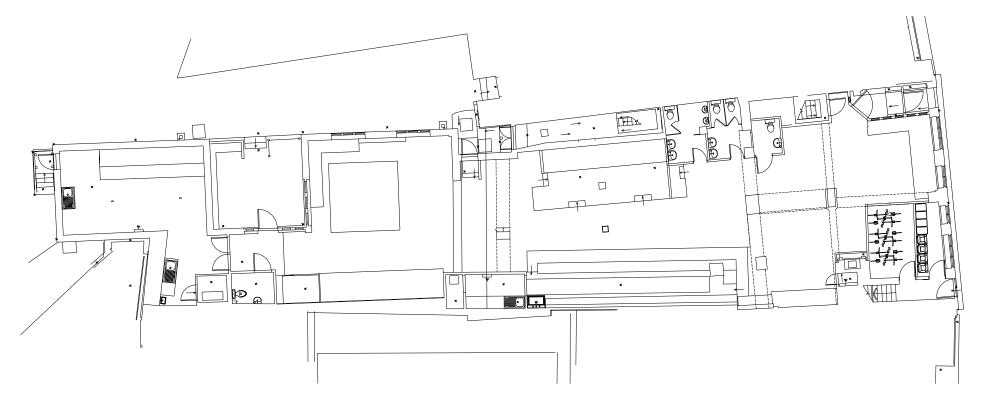
Existing Ground Floor Plan

Note: Internal layouts based on approved drawings for application reference 23/00686/F, which is currently being implemented
