**FIRST - TIER TRIBUNAL  
PROPERTY CHAMBER  
(RESIDENTIAL PROPERTY)**

**Case Reference** : **BIR/37UF/HIN/2024/0623**

**Property** : **St Crispins Court Stockwell Gate  
Mansfield, NG18 5GL**

**Type of Application** : **An appeal against an Improvement Notice  
under para 10(1) Schedule 1 of the Housing Act  
2004 (“the Act”).**

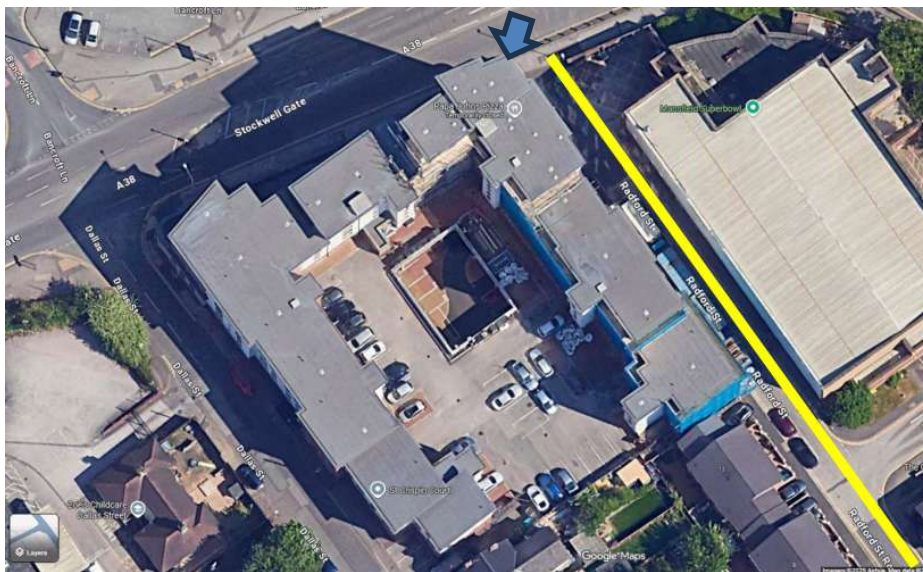
17. The means of escape from each residential block is via the single staircase leading through an external fire door to the upper podium level of the central car park. *Figure 1* is a satellite view showing the three sides of the U which face out onto Dallas Street, Stockwell Court and Radford Street, and the central podium level carpark. The blue arrow shows the orientation of the photograph at *Figure 2*.

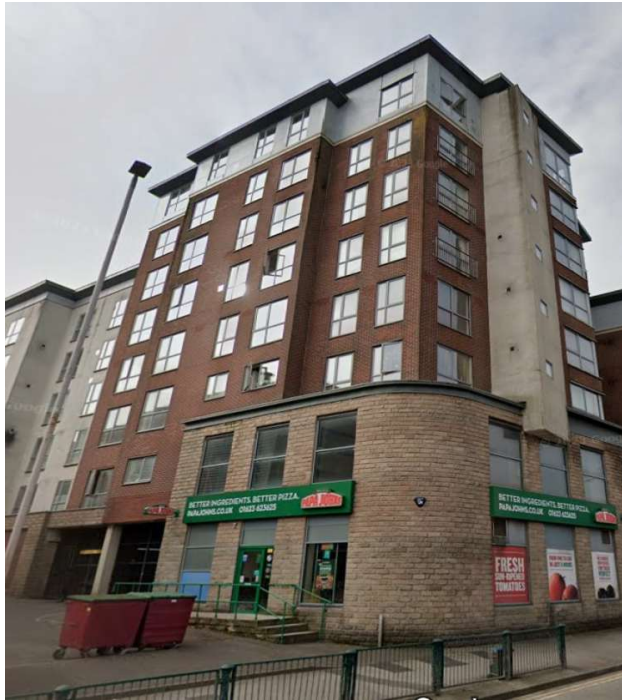
18. The paragraph 6 issue concerns Block E which comprises the northernmost corner block fronting Stockwell Gate and Radford Street. It sits on the lowest part of the slope. Access to the residential floors of Block E is through an external fire door on the rear upper carpark level into a central lobby giving access to an enclosed stairwell and lift. The stairwell and lift open onto similar lobbies on each floor, from which the flats are accessed. There are three flats on floors 1 to 3, and four flats on floors 4 to 6. *Figure 2* shows the external elevations of Block E facing Stockwell Gate and Radford Street, the access point from Radford Street.

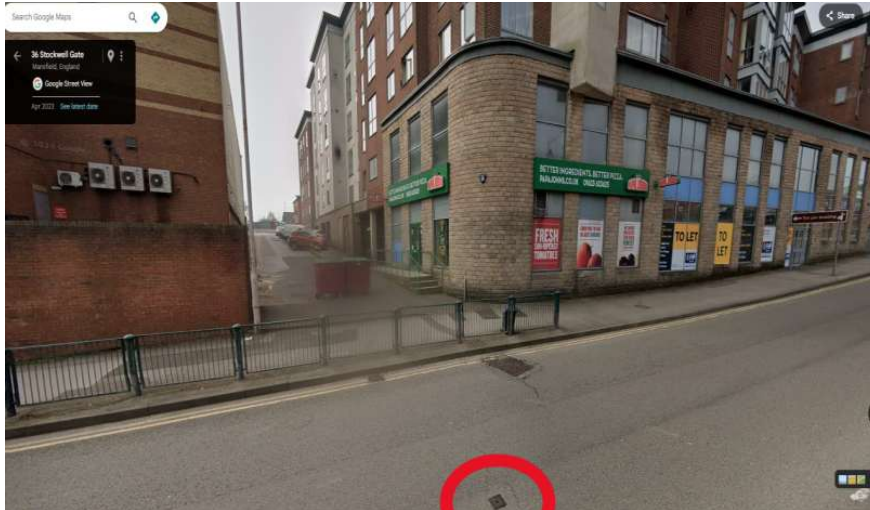
*Figure 3 showing position of fire hydrant*

- e. In her witness statement of 16 October 2025 Ms Flanagan commented that the fire and rescue service vehicle access for Block E is at ground floor level on Radford Street and the closest hydrant serving the vehicle access level is Stockwell Gate (*Figure 3*).

54. In oral evidence Ms Flanagan confirmed that; the improvement notice was issued in consultation with NFRS; the closest parking for fire service vehicles is Stockwell Gate outside PapaJohns (beneath Block E) and on Radford Street; In all the Respondent's work with NFRS, Stockwell Gate has been stated as the vehicle access point for Block E; The hose can be run through the Radford Street site access and lifted onto the podium level via decking; She had not witnessed the NFRS training exercises but from conversations with NFRS she understood that in an emergency situation the site would be flooded with fire service appliances allocated to different parts of the site to meet dynamic evolving events; The biggest issue is the height of Block E and NFRS main focus would be to access the nearest hydrant, which is the one on Stockwell Gate; Training exercises are not real events, Dallas Street is the entrance used for non-emergencies. In an emergency, 5 vehicles would be sent, and the main trunk roads would be closed, this doesn't happen on training events.
