Department  
for Education

# **Managing Older Buildings:**

**A guide for estates maintenance staff**

**July 2026**

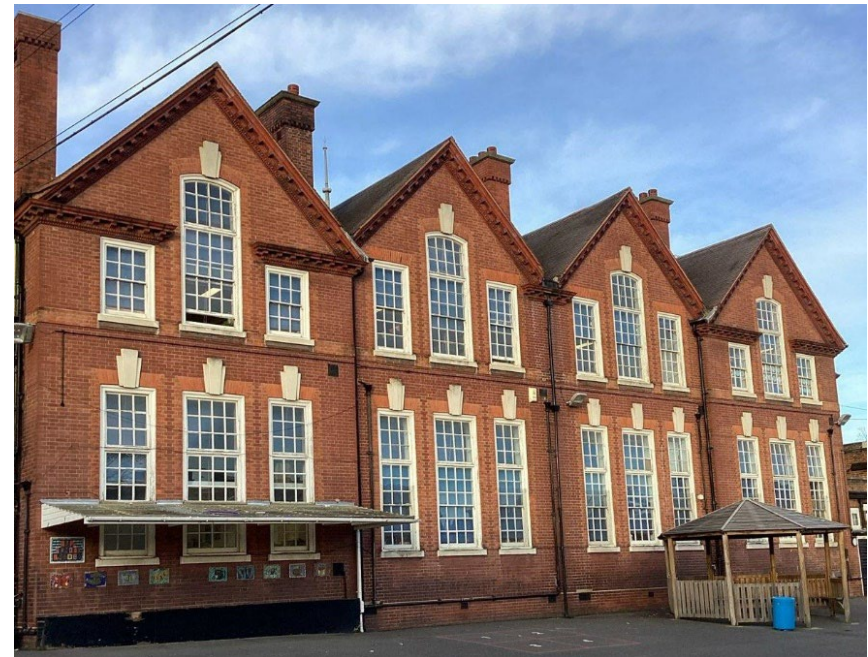
**Figure 1: Example of a traditional pre-war school building constructed from masonry with a pitched roof and chimney features**

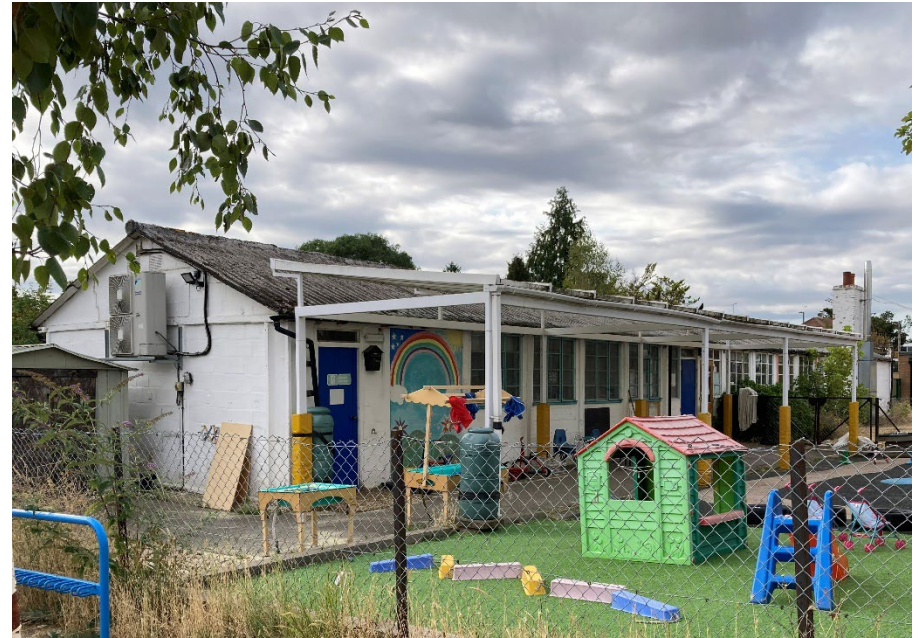
**Figure 2: Example of a simple, single-storey prefabricated HORSA hut with a lightweight structure and shallow roof**

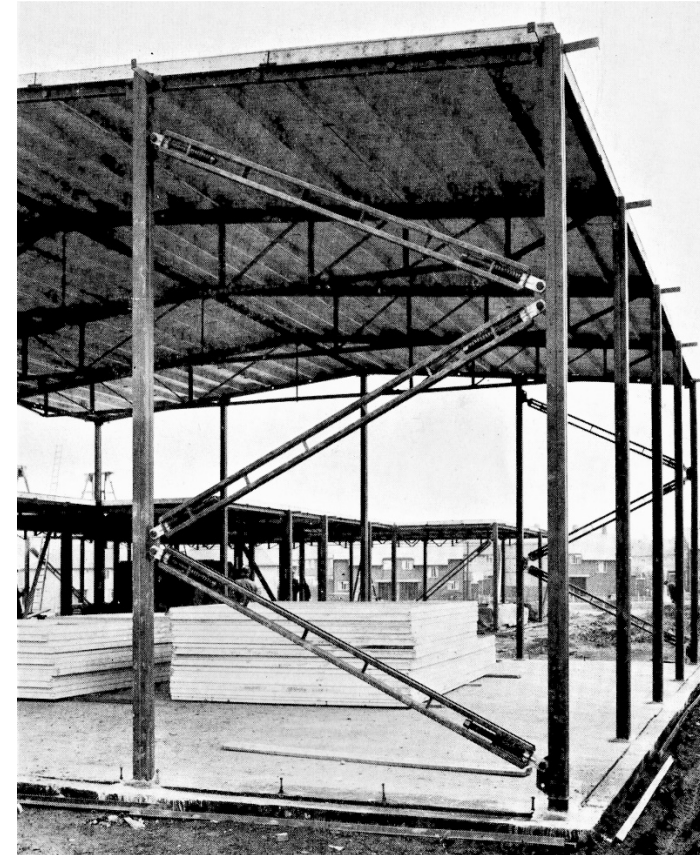
Figure 3: Example of a post-war CLASP system school building with a modular frame

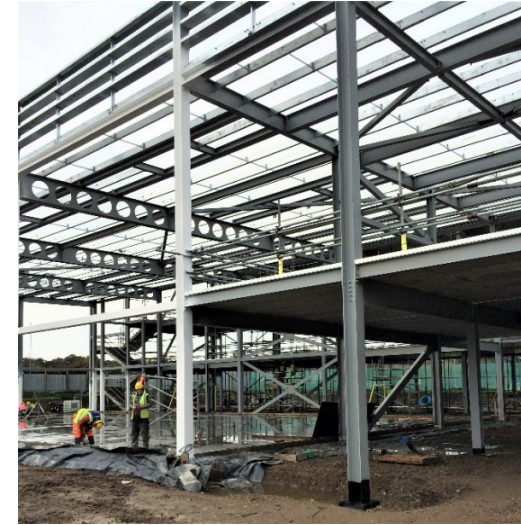
**Figure 4: Example of a steel-framed school building**

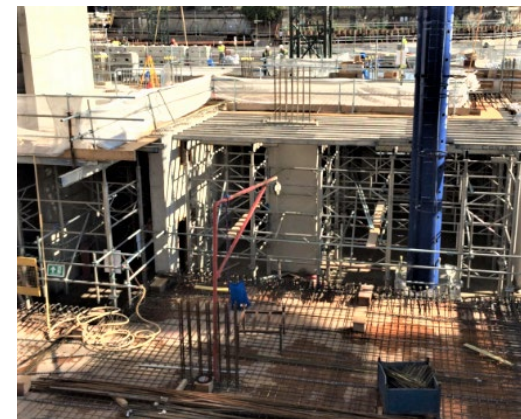
**Figure 5: Example of a concrete-framed school building**

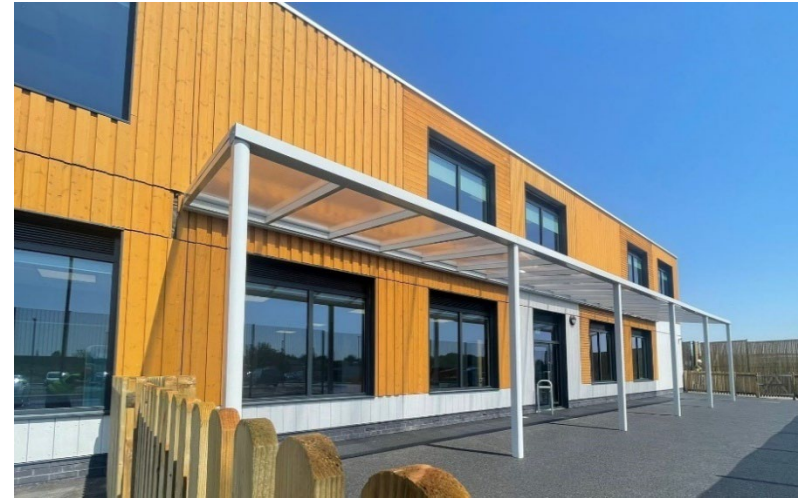
**Figure 6: Example of a completed modular school building using modern methods of construction**

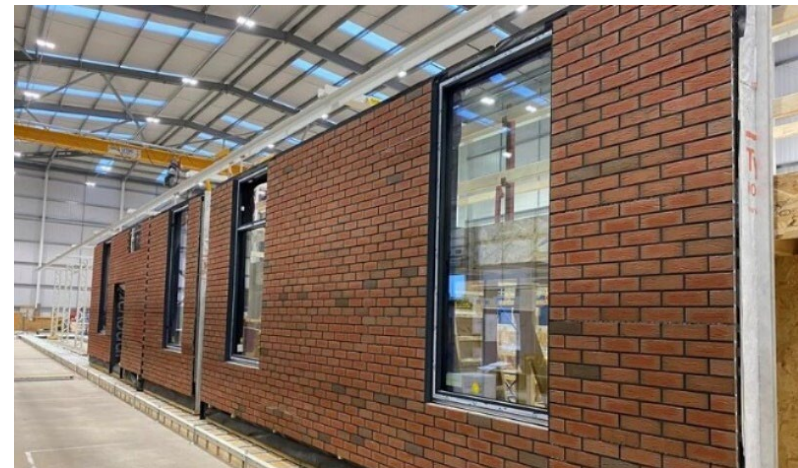
**Figure 7: Example of off-site manufacture of modular building units within a factory environment**

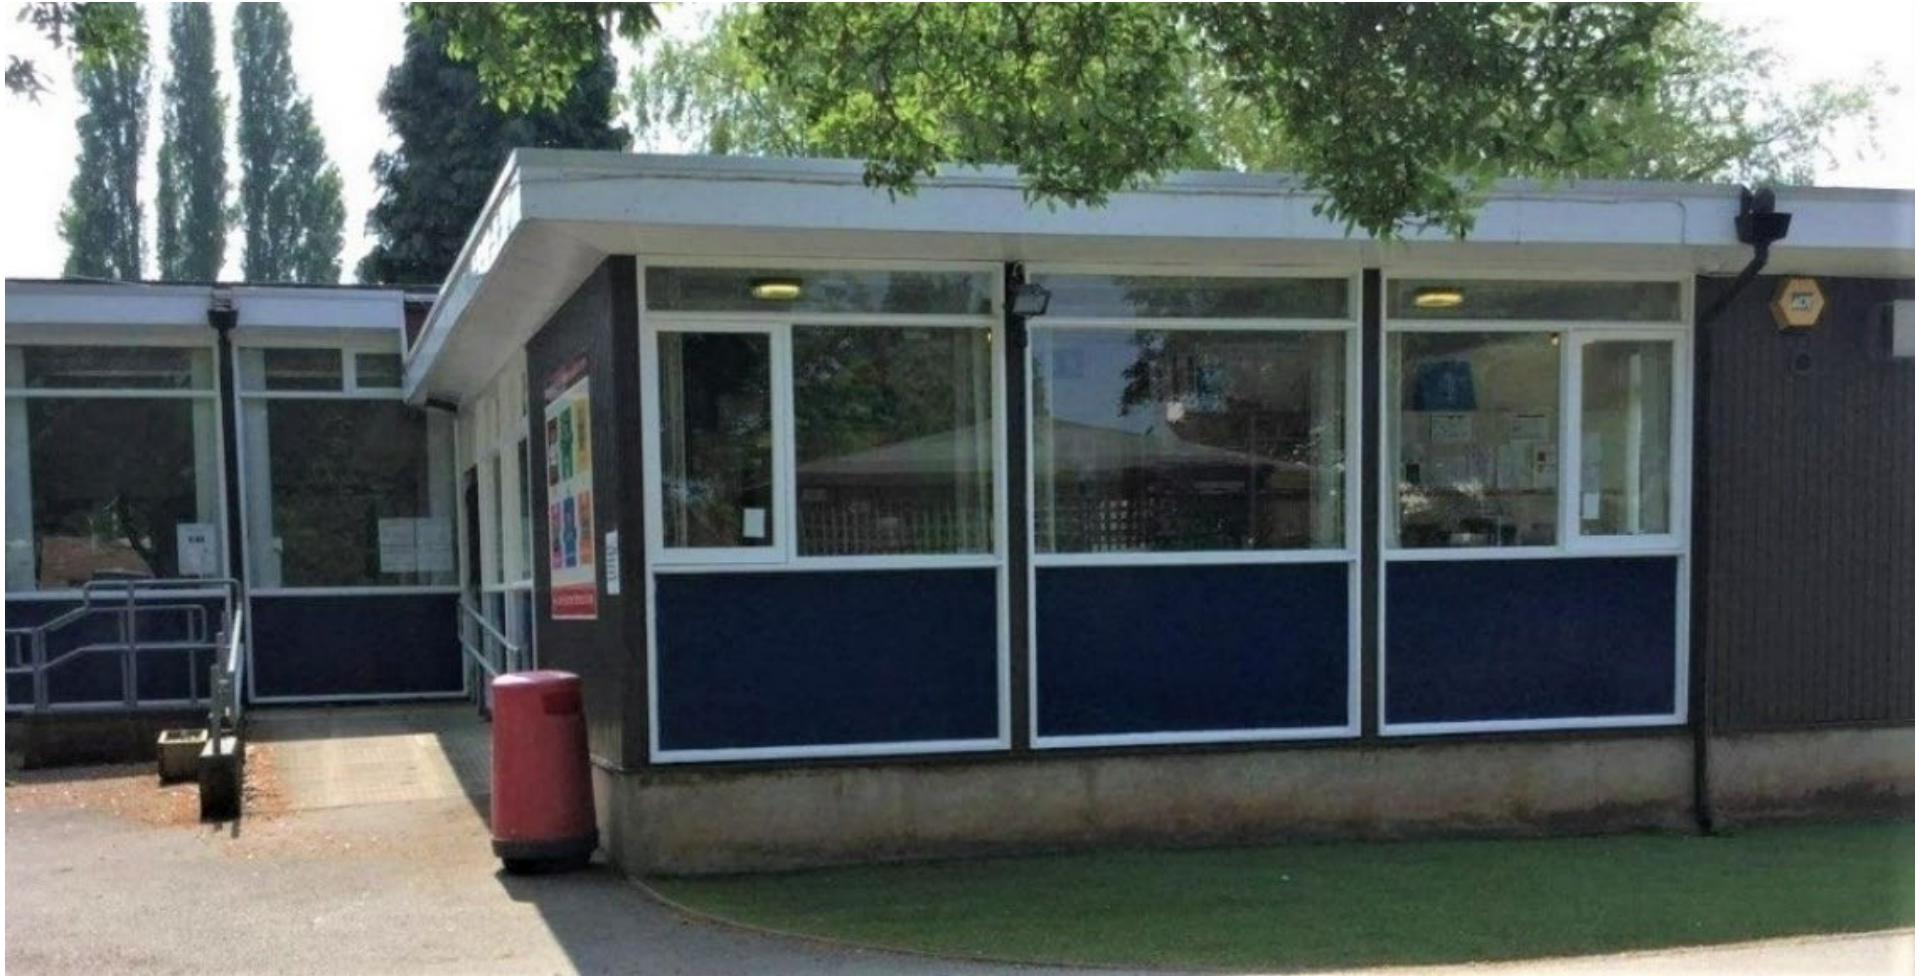
Figure 8: Example of a Derwent system school building with panelised external cladding

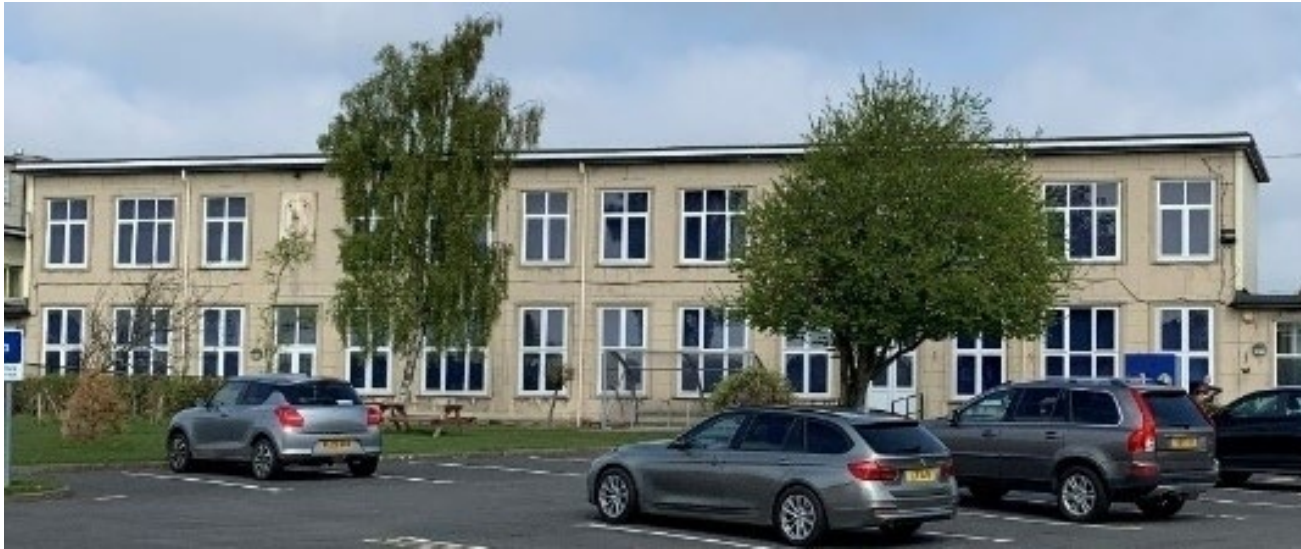
**Figure 15: Example of an Orlit system school building with a precast concrete frame and panel construction**

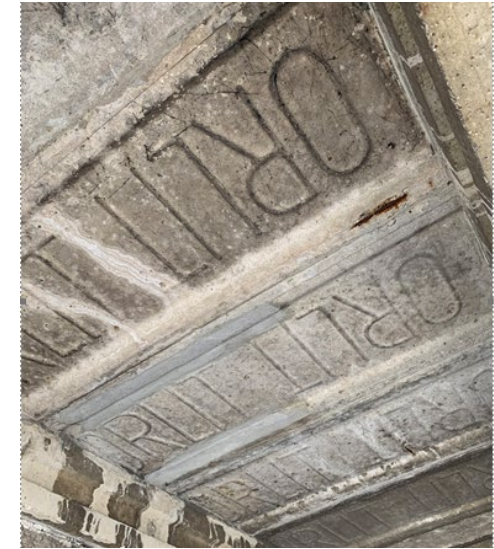
**Figure 16: Example of an Orlit soffit**

Note: Slabs are not always imprinted with 'Orlit'.

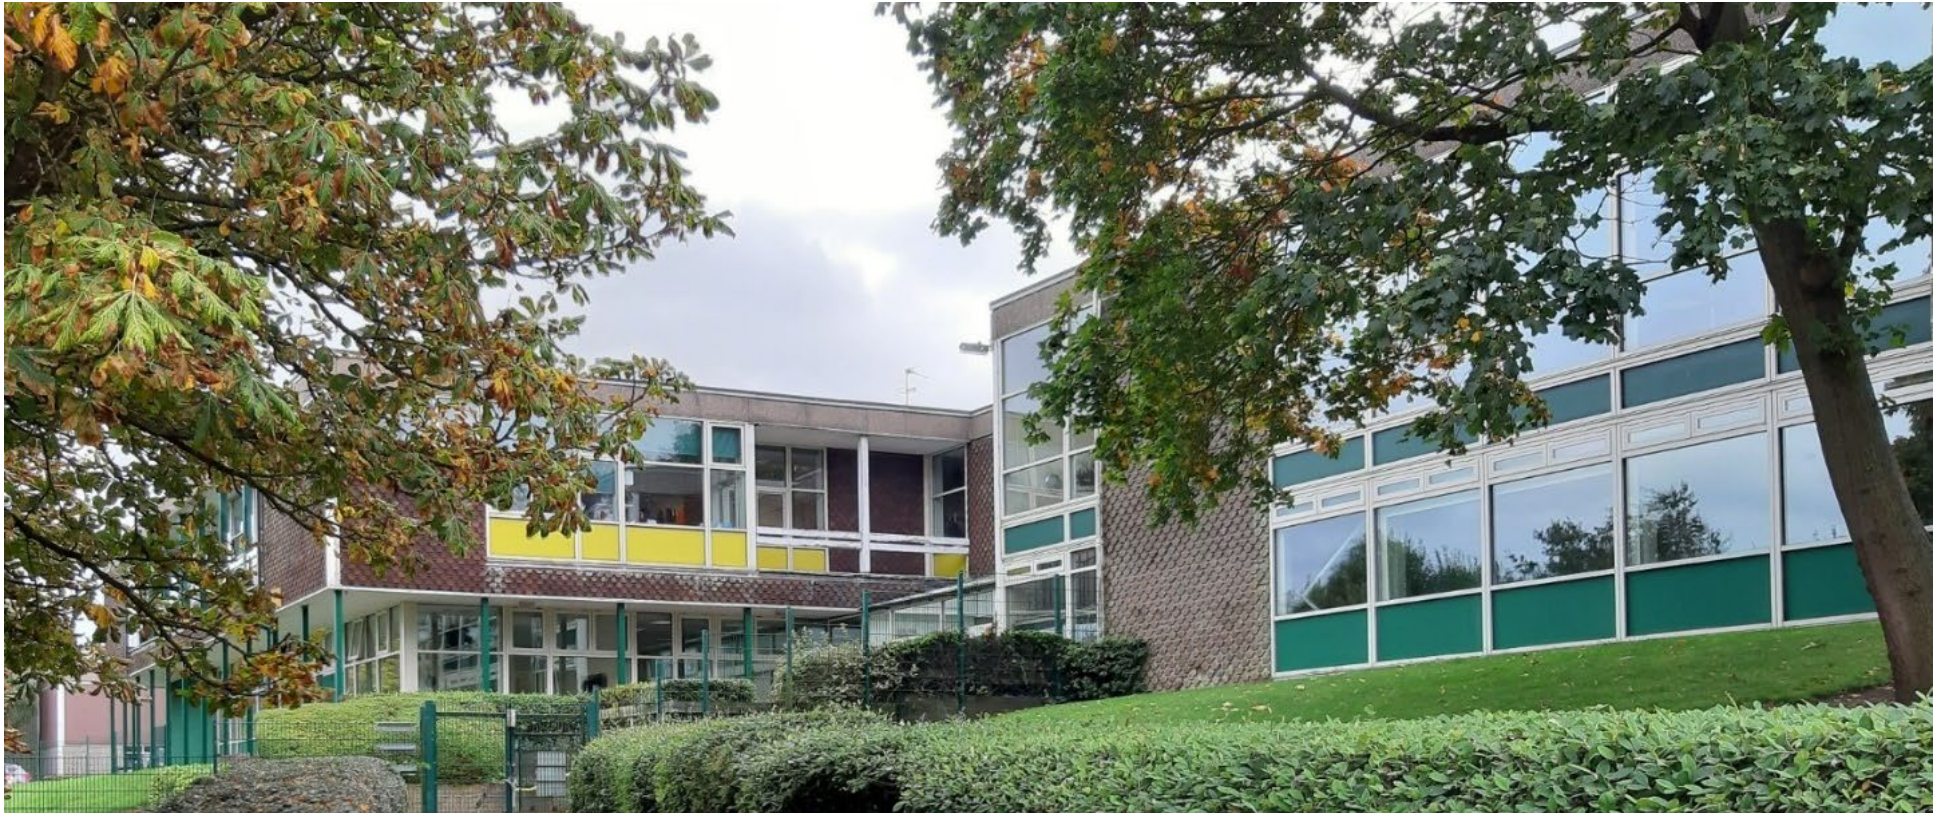
Figure 17: Example of a CLASP system school building with steel frame and external cladding panels

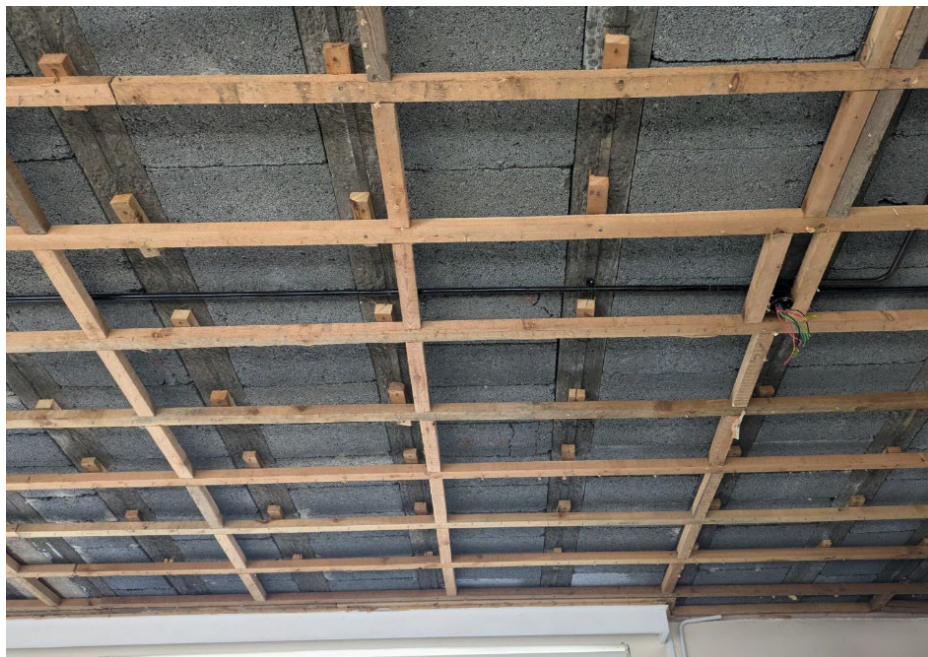
Figure 33: Example of a soffit to a beam and hollow concrete pot floor system

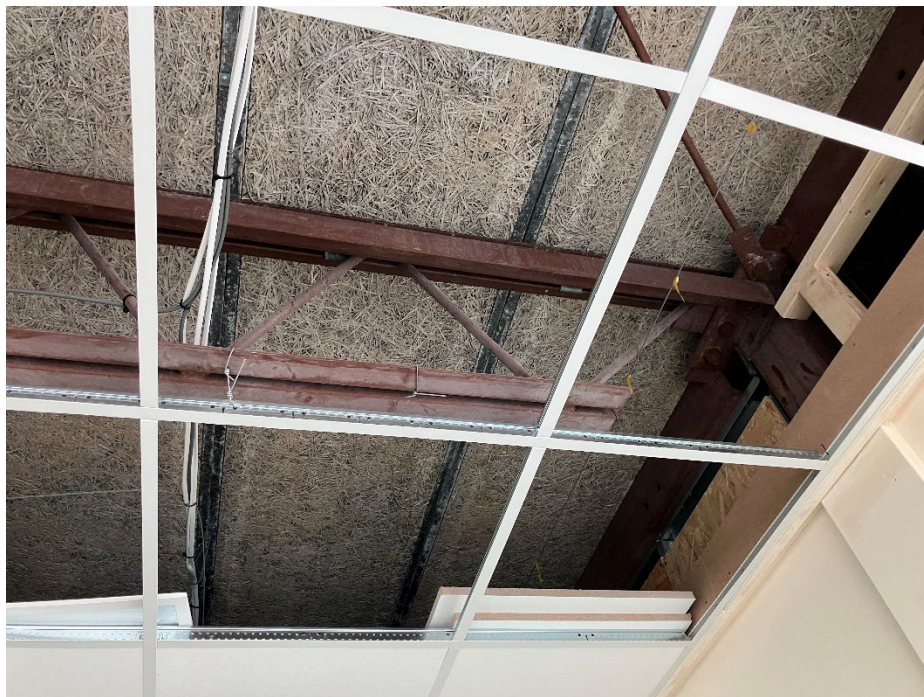
Figure 40: Woodwool roof slab supported by steel trusses

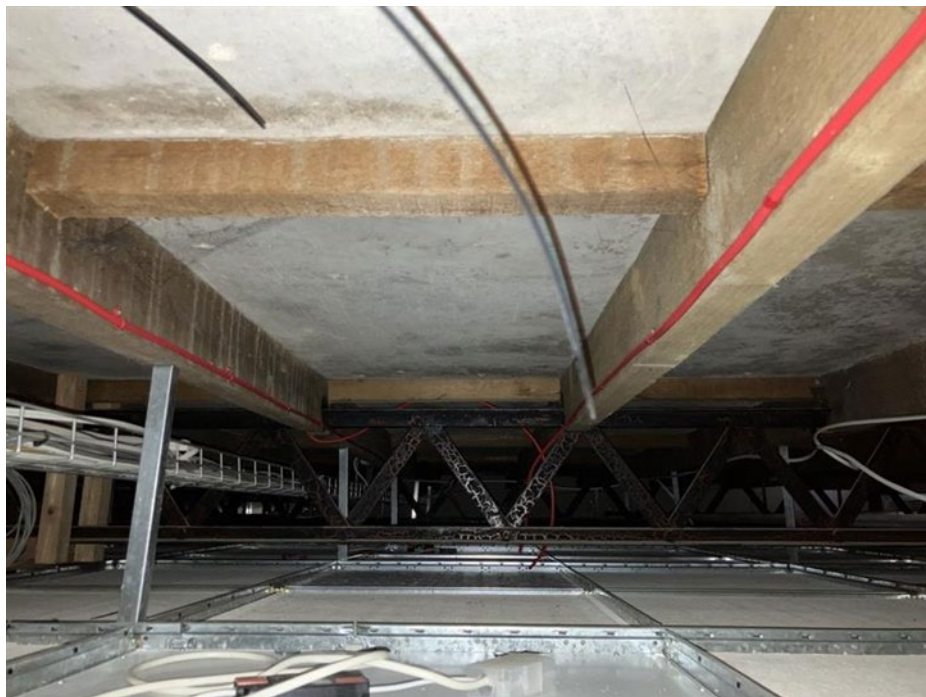
**Figure 41: Example of a TonkinDek slab roof system constructed from composite board materials**

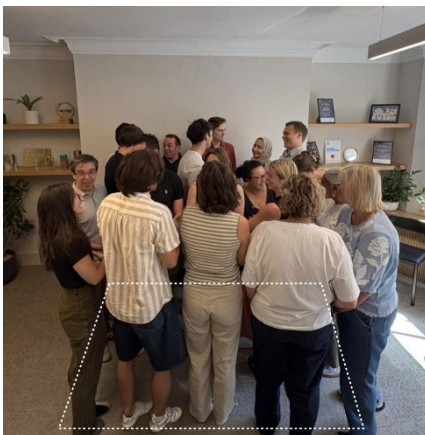
**Figure 44: Image showing permissible loadings for a classroom equating to 3.0kN/m<sup>2</sup> (equivalent to 300kg/m<sup>2</sup>)**

Figures 42 to 45 show the design loadings set out by current codes of practice for common uses of education buildings (specifically the variable actions or 'live' loads stated in the National Annex to BS EN 1991-1-1). When considering changes of use to spaces (for example, from a classroom to a library or storage area) it is important to consider whether the loads applied in the new configuration may exceed those considered in the original design. If this is the case, the structure may be overloaded resulting in damage or collapse.

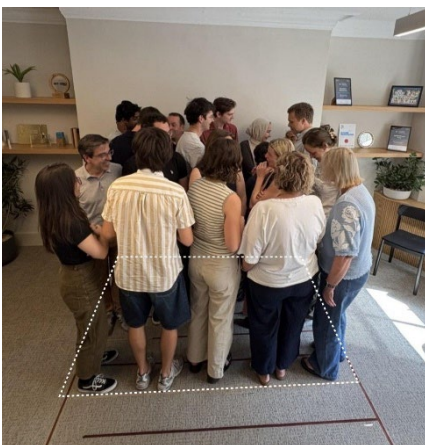
**Figure 45: Image showing permissible loadings for a corridor or stair equating to 4.0kN/m<sup>2</sup> (equivalent to 400kg/m<sup>2</sup>)**
