Vessel: Maarisk Kithira

# SAFETY FLASH 01/2009

### Movement/Inspections on deck during heavy weather

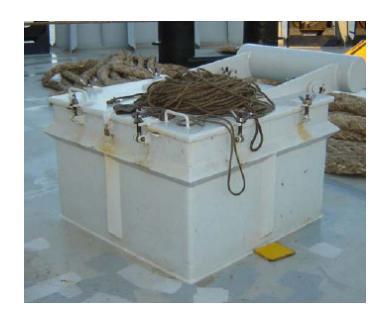
It appeared to the C/O's and the C/E's that there was a leakage from the forward store hatch. The C/O & C/E informed the bridge that the situation forward seemed favourable enough and that they would assess on deck whether the weather would allow further securing of the hatch once the vessel was steadied.

Once the vessel was steadied for about ten minutes, both the C/E and C/O made the decision to go up to the maindeck entrance, which is situated some 15 metres aft of the gulfbreaker on the foc'sl, to check out the weather circumstances.

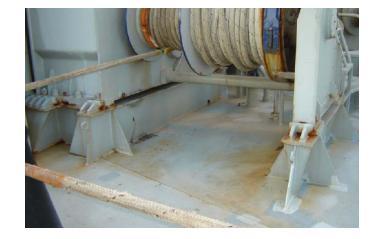
Busy with securing the ocean lashing, a green sea came over the foc'sl deck and both men were washed off their feet, with the C/E lying under the SB winch drum. Both the C/O and C/E were heavily wounded and requested assistance.

Unfortunately after all due medical care, the C/E passed away the following night as a result of the internal wounds which he had sustained during the incident.

- Review/create new and if necessary revise the SJA "Movement on Deck during Heavy Weather" to include lessons learnt from incident.
- Departure checks should be reviewed, especially when heading into rough weather.

- Avoid inspections on deck during dark hours
- If circumstances make it necessary to go on deck, make sure that the vessel is heading in such a direction that 'green water' cannot be encountered.
