# Development of Design Standards for Low-Volume Roads in Ethiopia AFCAP/ETH/005/A

Otta Seal Demonstration project: Combel Village, Tulubolo-Kela Road Construction and Workshop Report Report No. CPR1614

May 2013

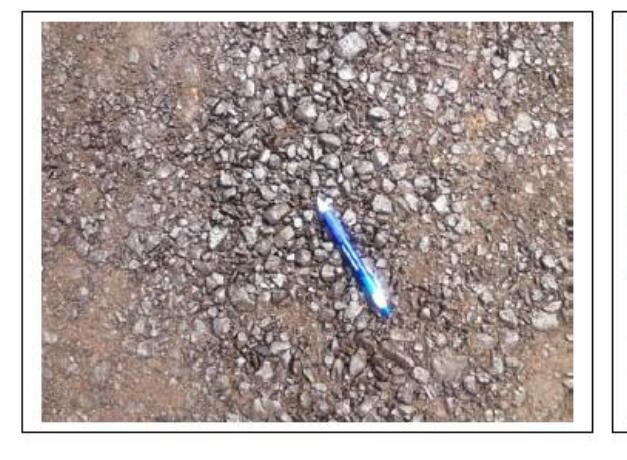
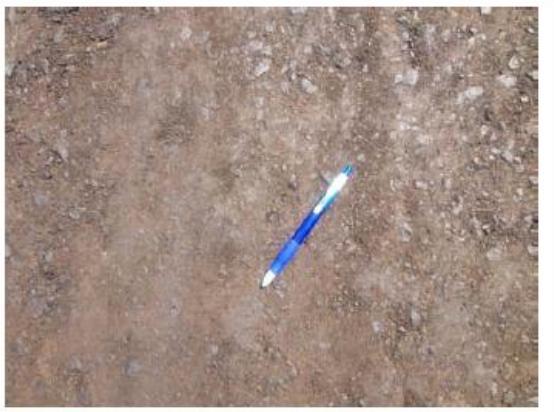
#### Figure 2 Coarse base and dense base layers after priming

The primed base was in a general satisfactory condition but segregation in the base material in localised areas left the base rather open in general from chainage 0 to 600 metres. The binder application rates for the surfacing were slightly increased in these areas to allow for this. From chainage 600 - 1000 metres, the base was very dense and hard. At the end of the section chainage 1000 - 1900 metres the base had become somewhat loose and areas with lamination and had to be improved prior to sealing. Figure 2 shows two photographs of the primed base.

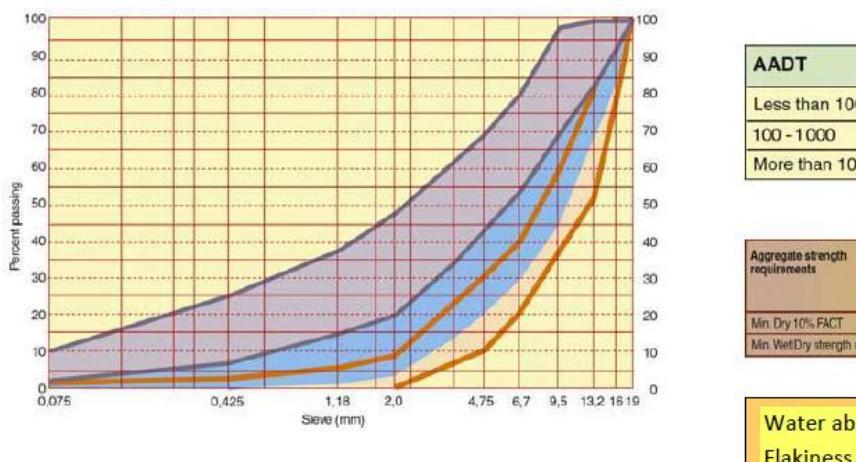
Figure 3recommended aggregate properties for an Otta seal

The recommended grading limits and other commonly-used key aggregate properties for an Otta seal are shown in Figure 3.

AADT	Best suited grading
Less than 100	"Open"
100 - 1000	"Medium"
More than 1000	"Dense"

Aggregate strength requirements	Vehicles per day at the time of construction		BS Test Designation
	< 100	>100	i.
Min Dry 10% FACT	90 k N	110 k N	BC 812
Min WetDry strength atto	0,60	0.75	00 012

Water absorbency max. 4%. PI max. 10. Flakiness Index for crushed aggregate 30

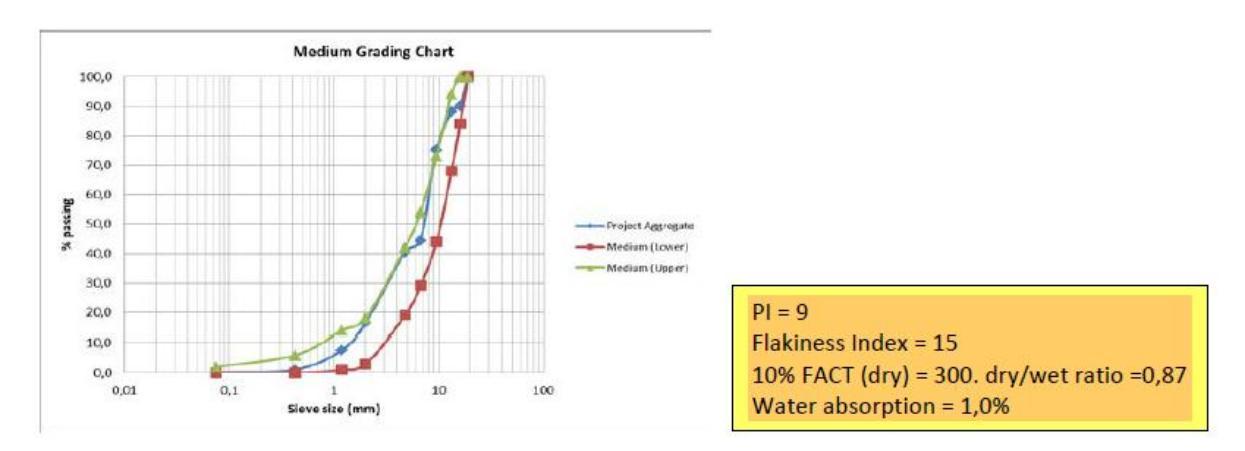
The aggregate produced from crushed rock was obtained from the quarry at Awash. The parent rock was "hard" fresh rock basalt. Three size fractions ( $\frac{3}{4}$ ",  $\frac{3}{8}$ " and < 5.0 mm) were produced at the quarry, hauled to site and mixed at site in the proportions of 2 + 2 + 1, respectively, to produce the required grading. The resulting grading and other key properties are shown in figure 4.

The grading of the above material follows the "medium" grading in the Otta seal Design Guide, although the material is somewhat gap-graded because the fraction between 6,7mm and 4mm is missing. The other key properties are well within the requirements such (e.g. PI of 9, Flakiness of 15, 10% FACT dry as high as 300kN and a wet/dry value of 0.87. Water absoption is low at 1,0%.

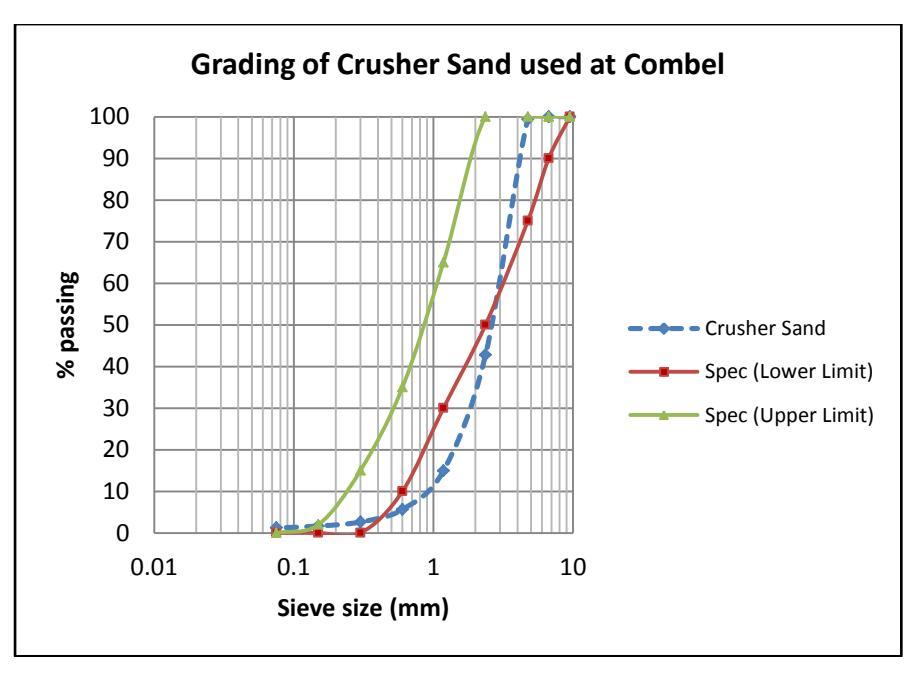
The crusher dust is the fine fraction (< 5mm) produced at the crusher. It is alaso often referred to as crusher –waste. The grading curve for the crusher dust is shown in Figure .

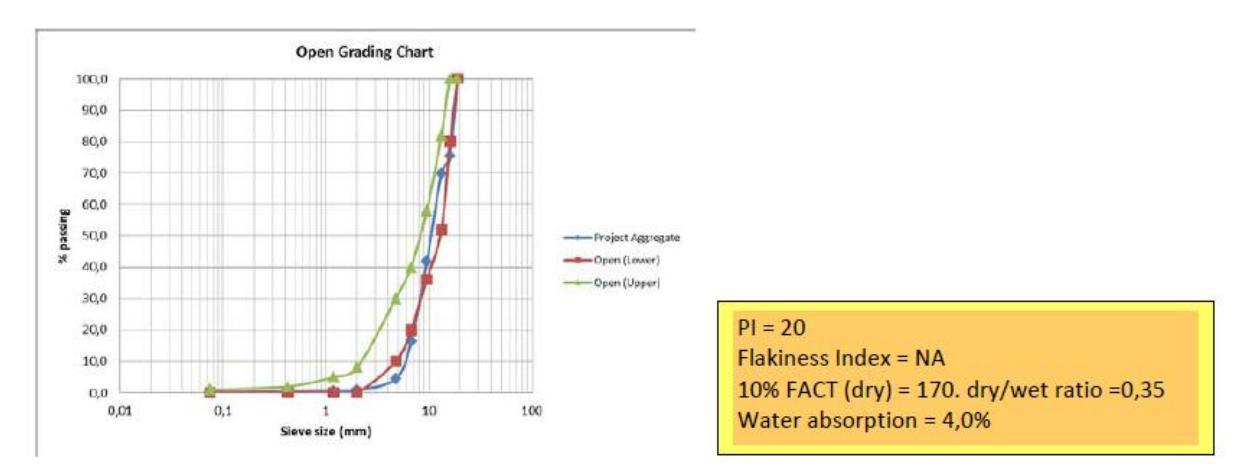
The source of the weathered basalt used for the base as surfacing aggregate was located approximately 5 km south of the demonstration project along the same road as the trial section. The aggregate was screened using labour-based techniques in order to remove oversize (> 19 mm) and fines. During the screening process some of the screens broke and as a result about 10 - 15% oversize were included. The grading and other key properties as shown in figure 6.

The grading follows the "open" grading, slightly gap-graded between the fractions 16 - 13 mm. The PI is as high as 20 and is in fact the double of what is recommended. The water absorption is 4% and is on borderline of what is recommended. The 10% FACT dry value is 170 kN and is within the strength requirement of 90 kN, however the wet/dry ratio of 0.35 is only ½ of the 0.75 requirement.

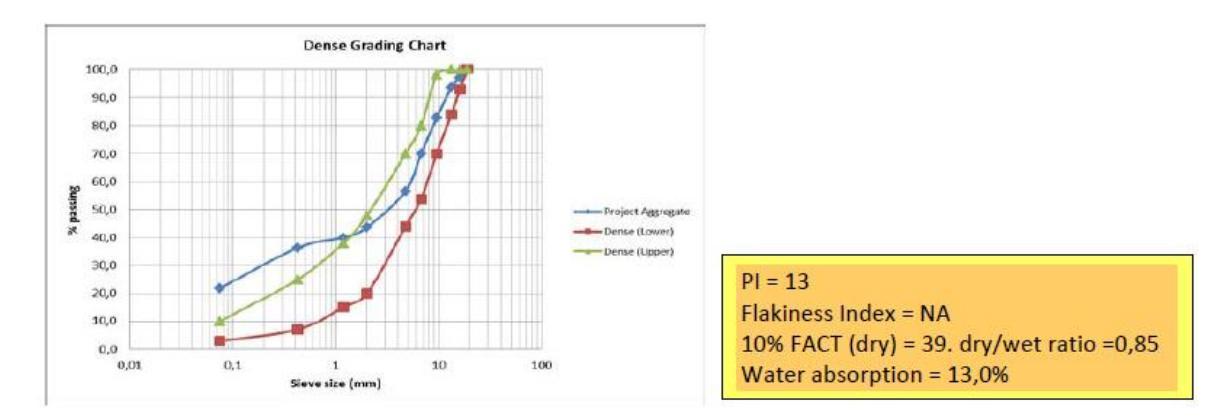
Figure 7 Grading curve for volcanic cinder gravel (screened) including other key properties

The source was about 46 km west of the demonstration project. Figure 7 shows the grading and other key properties for the cinder aggregate.

The grading follows the "dense" grading down to about the 2 mm sieve, then follows a much finer grading (about 10 %) than the recommended Otta seal grading requirements. The fraction passing the 0.075 mm sieve is 22%, which is more than double than the recommended value. The other key properties such as a PI of 13 is higher than the recommended value (10). The 10% FACT dry is as low as 39 (requirement 90) but the wet/dry ratio is 0.85. The most challenging parameter is the high water absorption value of 13%.

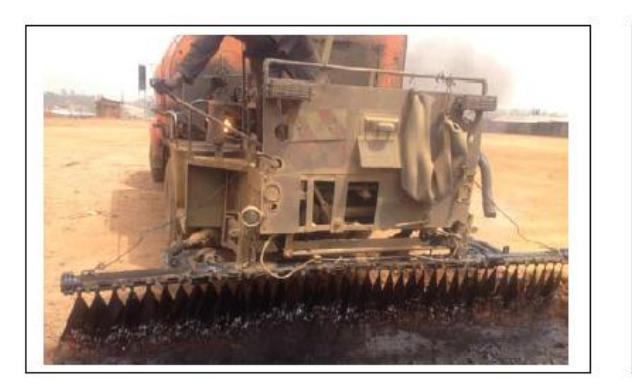
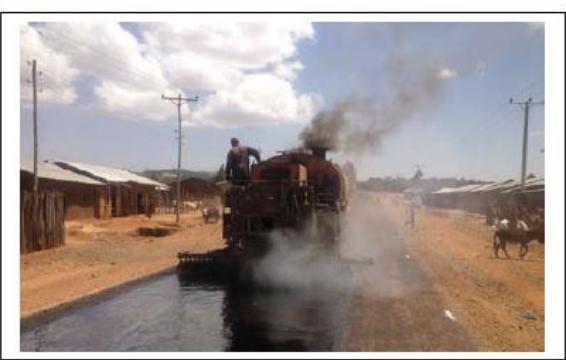
#### Figure 8 Checking the spray bar nozzles prior to spraying of binder

Prior to the daily sealing operations. the nozzels of the bitumen distributer where checked on site as shown in Figure 8.

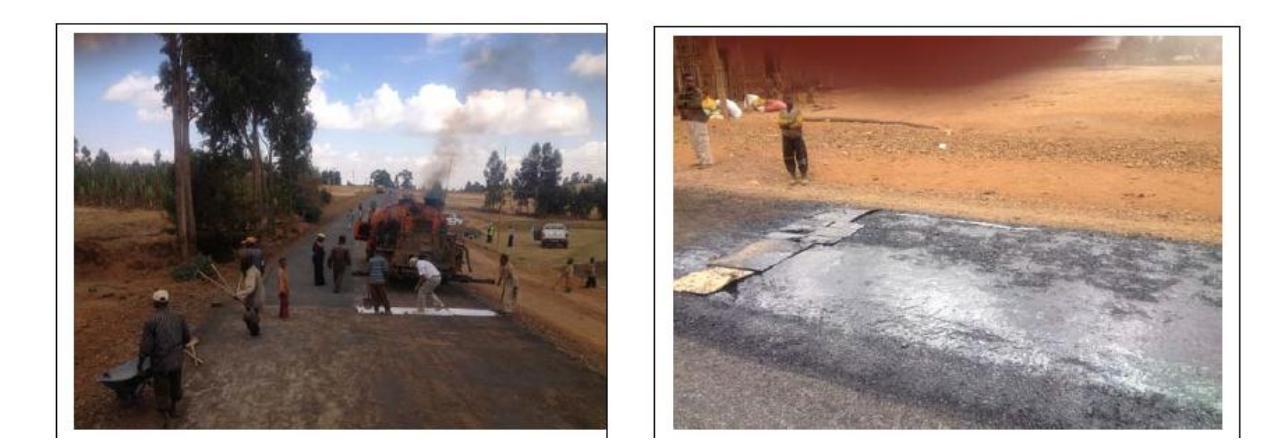
#### Figure 9 Paper laid to achieve straight transverse joints

Paper was laid between each start and stop position of the distributor in order to achieve straight transverse joints as shown in Figure 9.

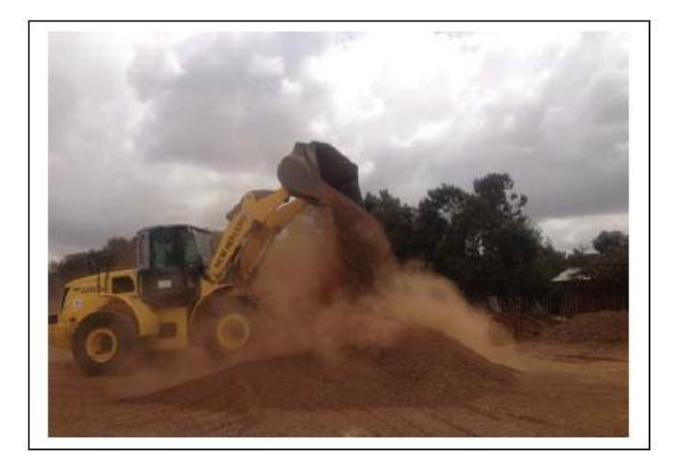
Figure 10 The front-end loader "airing" the aggregate in order to remove dust

The aggregate was pre-stockpiled in the site camp and before loading the aggregate into the tipper trucks, the front-end loader "aired" the aggregate in order to remove as much dust as possible. This entailed tipping the aggregate from a height above stockpile to allow the wind to blow away excess dust as shown in figure 10.

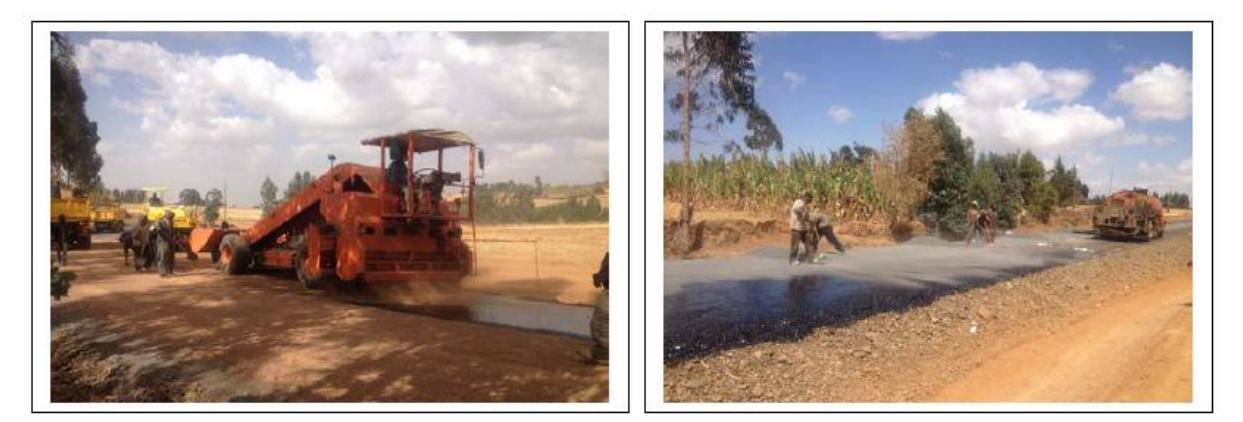
Figure 11 Self-propelled chipspreader in operation and the sprading of aggregate by the use of labour.

The aggregate application was carrried out by a self-propelled chip spreader which applied the aggregate evenly. However, due to two breakdowns some section of the medium hard natural decomposed basalt aggregate and the hard basalt aggregate had to be applied by the use of labour. This worked effectively but the spray length of the sections had to be reduced to about 50 metres in length to enable the aggregate to be applied when the binder was still hot. Also, for the sand seal section the crusher dust had to be spread by labour as the minimum opening for the chip spreader was too big for crusher dust.

The application rate of all the four types of aggregate was on the high side (about  $25 \text{ l/m}^2$  or even more) because of the relatively high rate of binder applied due to the difficulty of controlling the distributor spray rates. In fact, most of the entire length of the demonstration section was rechipped with aggregate due to the high binder spray rates in order to avoid excessive bleeding during the rolling operation. Figure 11 shows the self-propelled chip-spreader in operation and the spreading of aggregate by the use of labours.

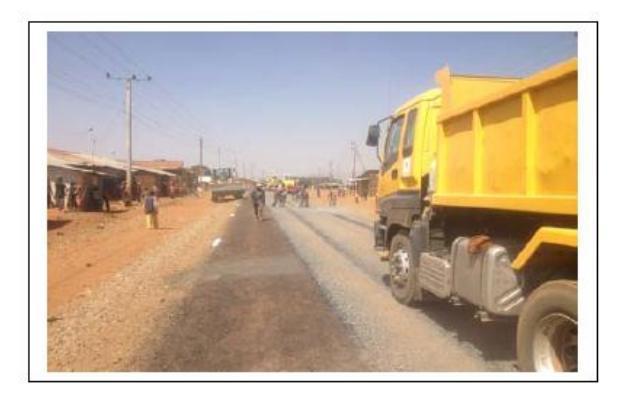
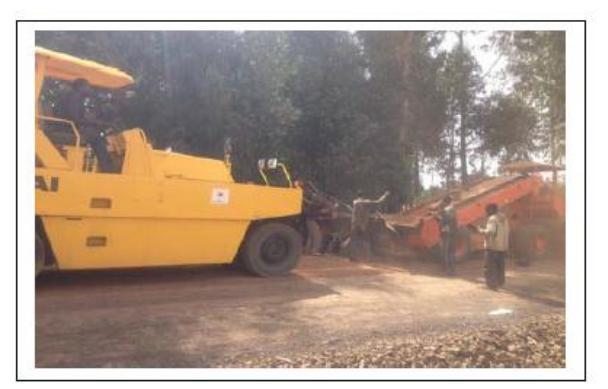
Figure 12 Rolling in progress by the use of both a pneumatic roller and the loaded tipper truck.

The rolling during the construction and after was carried out using a 12 tonne pneumatic roller, a 5 tonne steel roller and the two tipper trucks fully loaded with aggregate (capacity 9 m<sup>3</sup>). The rolling was carefully supervised so the entire width of the surfacing and all sections in the trial received adequate rolling. After completion of the sealing operations the entire length of the trial (1000 – 1800) received three days of full rolling using the same equipment,

except for the cinder aggregate which received only two passes of the steel to avoid the the weak aggregate was crushed down.

Figure 12 shows rolling with a loaded tipper truck and the pnumatic roller immediately after the chip-spreader
