EAST ANGLIA HOLM CHANNEL (EA9) FOCUSED ASSESSMENT EA9/2016–V3

An assessment of the 2016 hydrographic survey of the area: to monitor recent seabed movement; to identify any implications for shipping; and to make recommendations for future surveys.

HOLM CHANNEL FOCUSED, EA9, 2016

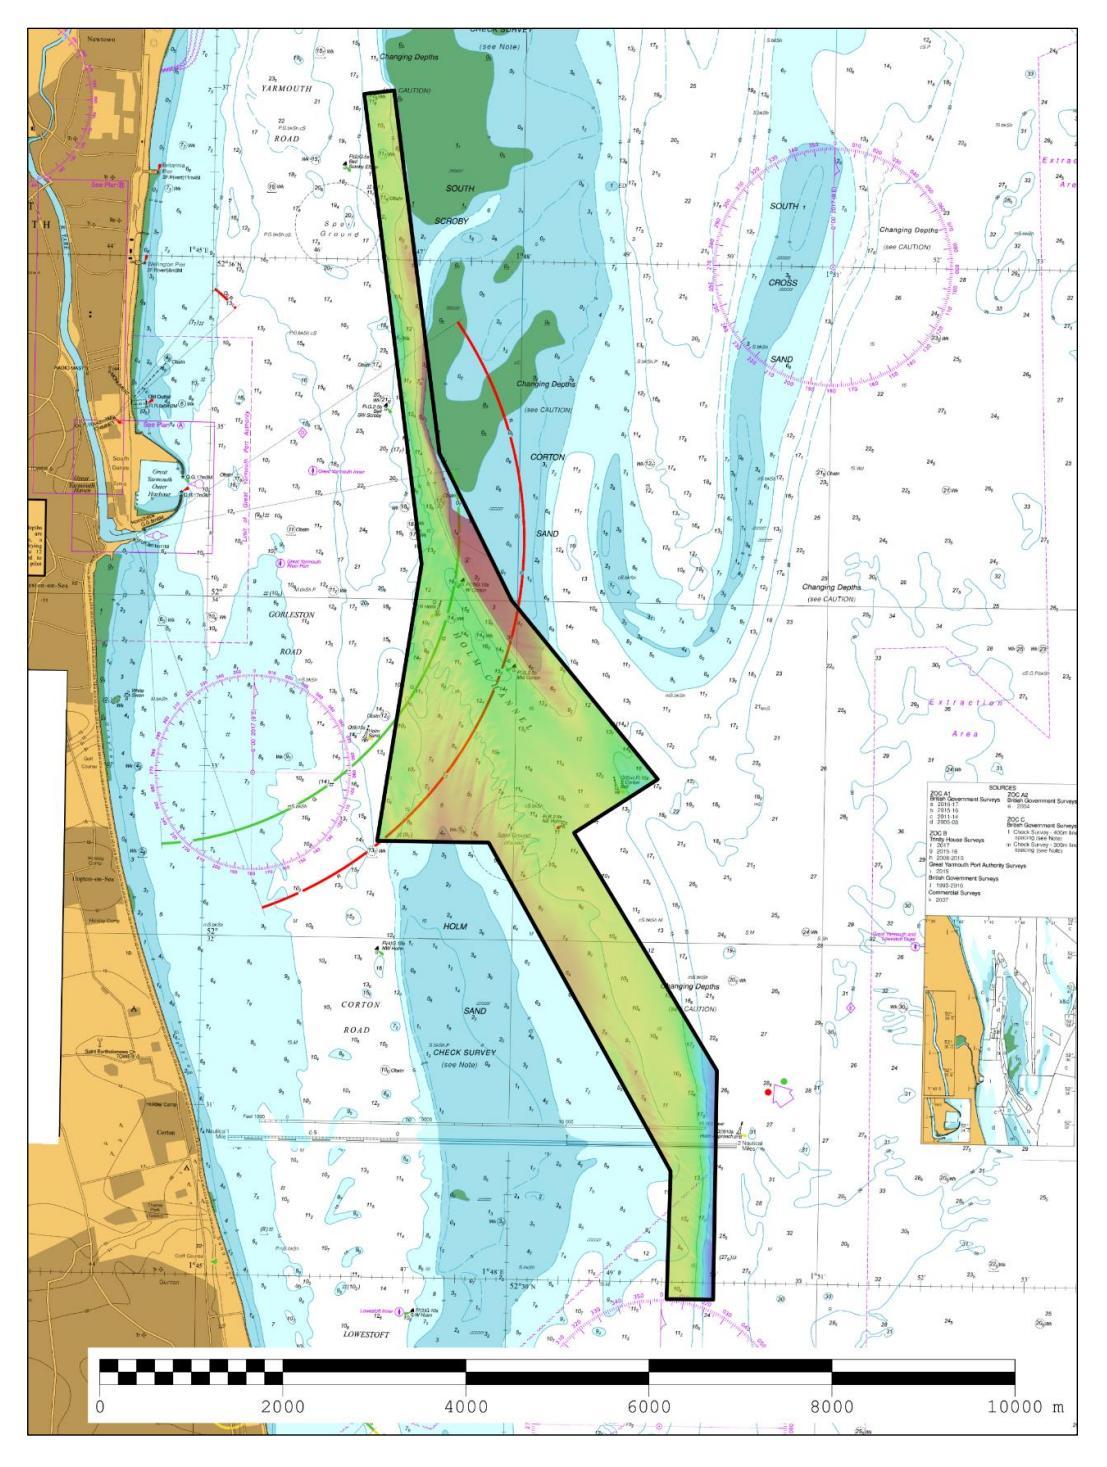
- 4.1 Focused area EA9 covers Holm Channel, which is the main approach to Great Yarmouth, and the banks that delimit it. The area extends south to cover the north and eastern banks of Holm Sand, and extends north to cover the southern and western banks of Corton Sand and South Scroby.
- 4.2 The focused area is sited within the limits of the full area EA9 which is surveyed every three years, covering: The southern end of Corton Sand and South Cross Sand, to the east of Holm Channel; and the eastern extent of Holm Sand.
- 4.3 Area covered during the focused survey: 3.55 NM² (12.2 km²) as shown in Figure 1 below.

Figure 1 – 2016 survey data sun-illuminated view overlaid on BA Charts 1534 and 1535

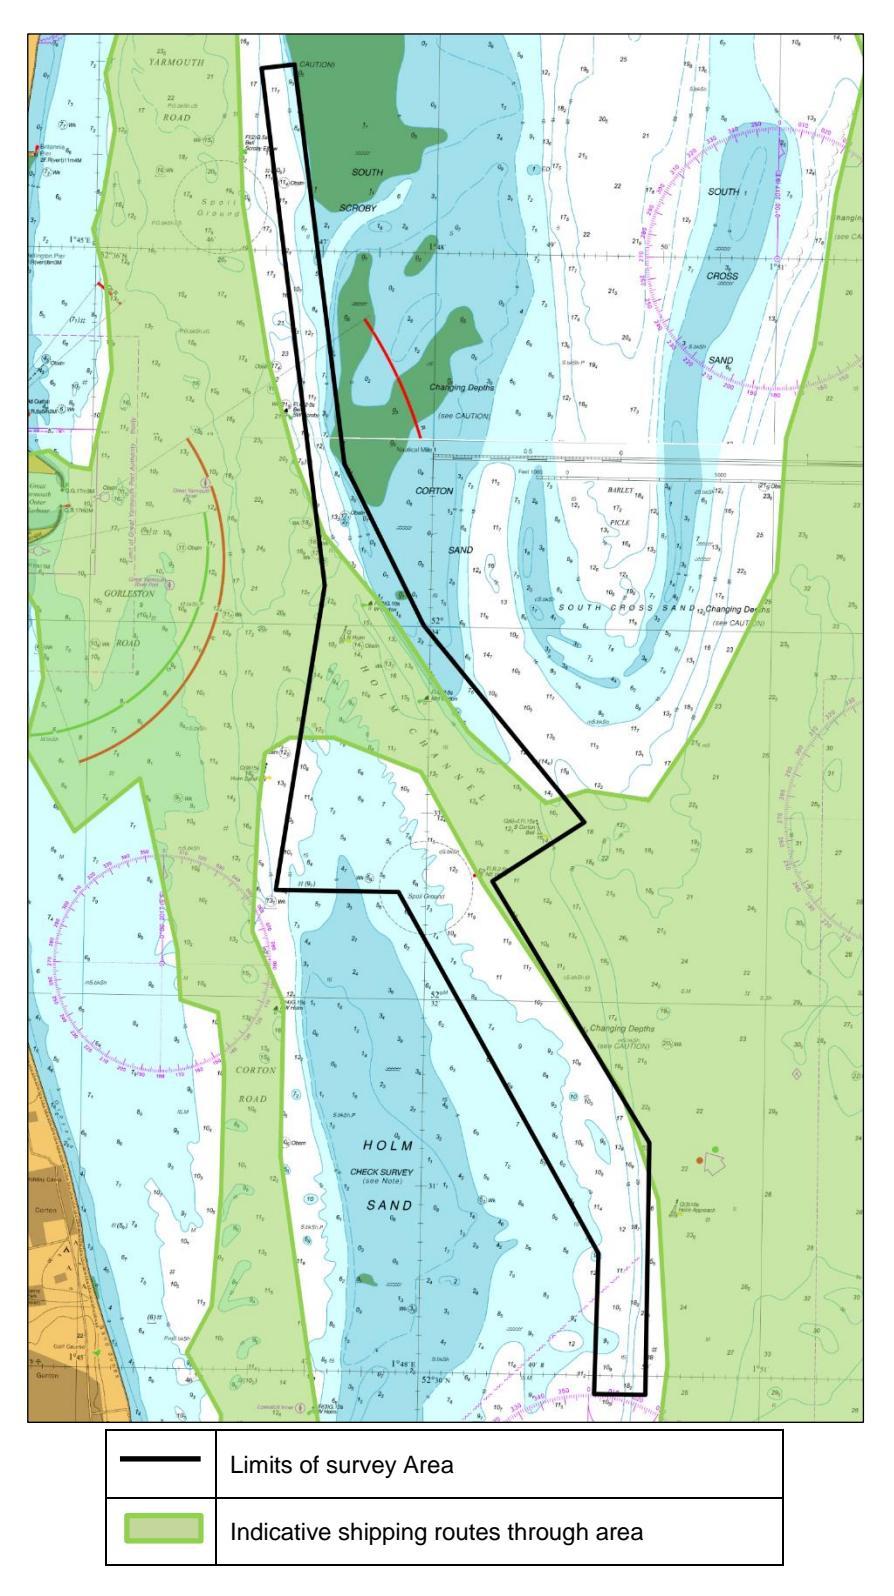
5.1 Shipping data from satellite AIS data for 2016 of vessels larger then 2000GT shows the maximum registered draught of vessel to transit through Holm Channel the area was 10.8m.

Figure 2 – Indicative shipping routes overlaid on BA Charts 1534 and 1535

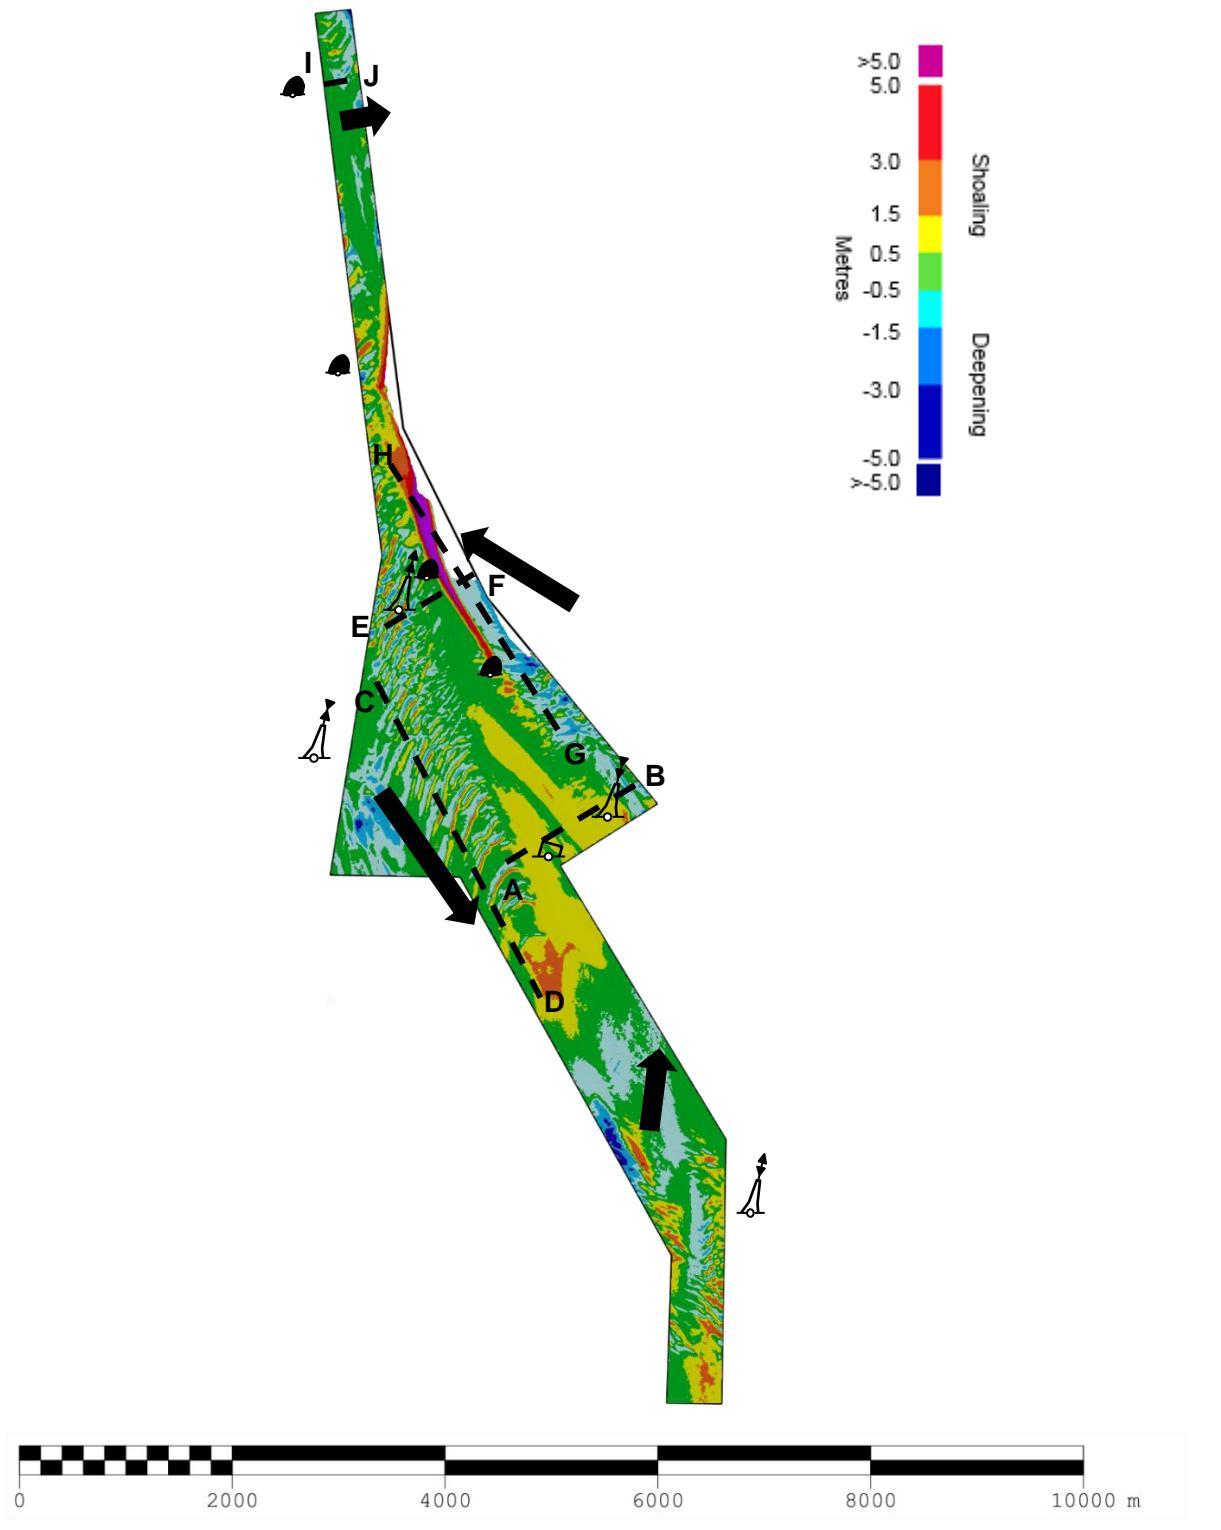
8.1 Figure 3 shows a Variability Plot highlighted depth differences between 2015 and 2016, with arrows indicating the general direction of sediment movement and dashed lines showing the location of profile plots. The general trend shows a north to north-westward movement of sediment along the south-west bank of Corton Sand, compared with a south to south-easterly movement of sediment along the north-east bank of Holm Sand; as shown by arrows in Figure 3.

Figure 3 – Variability Plot showing Bathymetric Changes between the 2015 and 2016 Surveys

8.2 The eastern bank of Holm Sand has migrated east and north by up to 60m as part of larger anticlockwise rotation of both Corton and Holm Sand. This rotation is centred between Mid Corton and NE Holm Channel Buoys. In addition, there is a transfer of material along the eastern bank of Holm Sand north west in to Holm Channel as described in paragraph 8.6. Both are causing depths around the east entrance to Holm Channel between north East Holm Buoy and South Corton Bell to decrease by up to 1.8m, as shown in the above Variability Plot in Figure 3 and Profile Comparison A-B in Figure 4 below.

- 9.1 Corton Sand continues to migrate westwards into Holm Channel, where shipping is focussed between West Corton and North Holm Buoys.
- 9.2 Shoaling has occurred to the south and west of South Corton Bell at the entrance to Holm Channel. Shipping traffic is currently directed between South Corton Bell and North-East Holm Buoys where the controlling depth is 10.8m along the east limit of the focus area. This poses a risk to the largest vessels recorded in the area (up to 10.8m registered draught) during 2016.

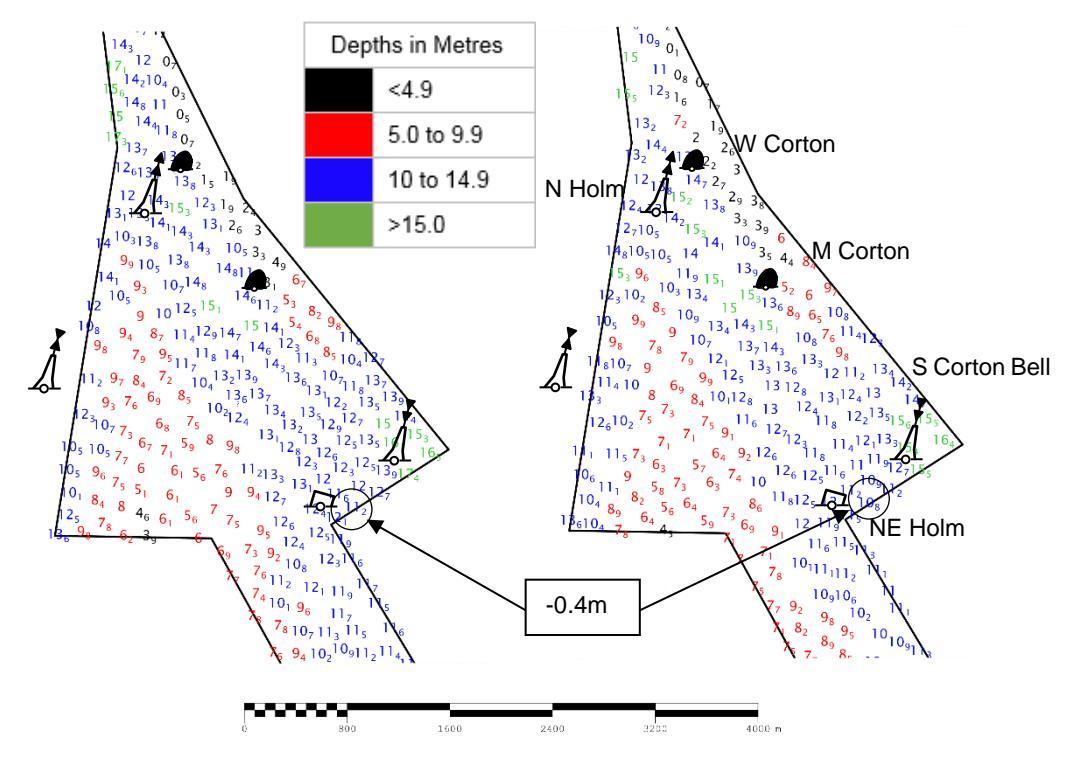
8.3 The Depth Plot focused on Holm Channel in Figure 5 below, highlights the controlling depth in the area just east of North East Holm Buoy, decreasing from 11.2m in 2015 to 10.8m in 2016.

Depth changes indicated above are from the closest corresponding 2015 sounding available. Hence depth differences will be from different positions from the 2016 sounding selection as an automatic shoal bias sounding selection tool has been utilised which produces a representation of the shoal values in a data set. Positive values (+) represent deepening. Negative values (-) represent seabed depths becoming shallower.

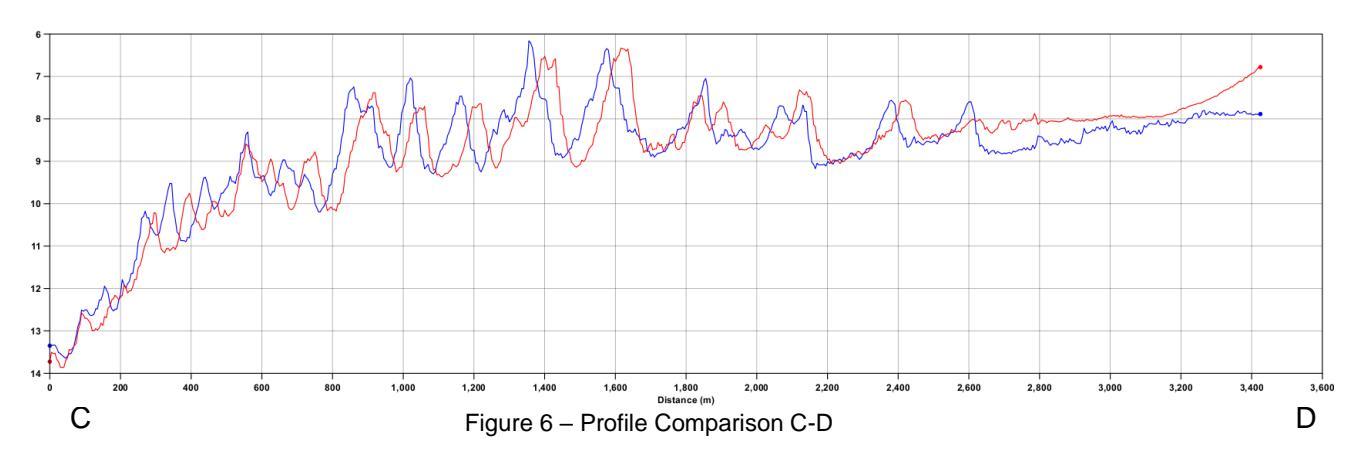
8.4 Sandwaves along the north-east bank of Holm sand continue to migrate in a south to southeasterly direction by approximately 50-100m.

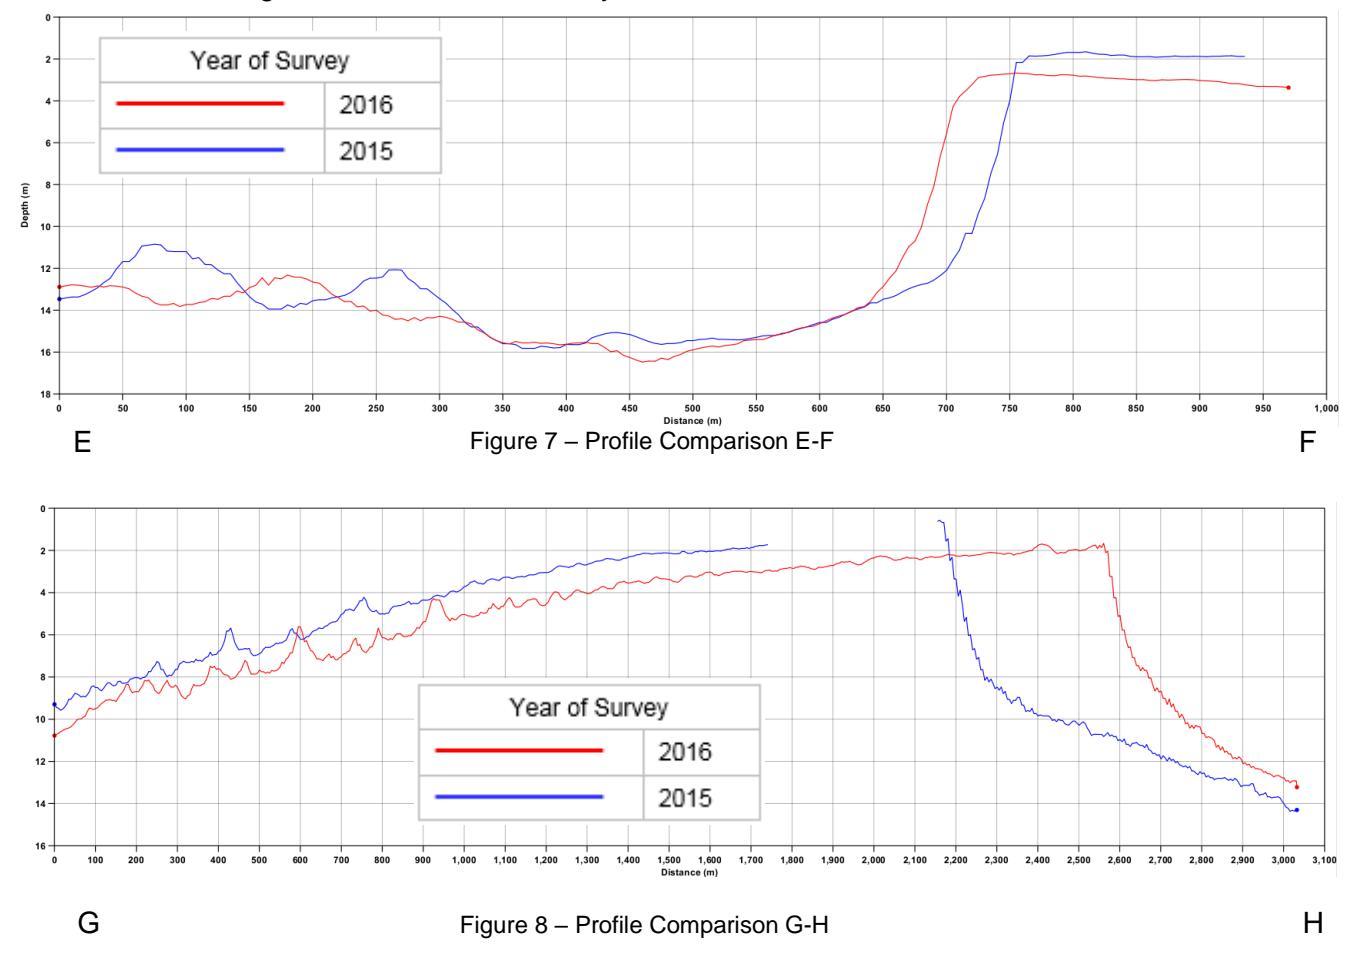
8.5 The Profile Comparison E-F in Figure 7 shows the south western bank of Corton Sand continues to expand approximately 30m into Holm Channel, with Profile G-H in Figure 8 additionally showing a northward expansion of the bank. AIS data indicates marine traffic through this area is concentrated between West Corton Buoy and North Holm Cardinal Buoy, with only isolated vessels moving south of north Holm Buoy.

- 10.1 The focused area of EA9 should be re-designated EA9A to allow it to be distinguished from the full area survey limits EA9.
- 10.2 The south west bank of Corton Sand continues to migrate westwards into Holm Channel, supporting the continued annual resurvey of the focused area to ensure accurate depths around west Corton buoy. The annual resurvey interval should be maintained for the focused area.

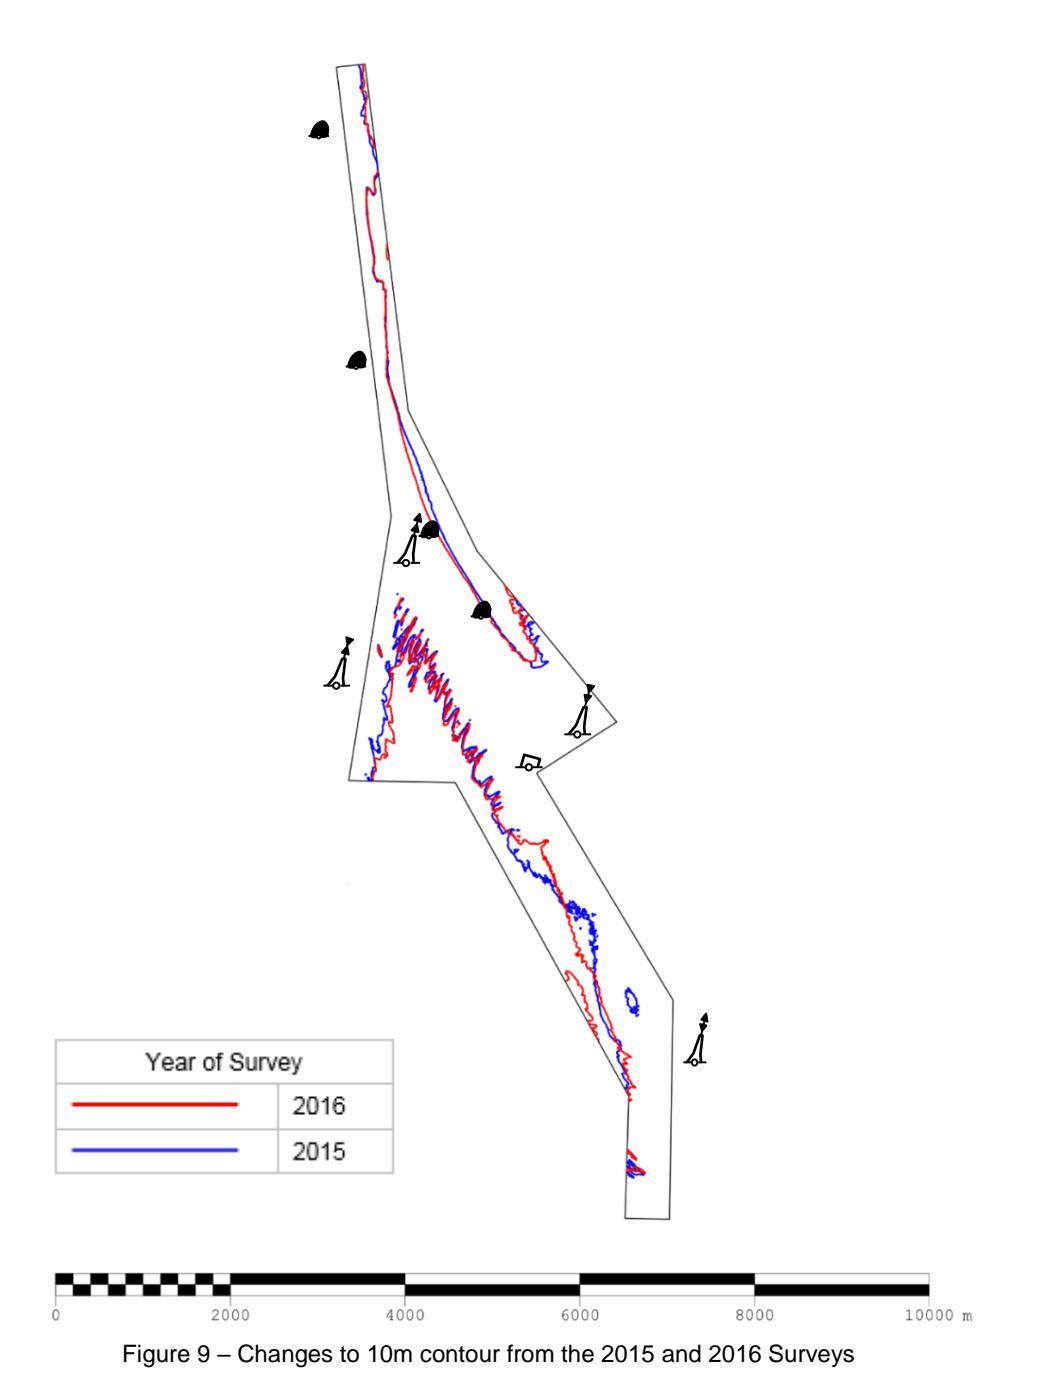
8.6 The Changes to the 10m contour shown in Figure 9 shows a significant shift of up to 1050m along the eastern bank of Holm Sand due to a transfer of material north west in to Holm Channel. In the north of EA9, little change can be seen in the 10m contour.

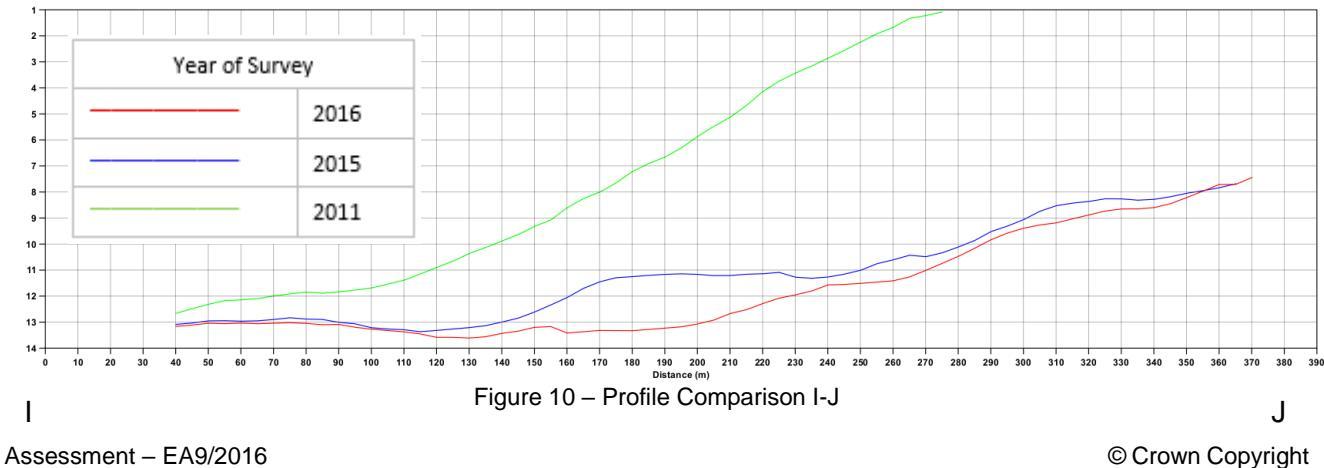
8.7 The western bank of South Scroby in the northern part of EA9 has continued to migrate eastwards. This continues the trend observed in the 2015 routine resurvey where the 10-metre contour migrated by 60m. The Profile Comparison I-J in Figure 10 includes the 2011 bathymetry to highlight the long-term migration.

- 10.4 The eastern boundary in the north of EA9A should be shifted east up to the 2m contour to monitor the migration of South Scroby.
- 10.5 Move western limits of EA9A seaward towards Holm Channel to represent the gradual migration of the sandbanks in the area and remove areas shown to be deepening

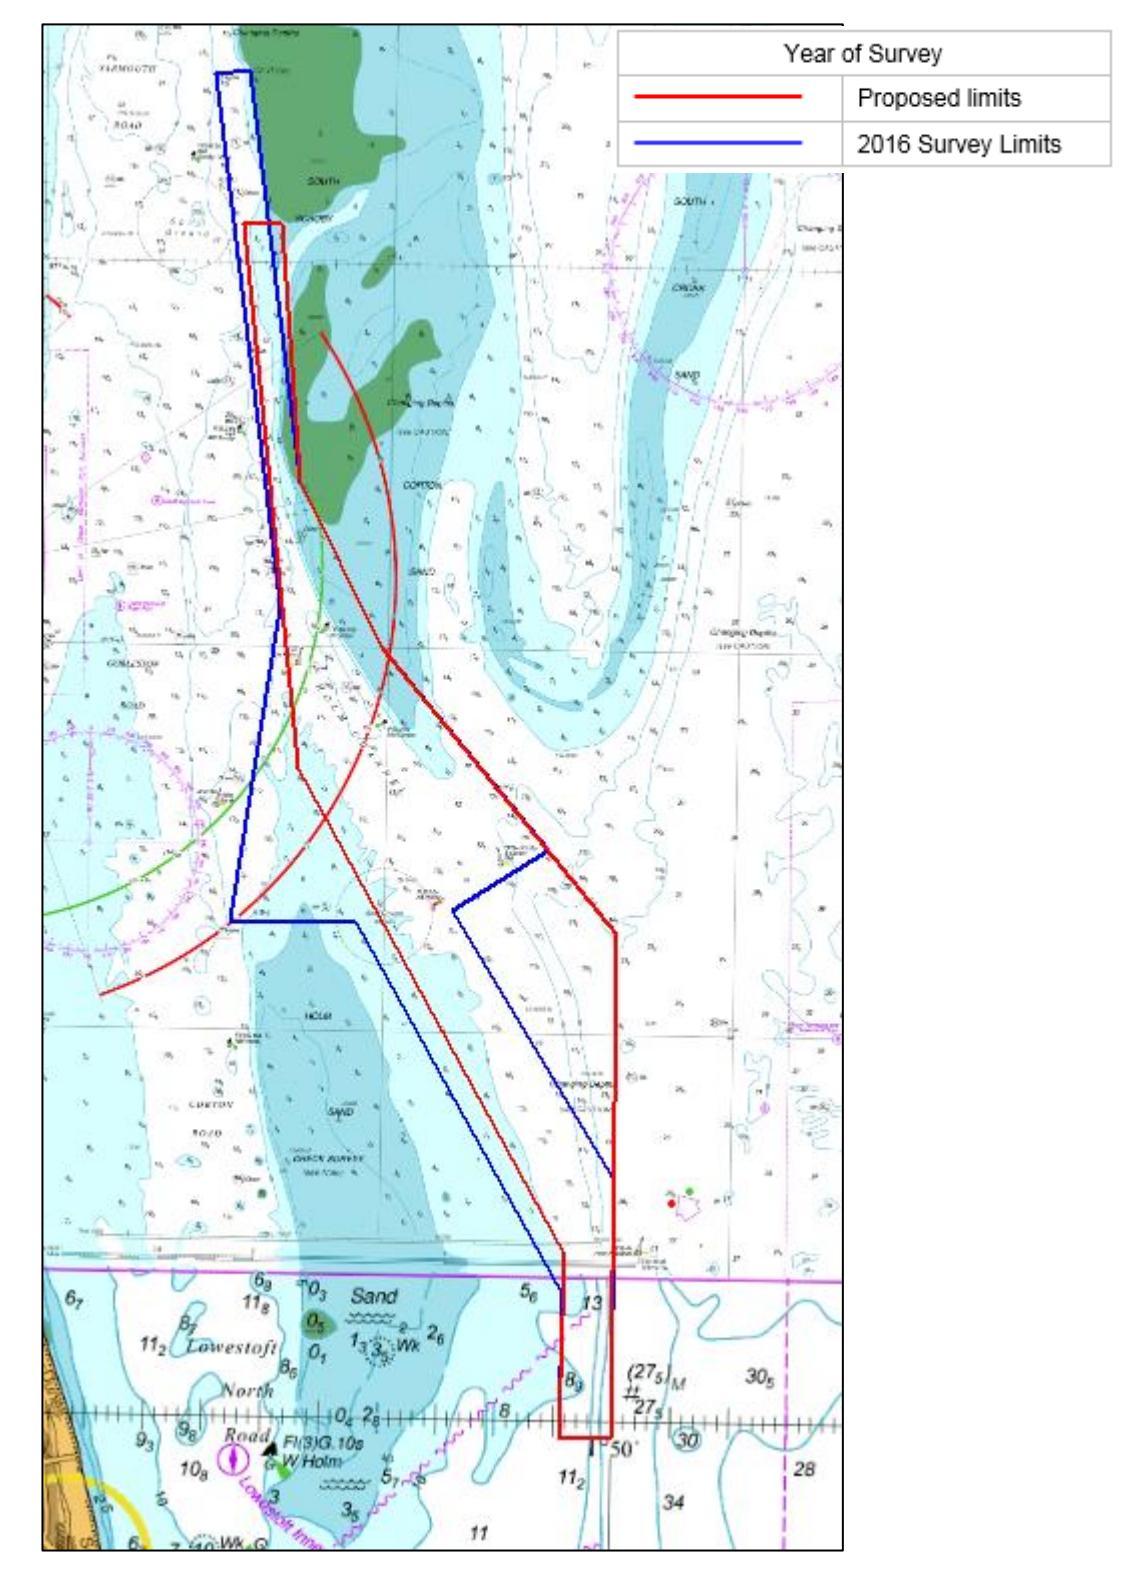
- 10.6 Remove the area in the vicinity of Scroby Elbow in the north extent of the EA9A focused area
- 10.7 The proposed limits to the EA9 focused area is displayed in Figure 11 and coordinates given in Table 2 below with the changes decreasing the focused survey area by 0.19 NM² (0.64 km²) to give a total for the EA9 focused area 3.38 NM² (11.59 km²).

Figure 11 – Proposed change to the extent of EA9A - focus area

- 10.3 Shoaling between North Holm and South Corton Bell due to the north and eastward migration of Holm Sand poses a risk to vessels entering Holm Channel. The eastern boundary of EA9 focussed area should be extended to monitor depths in this area and provide a comparison data set in 2018 following the full EA9 survey planned for 2017.

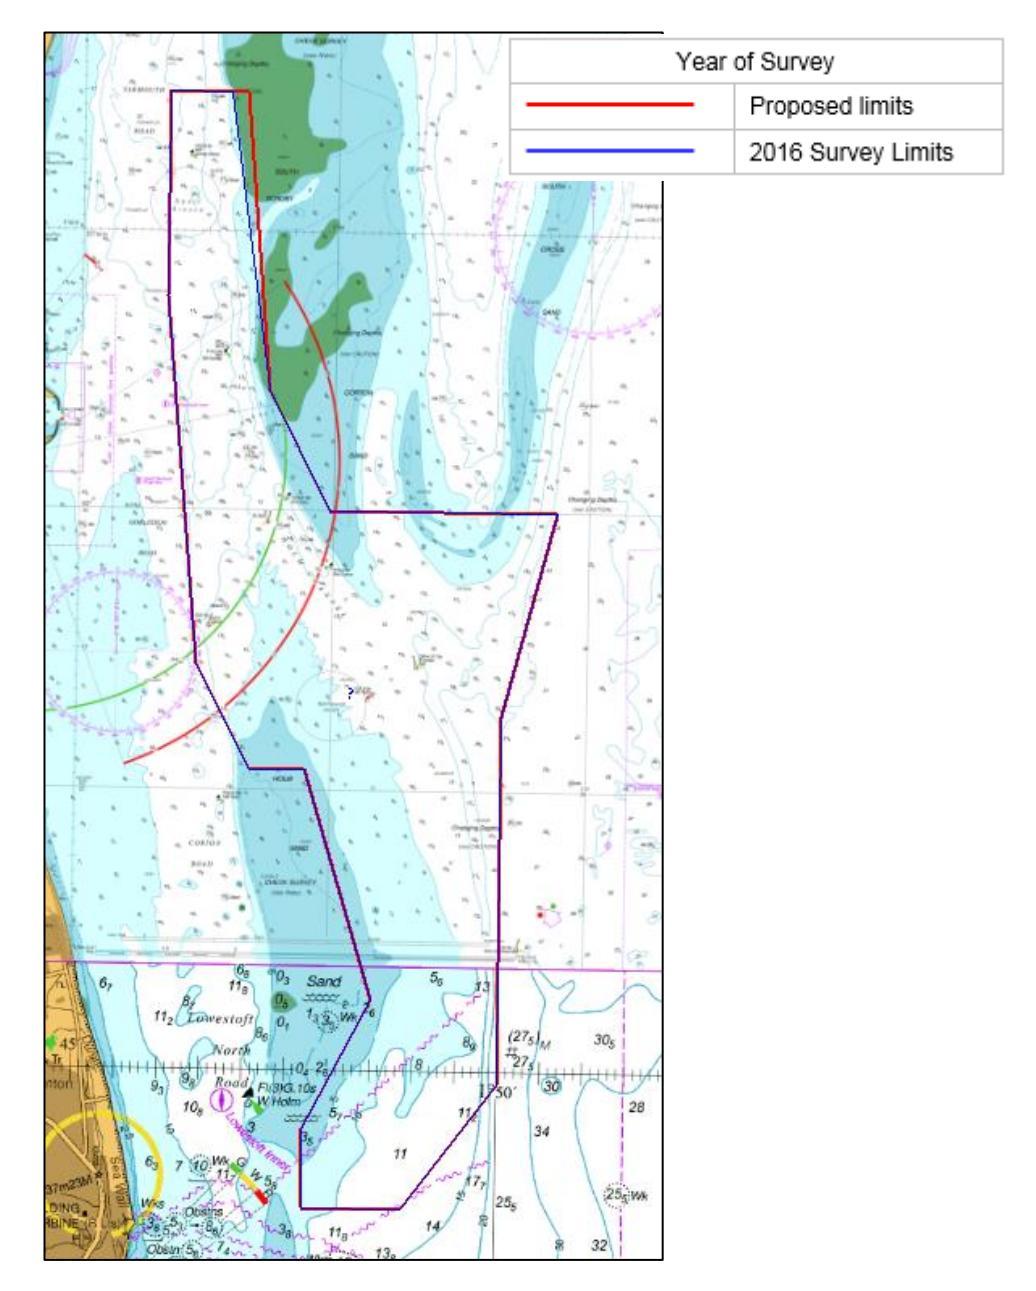
10.8 The proposed limits to the EA9 full survey area because of the changes to the EA9A focused area is shown in Figure 12 and in Table 3 below. The proposed changes increase the full survey area by 0.12 NM² (0.44 km²) to give a total for the EA9 full survey area 9.86 NM² (33.84 km²).

Figure 12 - Proposed change to the extent of EA9 - full area
