AAIB Bulletin	G-BXFI	EW/C2015/08/04
SUPPLEMENT		
Registered Owner and Operator	Canfield Hunter Ltd	
Aircraft Type	Hawker Hunter T7	
Nationality	British	
Registration	G-BXFI	
Place of accident	A27, Shoreham Bypass, at the Shoreham Road, North of Sho	e junction with Old preham Airport
Date and Time:	22 August 2015 at 1222 hrs (T are UTC¹ unless stated otherw	imes in this report /ise)

Summary

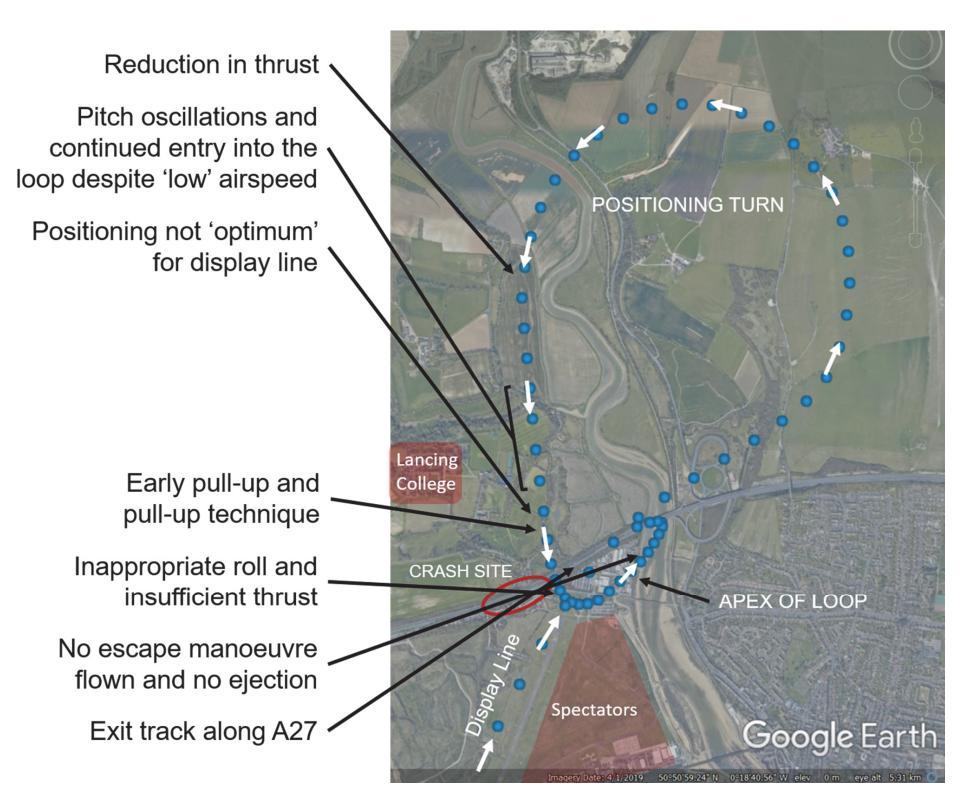
Figure 1 summarises how the analyses considered that the pilot's performance diverged from what was required.

Summary of pilot actions according to material provided to the AAIB

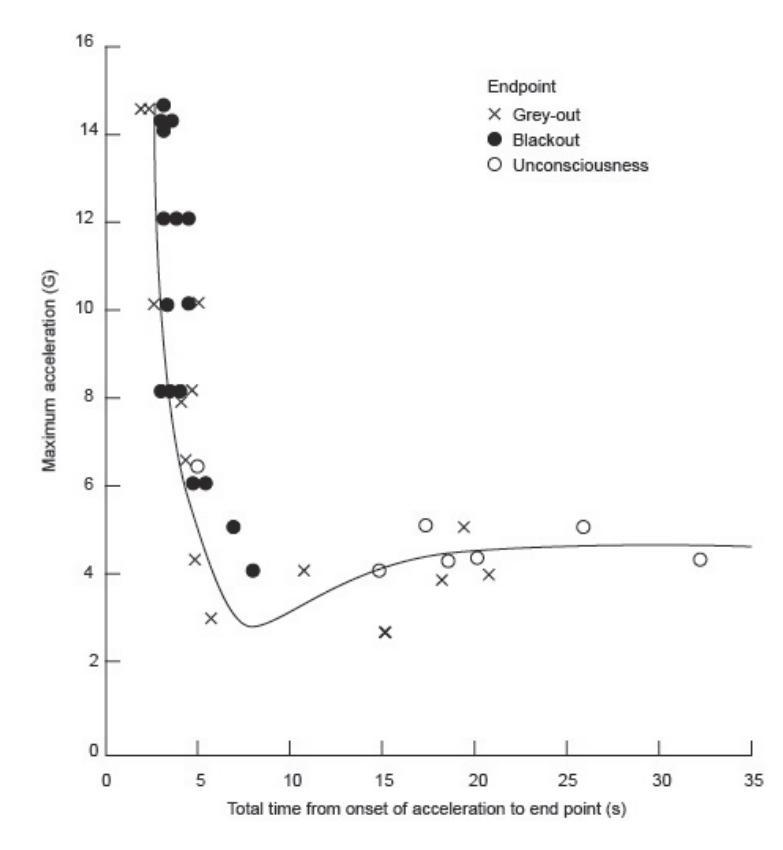
The figures stated for average levels of Gz tolerance varied slightly in the literature depending on what research source was used. Figure 2 summarises results from a compilation of Gz tolerance studies involving participants who were not wearing any anti-G clothing or performing any techniques to increase their G tolerance. Each point on the graph shows the result of a research study in terms of when the end point of greyout, blackout or unconsciousness was experienced under different levels of Gz and different durations of exposure. The line on the graph summarises the general finding seen across studies that high levels of Gz of short duration may not result in symptoms, but symptoms progress quickly if the onset of Gz is rapid. Lower levels can be tolerated for longer, especially if the onset is slow. It shows that it is rare to find effects within four seconds of exposure or below +3 g.

Relaxed participants' tolerance to +Gz acceleration based on a compilation of research studies (reproduced from Gradwell, D.P. and Rainford, D.J., 2016)

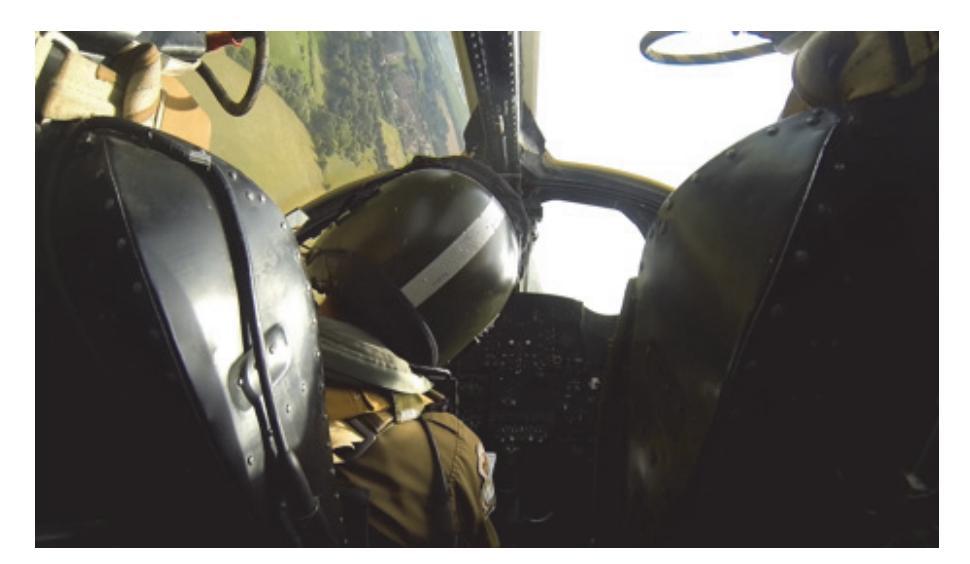
Figure 3 and Figure 4 illustrate one of the behaviours he described as an example of optokinetic cervical reflex.^{16,17,18,19} This is a well-documented phenomenon in low-level flight in visual meteorological conditions, in which a pilot orients their head with respect to the visible horizon rather than the aircraft's attitude. This aeromedical expert noted that:

Figure 3Shoreham 2014: Head movement example of optokinetic cervical reflex

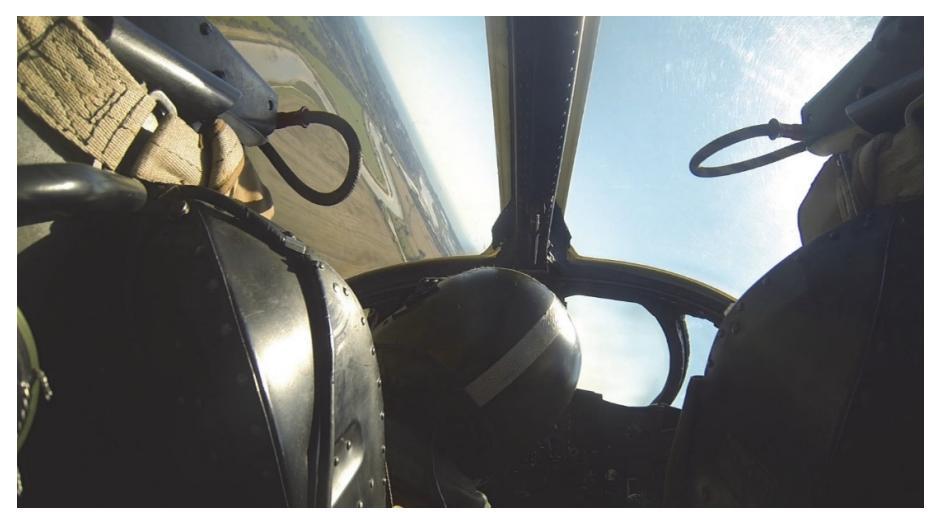
Figure 4 Accident flight: Head movement example of optokinetic cervical reflex

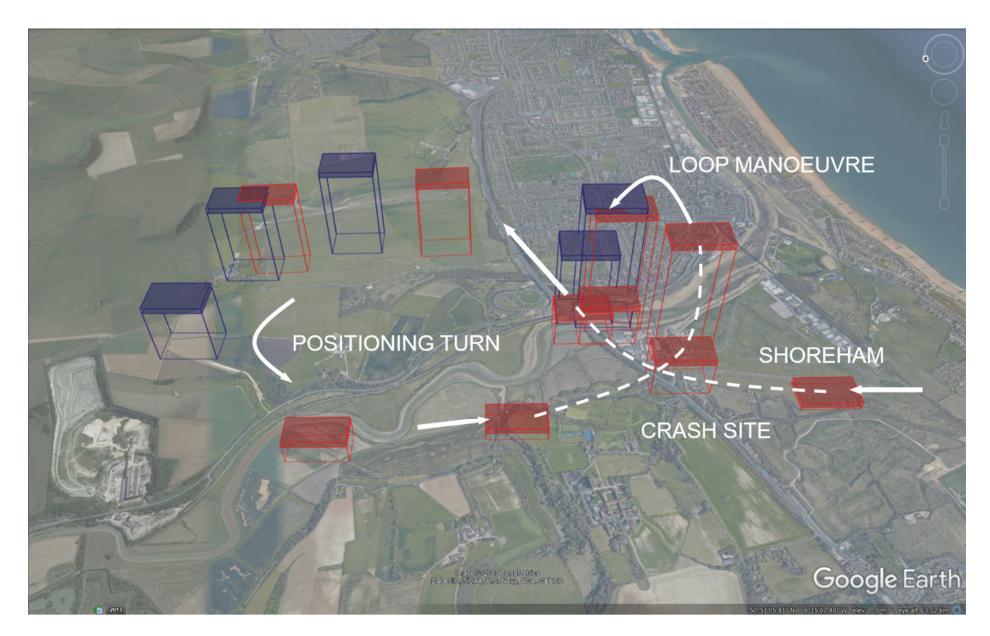
Figure A-1

The radar data on its own does not define the flightpath sufficiently to rule out a wide variety of flightpaths transitioning through the radar boxes. However, the on-board imagery taken by the two action cameras mounted within the cockpit³³ showed a smooth path which provided assurance that any short-term variations in Gz were not large. This was also evident in the imagery of the aircraft taken from the ground. The same imagery can be further processed to more tightly define the flightpath. The action cameras show, for example, whether the flightpath was smooth or involved the aircraft pitching up and down, and which ground features the aircraft flew over.

Boxes showing with 95% confidence the position of the aircraft indicated by Pease Pottage (red) and Gatwick (blue) radar heads (note that the corners of the boxes have been extended down to show their position over the ground)

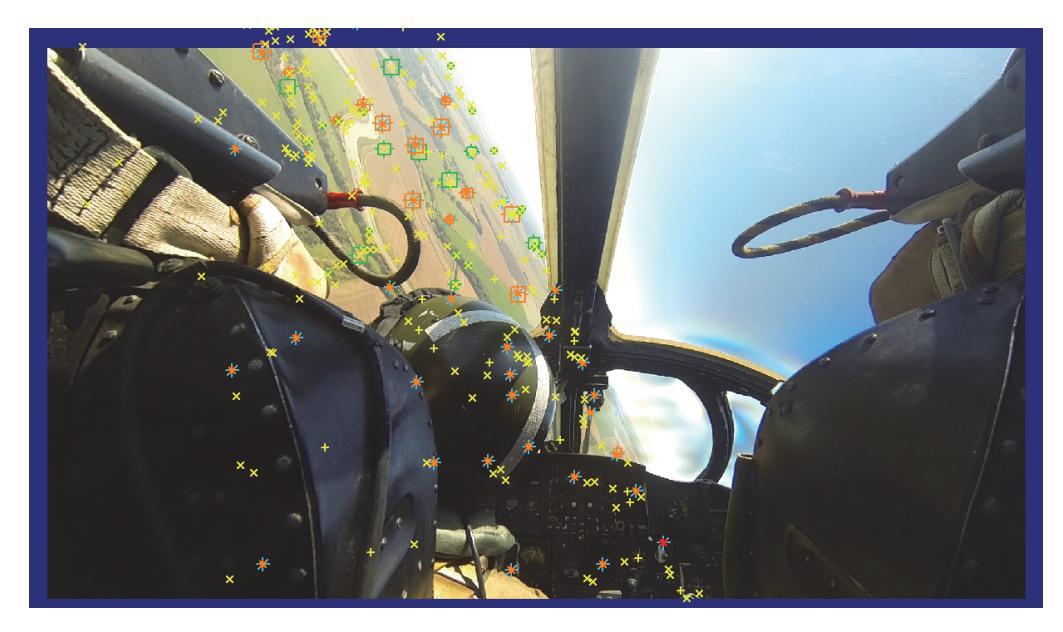
Figure A-2 shows a frame from the GoPro video and the associated track points used by the photogrammetry software. The position calculations close to the start of the pull-up of the loop manoeuvre are less accurate due to the diminishing view of ground reference points with the wings level. The cockpit windows create distortions in the imagery of the scene beyond it in a way that the software is not designed to derive and compensate for. However, the quality of the results indicates that the additional errors this introduces are small enough to be addressed adequately by a standard lens distortion derivation process.

Snapshot from the GoPro action camera with markers for track points and the locations of ground features including those not in frame or obscured in the frame

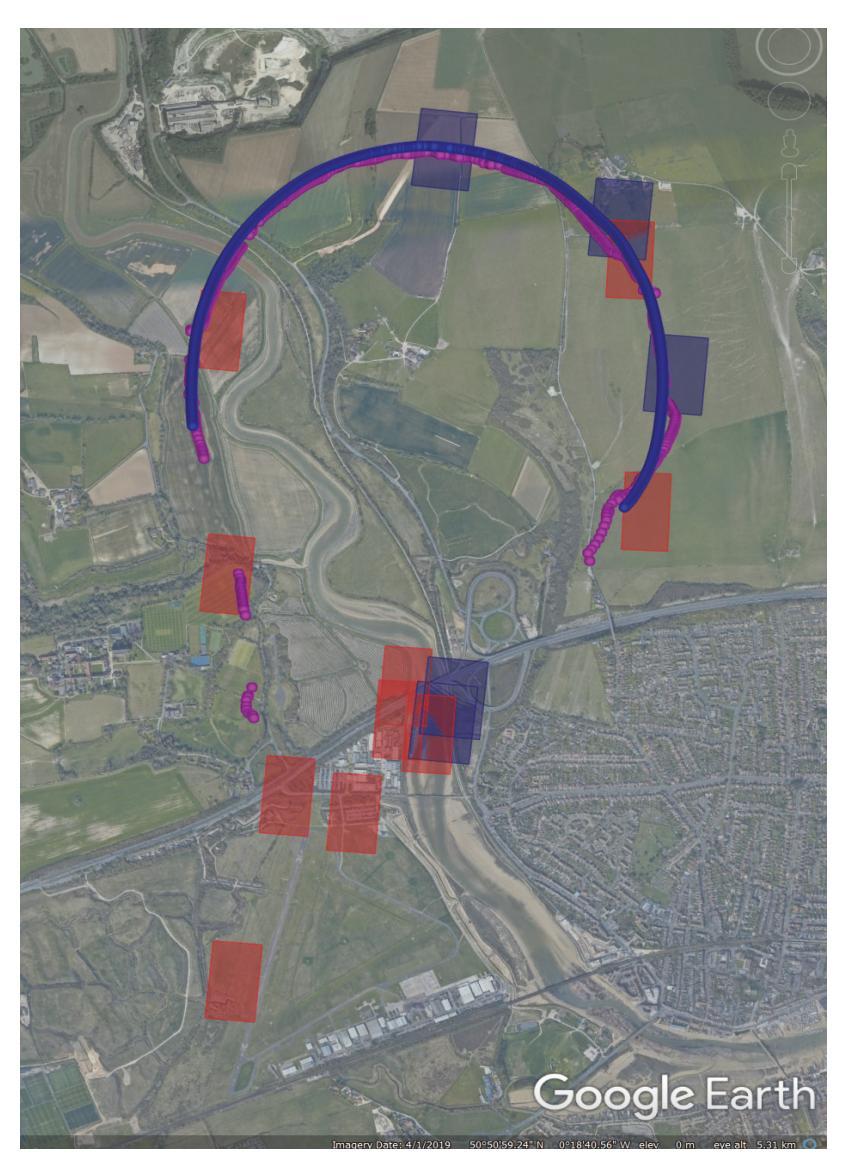
The DogCam video was roughly processed using fewer reference points to provide a reasonableness check of the GoPro results. This was done for a similar period to that of the GoPro analysis work to ensure the process was consistent using a different camera in the cockpit with a different view of the ground. The photogrammetry software declared more positional errors for the DogCam results, and these errors were apparent in the results. However, in general the calculated 3-D positions were consistent with the GoPro results (Figure A-3).

Overview and comparison of derived tracks from DogCam (dark pink dots) and GoPro (dark blue dots) cockpit action cameras with Pease Pottage (red) and Gatwick (blue) radar boxes

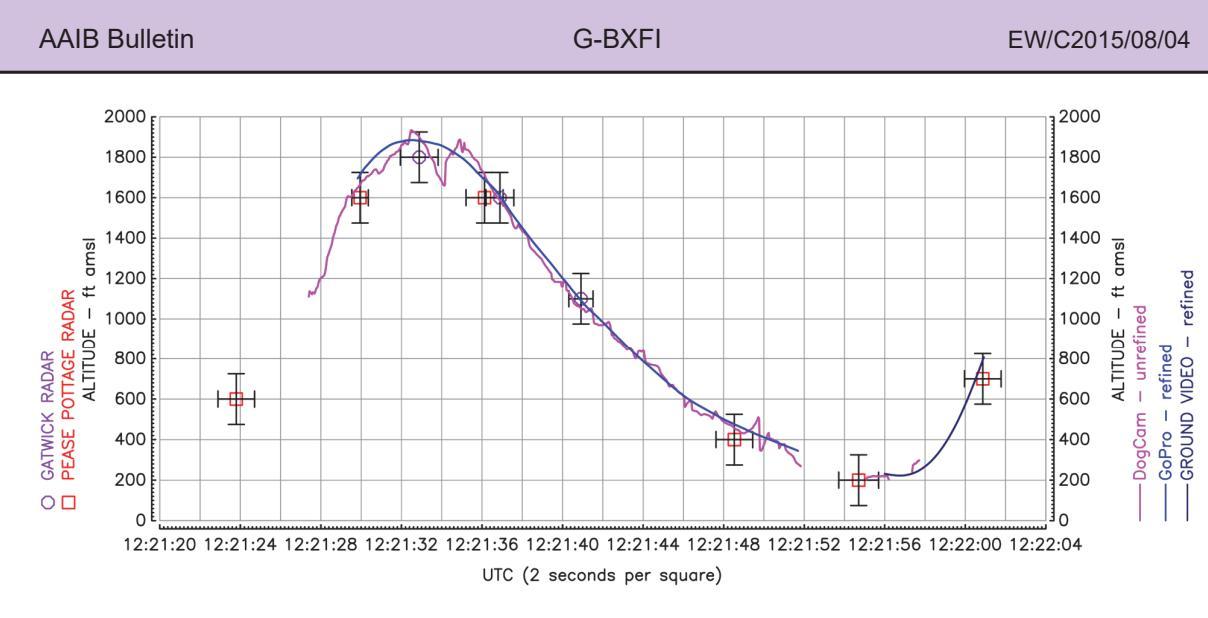
Figure A-4 compares the derived altitudes of the GoPro, DogCam and ground videos with each other and with the Mode C radar altitudes. They are consistent with each other and with the radar altitudes. Note that the along-track length of the radar boxes equates to a flight time of up to 2 seconds at a groundspeed of 300 kt. This is shown in Figure A-4 by the length of the horizontal lines through each of the points; the vertical lines represent the ± 125 ft Mode C accuracy requirement. Note also that the radar altitudes were consistently between 50 and 200 ft less than the GNSS³⁴ recorded altitudes when the aircraft flew along the coast toward Shoreham.³⁵

Comparison of altitude derived from DogCam (dark pink), GoPro (dark blue) cockpit action cameras and ground video (black) with Pease Pottage (red square) and Gatwick (purple circle) Mode C altitudes

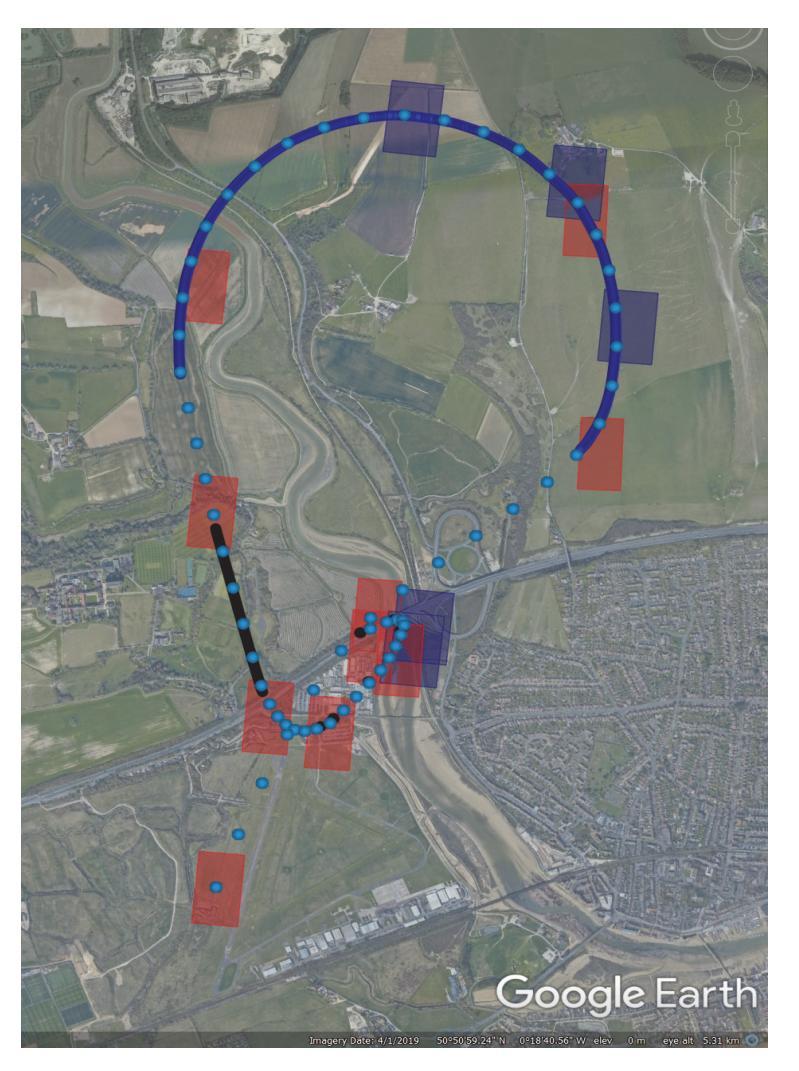
Figure A-5

1Hz interpolated flightpath ground track (light blue dots) through the radar boxes and the derived GoPro (dark blue dots) and ground video (black) positions

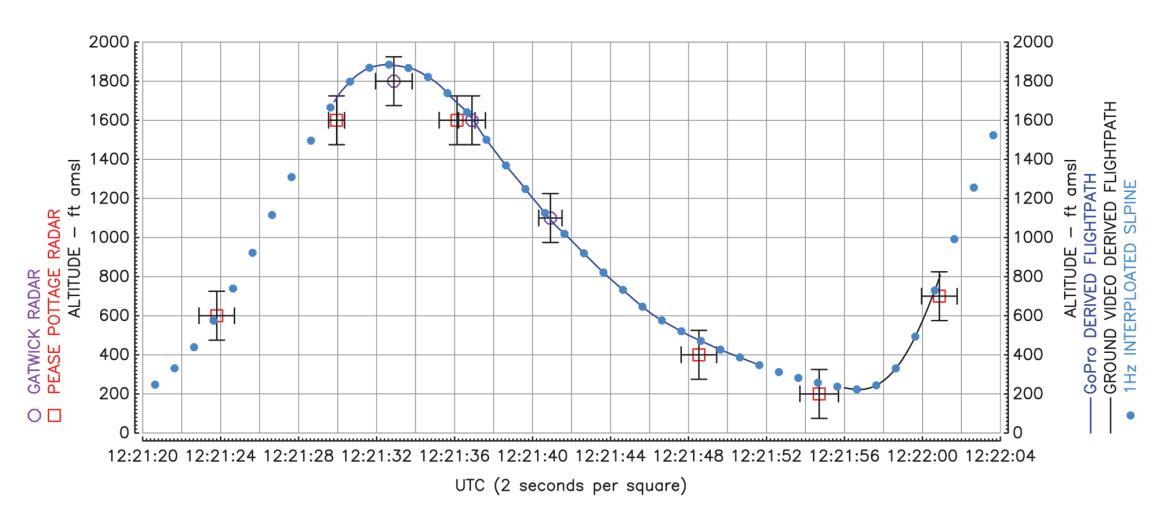
Figure A-6

1Hz interpolated altitude profile (light blue) through the radar boxes and the derivedGoPro (dark blue) and ground video (black) positions

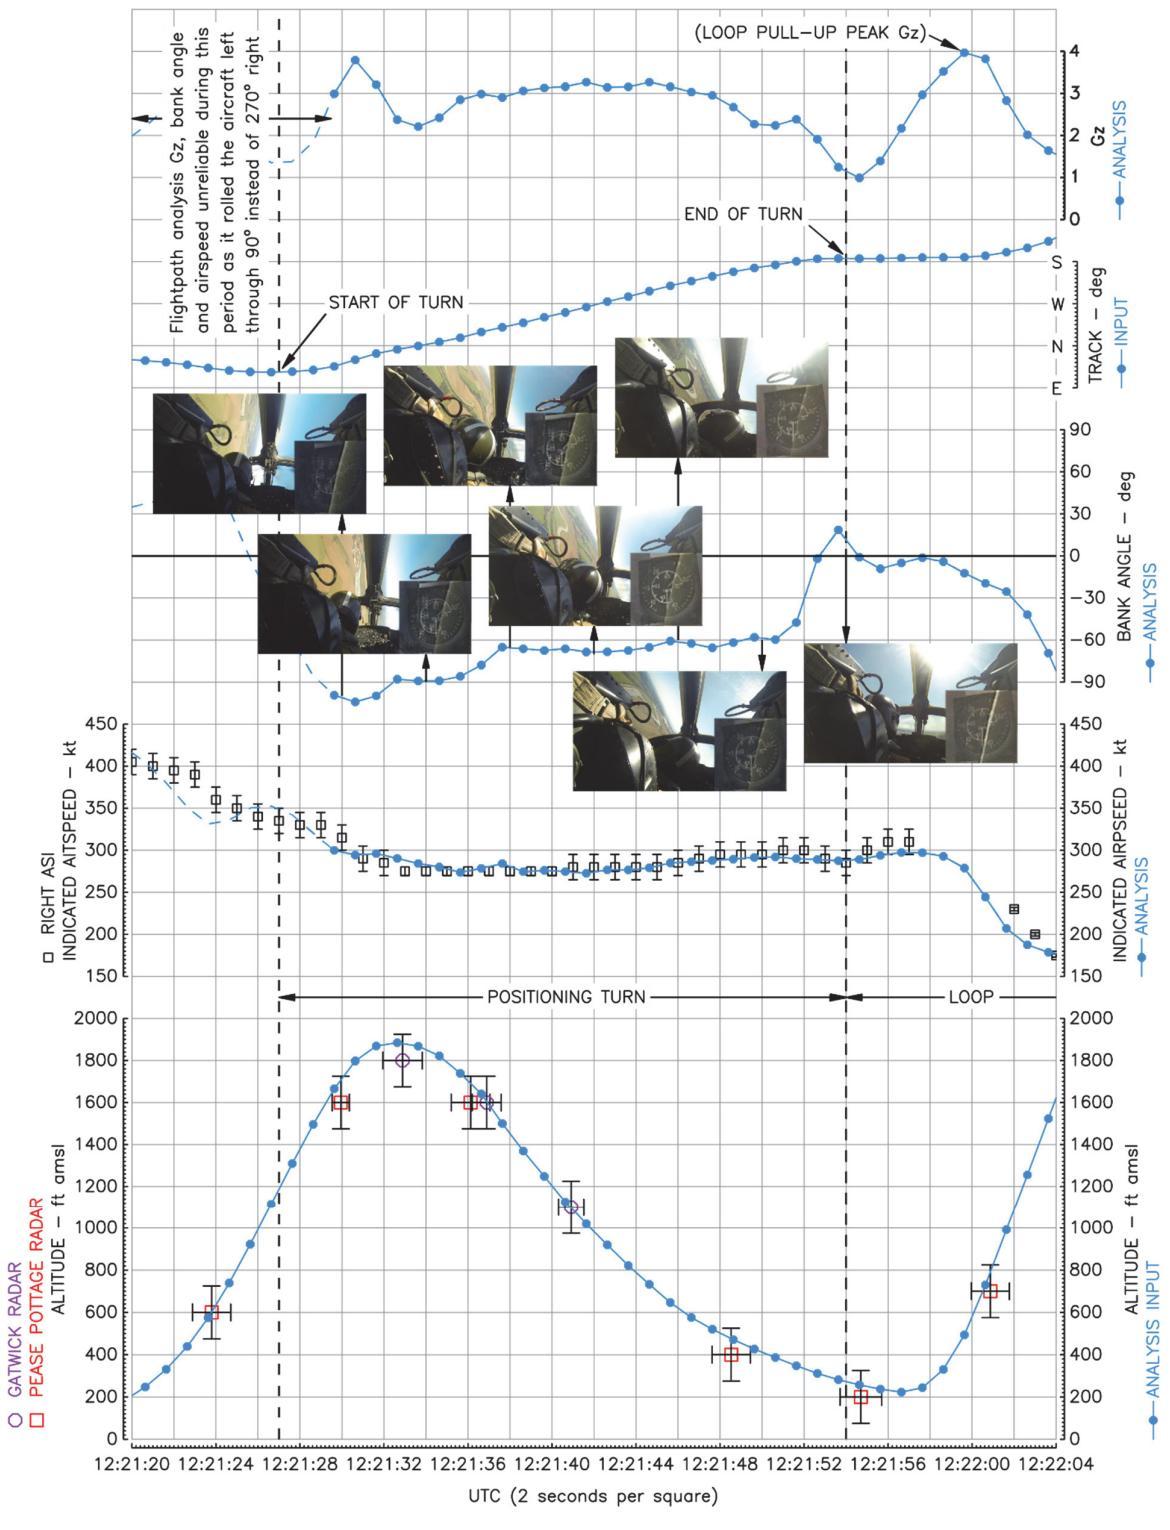
Figure A-7

Results of flightpath analysis to determine Gz in the positioning turn

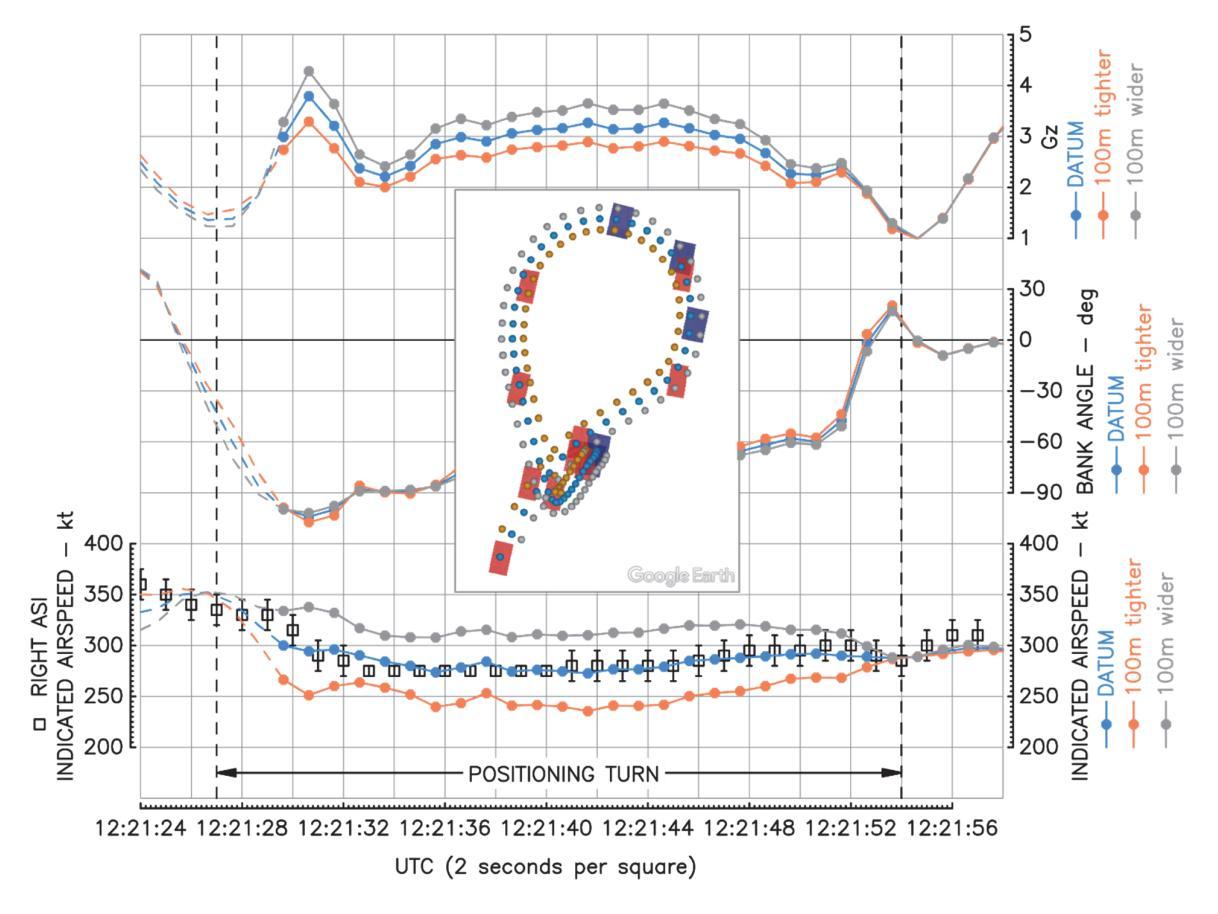
Results of sensitivity study comparing datum flightpath analysis (light blue dots) with a turn which is tighter (orange dots) or wider (grey dots) by 100 m (the overlay shows a plan view of these tracks relative to the radar boxes)

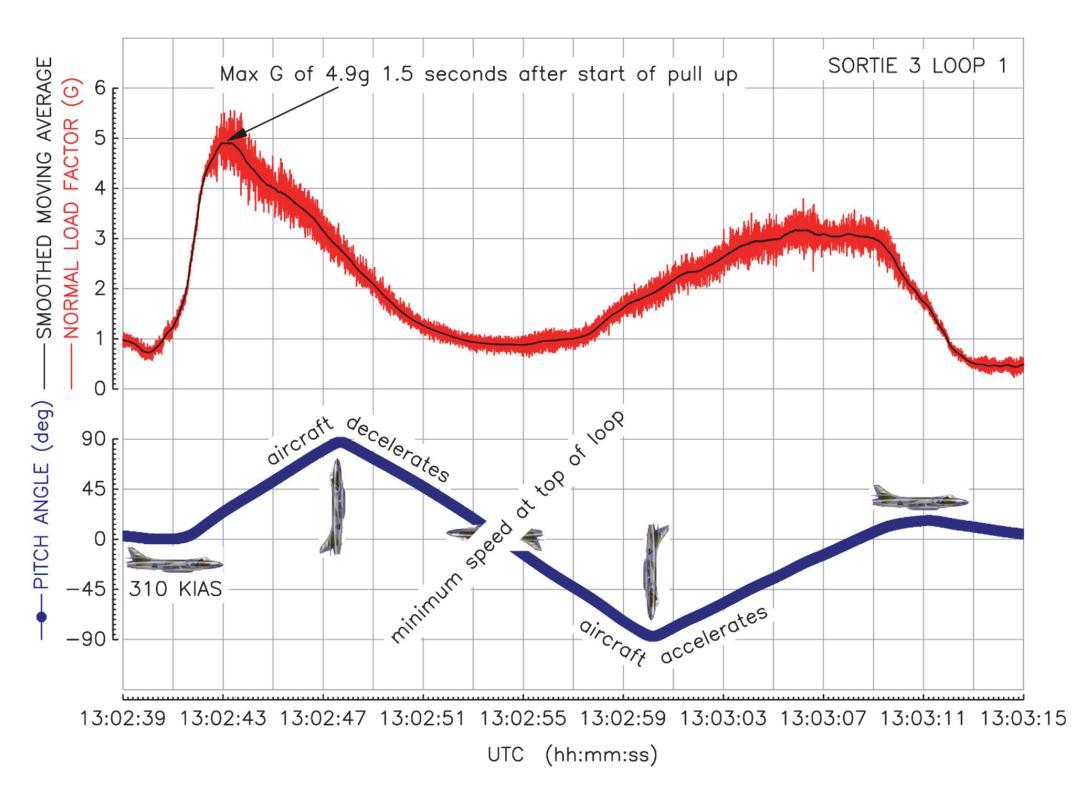
Figure A-9 shows the Gz profile of a maximum performance loop that was flown during Sortie 3 of the data gathering flights. The Gz trace has lots of noise which is probably a result of the accelerometer used to measure the Gz vibrating; therefore, a smoothed moving average has been calculated to find the median Gz of the noise. The figure shows that the maximum Gz of 4.9 g occurred shortly after the initial pull-up, and since Gz is proportional to lift, which is proportional to equivalent airspeed⁴¹ (EAS) squared, this corresponds to when the airspeed was at its highest. The G-onset rate peaked at 3.3 g/s.

The entry speed for the loop in Figure A-9 was 310 KIAS which was the highest entry speed for the loops flown in the flight trials. It was also the nominal entry speed for the accident manoeuvre.⁴²

Figure A-9 Gz profile for a maximum performance (minimum radius) loop

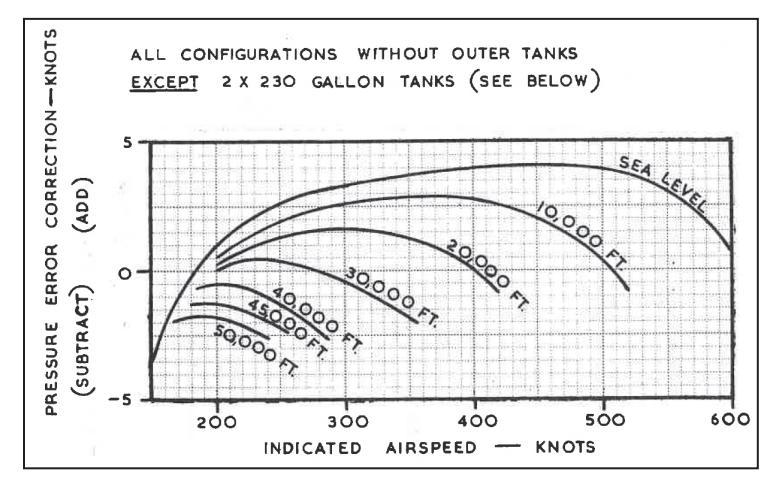
Figure A-11

PECs for Hawker Hunter Mk.7 for the configuration flown during accident flight
