AAIB Bulletin: 10/2018	G-BICS	EW/G2018/05/06	
ACCIDENT			
Aircraft Type and Registration:	Pierre Robin R2100A	, G-BICS	
No & Type of Engines:	1 Lycoming O-235-H2	2C piston engine	
Year of Manufacture:	1977 (Serial no: 128)		
Date & Time (UTC):	6 May 2018 at 1100 h	rs	
Location:	Eaton Bray Farm Airfield, Bedfordshire		
Type of Flight:	Private		
Persons on Board:	Crew - 1	Passengers - 1	
Injuries:	Crew - None	Passengers - None	
Nature of Damage:	Substantial		
Commander's Licence:	Light Aircraft Pilot's Licence		
Commander's Age:	55 years		
Commander's Flying Experience:	876 hours (of which 274 were on type) Last 90 days - 7 hours Last 28 days - 4 hours		
Information Source:	Aircraft Accident Report Form submitted by the pilot

Synopsis

During takeoff, the aircraft did not attain flying speed and collided with a hedge at the far end of the runway. Performance calculations by the AAIB indicated that, although the ground run required was less than the runway length available, the takeoff distance required exceeded the takeoff distance available.

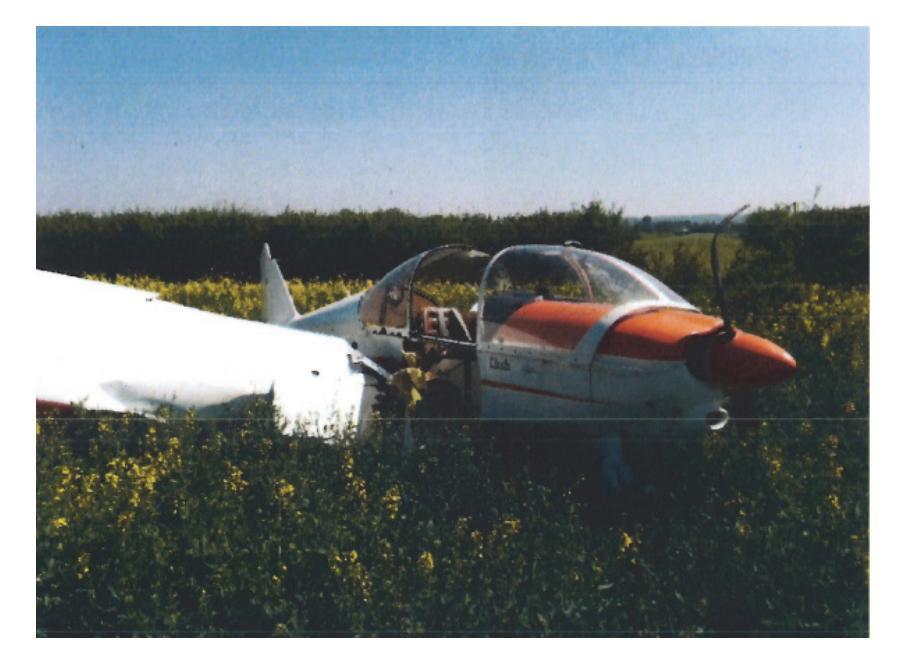
The pilot decided to use Runway 29, although it would involve a slight tailwind, as it would be away from buildings close to the threshold of the runway. After completing his checks, the pilot commenced the takeoff roll. The aircraft reportedly reached an airspeed of 40 kt approximately 400 m along the runway, but its acceleration did not continue as expected. The aircraft collided with a 2 m (6.6 ft) high hedge at the far end of the runway at an estimated airspeed of 45 kt. (The rotate speed for this aircraft is 49 kt and the best climb angle speed is 62 kt.) Both occupants, who were wearing four-point harnesses, were uninjured and able to vacate the aircraft unaided. The aircraft was substantially damaged, (Figure 1).

Figure 1 General view of the aircraft post-accident

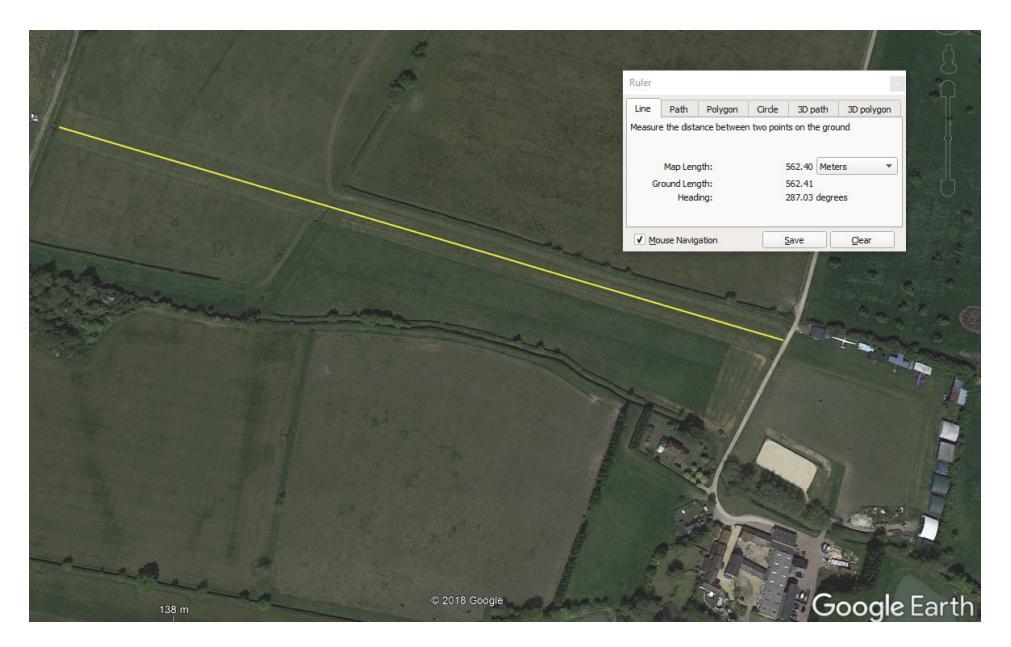
The runway is orientated 29/11 and has a grass surface. Its condition was reported as dry and newly rolled. The farm's website states the runway length is 600 yards (549 m). The pilot reported that he had measured the strip and found it to be 615 m long. Measurements taken from aerial imagery of the airfield more closely match the length stated on the farm's website. Adjacent to the Runway 29 threshold and under the approach path are a parking area and hangars, (Figure 2).

The pilot had previously measured the runway as 615 m long, but information provided on the farm's website indicated it was 600 yards (549 m) long. Measurements taken from a satellite image of the airfield more closely match the length stated on the farm's website. These measurements were all less than the minimum takeoff distance required for the aircraft's weight and the conditions on the day.
