SAFETY FLYER TO THE FISHING INDUSTRY

Foundering of the whelk potter *Nicola Faith* (BS58), resulting in the loss of all three crew, in Colwyn Bay, North Wales, on 27 January 2021

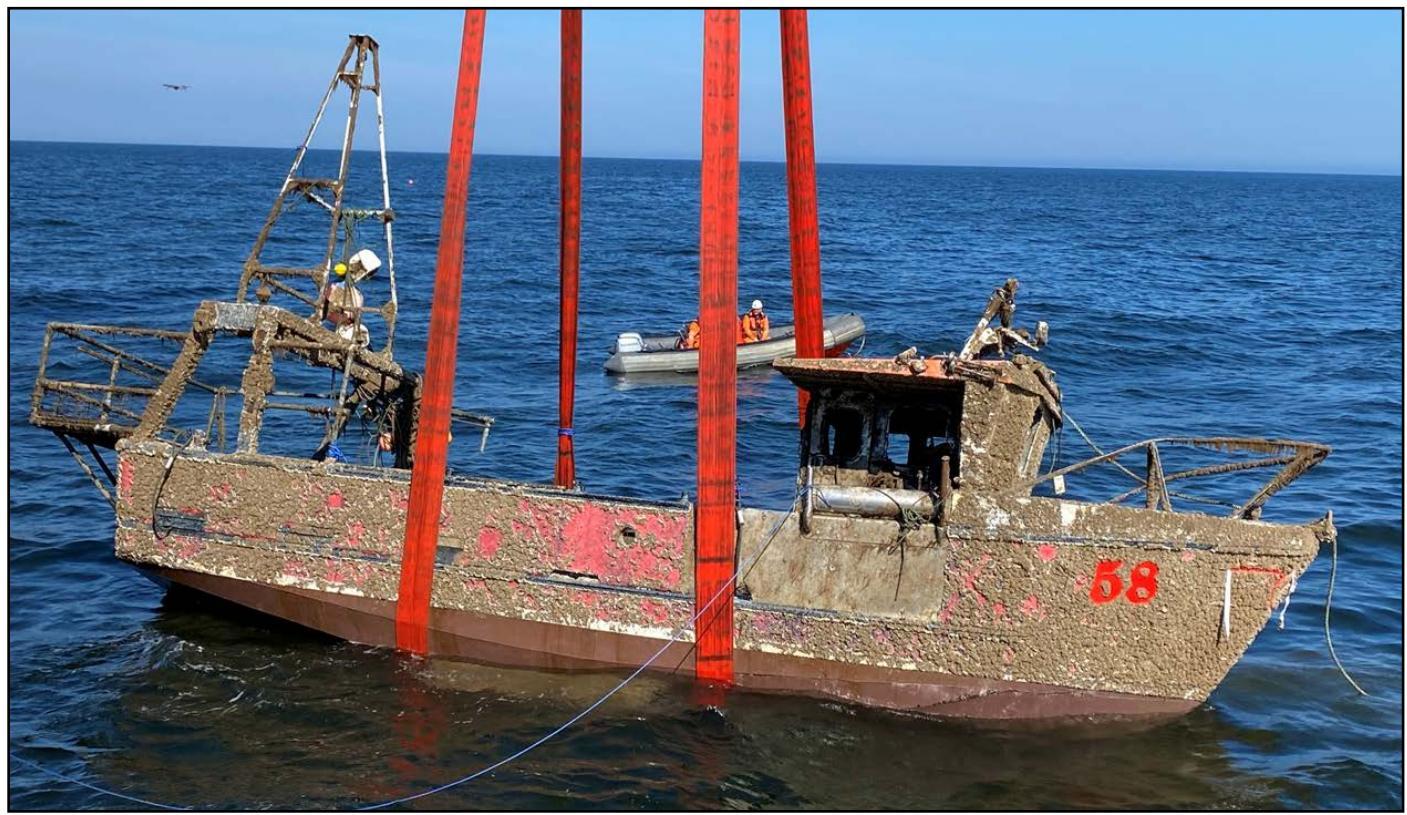
Nicola Faith

On the 27 January 2021, the 9.81m whelk potter *Nicola Faith* was fishing about 2-3 miles offshore and relocating whelk pots. Loaded with a day's catch and four strings of pots (approximately 240 in total) to be relocated, the vessel capsized and foundered with the loss of all three of its crew.

The MAIB investigation found that the boat had undergone extensive modifications in the 2 years before the accident, none of which had been approved by the Maritime and Coastguard Agency (MCA). The modifications had eroded its stability safety margin and this meant that, when combined with an estimated 2090kg of catch plus a weighed 2521kg of fishing gear on board at the time of the accident, the vessel had a very small amount of positive stability. The working deck was cluttered and partially covered by a canopy made from steel tubes and plywood sheets. The vessel capsized quickly; this is likely to have trapped the crew on board and they were probably taken down with the vessel when it sank.

- 1. When *Nicola Faith* was built it had adequate stability for its designed purpose. The unauthorised modifications carried out to the vessel severely compromised its stability. Thought must be given to how planned modifications will affect a vessel's stability and may involve the services of a naval architect to accurately calculate what effect the additions or changes to the vessel will have on the stability safety margin. Additionally, permission must be sought from the MCA before any significant modifications are undertaken.

- 2. Skippers should have a good understanding of their vessel's underlying stability and how this can change during fishing operations. Simple roll tests, heel tests, or a Wolfson assessment will provide skippers with the basic information. Loading a vessel heavily with catch, and then adding retrieved fishing gear, can quickly render a vessel unstable.

- EPIRBs and/or PLBs are mandatory safety equipment for very good reason. Their purpose, to transmit the location of an incident and thereby focus any search and rescue effort, undoubtedly saves lives. A personal flotation device (PFD) can keep a casualty afloat sufficiently long enough for the rescue services, or their own vessel, to find them.
