## Chiropteran report Land to the east of Ugley Village Hall 2023 – 2024

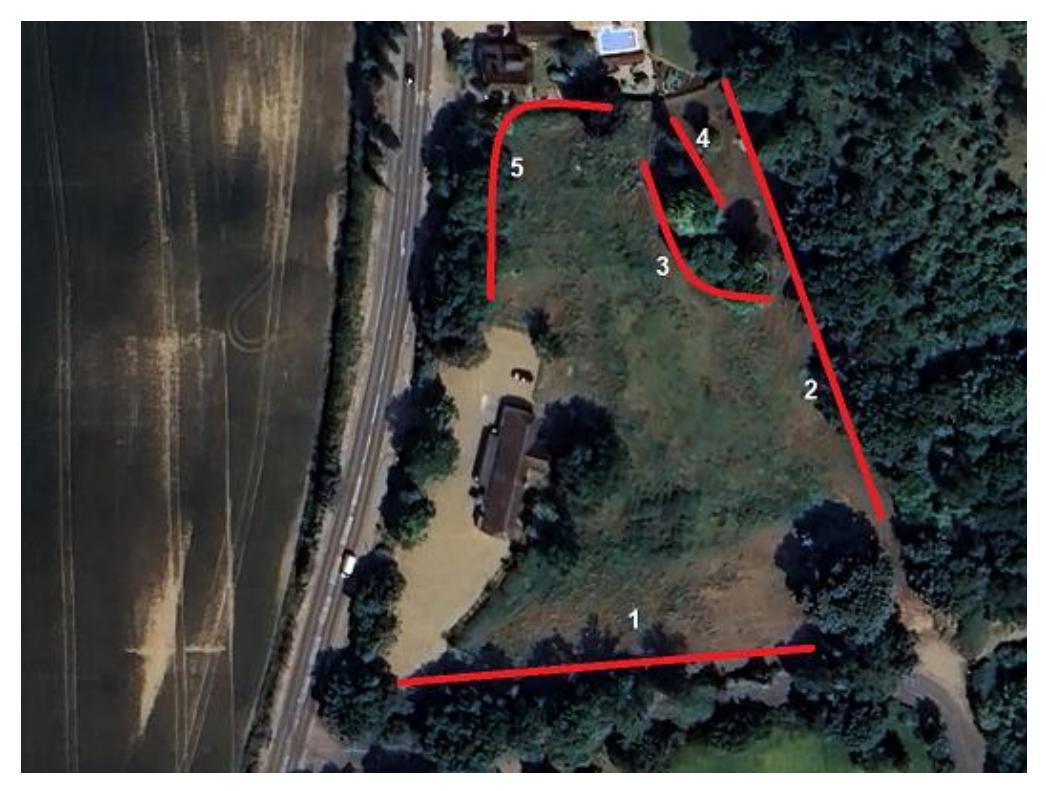
All the perimeter trees are suitable for navigation and foraging. All these trees and the lone Acer pseudoplatanus are to be retained. The foraging patterns briefly recorded on the evening of the 4<sup>th</sup> August 2023 were 1 x Pipistrellus pygmaeus 55 kHz flying due west along the southern boundary and a Pipistrellus pipistrellus 44 kHz with a regular return of 3 minutes passed 6 times around the northeast corner. One would suggest that all perimeter trees should be considered as potential suitability: moderate. There are no established roost sites at present. One can assume that the woodland to the east, Linnet's Wood , is capable of supporting numerous species even though a good deal of that area is planted relatively recently.

Likely foraging patten Would recommend a further survey to Collins 4<sup>th</sup> Edition methodology showing more detailed foraging pattens, including thermal imaging, in May 2024. This was not available until mid-September 2023 very close to the end of the recognized volant season. This can then accurately inform all external lighting design.

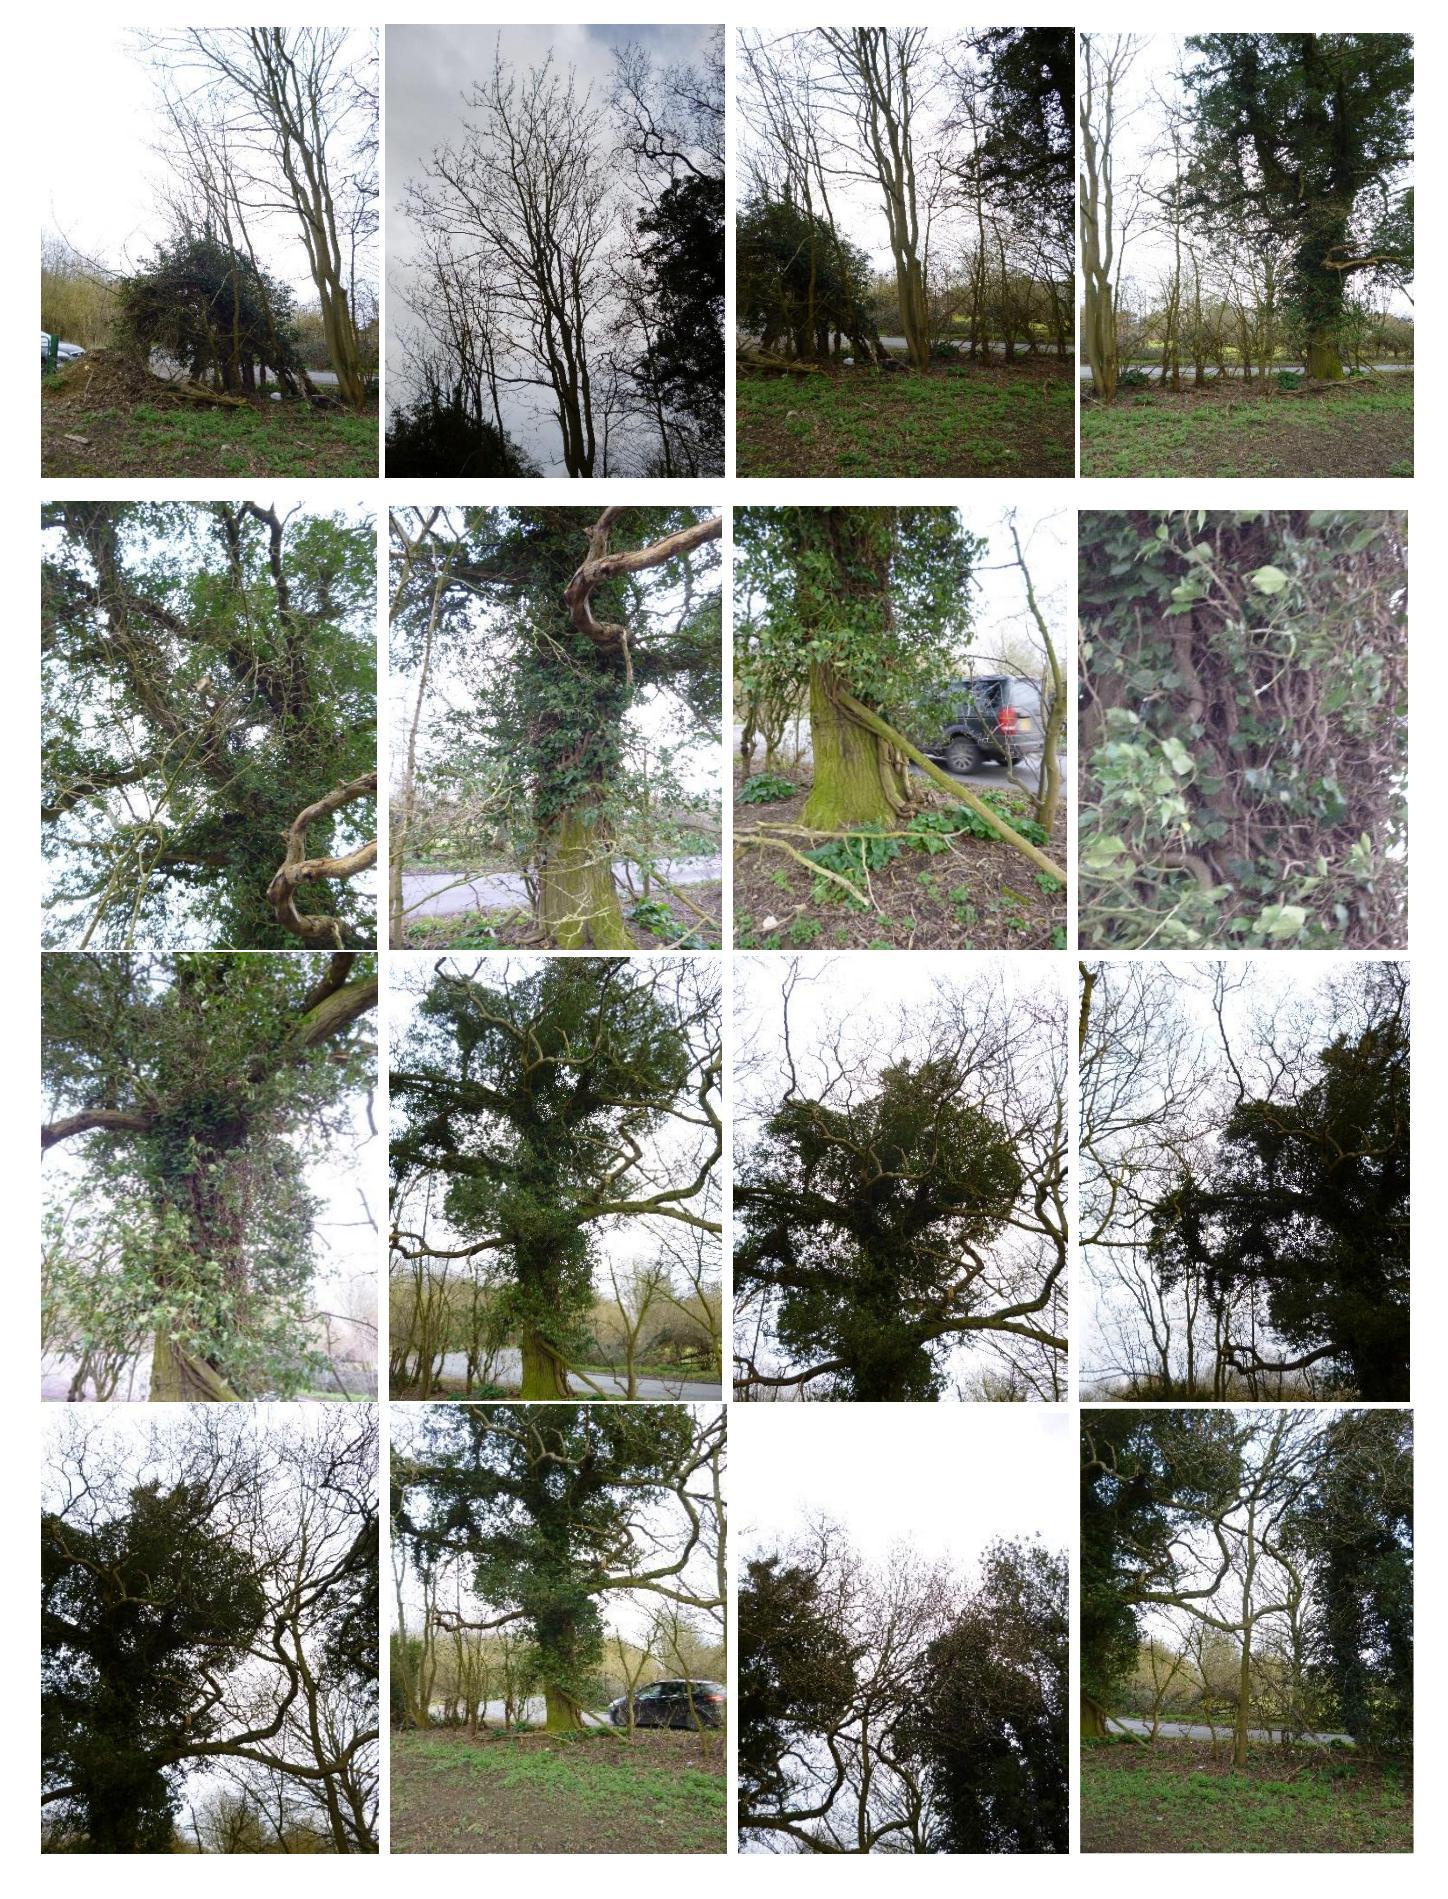
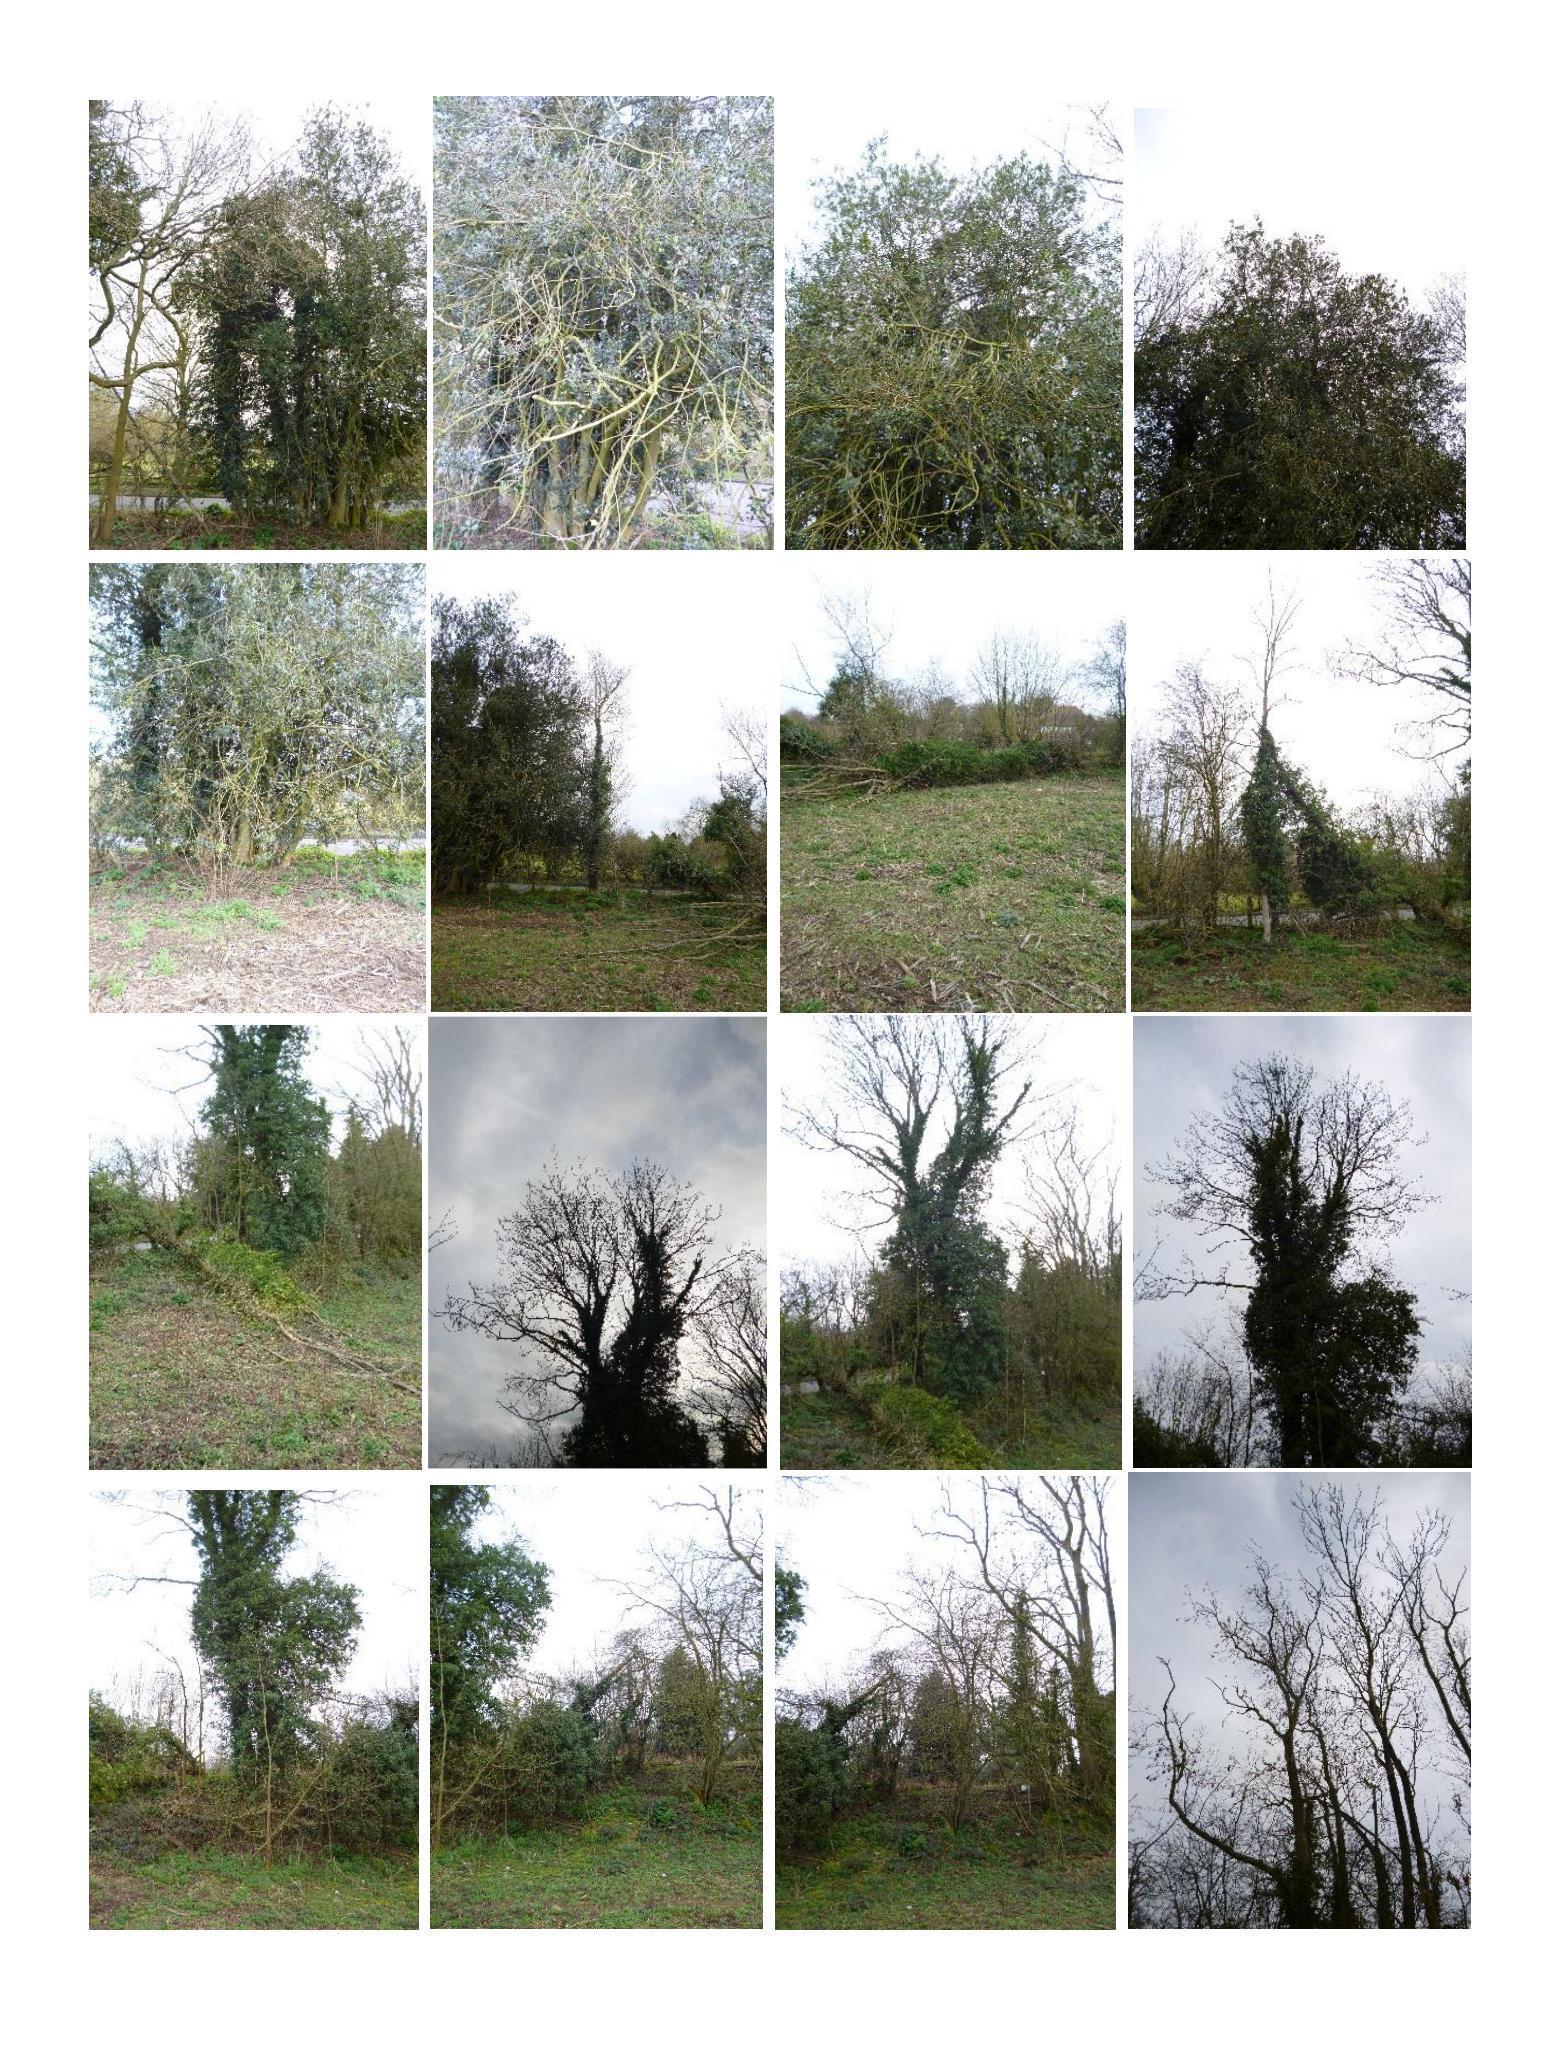
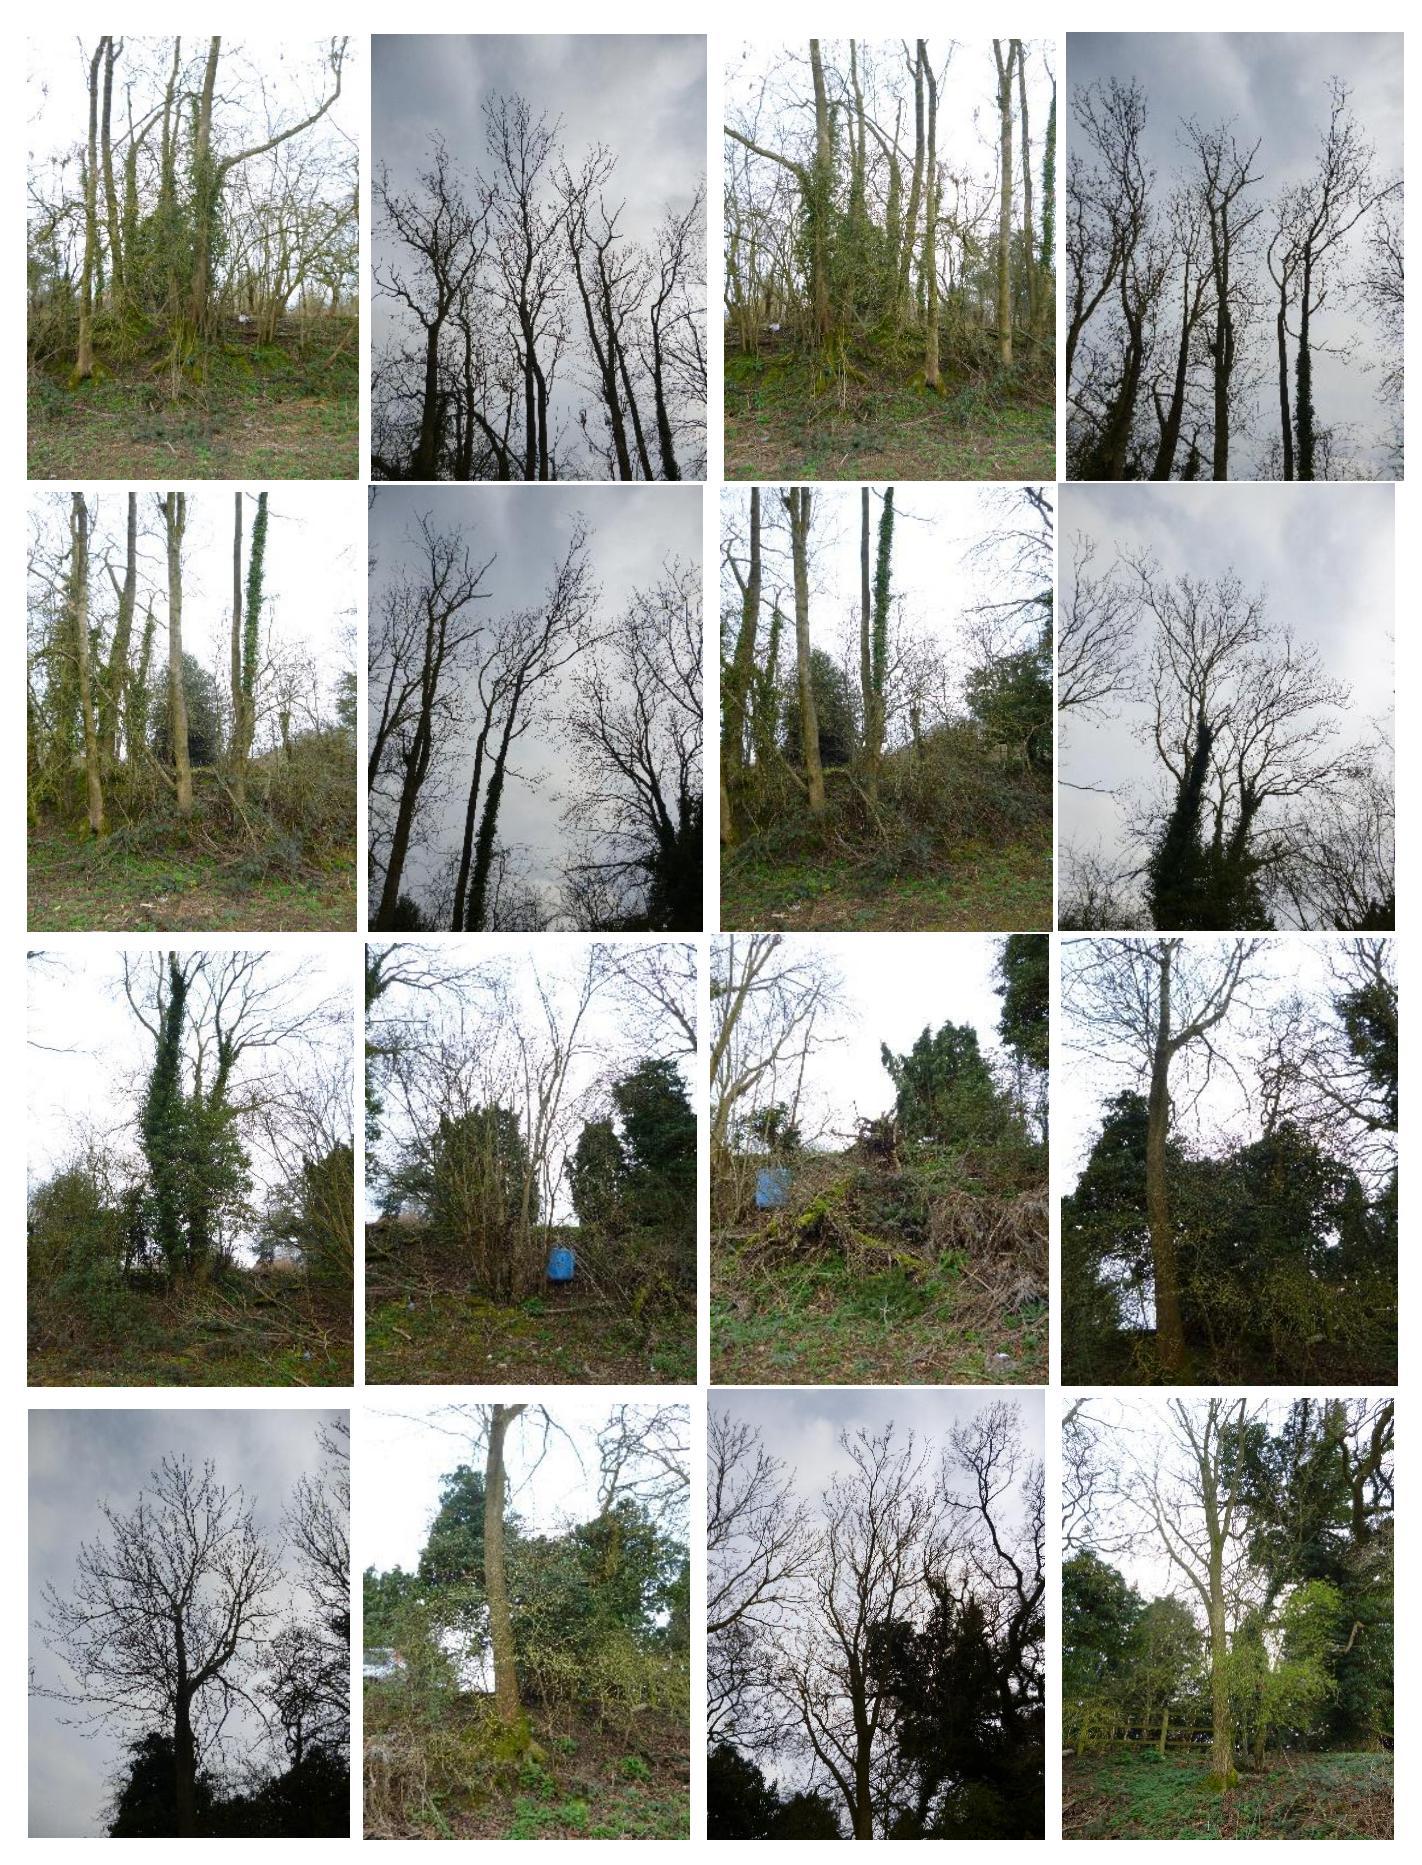
## The trees along the southern boundary from east to west.

There are numerous trees along this boundary that have a confluent growth of Hedera helix; binocular searches are not sufficient.. These trees need a further investigation during the volant season, May 2024 onwards, with night time observations and thermal imagery. Although none of these trees are scheduled for removal, the external lighting design to the rear of the affordable house could be informed by an additional search.

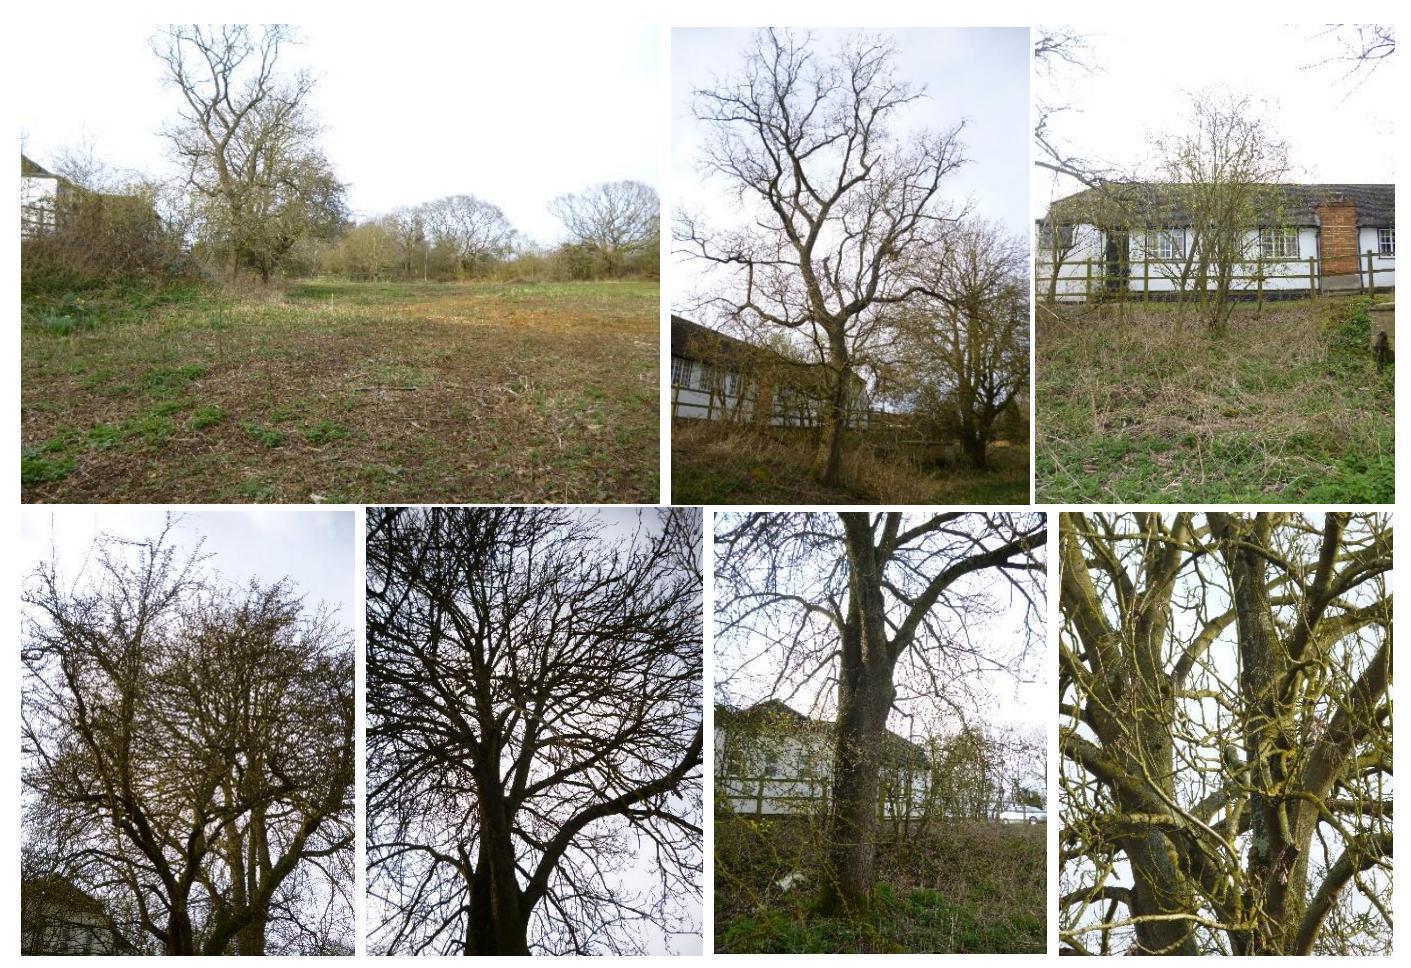
The trees along the western boundary from south to north, below.

The large Fraxinus excelsior, the northernmost tree of those directly behind the Village Hall, has a Potential Roost Feature on the northern part of the southernmost of the three stems.

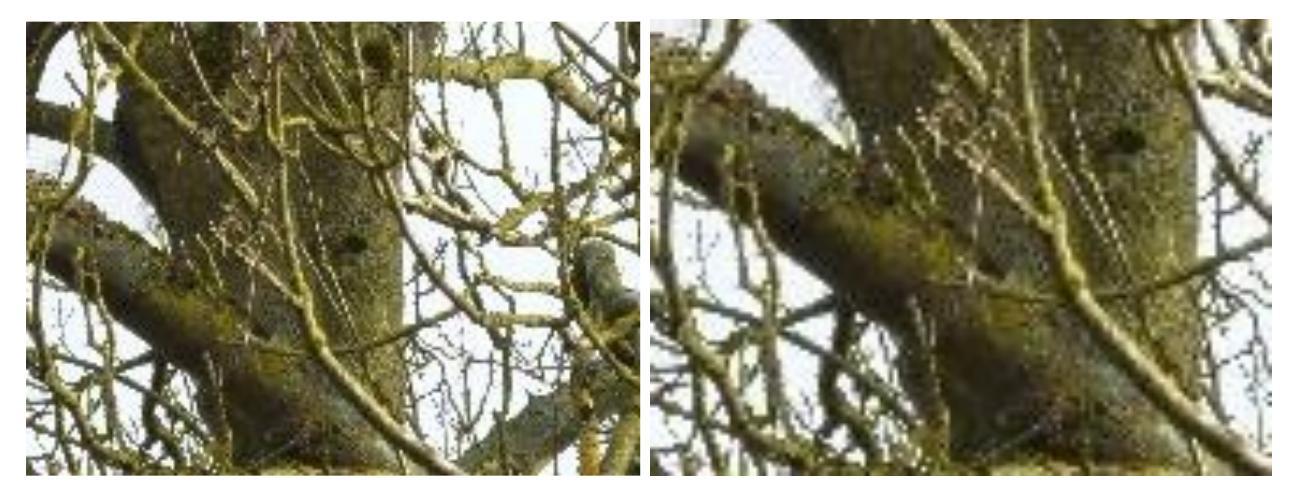
See image above. Binoculars show this to be a small hollow perhaps not deep enough.

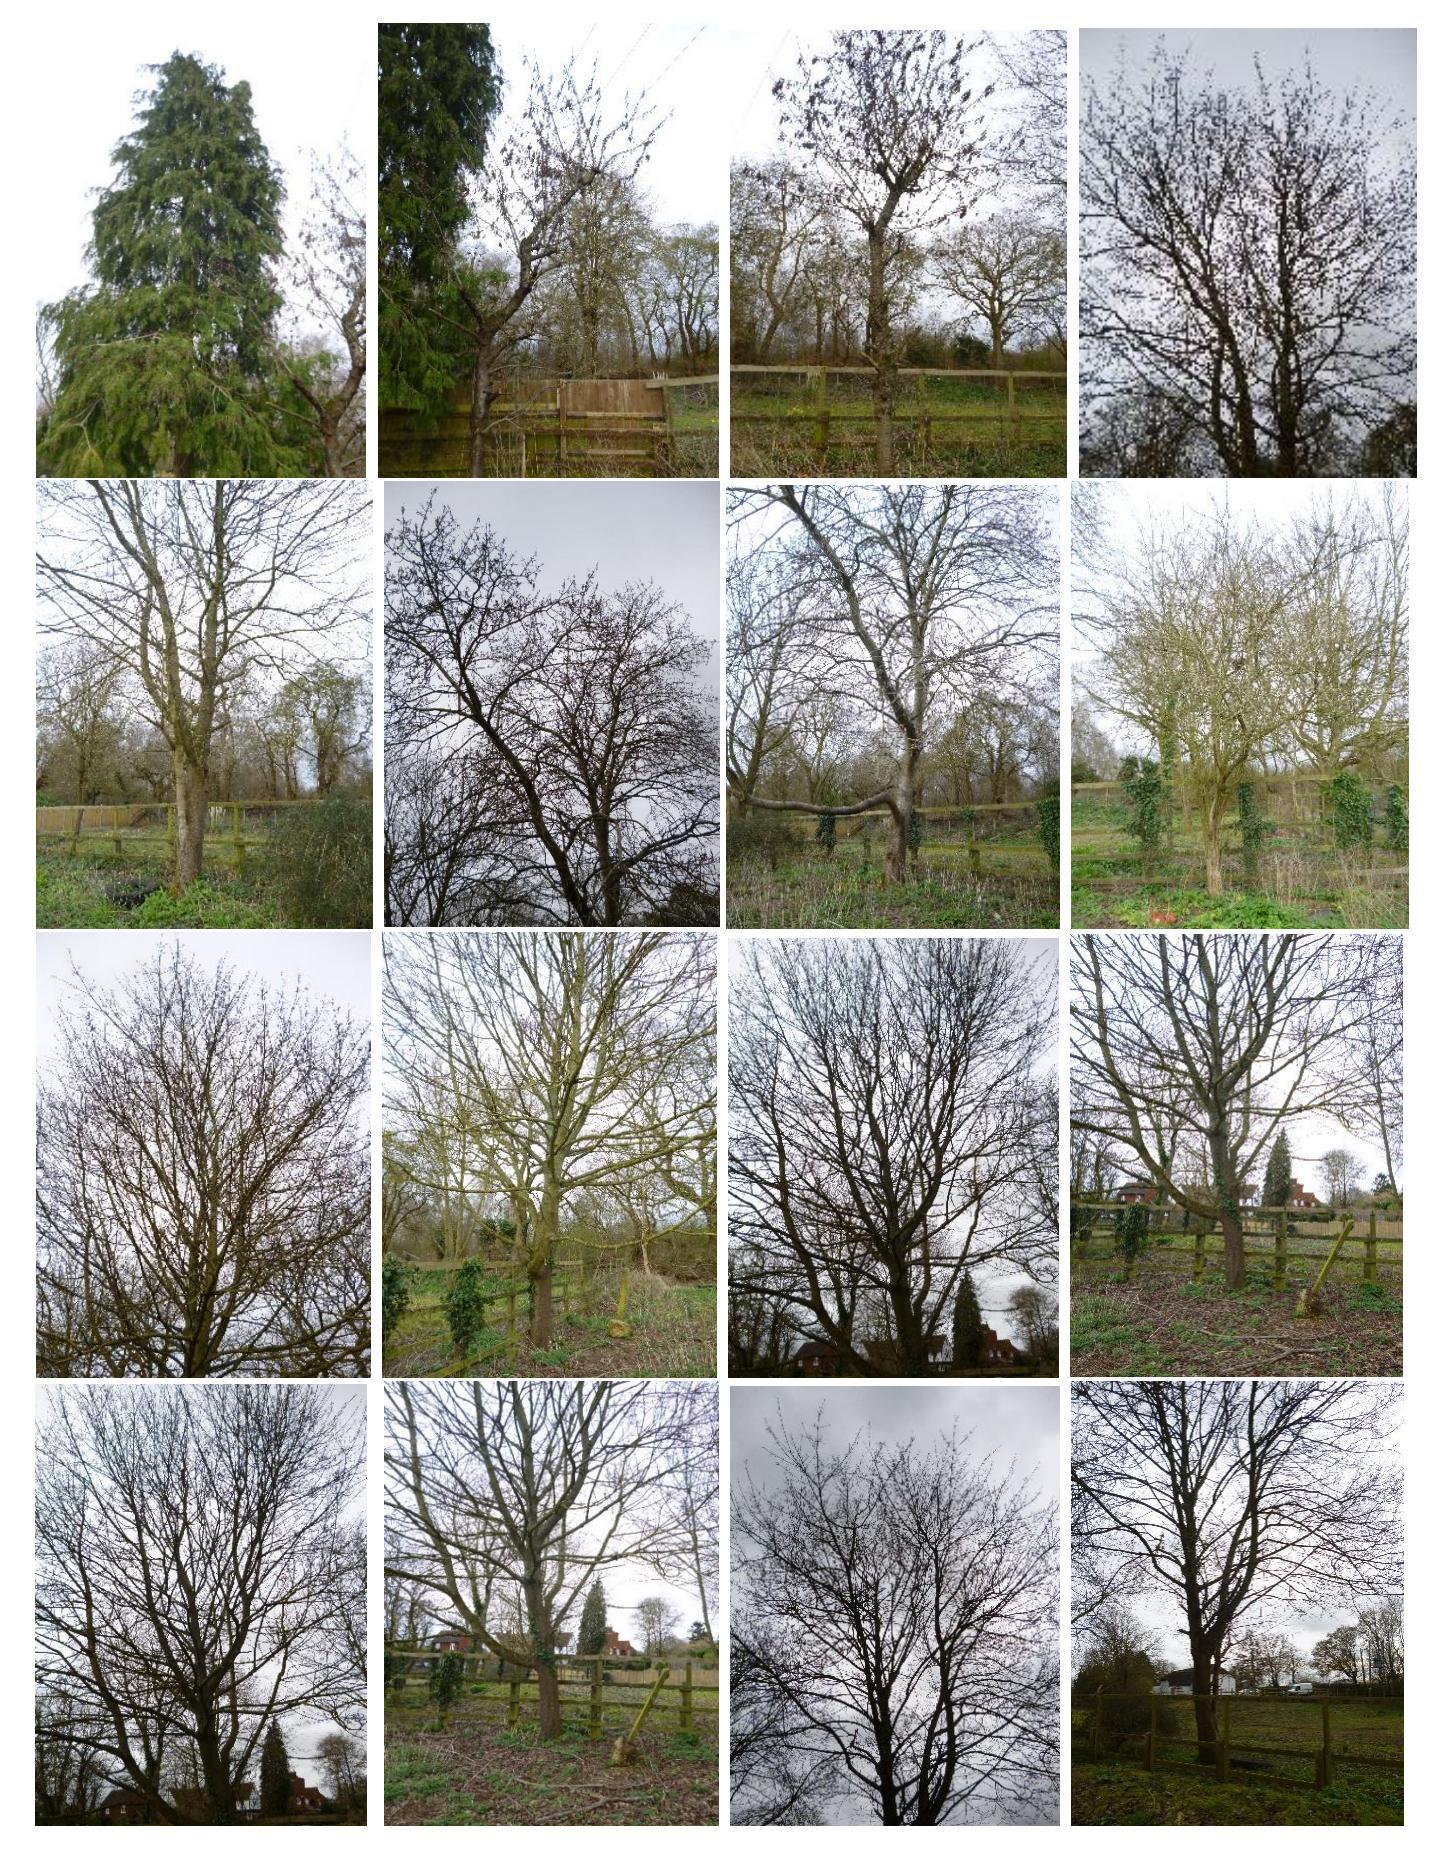
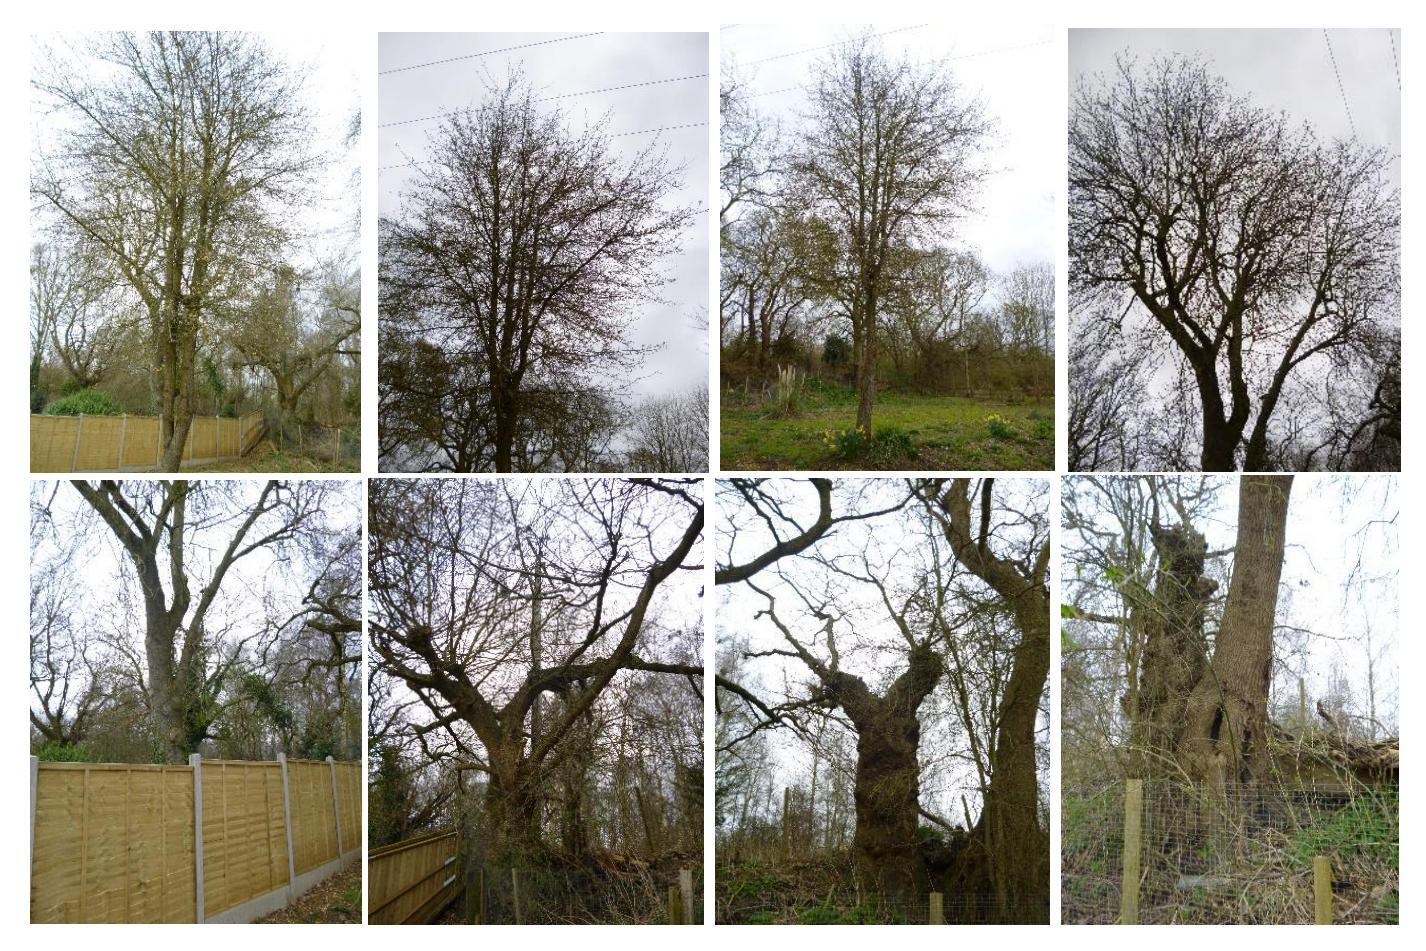
Below, the trees scheduled for removal.

The three trees in the extreme northeast corner do have a limited amount of crevices that could provide an opportunity Potential Roost Site, if not in 2024 then within two years if rot progresses further.

There are no Potential Roost Features on any of the trees scheduled for removal. Potential Suitability Negligible to Nil

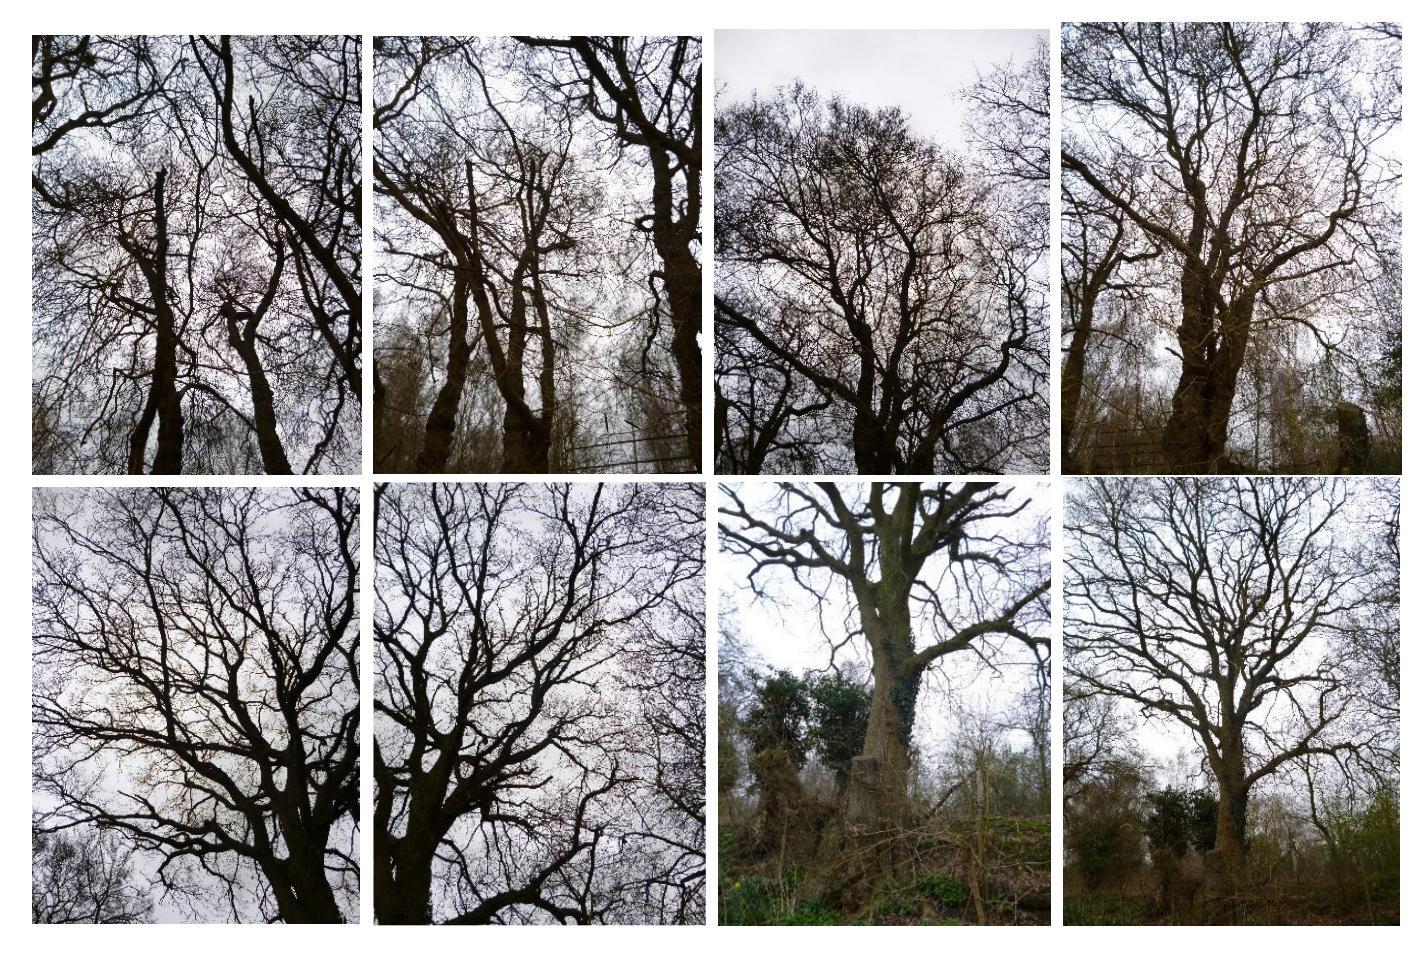
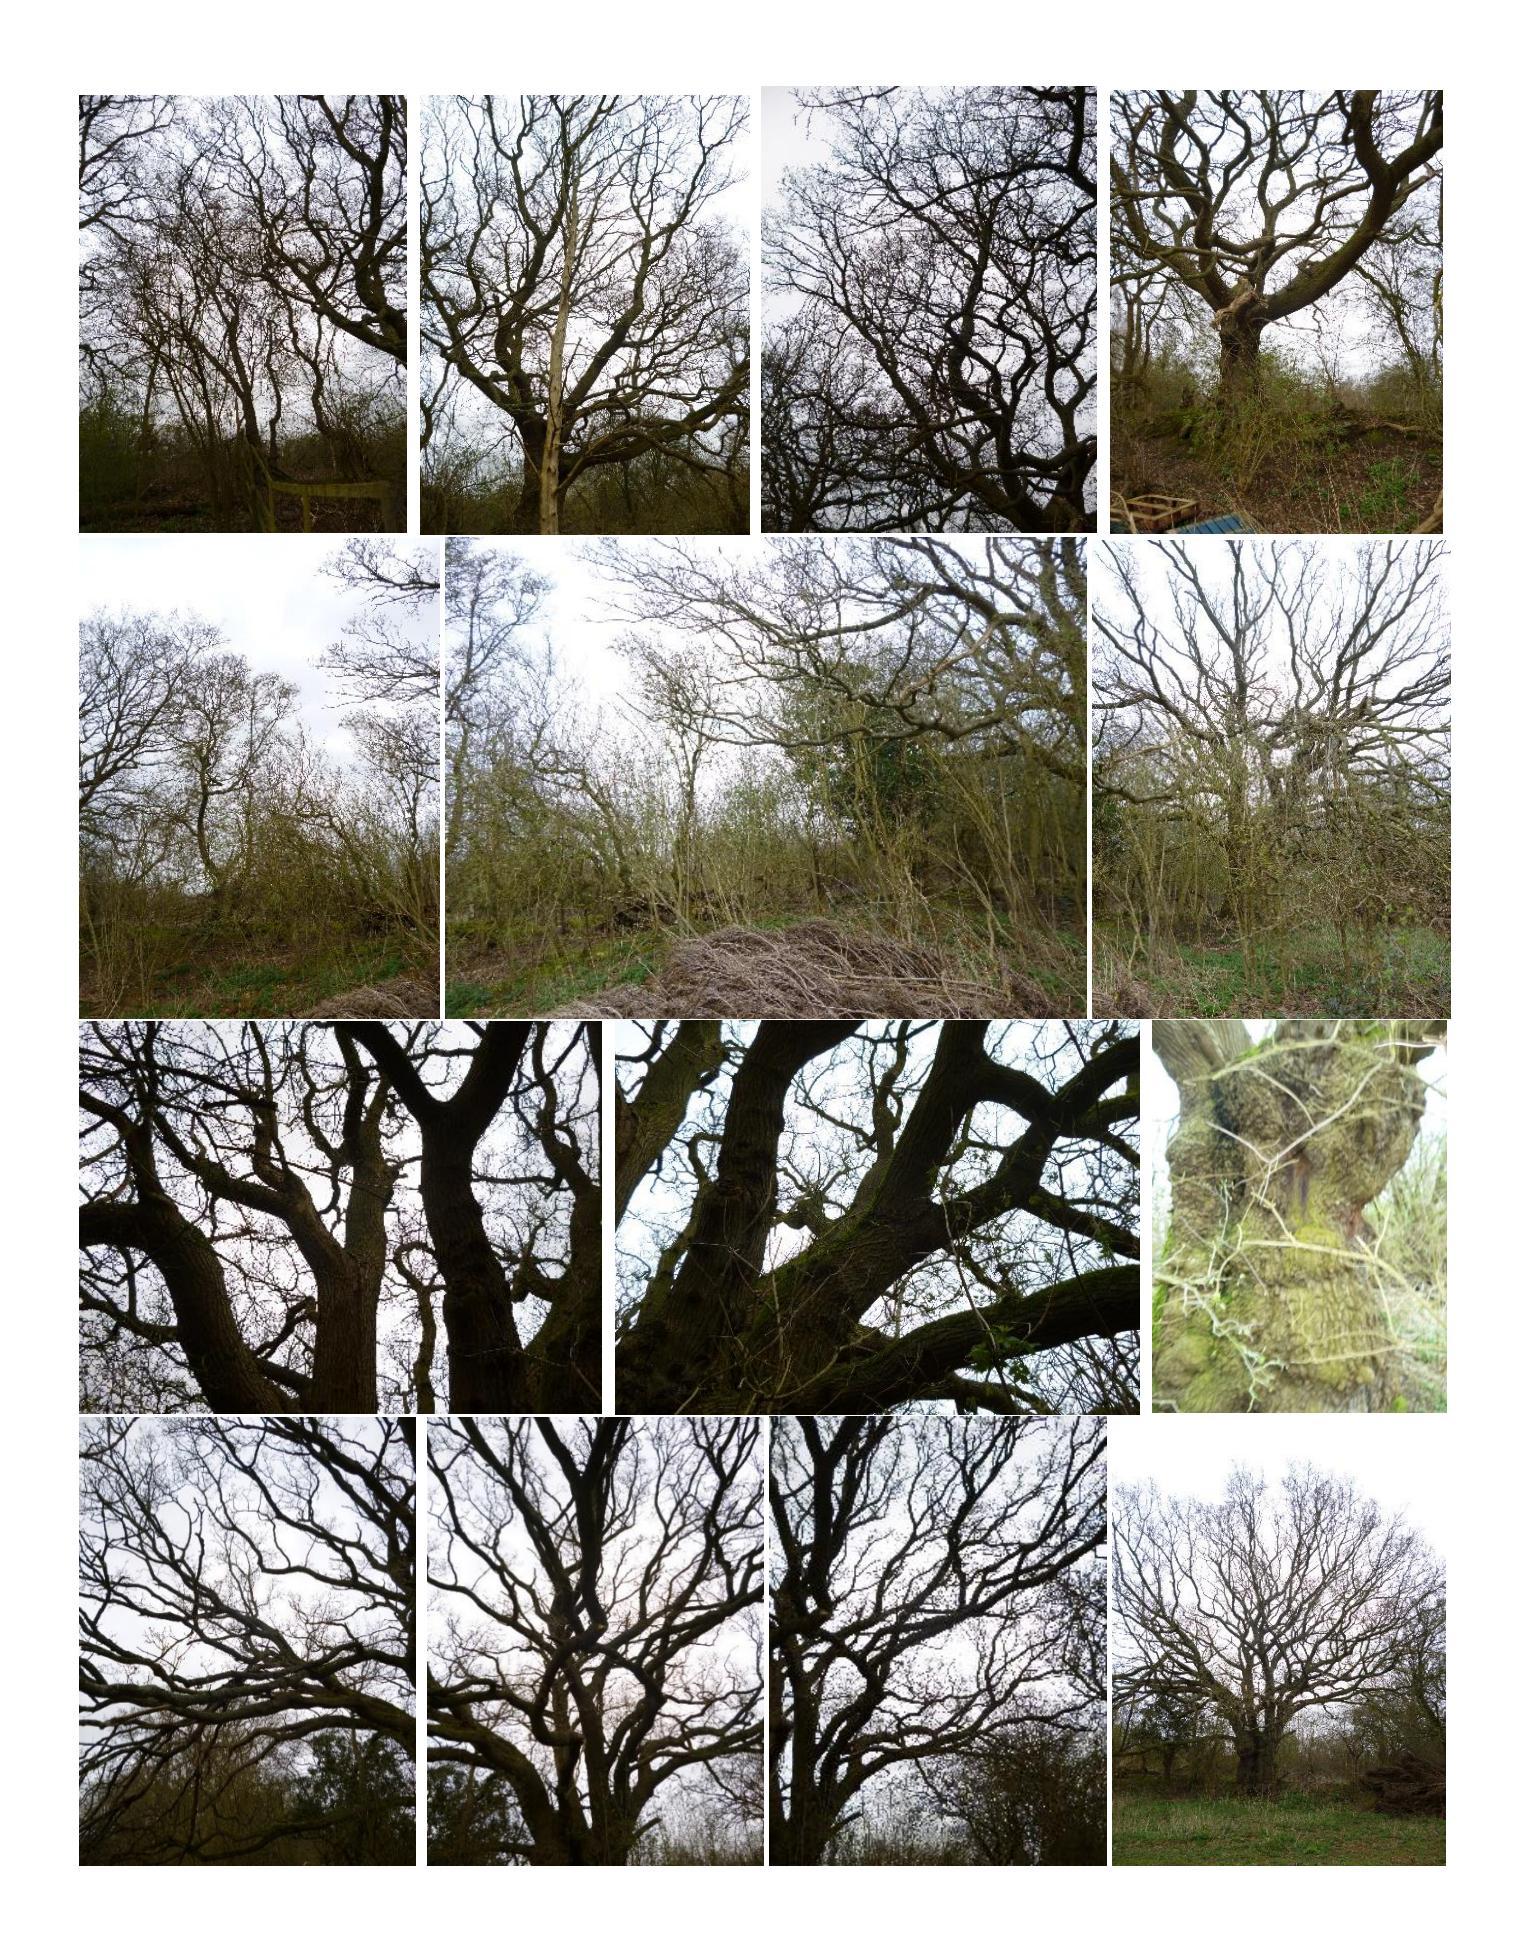
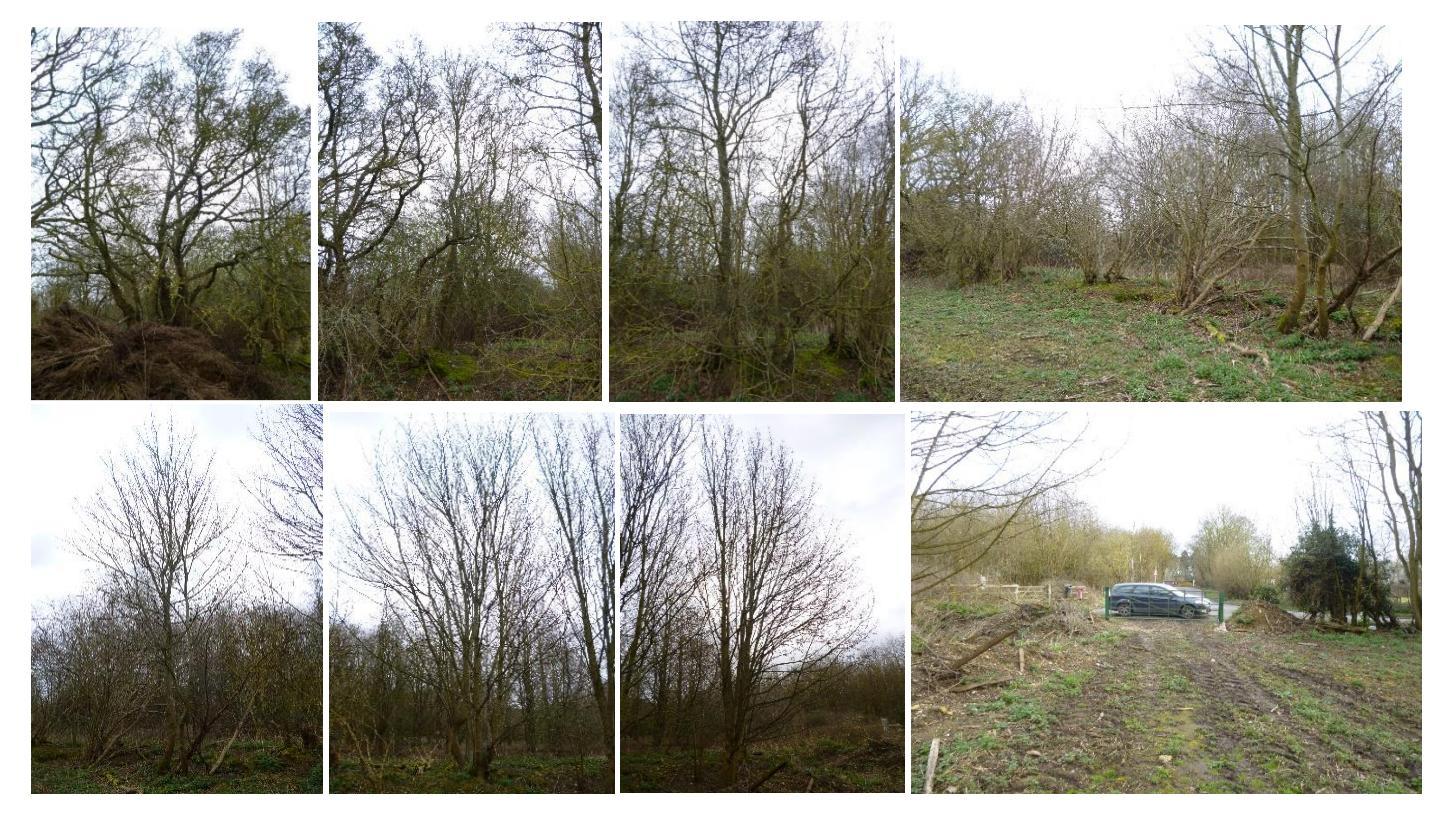
Below the eastern boundary trees.

The veteran Quercus robur along the eastern boundary are in good condition. Although a prime site for numerous species to roost, there was no obvious hollows or crevices. The walkway in Linnet's Wood allowed binocular observations on all sides. See below.
