Construction Noise and Vibration Monthly Report – July 2022

Lichfield District Council

Non-Technical Summary

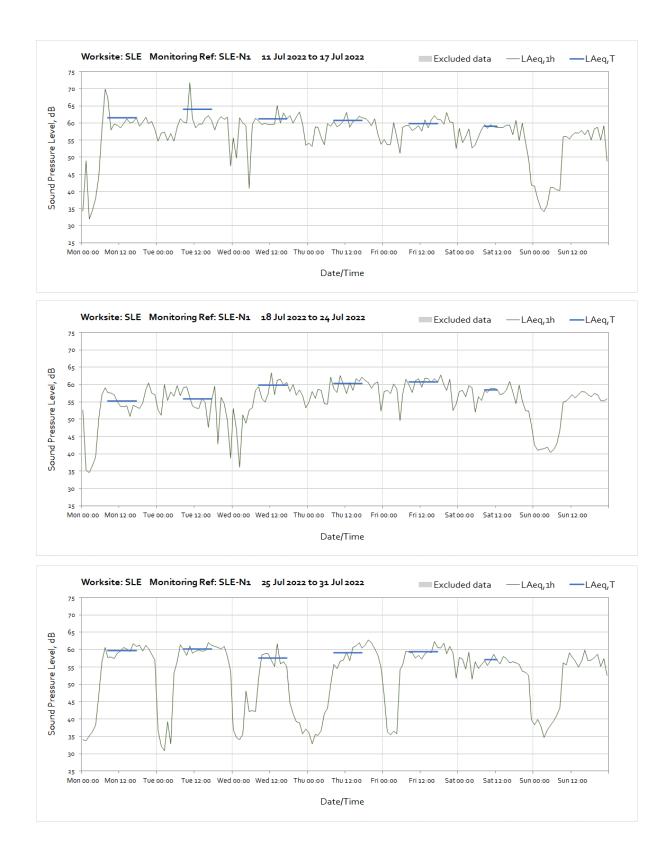
Worksite:SLE – Monitoring Ref: SLE-N1

The following graphs show the hourly measured ambient noise level $L_{Aeq,1h}$ and, where relevant, the averaged noise level $L_{Aeq,T}$ values, where the time period T is as specified in Table 1 of HS2 Information Paper E23. Periods with adversely weather affected noise levels are greyed out and have been excluded from the calculation of the $L_{Aeq,T}$ values in Table 3 of the main report.
