# **Construction Noise and Vibration Monthly Report – August 2022**

**Birmingham City Council**

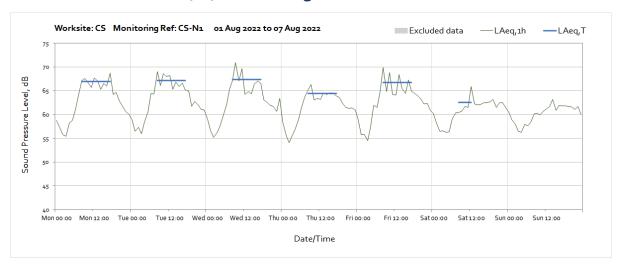
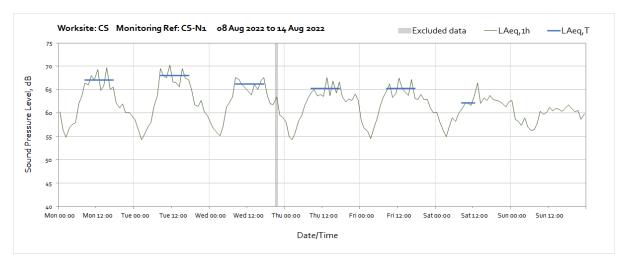
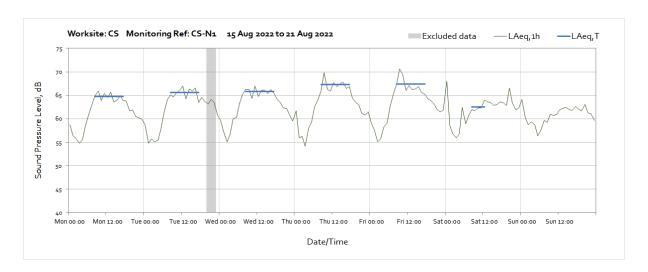
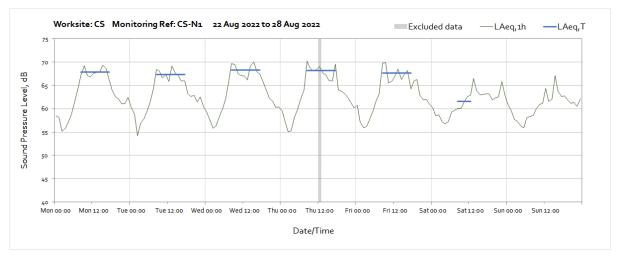
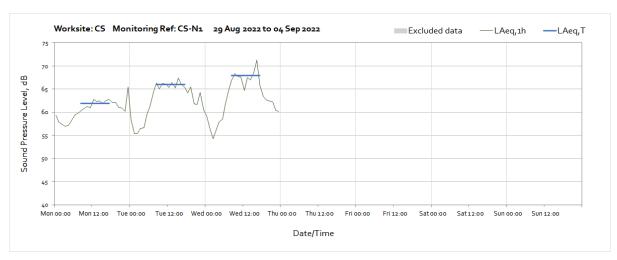
#### Worksite: Curzon Street (CS) - Monitoring Ref: CS-N1

The following graphs show the hourly measured ambient noise level  $L_{Aeq,1h}$  and, where relevant, the averaged noise level  $L_{Aeq,T}$  values, where the time period T is as specified in Table 1 of HS2 Information Paper E23. Periods with adversely weather affected noise levels are greyed out and have been excluded from the calculation of the  $L_{Aeq,T}$  values in Table 3 of the main report.

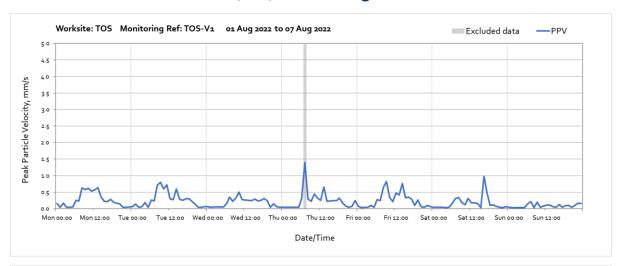
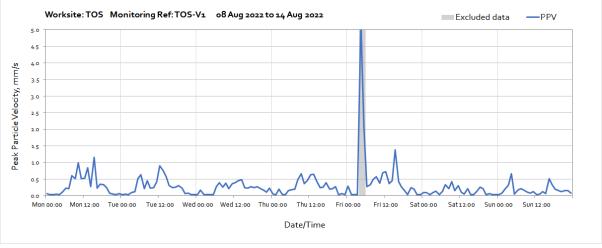
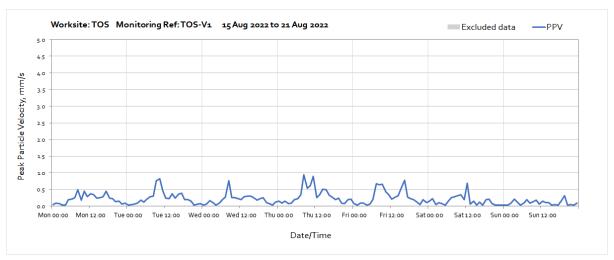
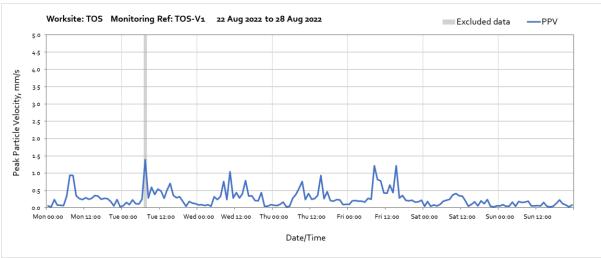
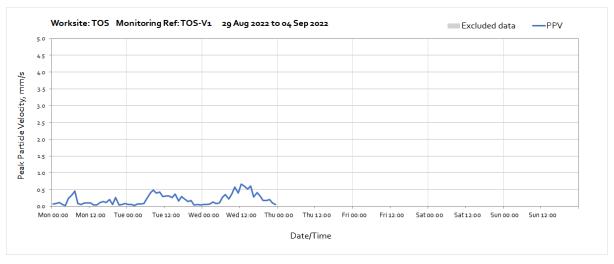
#### Worksite: Twisted Oak Stables (TOS) - Monitoring Ref: TOS-V1

The following graphs show the hourly measured peak particle velocity PPV recorded during the monitoring period. The graphs show the highest PPV of the three orthogonal axis x, y and z. Where high values of PPV were caused by local interference with the vibration monitor, which are not representative of HS2 construction works, these values have been greyed out in the following charts and have been excluded to calculate values in Table 4 of the main report.

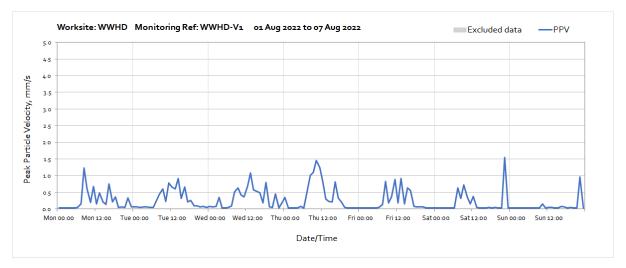
#### Worksite: Washwood Heath Depot (WWHD) - Monitoring Ref: WWHD-V1

Note: High vibration levels measured throughout the week were due to movement along the haul road. The nearest sensitive receptor is 50m further away from the monitor and therefore HS2 related vibration levels will be lower at the receptor.

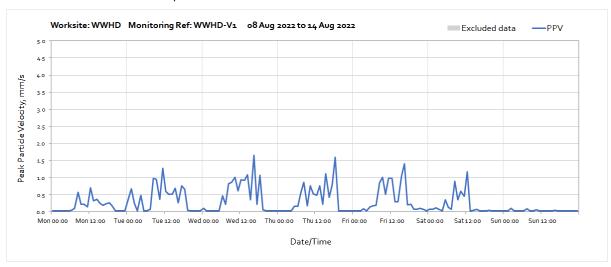
Note: High vibration levels measured throughout the week were due to plant movement along the haul road. The nearest sensitive receptor is 50m further away from the monitor and therefore HS2 related vibration levels will be lower at the receptor.

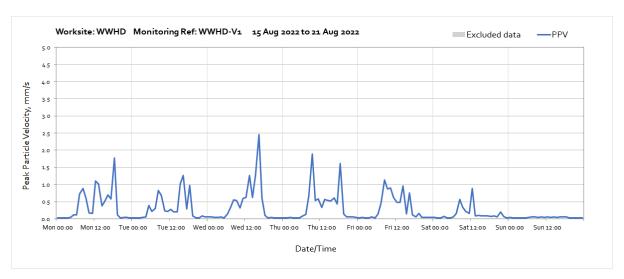
Note: High vibration levels measured throughout the week were due to ADT movement along the haul road, steel loading, use of roller near the monitor. The nearest sensitive receptor is 50m further away from the monitor and therefore HS2 vibration levels will be lower at the receptor.

High PPV value recorded 08:00 on Friday 19th August was due to local disturbance.

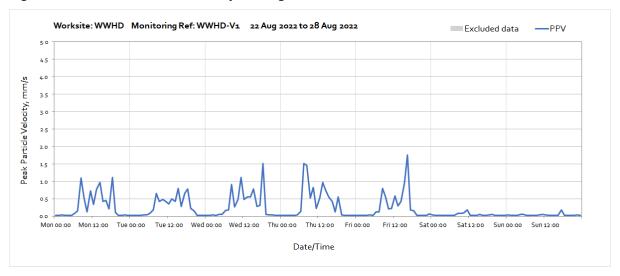
Note: High vibration levels measured throughout the week were due to loading & unloading rebar and use of roller near the monitor. The nearest sensitive receptor is 50m further away from the monitor and therefore HS2 related vibration levels will be lower at the receptor.

High PPV value recorded 08:00 and 18:00 on Monday 22<sup>nd</sup> August was due to local disturbance.

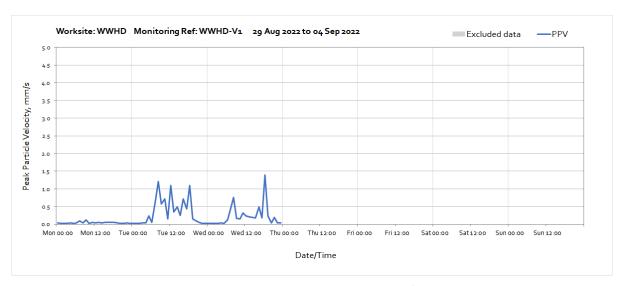
Note: High PPV value recorded at 08:00, 12:00 and 18:00 on Tuesday  $30^{th}$  August and at 18:00 Tuesday  $31^{st}$  August was due to local disturbance.
