## **Construction Noise and Vibration Monthly Report – August 2022**

**Lichfield District Council**

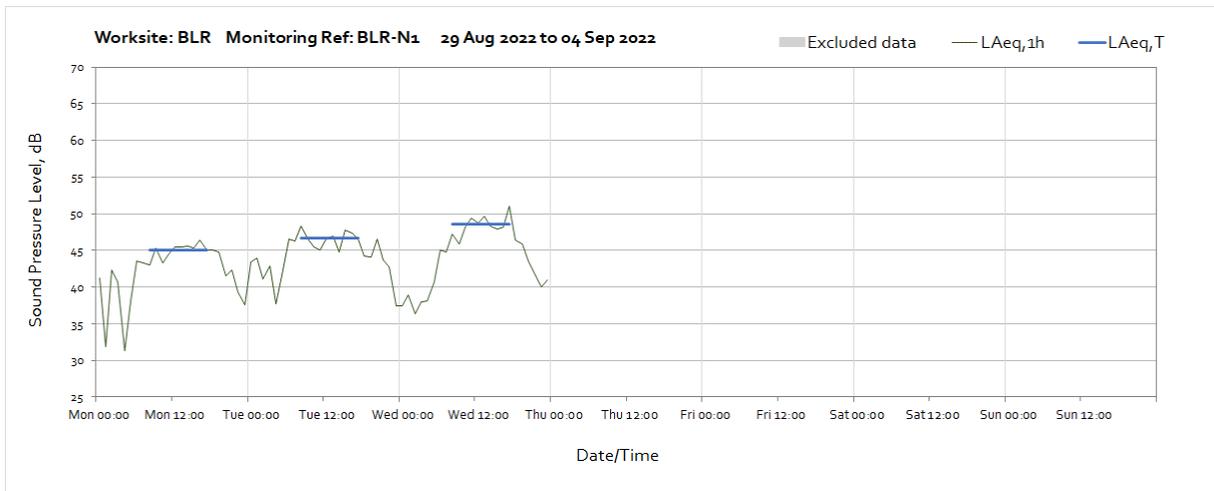
**Worksite: BLR – Monitoring Ref: BLR-N1**

The following graphs show the hourly measured ambient noise level  $L_{Aeq,1h}$  and, where relevant, the averaged noise level  $L_{Aeq,T}$  values, where the time period T is as specified in Table 1 of HS2 Information Paper E23. Periods with adversely weather affected noise levels are greyed out and have been excluded from the calculation of the  $L_{Aeq,T}$  values in Table 3 of the main report.

Note: Monitor installed at 11:00 on 11<sup>th</sup> August 2022.
