# **Construction Noise and Vibration Monthly Report – September 2022**

**West Northamptonshire District Council**

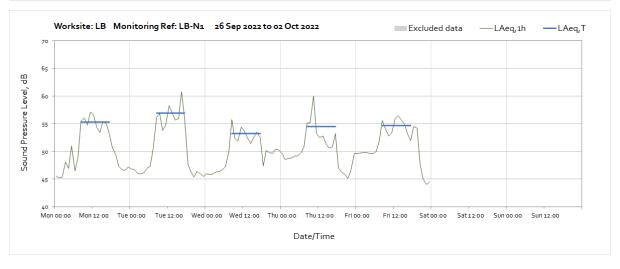
#### Worksite: LB - Monitoring Ref: LB-N1

The following graphs show the hourly measured ambient noise level  $L_{Aeq,1h}$  and, where relevant, the averaged noise level  $L_{Aeq,T}$  values, where the time period T is as specified in Table 1 of HS2 Information Paper E23. Periods with adversely weather affected noise levels are greyed out and have been excluded from the calculation of the  $L_{Aeq,T}$  values in Table 3 of the main report.

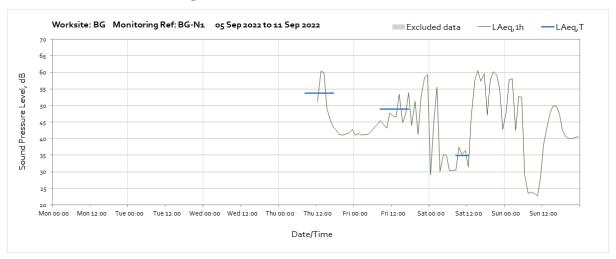
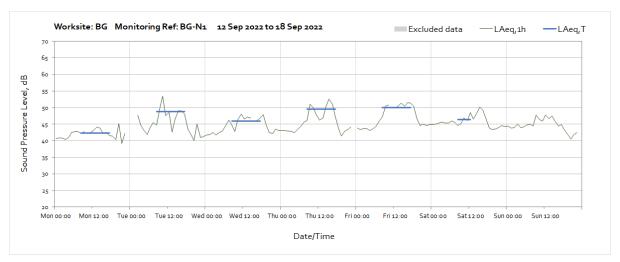
#### **Worksite: BG - Monitoring Ref: BG-N1**

Note: The noise monitor was installed at 12:00 on Thursday 8th September 2022

Note: Missing data throughout the week was due to maintenance of the monitor

Note: Missing data at 23:00 on Friday 23<sup>rd</sup> September was due to maintenance of the monitor

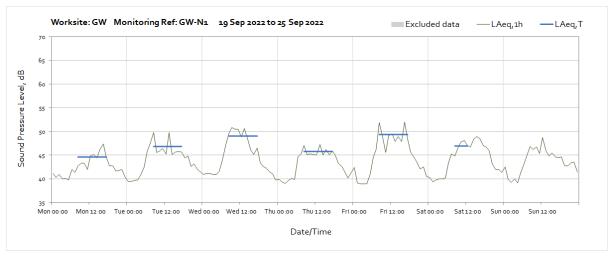
#### Worksite: GW - Monitoring Ref: GW-N1

Note: Missing data between 12:00 and 14:00 on Wednesday 28<sup>th</sup> September was due to maintenance of the monitor.
