Construction Noise and Vibration Monthly Report – October 2022

Stratford-on-Avon District Council

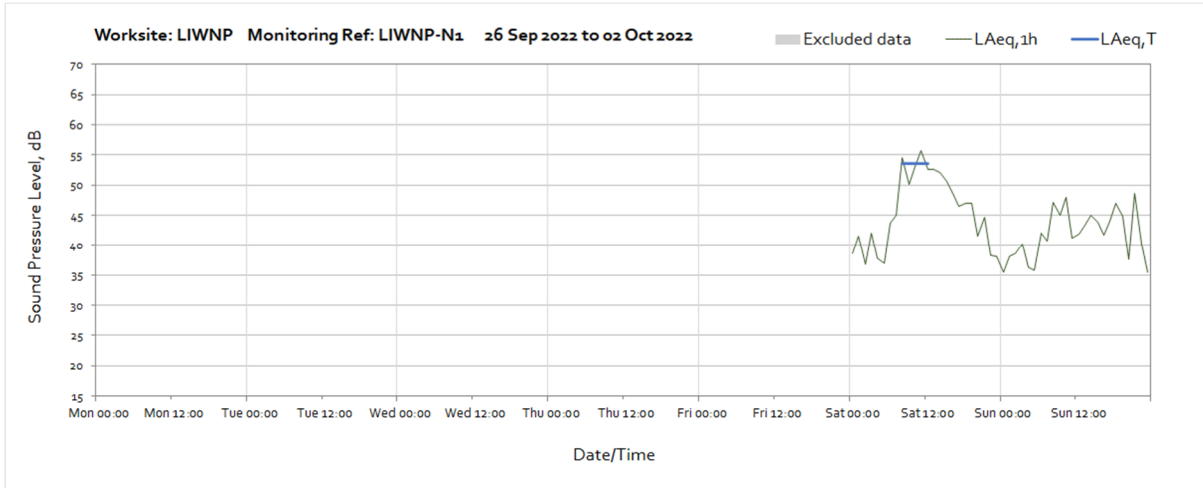
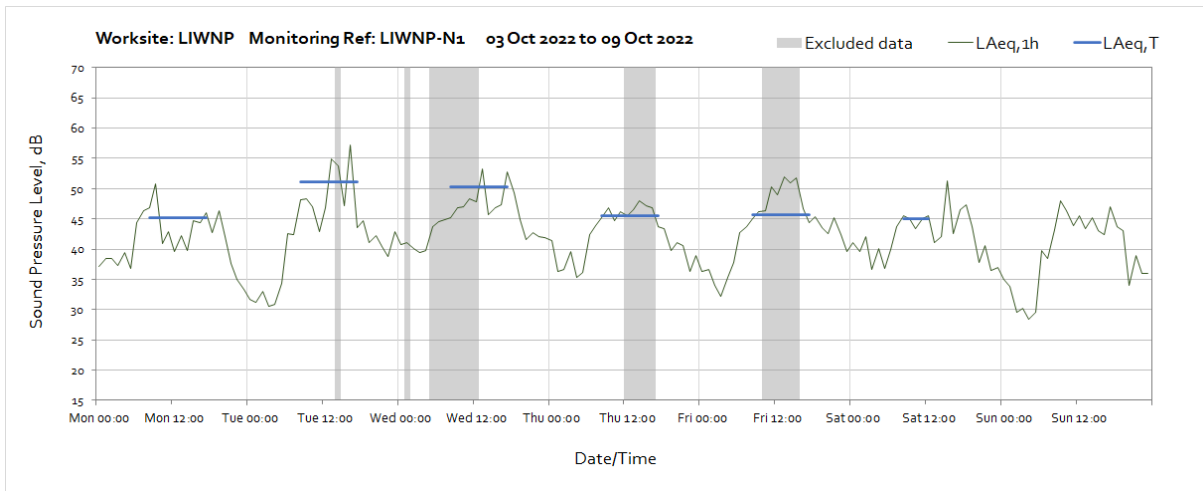
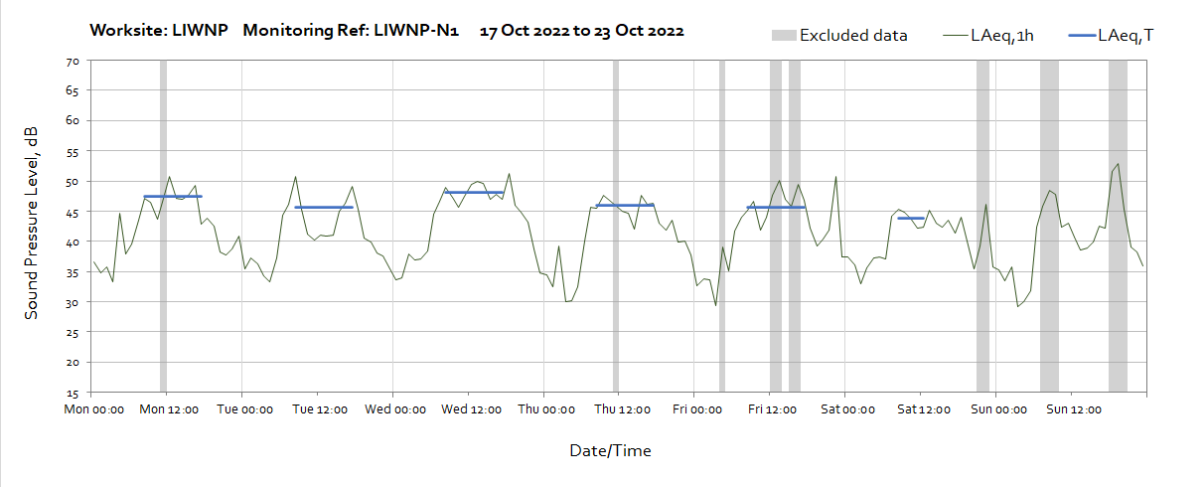
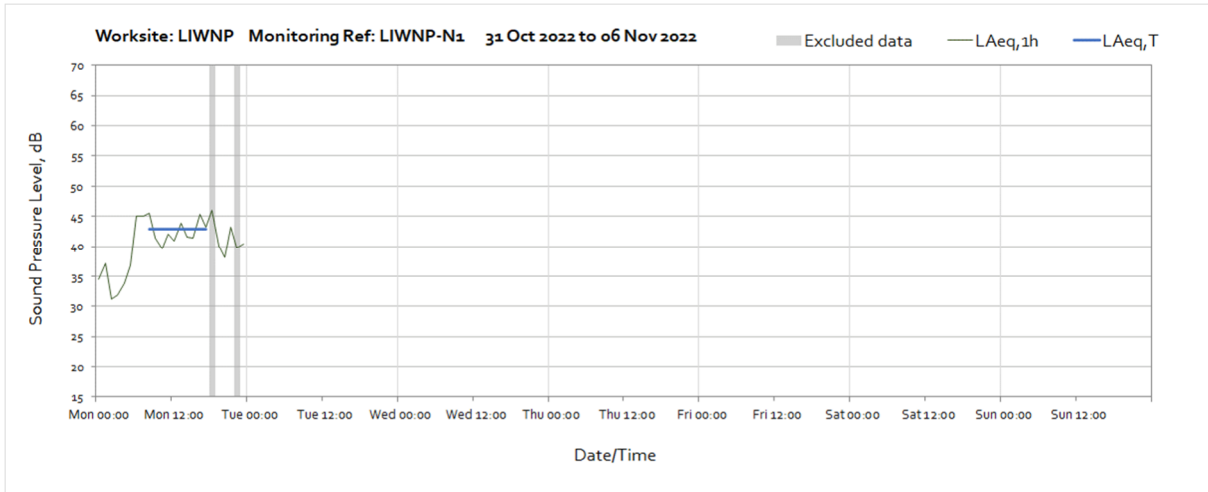
Worksite: LIWNP Monitoring Ref: LIWNP-N1

The following graphs show the hourly measured ambient noise level $L_{Aeq,1h}$ and, where relevant, the averaged noise level $L_{Aeq,T}$ values, where the time period T is as specified in Table 1 of HS2 Information Paper E23. Periods with adversely weather affected noise levels are greyed out and have been excluded from the calculation of the $L_{Aeq,T}$ values in Table 3 of the main report.

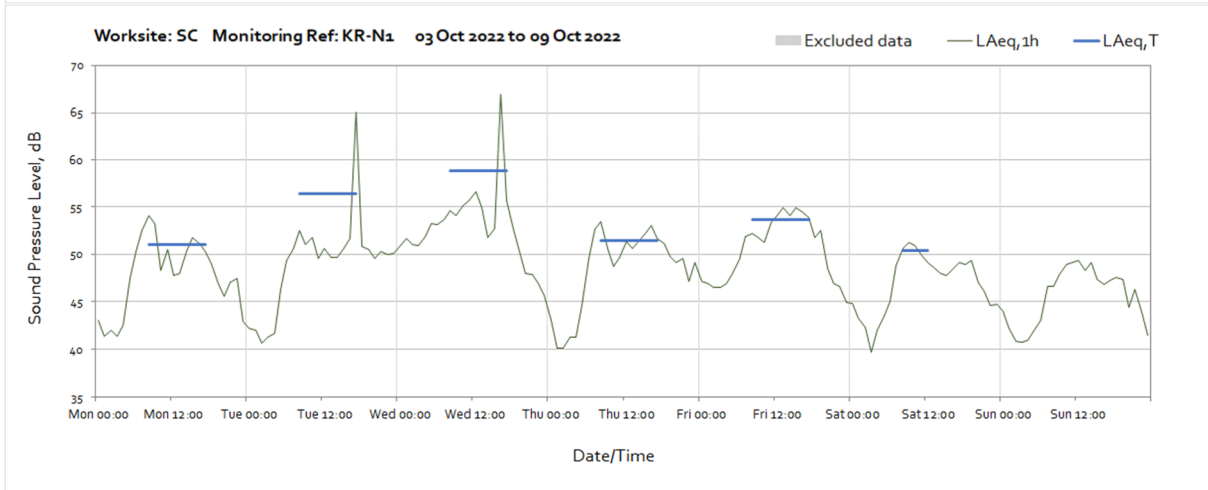
Worksite: KR Monitoring Ref: KR-N1

2.2.6 There was one exceedance of the LOAEL at monitoring location KR-N1 during the month of October 2022.

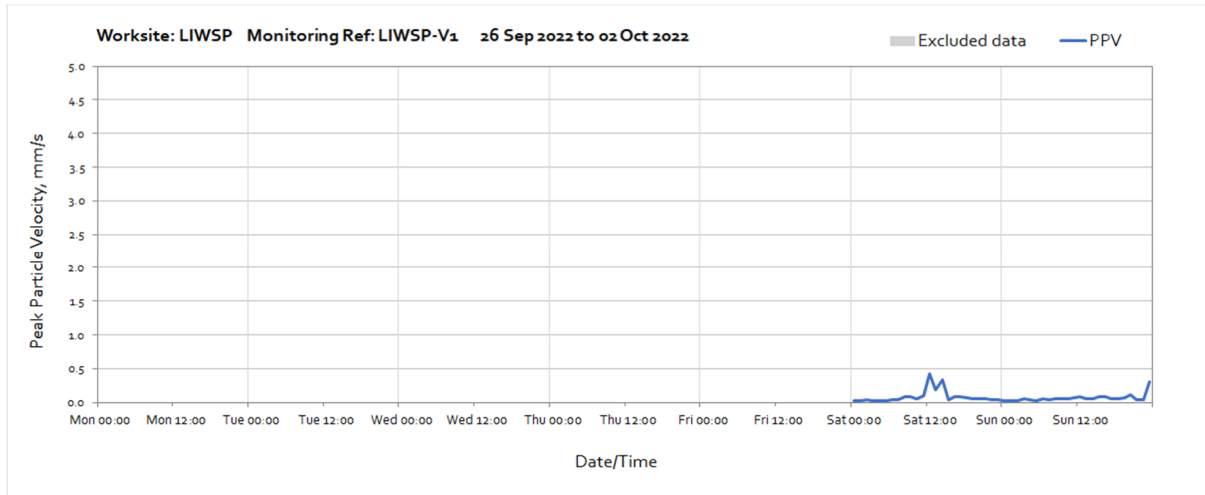
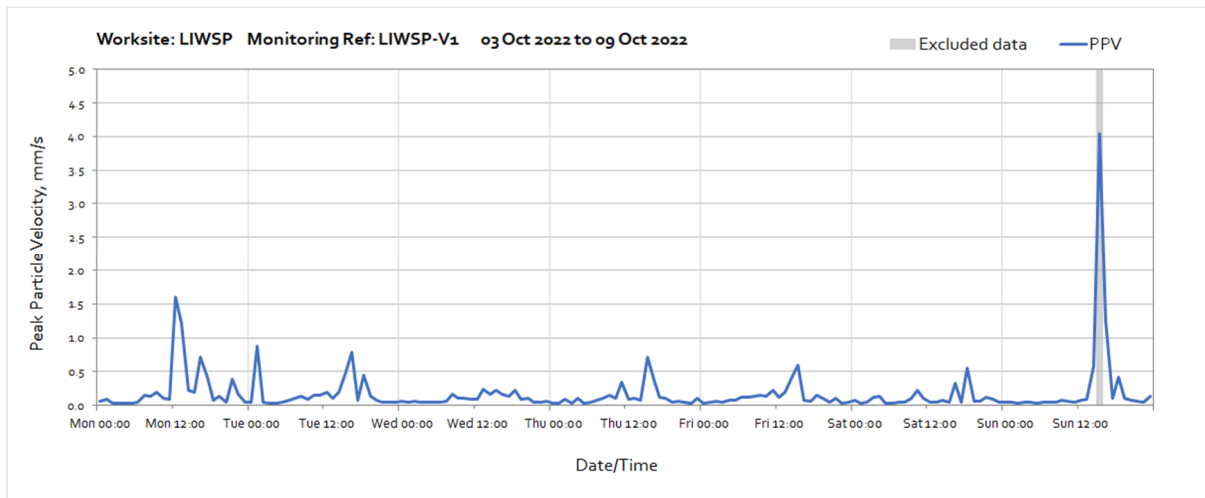
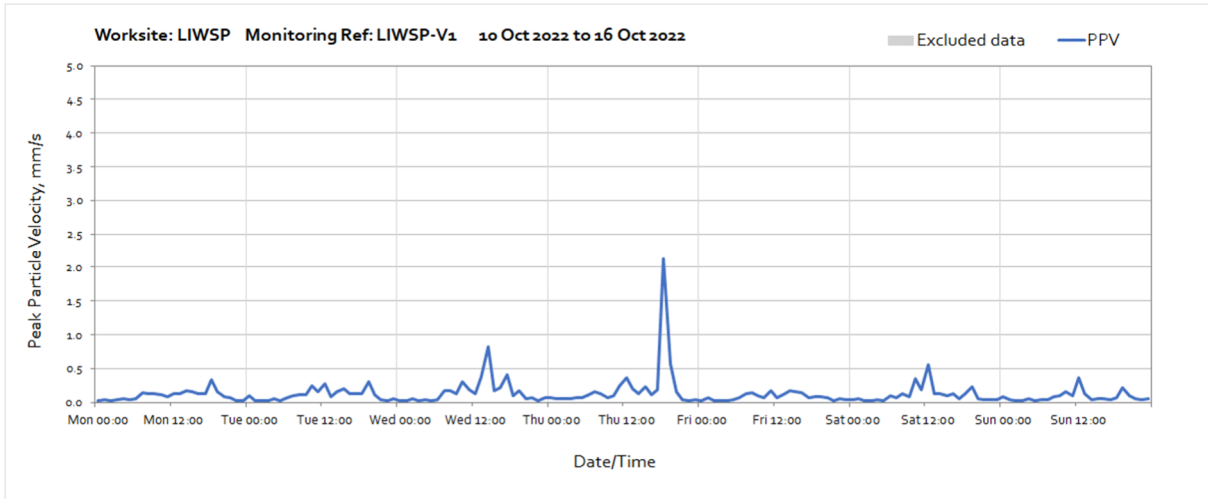
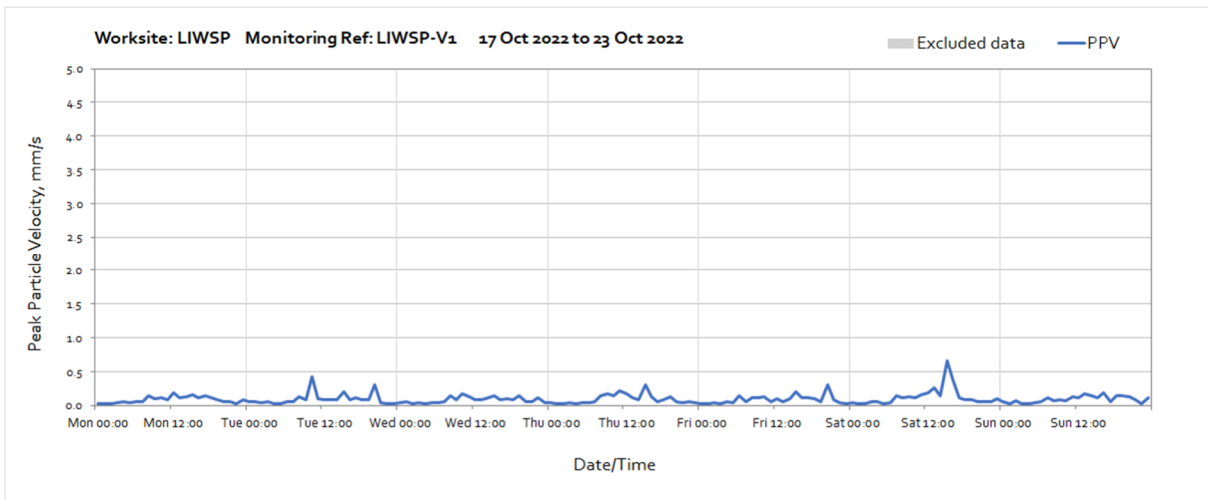
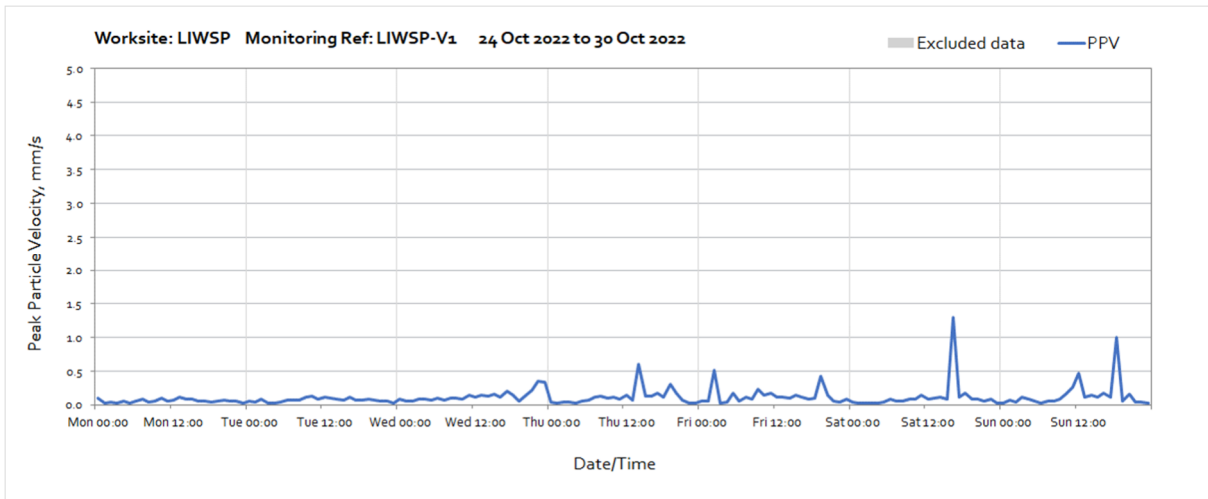
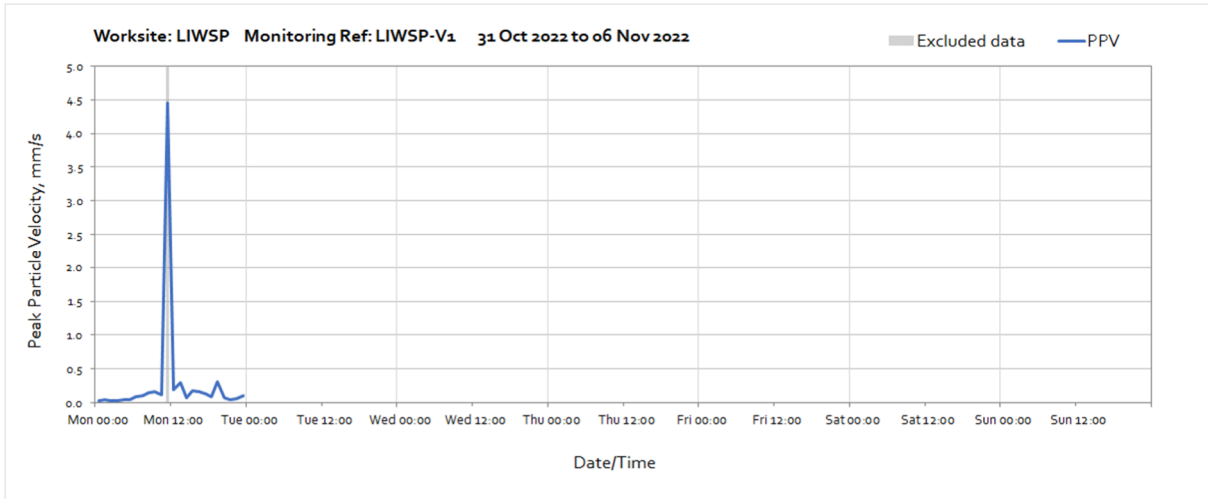
Worksite: LIWSP Monitoring Ref: LIWSP-V1

Worksite Reference	Measurement Reference	Monitor Address	Highest PPV measured in any axis, mm/s
LIWSP - Long Itchington Wood South Portal	LIWSP-V1	Woodside House, Bascote Heath, Southam	1.6 (X-axis)

The following graphs show the hourly measured peak particle velocity PPV recorded during the monitoring period. The graphs show the highest PPV of the three orthogonal axes x, y and z. Where high values of PPV were caused by local interference with the vibration monitor, which are not representative of HS2 construction works, these values have been greyed out in the following charts and have been excluded to calculate values in Table 4 of the main report.
