## **Construction Noise and Vibration Monthly Report – November 2022**

**Solihull Metropolitan Borough Council**

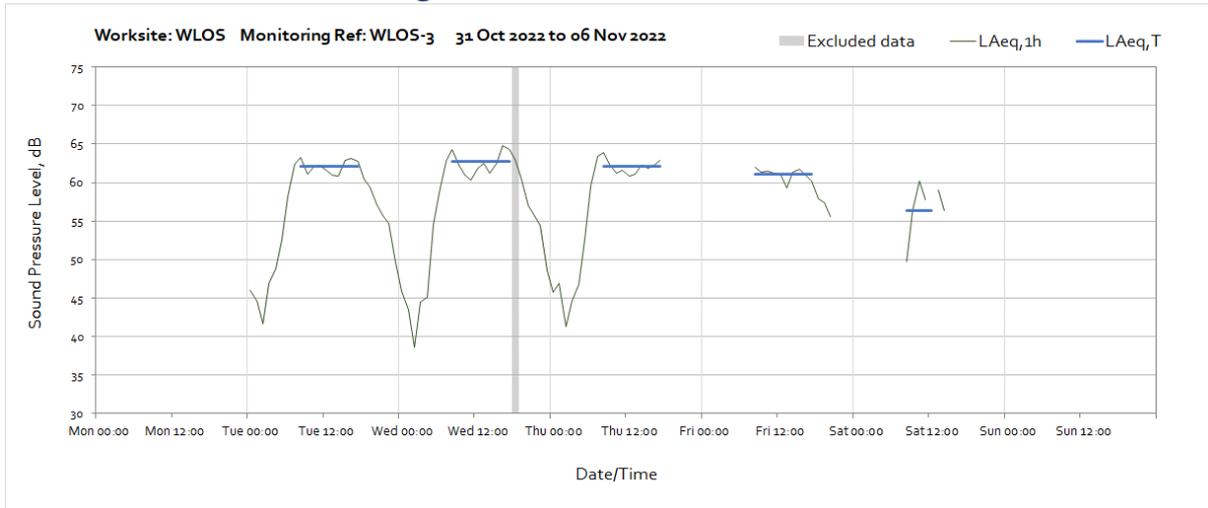
## Worksite: WLOS – Monitoring Ref: WLOS-3

Note: Missing data throughout the week was due to loss of power supply to the monitor.

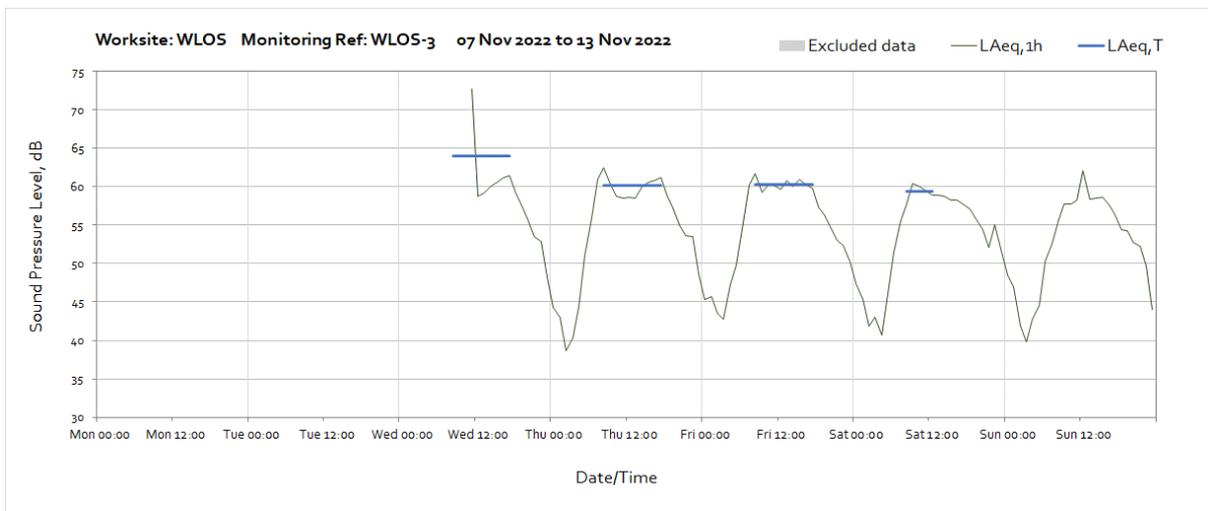
Note: Missing data from 00:00 on Monday 7<sup>th</sup> November till 11:00 on Wednesday 9<sup>th</sup> November was due to loss of power supply to the monitor.

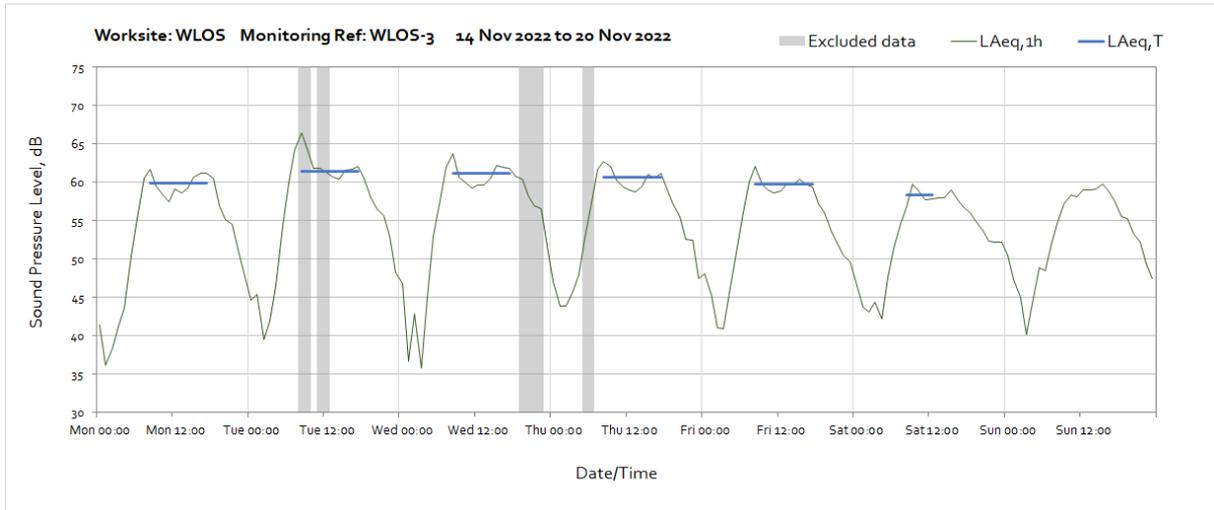
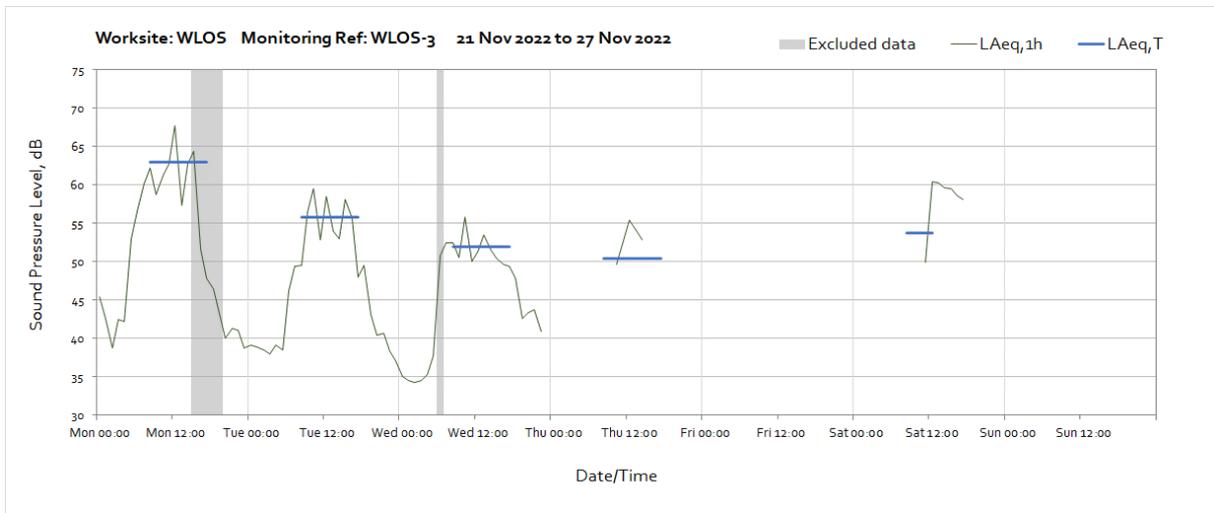
Note: Missing data throughout the week was due to loss of power supply to the monitor.

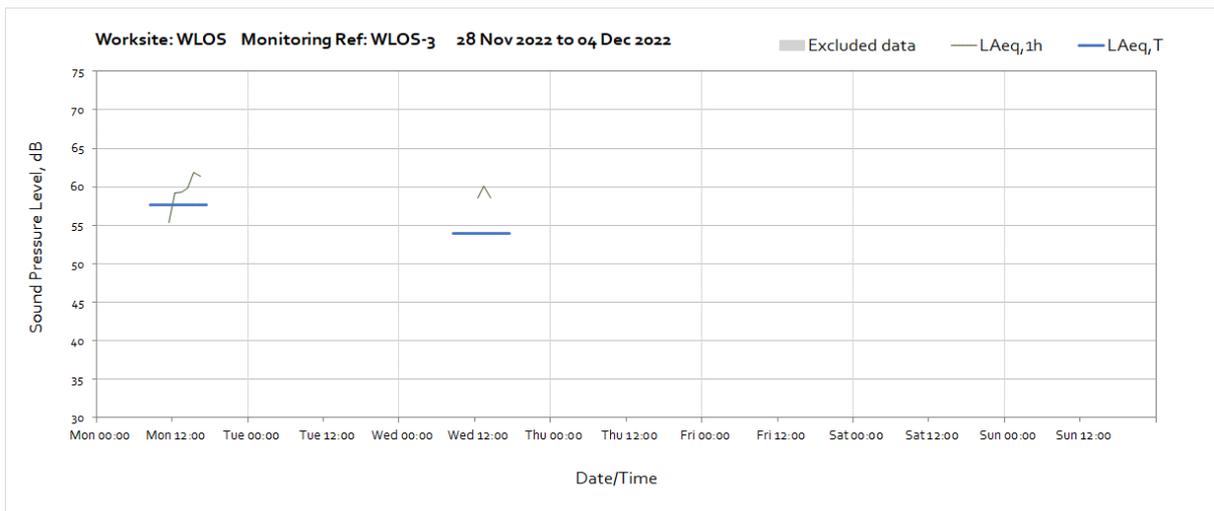
Note: Missing data throughout the week was due to loss of power supply to the monitor.

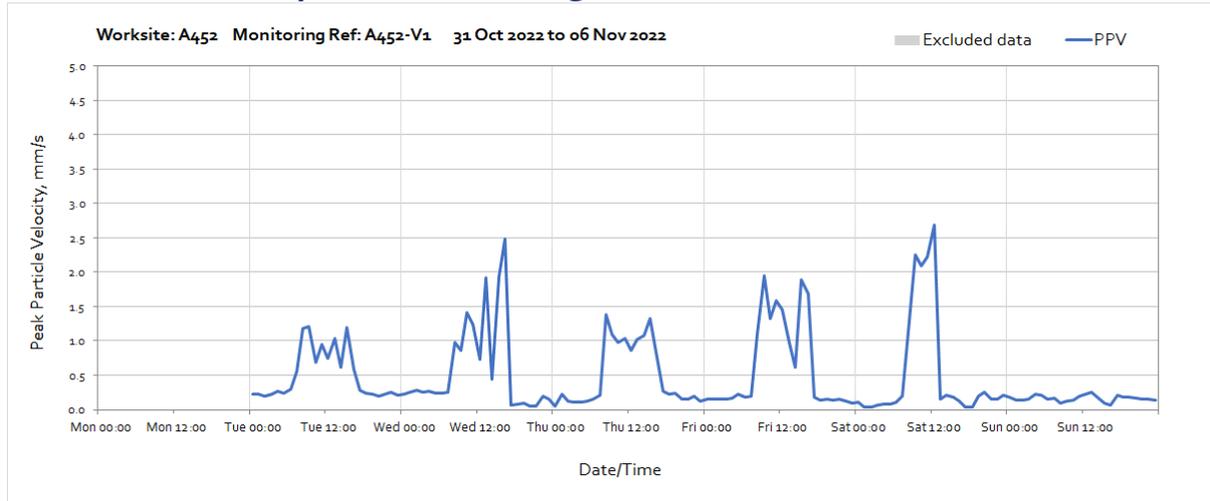
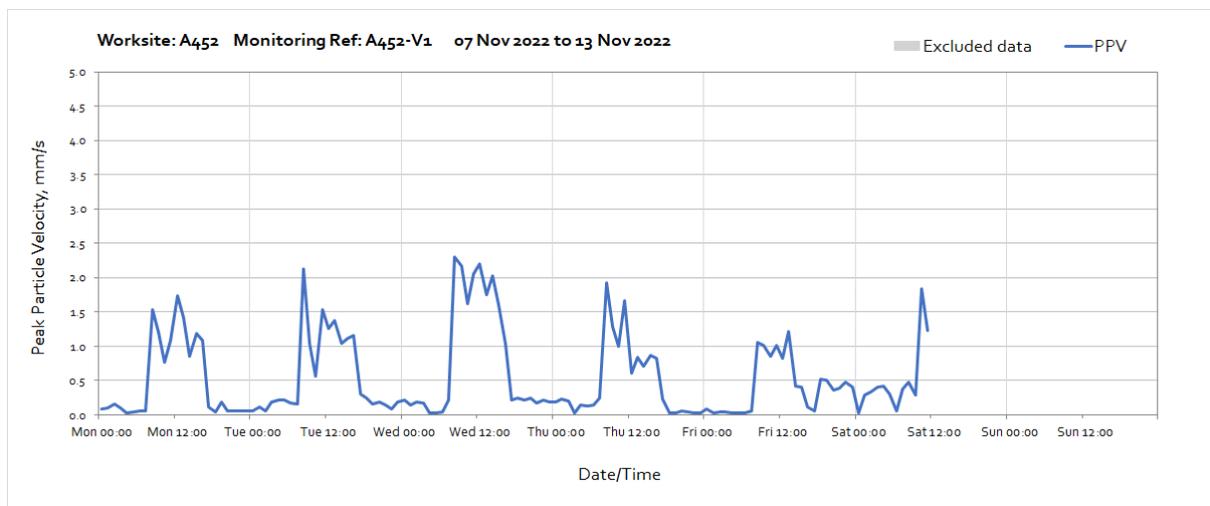
### Worksite: A452 compound – Monitoring Ref: A452-V1

Note: Missing data from 12:00 on Saturday 12<sup>th</sup> November till the end of the month was due to loss of power to the monitor.

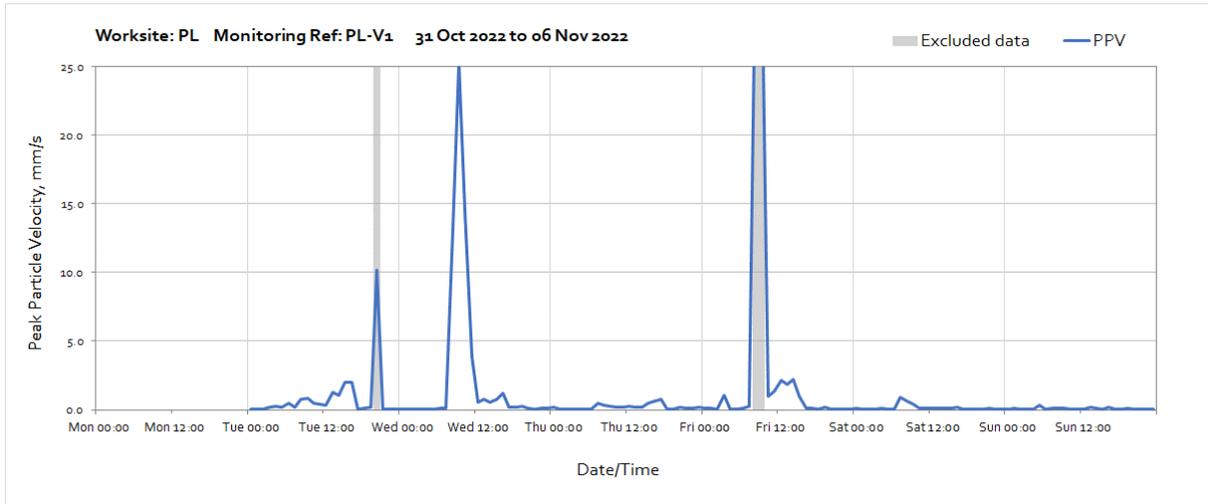
## Worksite: PL – Monitoring Ref: PL-V1

Note: High vibration levels measured at 09:00 on Wednesday 2<sup>nd</sup> November was due to topsoiling and hydroseeding works undertaken in vicinity of the monitor.

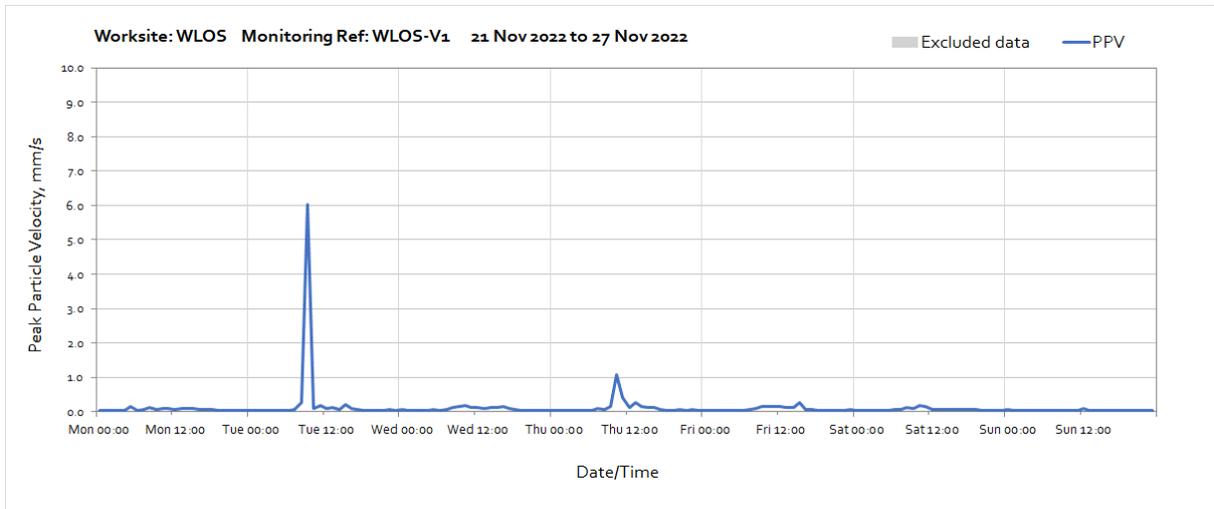
Note: High vibration levels measured at 09:00 on Tuesday 9<sup>th</sup> November was due to ground works undertaken in vicinity of the monitor.
