## Air Quality and Dust Monitoring Monthly Report – December 2022

London Borough of Hammersmith and Fulham

A report prepared by EWCs and MWCCs on behalf of HS2 Ltd.

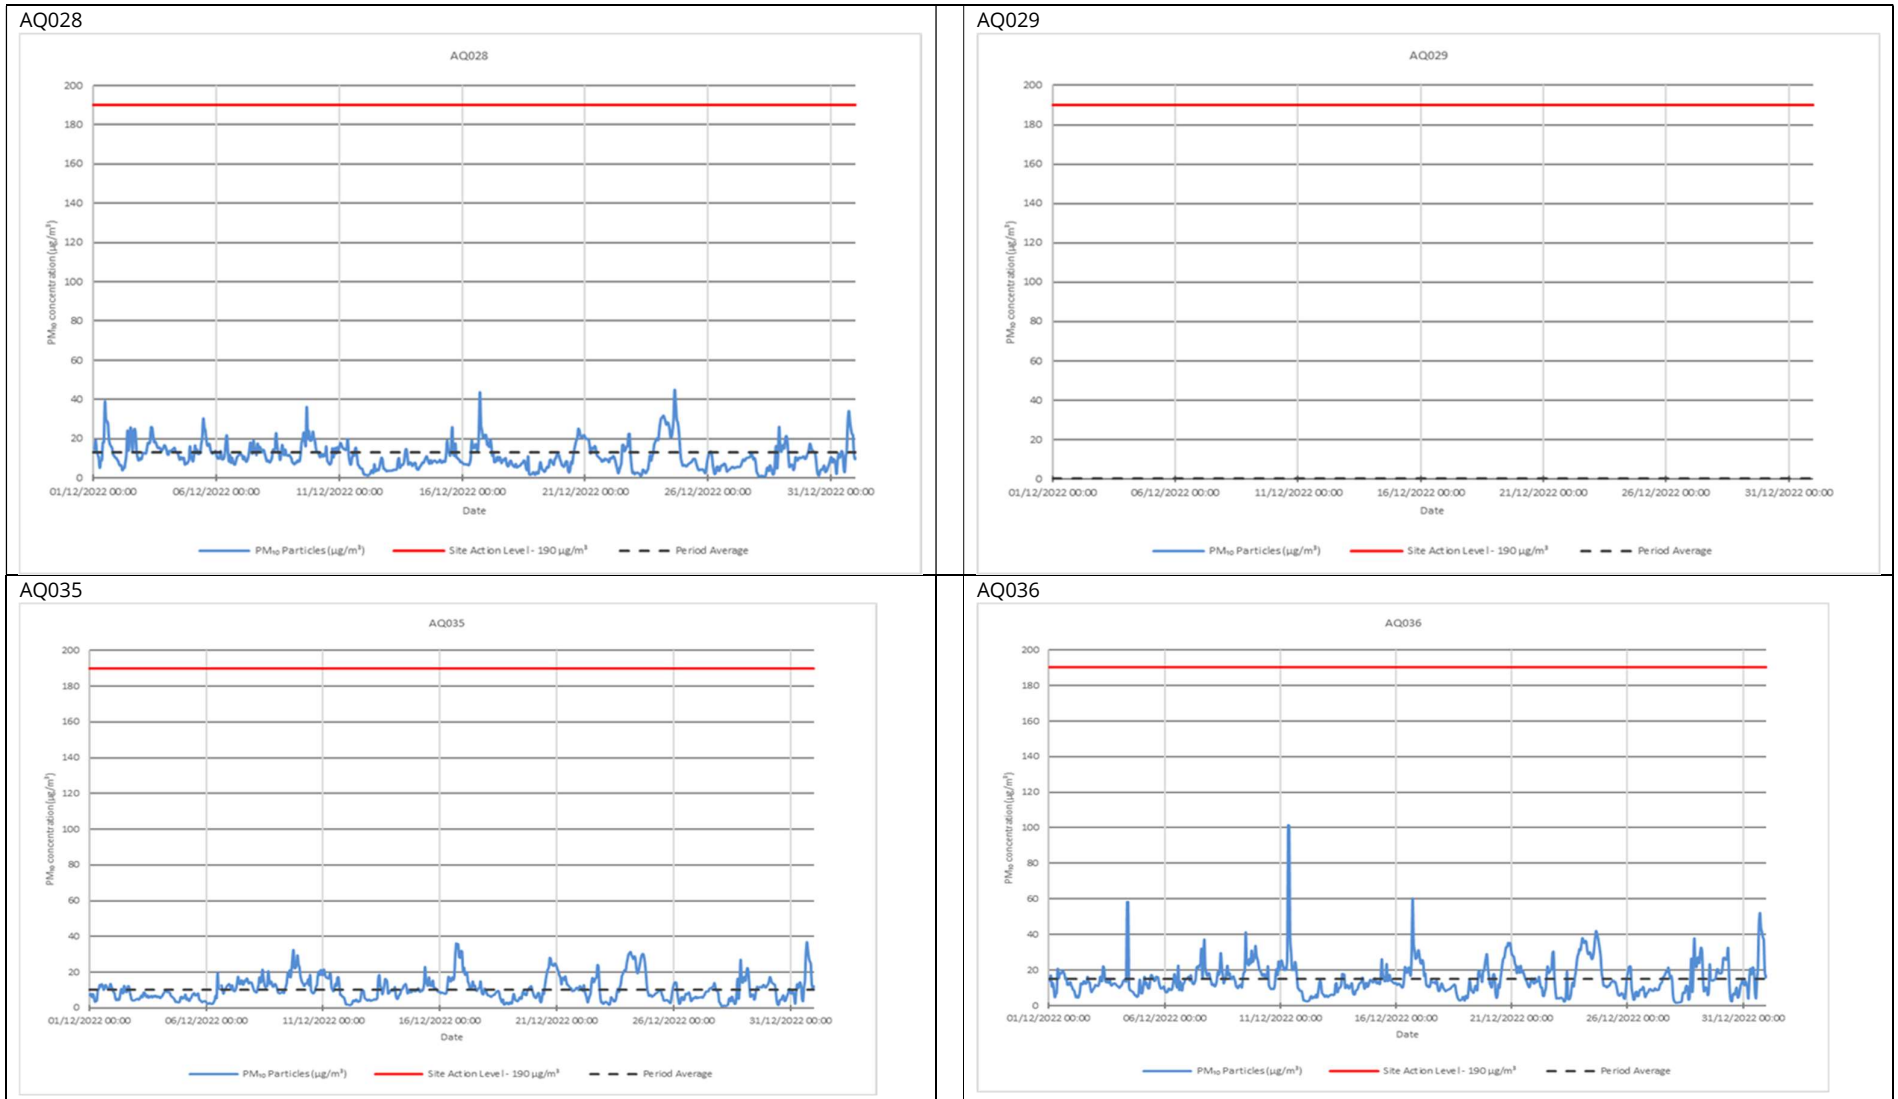
- 1.1.5 Four (4) dust monitors are installed around the worksite. This site returned a medium to high dust risk rating.
- 1.1.6 Dust monitoring locations and results are presented in Appendix B, Table 1, together with line charts of monthly data from each dust monitor in Figure 3. All continuous dust monitoring is undertaken using indicative monitors. Despite being Environment Agency (MCERTS) certified, indicative monitors carry a higher level of uncertainty than reference monitors, and therefore cannot be strictly compared with Air Quality Standards for human health and the environment. The purpose of the monitoring undertaken is to ensure the effectiveness of the on-site mitigation.

- 1.1.8 No (0) dust trigger alerts were recorded during the monitoring period.

Figure 3: Construction dust 1-hour mean indicative PM<sub>10</sub> concentration for dust monitors

- 1.1.9 Data capture was below 90% for monitor AQ029 due to a power supply issue. The monitor is being relocated to a more suitable location to resolve this issue.
