Air Quality and Dust Monitoring Monthly Report - February 2023

West Northamptonshire District Council

A report prepared by EWCs and MWCCs on behalf of HS2 Ltd.

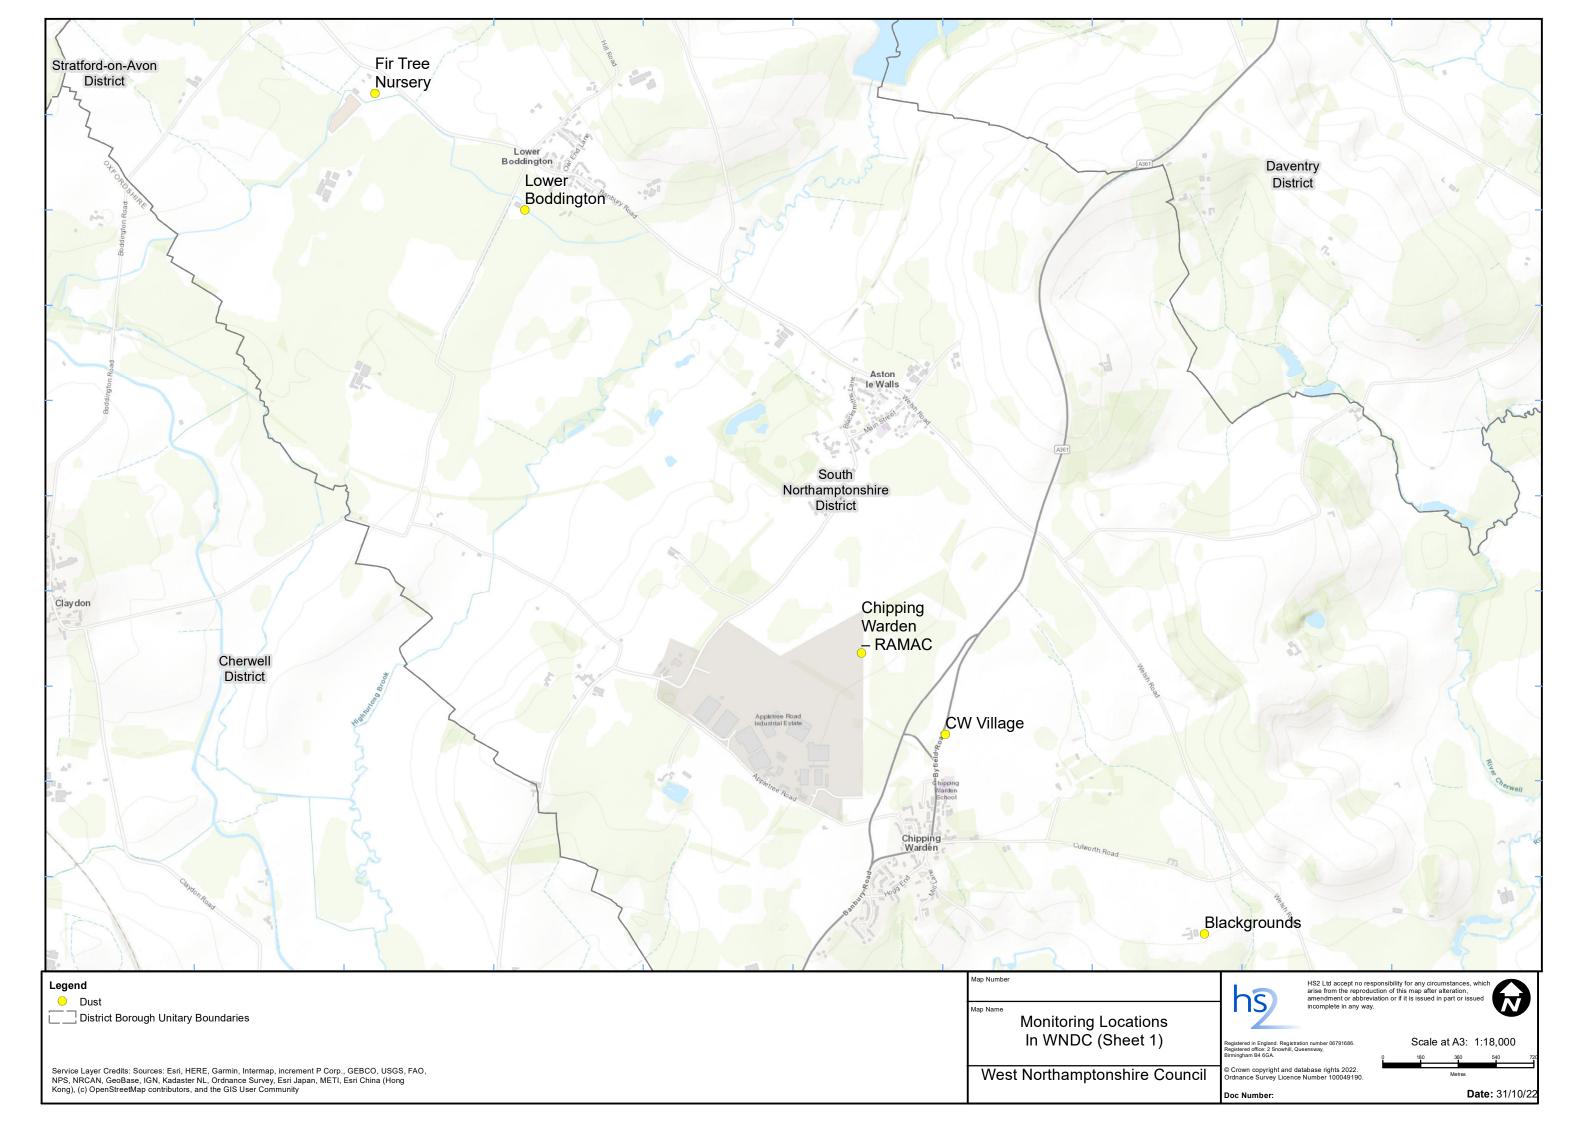
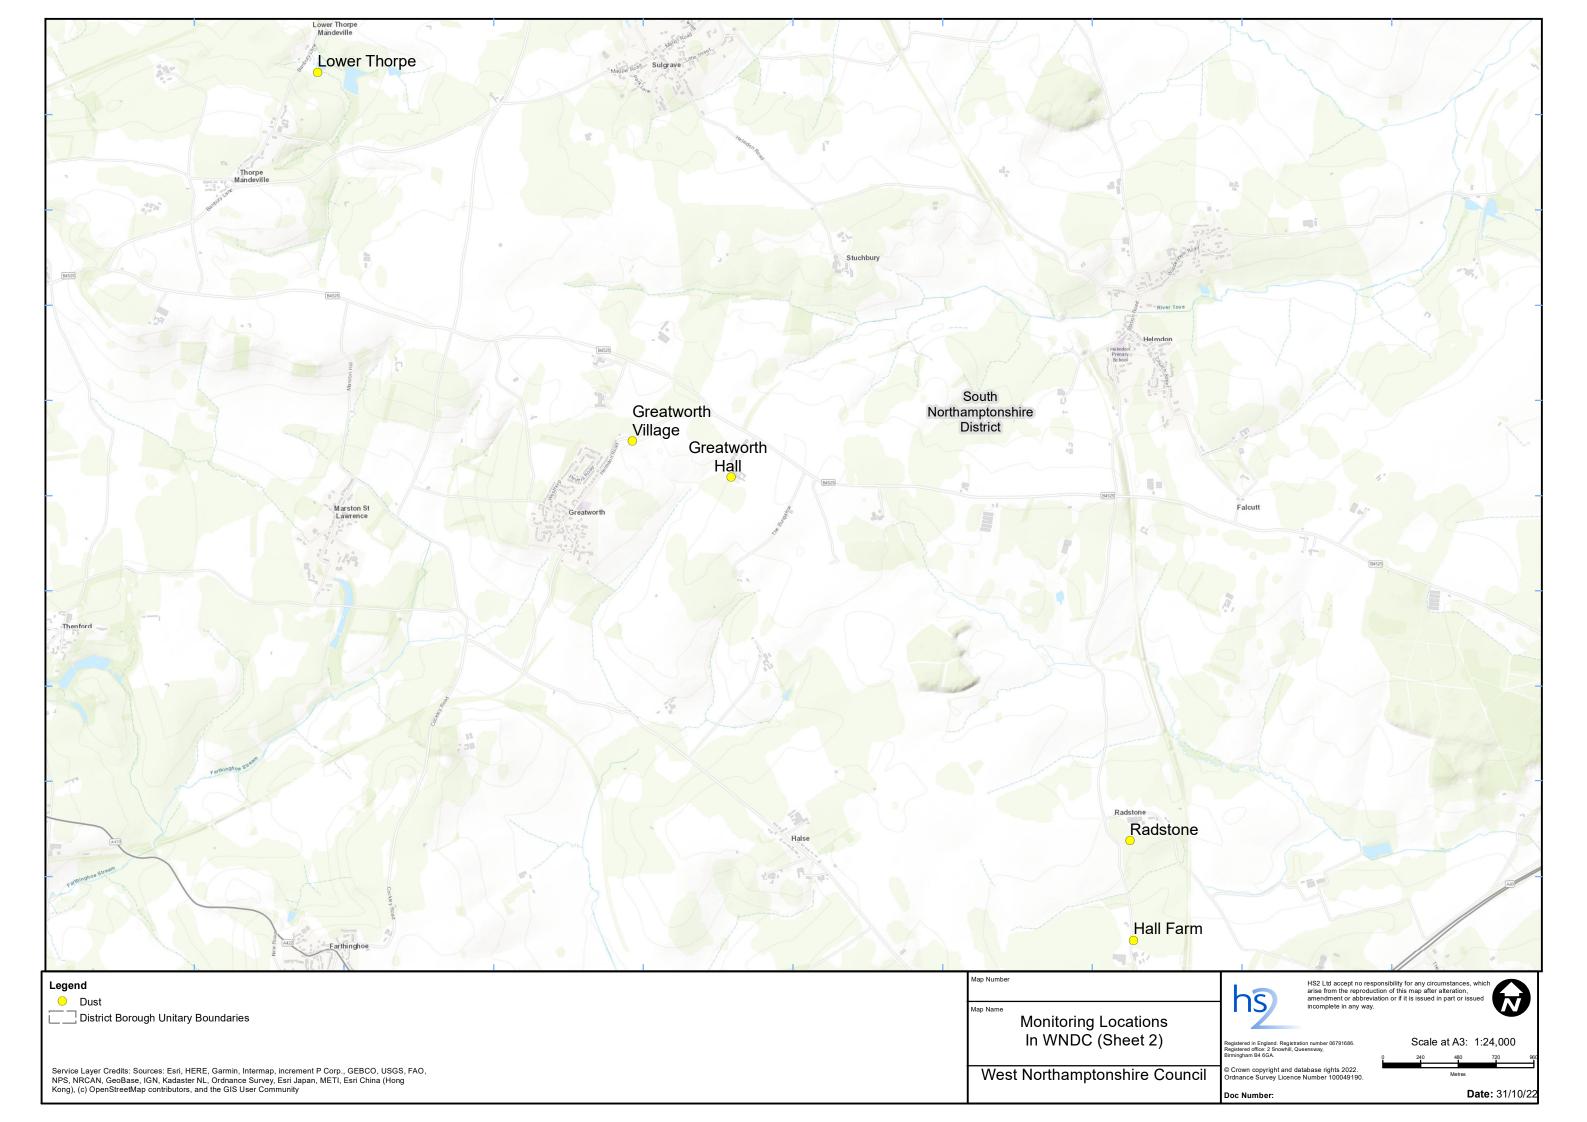
Figures 1 and 2: Worksite and Monitoring locations within the WNDC

- 1.1.2 Figures 1 and 2 in Appendix A present the current worksites together with the dust monitoring locations for February 2023.
- 1.1.3 This summary should be read in conjunction with the overview monitoring report available from www.gov.uk/government/collections/monitoring-the-environmental-effects-of-hs2, which highlights: the applicable standards and guidance, as well as the air quality and dust monitoring methodologies to be implemented by nominated undertakers throughout construction.

- 1.1.4 The current worksites, as presented in Appendix A, Figure 1 and 2, include:

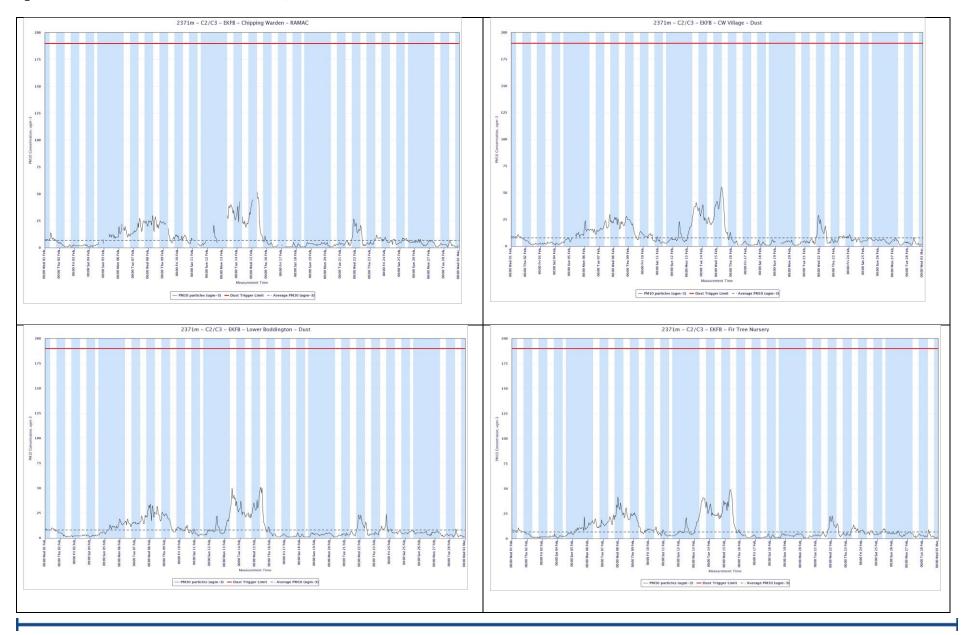
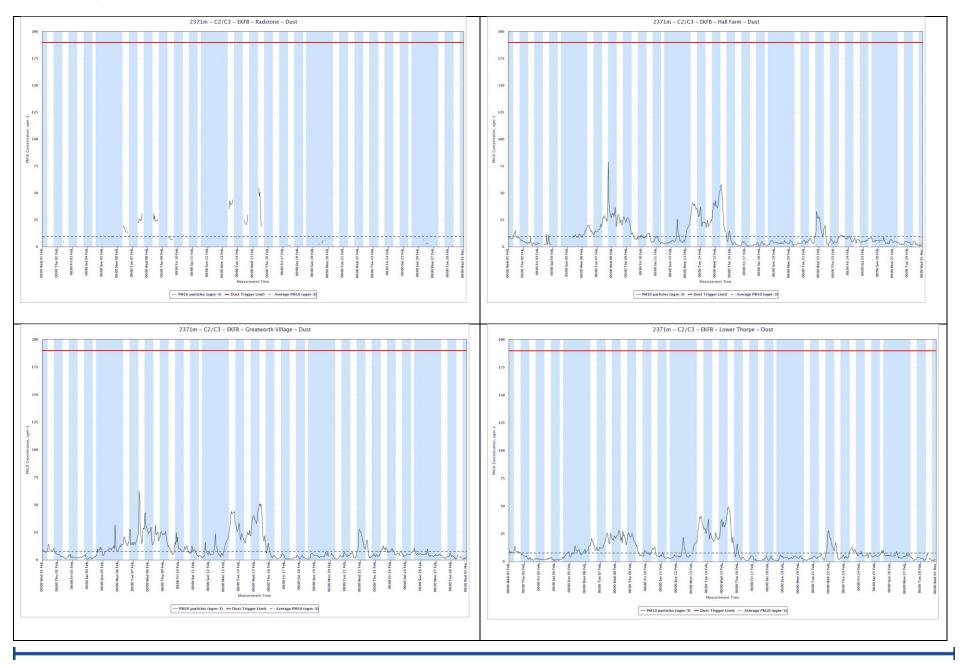
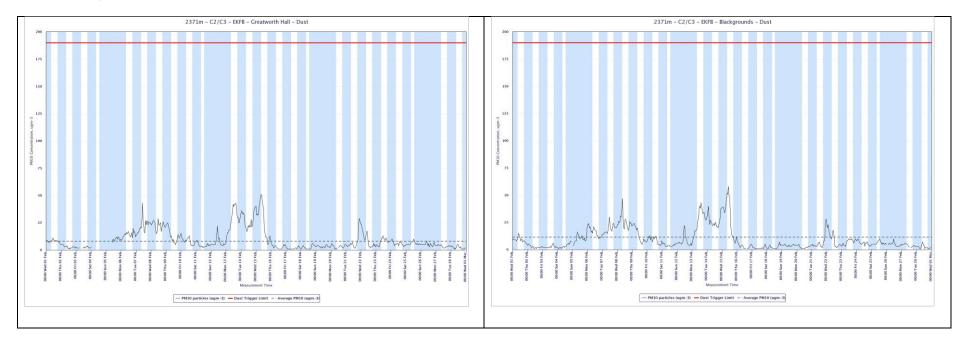
Figure 3: Continuous dust 1-hour mean indicative PM₁₀ concentration for all dust monitors

- 1.1.5 Ten (10) dust monitors are installed around the worksites, where works are underway. These sites returned a medium dust risk rating.
- 1.1.6 The trigger level for PM₁₀ concentrations of 190 μg/m³, over a 1-hour period, in accordance with the updated guidance document 'Guidance on Monitoring in the Vicinity of Demolition and Construction Sites (October 2018)' has been applied.

- 1.1.7 Dust monitoring locations and results are presented in Appendix B, Table 1, together with a line chart of monthly data from the dust monitor presented in Figure 3. All continuous dust monitoring is undertaken using indicative monitors. Despite being Environment Agency (MCERTS) certified, indicative monitors carry a higher level of uncertainty than reference monitors, and therefore cannot be strictly compared with Air Quality Standards for human health and the environment. The purpose of the monitoring undertaken is to ensure the effectiveness of the on-site mitigation.

- 1.1.8 No (0) dust alerts were recorded during the monitoring period (February 2023).
- 1.1.9 Data capture was below 90% for Chipping Warden and Radstone due to lack of solar charge.
