Construction Noise and Vibration Monthly Report – February 2023

London Borough of Ealing

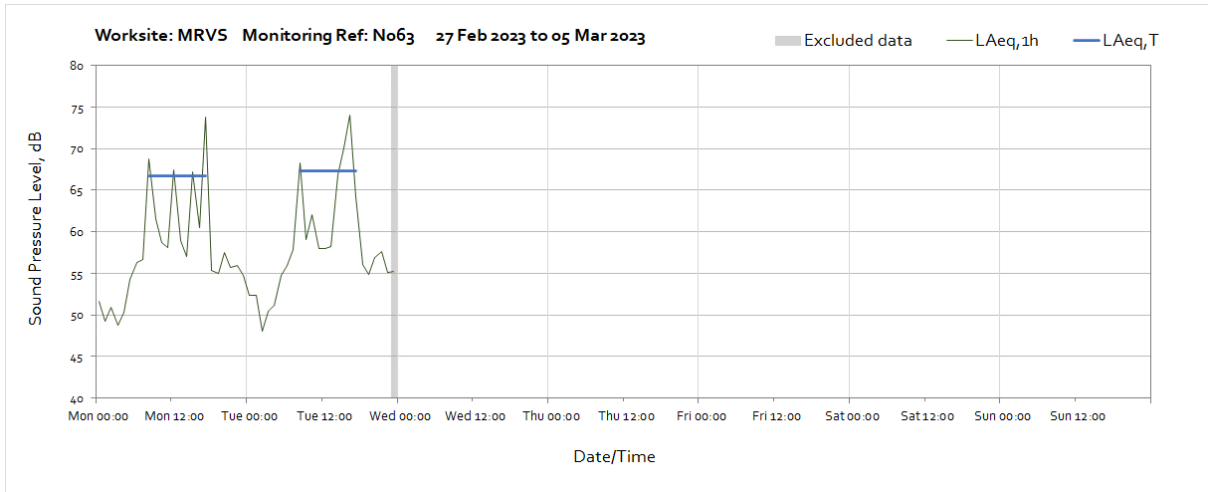
Worksite: Mandeville Road Ventilation Shaft (MRVS) - Monitoring Ref: N063

2.2.6 Ten (10) 24-hour periods that experienced an exceedance of the SOAEL were recorded due to HS2 construction works during February 2023. Exceedances occurred at noise monitors WT-N01 and N063 during Sundays and night-time periods.

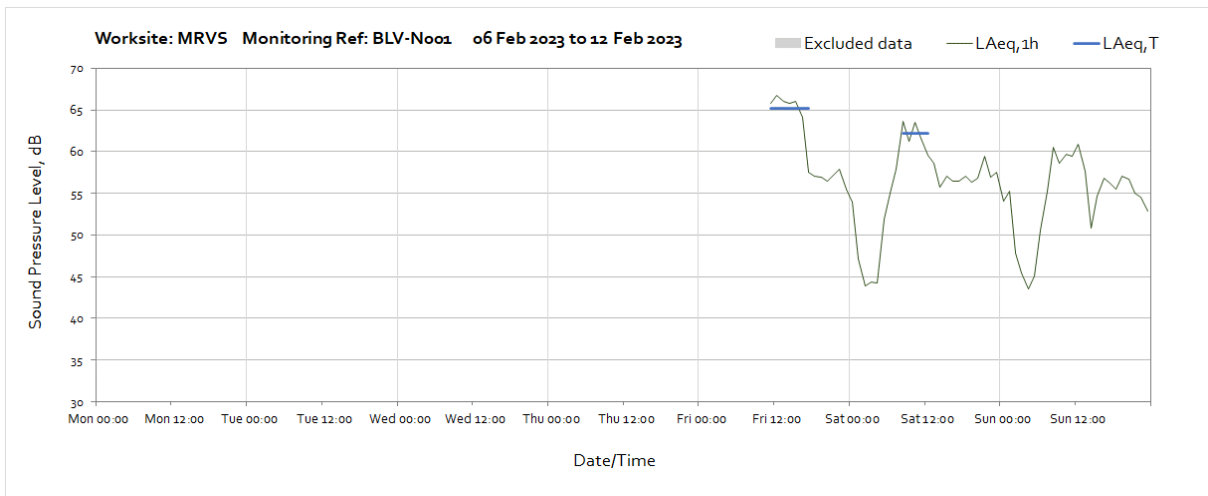
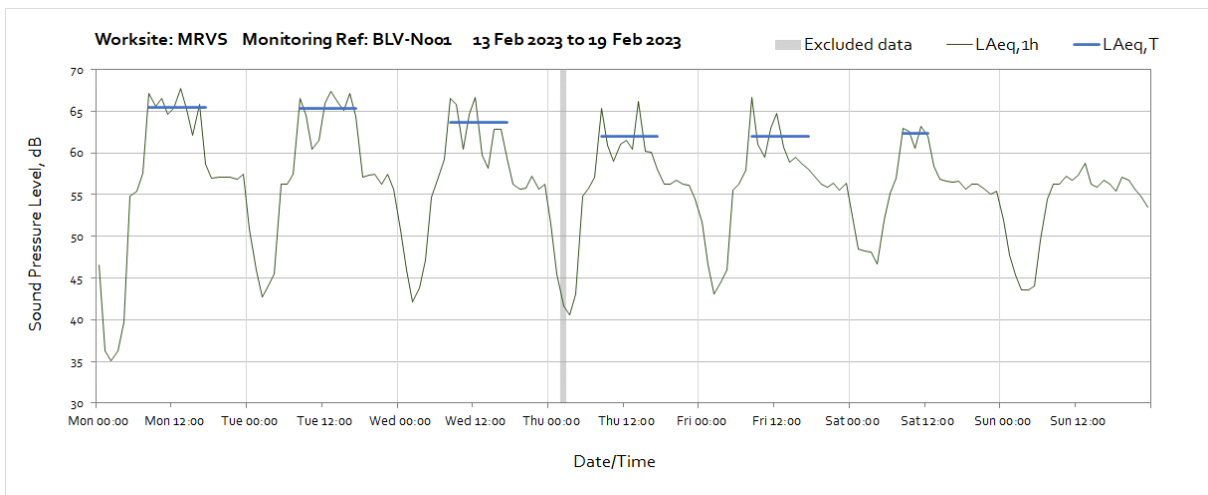
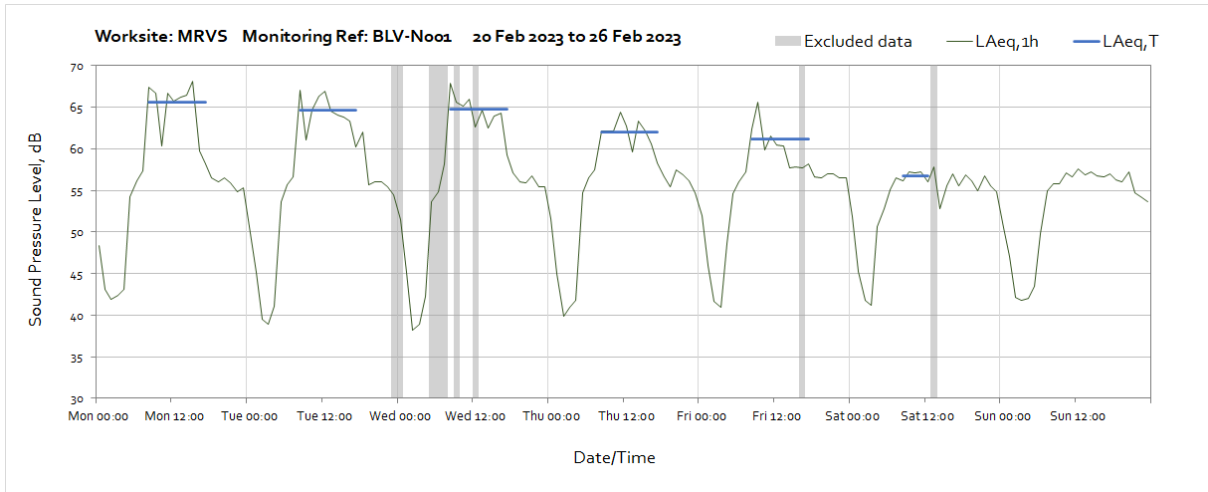
Worksite: Mandeville Road Ventilation Shaft (MRVS) – Monitoring Ref: BLV-N001

Note: Noise monitor installed at 11:00 on Friday 10th February.
