Air Quality and Dust Monitoring Monthly Report – March 2023

West Northamptonshire District Council

A report prepared by EWCs and MWCCs on behalf of HS2 Ltd.

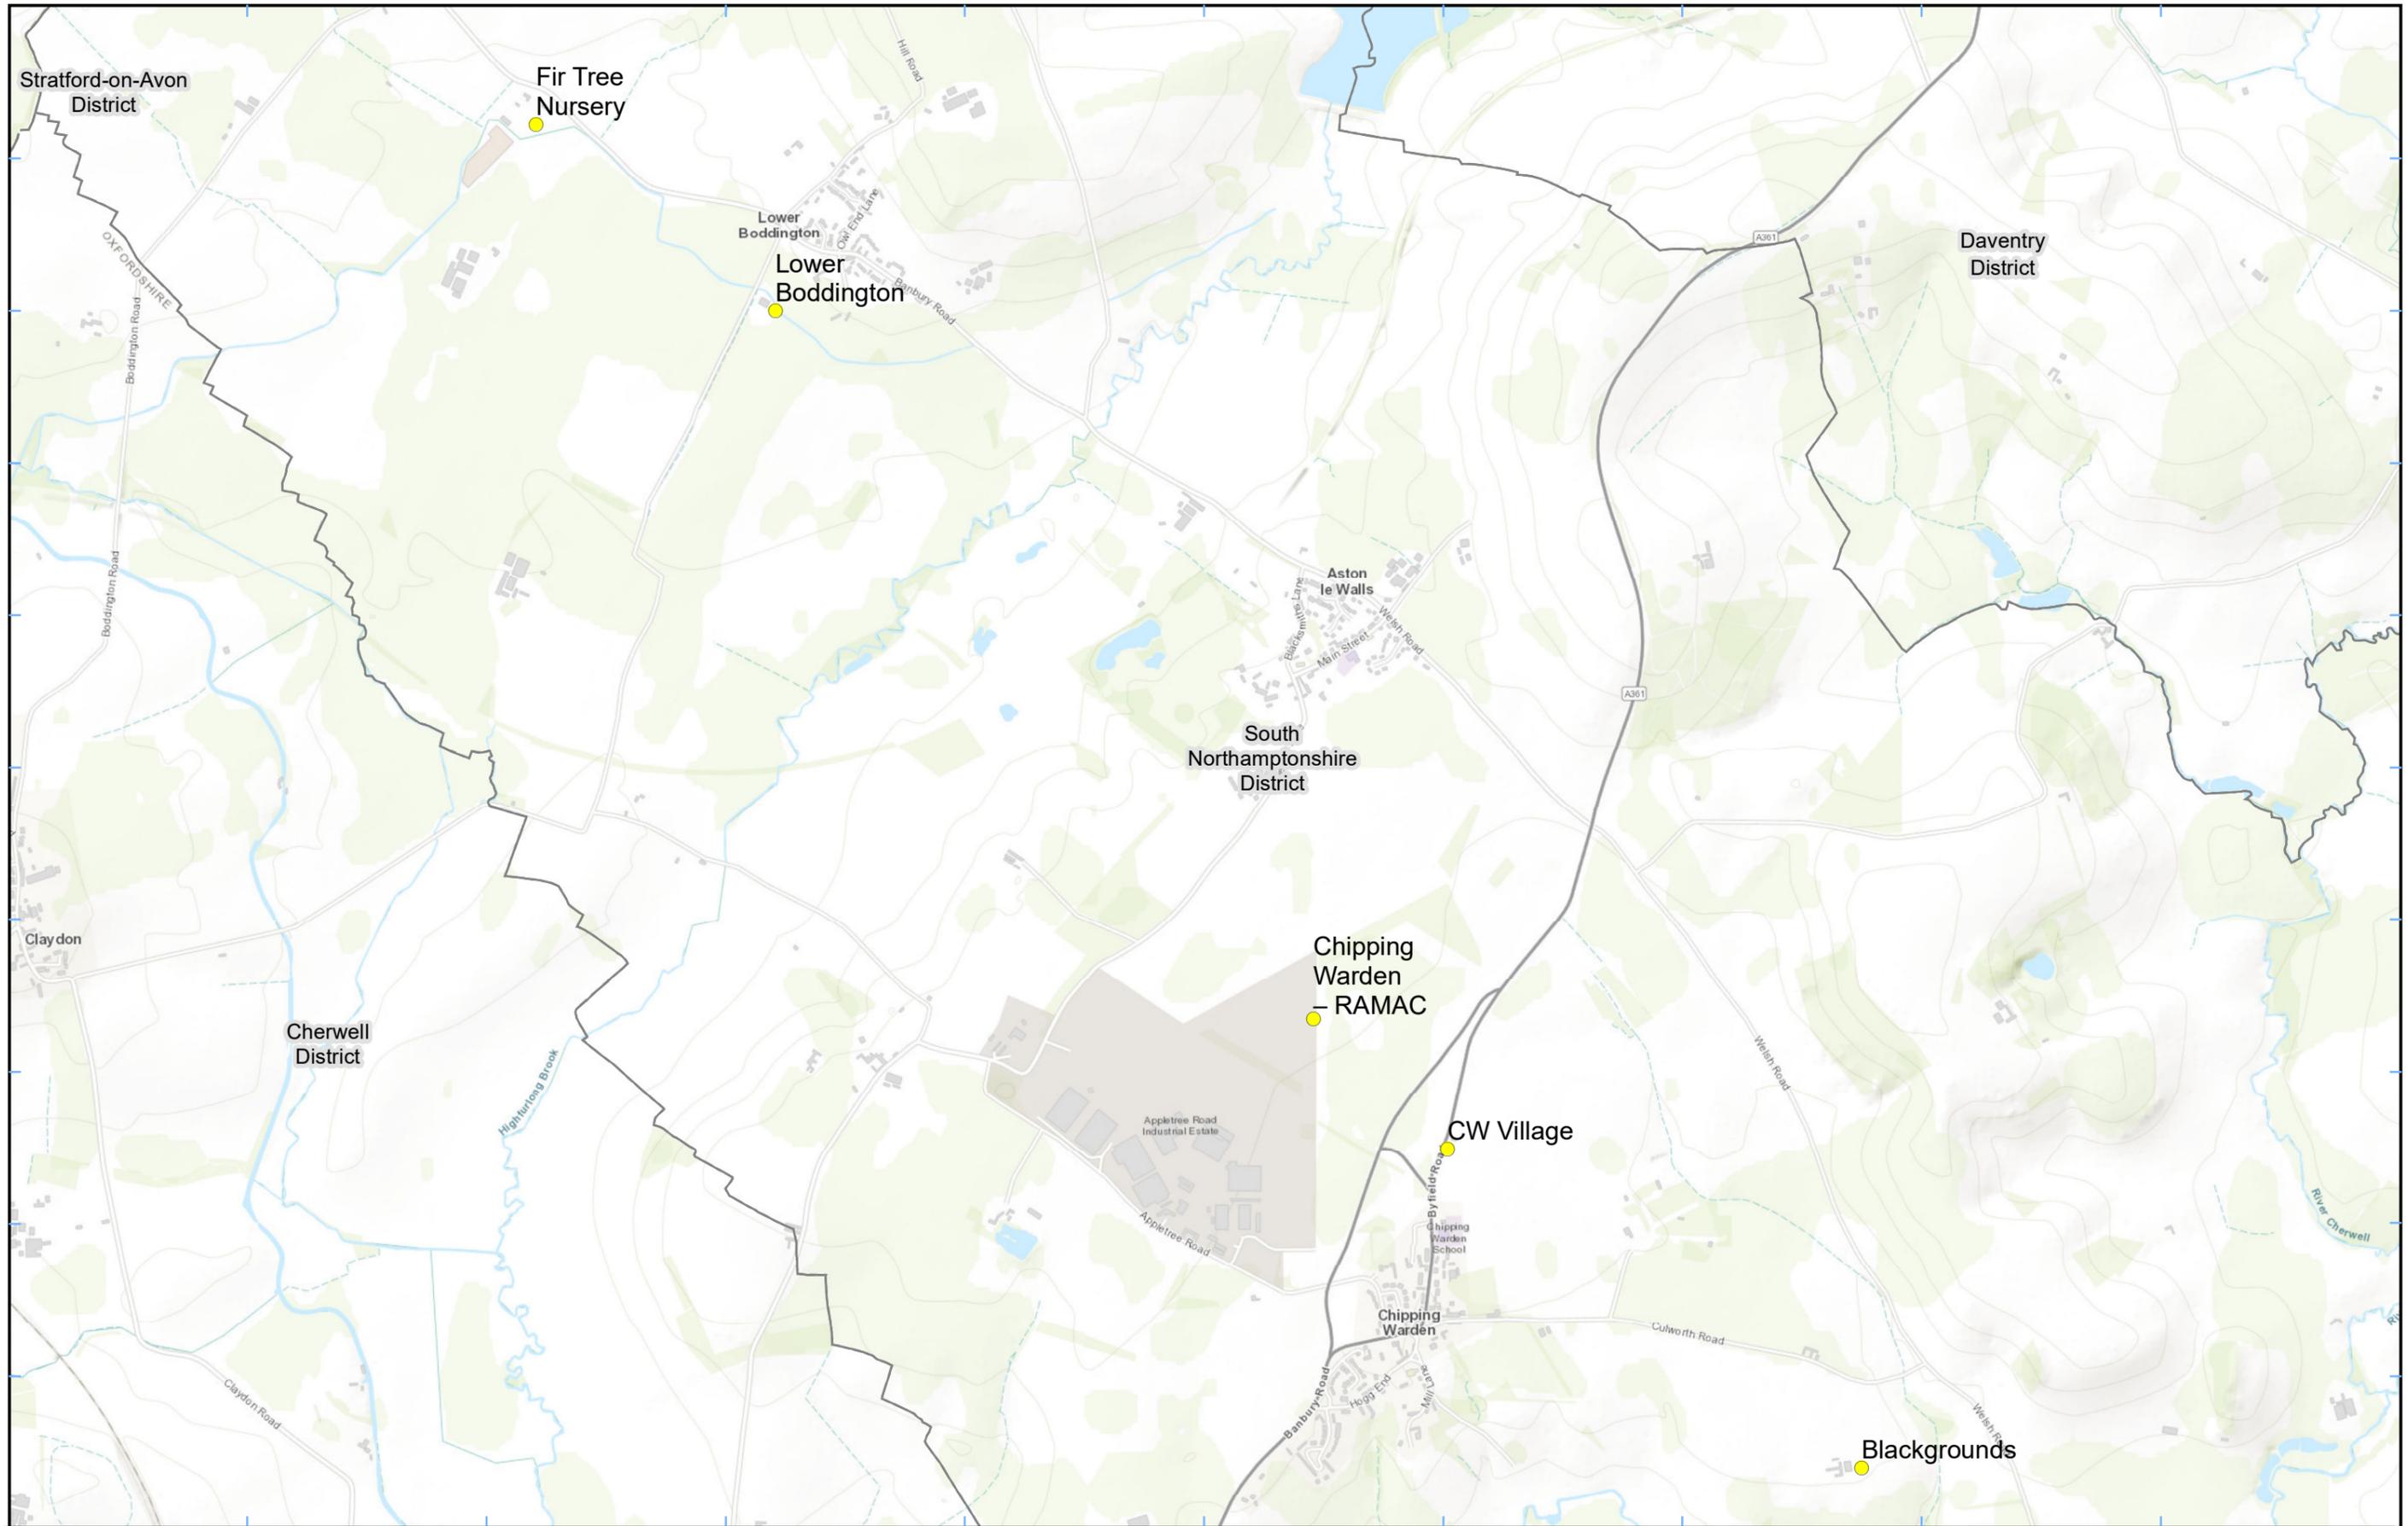
Map Name
**Monitoring Locations
In WNDC (Sheet 1)**

- 1.1.2 Figures 1 and 2 in Appendix A present the current worksites together with the dust monitoring locations for March 2023.
- 1.1.3 This summary should be read in conjunction with the overview monitoring report available from www.gov.uk/government/collections/monitoring-the-environmental-effects-of-hs2, which highlights: the applicable standards and guidance, as well as the air quality and dust monitoring methodologies to be implemented by nominated undertakers throughout construction.

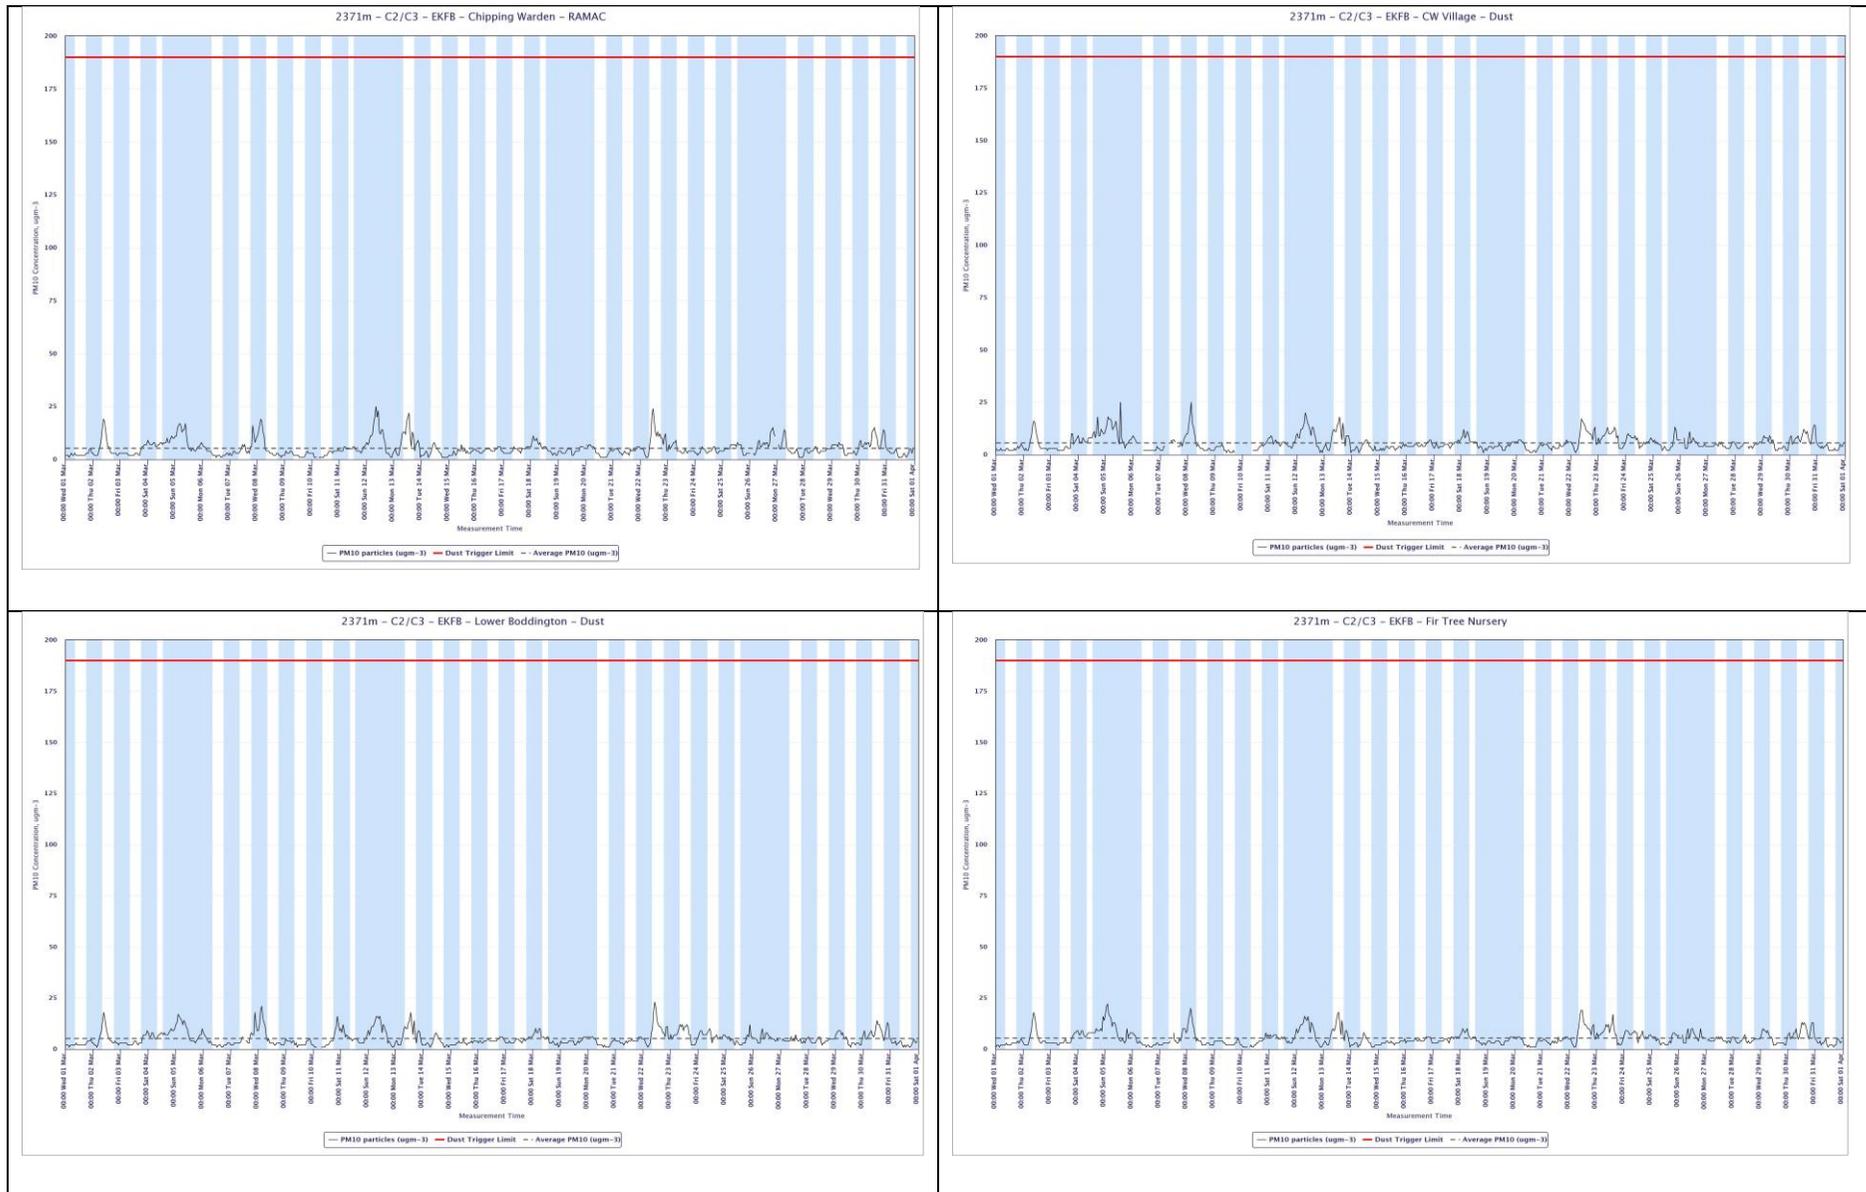
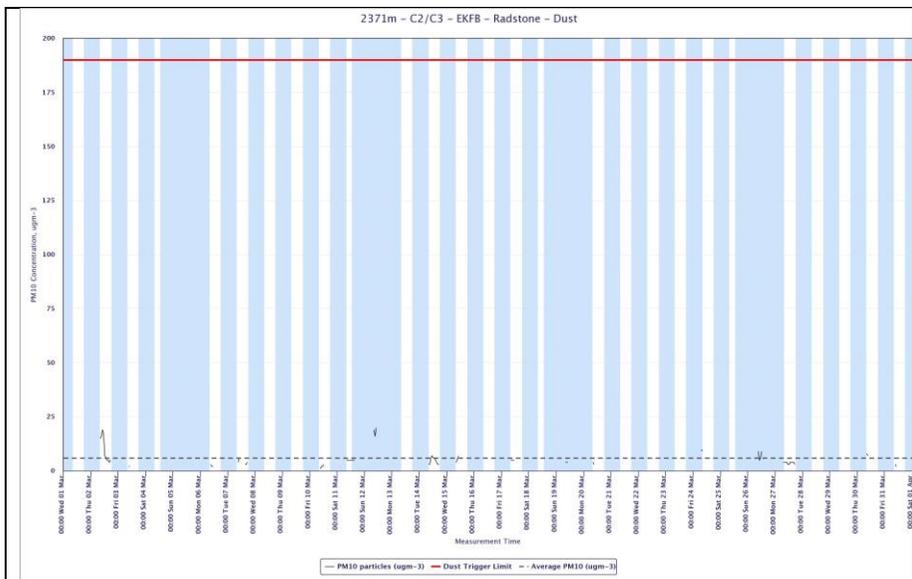
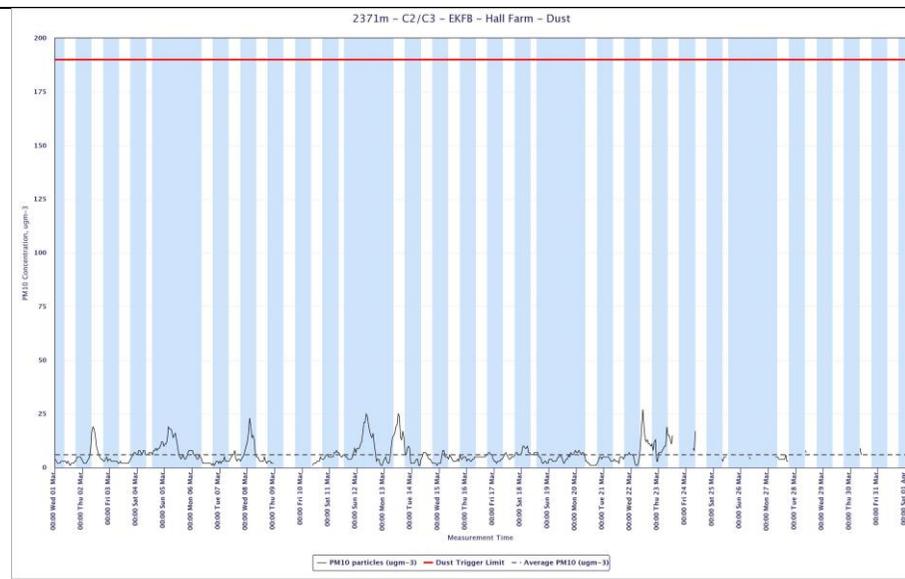
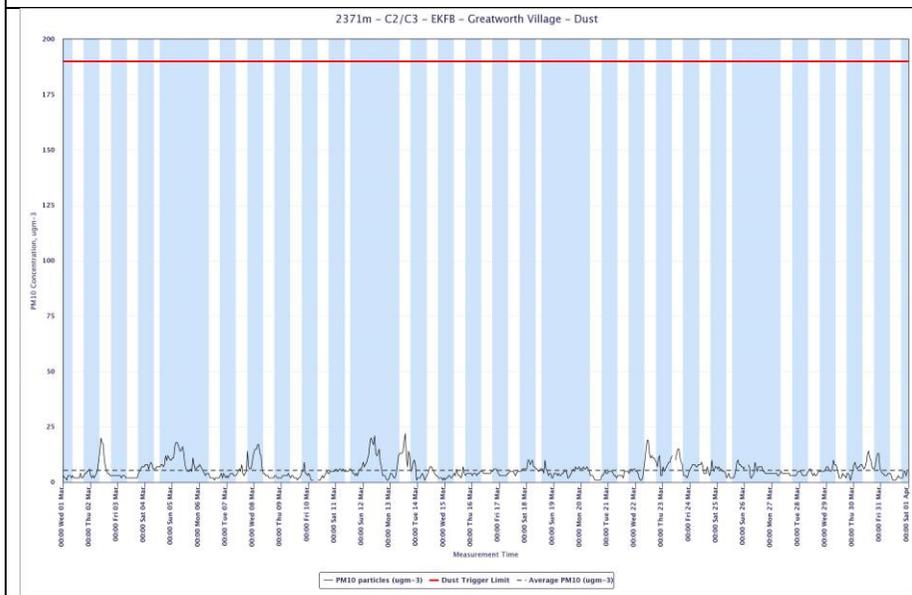
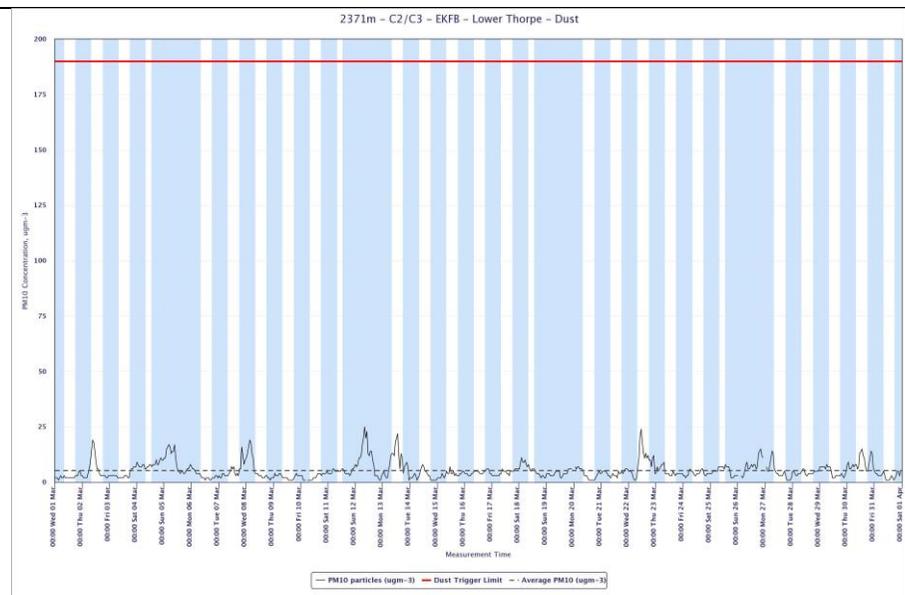
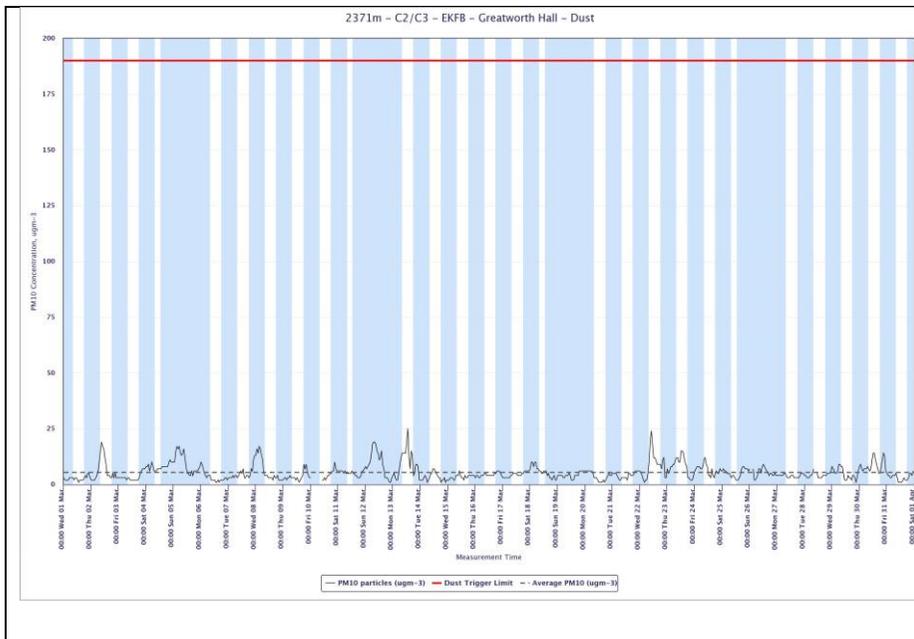
Figure 3: Continuous dust 1-hour mean indicative PM₁₀ concentration for all dust monitors

1.1.5 Dust monitoring locations and results are presented in Appendix B, Table 1, together with a line chart of monthly data from the dust monitor presented in Figure 3. All continuous dust monitoring is undertaken using indicative monitors. Despite being Environment Agency (MCERTS) certified, indicative monitors carry a higher level of uncertainty than reference monitors, and therefore cannot be strictly compared with Air Quality Standards for human health and the environment. The purpose of the monitoring undertaken is to ensure the effectiveness of the on-site mitigation.

1.1.6 The trigger level for PM₁₀ concentrations of 190 µg/m³, over a 1-hour period, in accordance with the updated guidance document '*Guidance on Monitoring in the Vicinity of Demolition and Construction Sites - (October 2018)*' has been applied.

1.1.8 There were no (0) dust alerts recorded during the monitoring period (March 2023).

1.1.7 Data capture was below 90% for the Radstone monitor due to a fault with the pump. Monitor will need to be retrieved for investigation/ repair. The Hall Farm monitor also had low data capture due to a fault with the monitor.
