## **Construction Noise and Vibration Monthly Report – March 2023**

**Birmingham City Council**

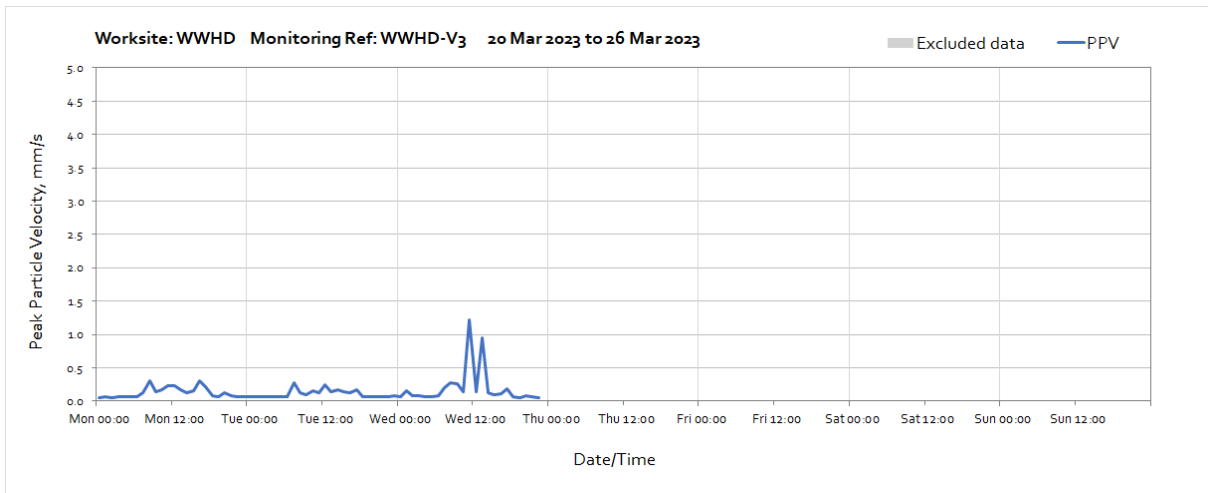
Note: Missing data from 23:00 on Wednesday 22<sup>nd</sup> March to the end of the month was due to synchronisation issues at the monitoring station.
