## **Construction Noise and Vibration Monthly Report – March 2023**

**Cherwell District Council**

# Non-Technical Summary

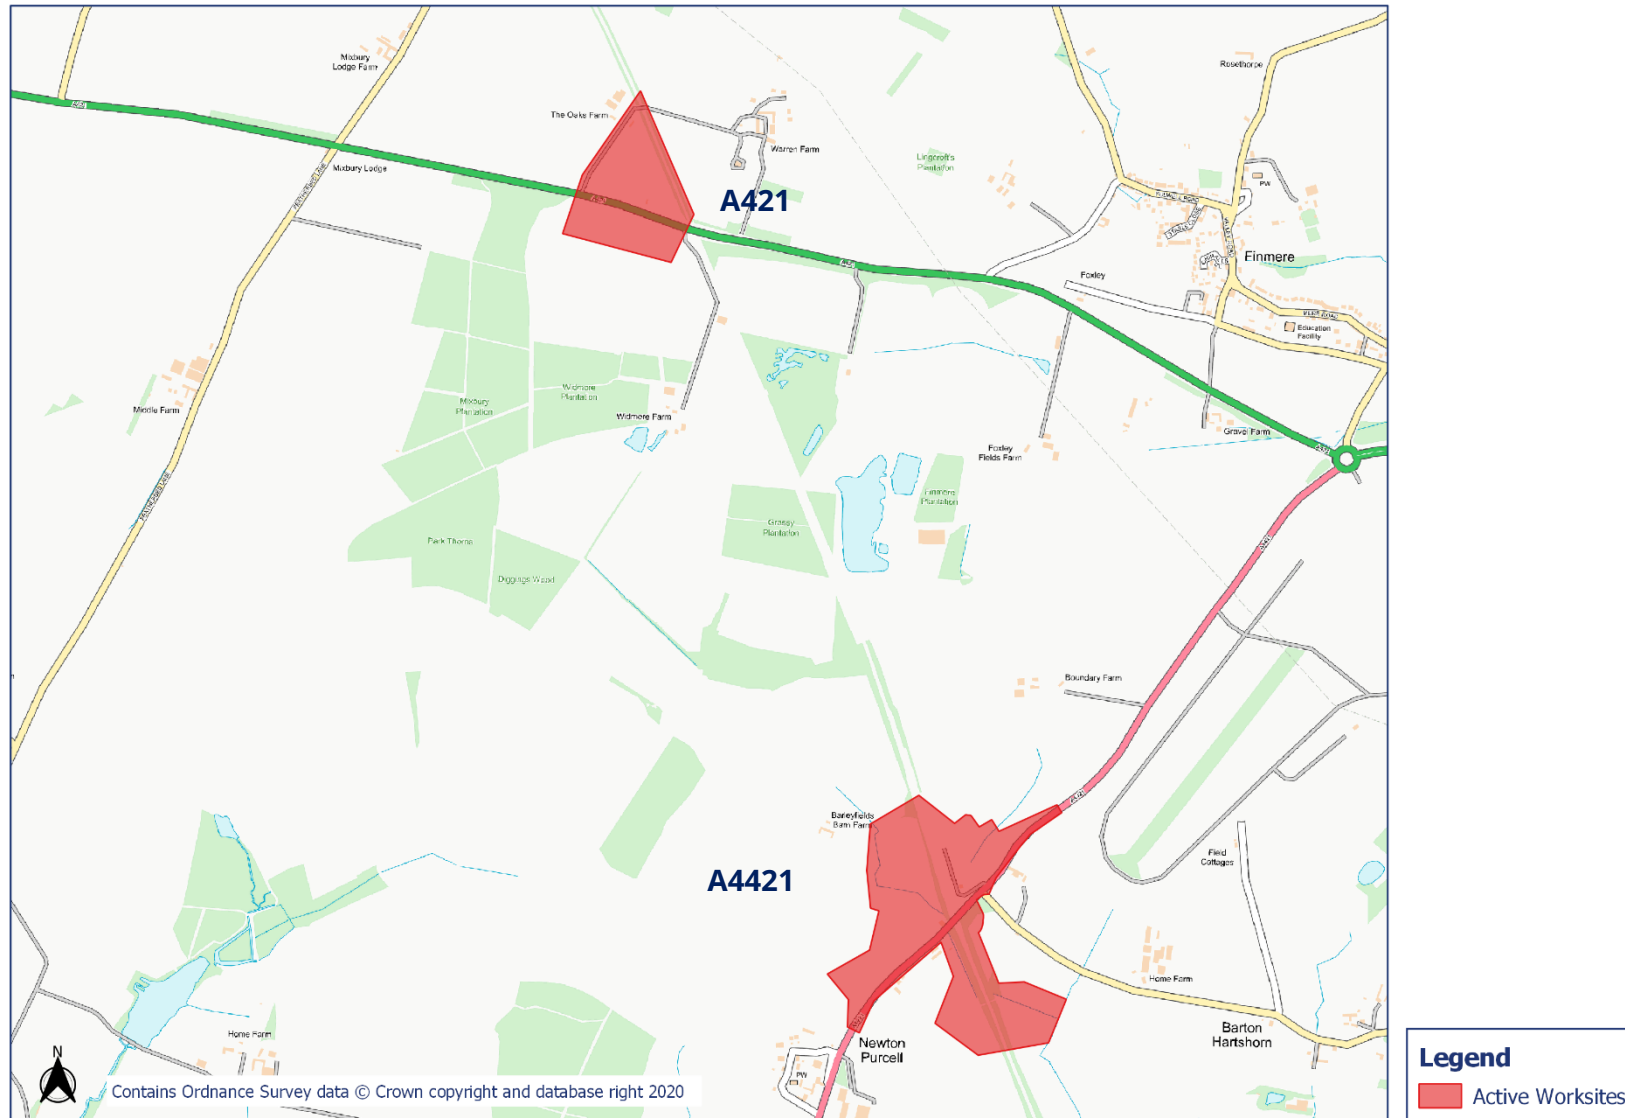
# Appendix A Site Locations

- A421 North Warren Farm worksite ref.: A421 North (see Works Identification Plan 1 in Appendix A), where the following work activities were undertaken:
  - Topsoil stripping.
  - Formation testing.
  - West side piling platform works, including reinforcement, formation and filling works.
  - Stockpiling.
  - Mulching of stumps.
  - Construction of utility protection slabs.
  - Surfacing work preparation.
  - Duct installation.
  - Lamppost and inspection chamber installation.
  - Slab Installation.

- A4421 South, Shelswell Inn, worksite ref.: A4421 South (see Works Identification Plan 1 in Appendix A), where the following work activities were undertaken:
  - Drainage works.
  - Ditch diversion and reprofiling.
  - De-vegetation works.
  - Pond excavation.
  - Deliveries.
  - Platform extension.
  - Ground remediation works.
  - Dewatering well installation.

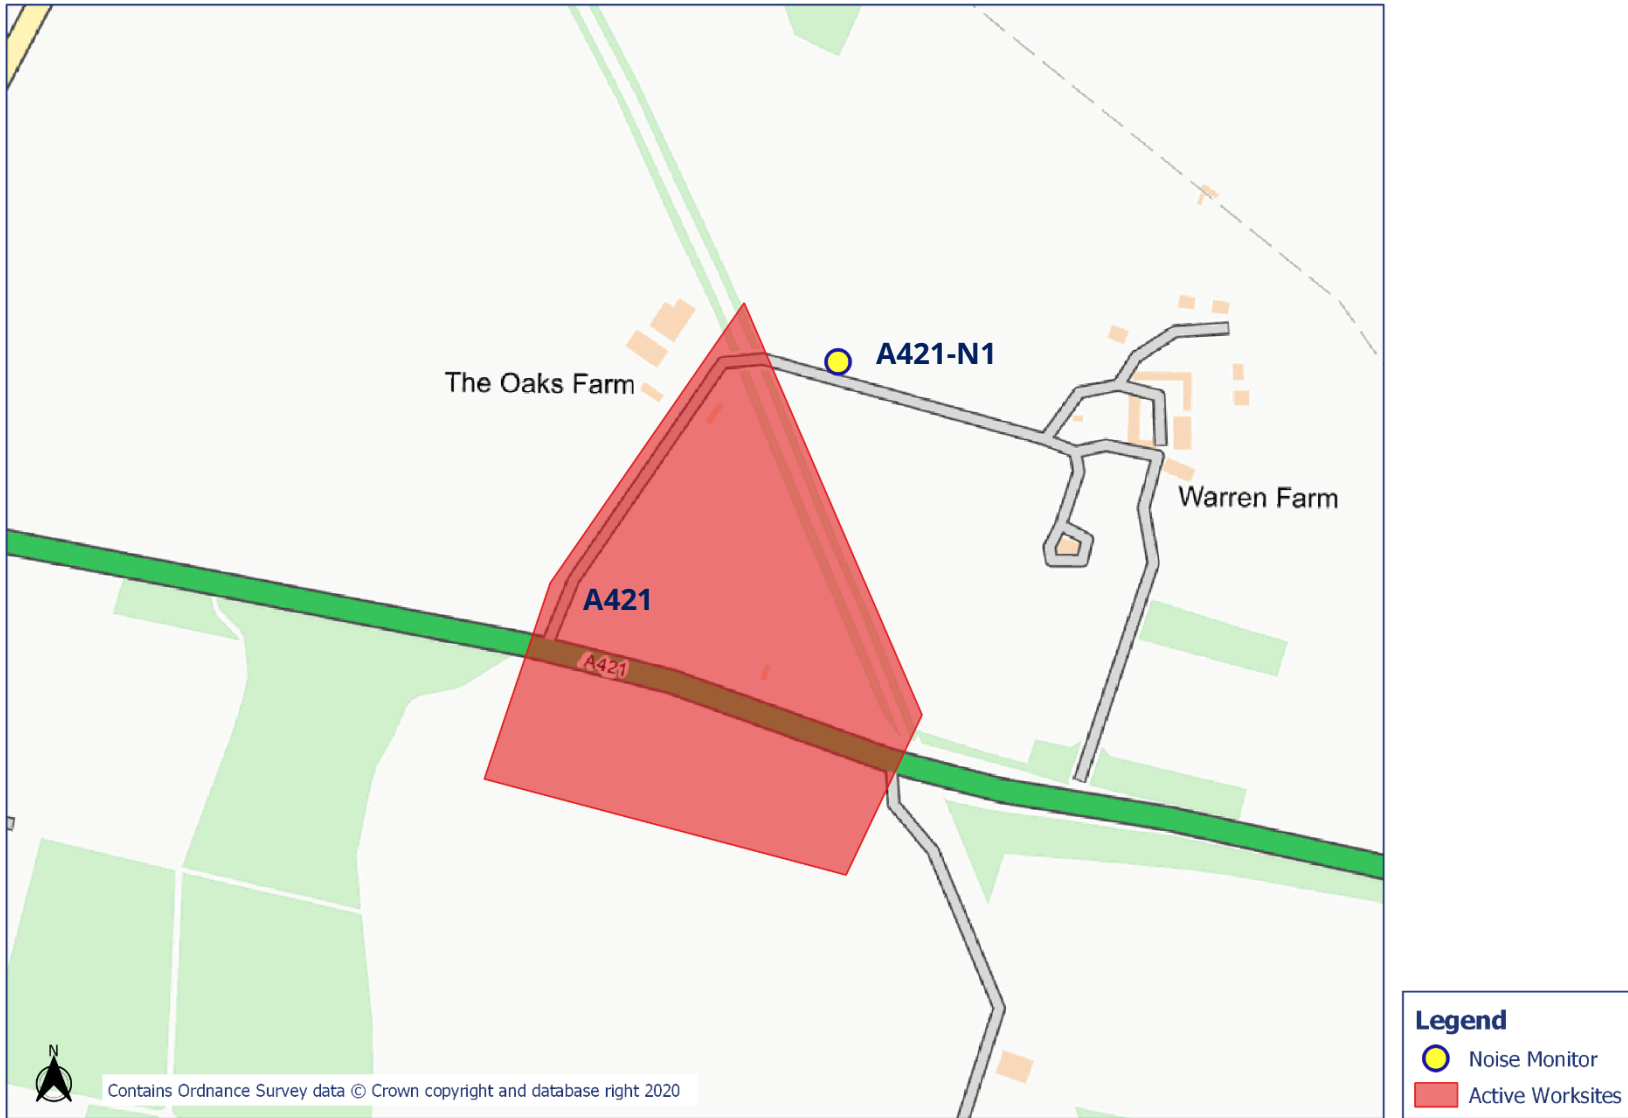
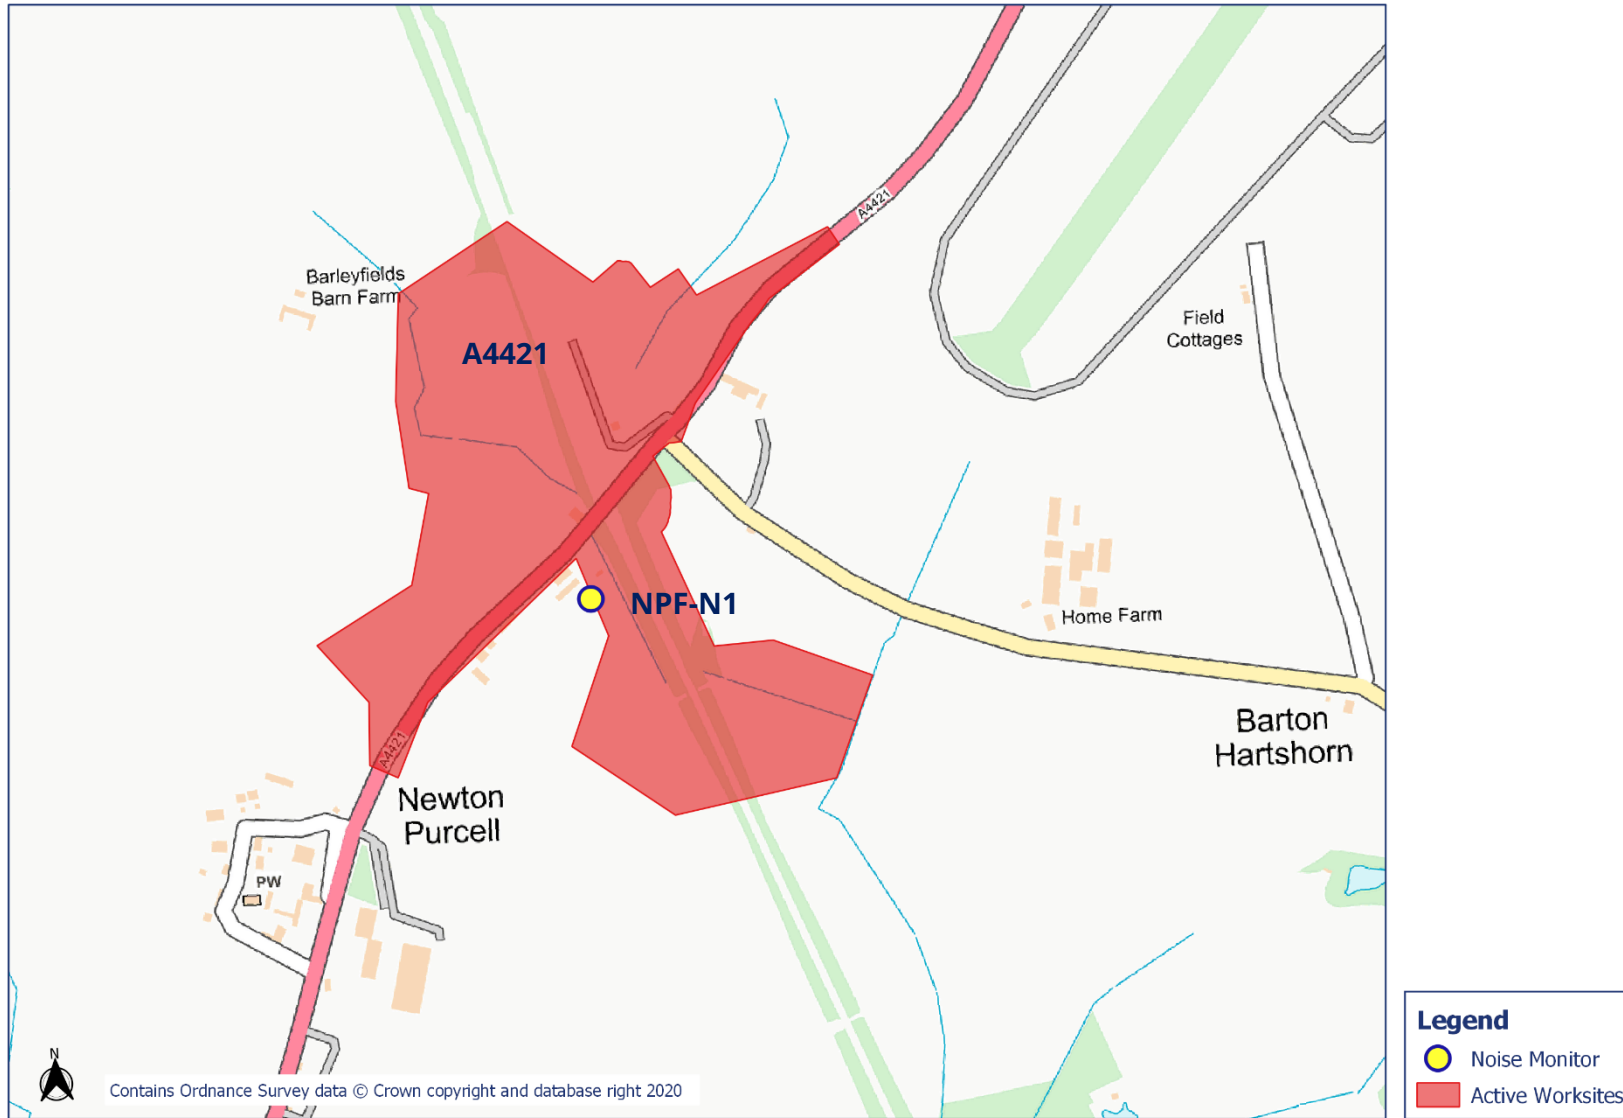
# Appendix B Monitoring Locations

1.2.3 Maps showing the position of noise monitoring installations are presented in Appendix B.

<b>Worksite Reference</b>	<b>Measurement Reference</b>	<b>Address</b>
A4421 South	NPF-N1	A4421 South, Shelswell Inn
A421 North	A421-N1	A421 North, Warren Farm

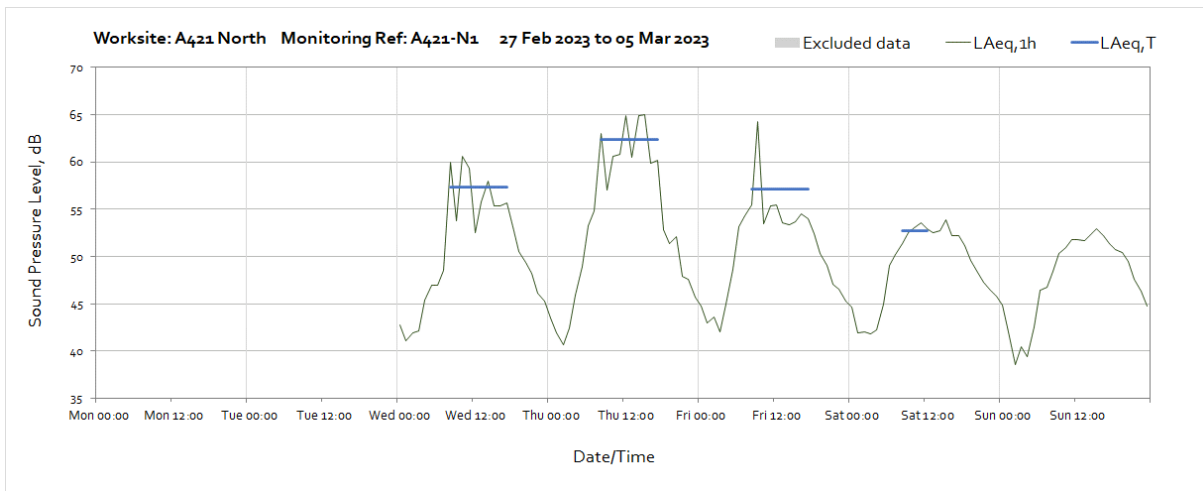
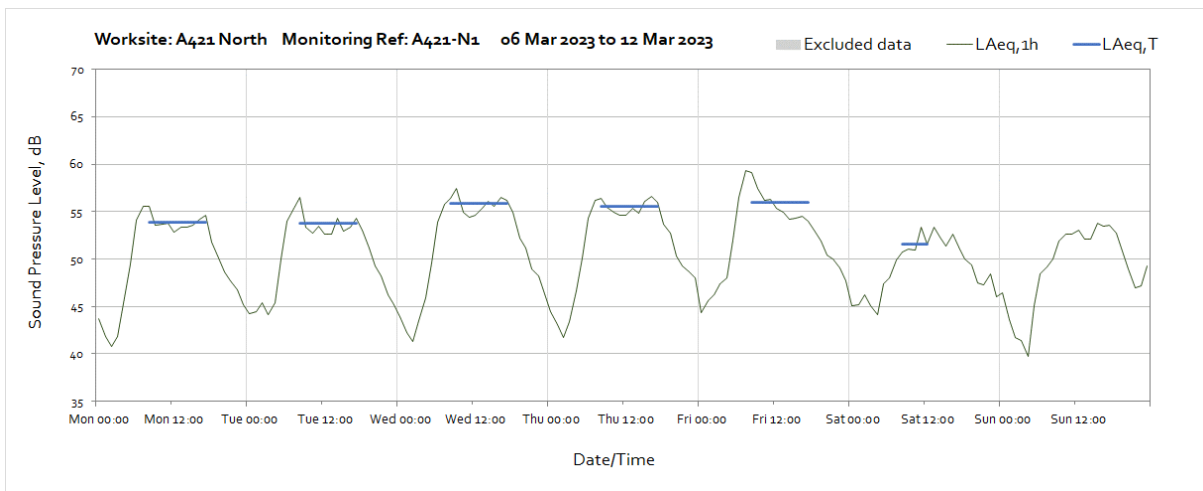
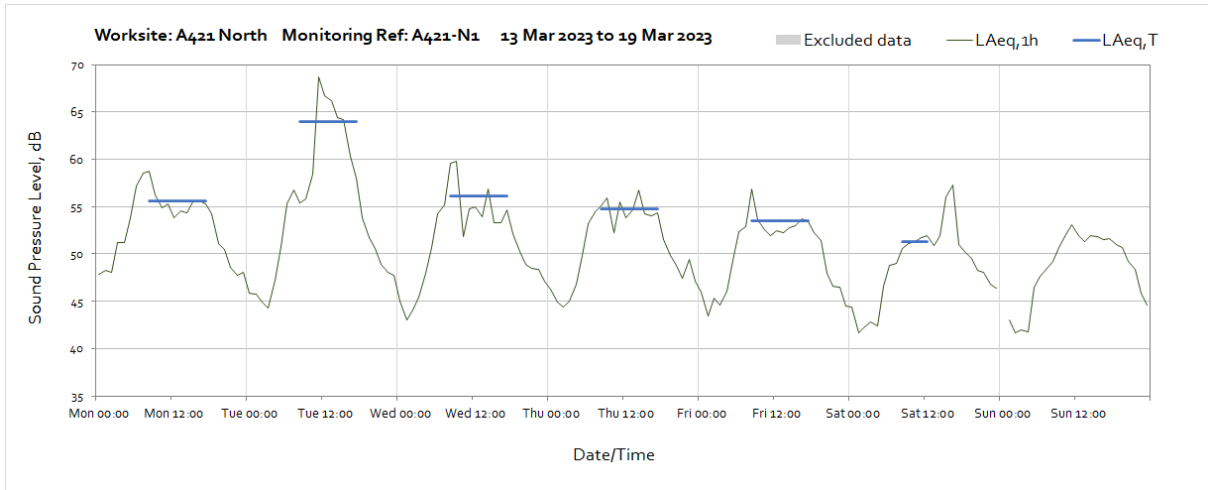
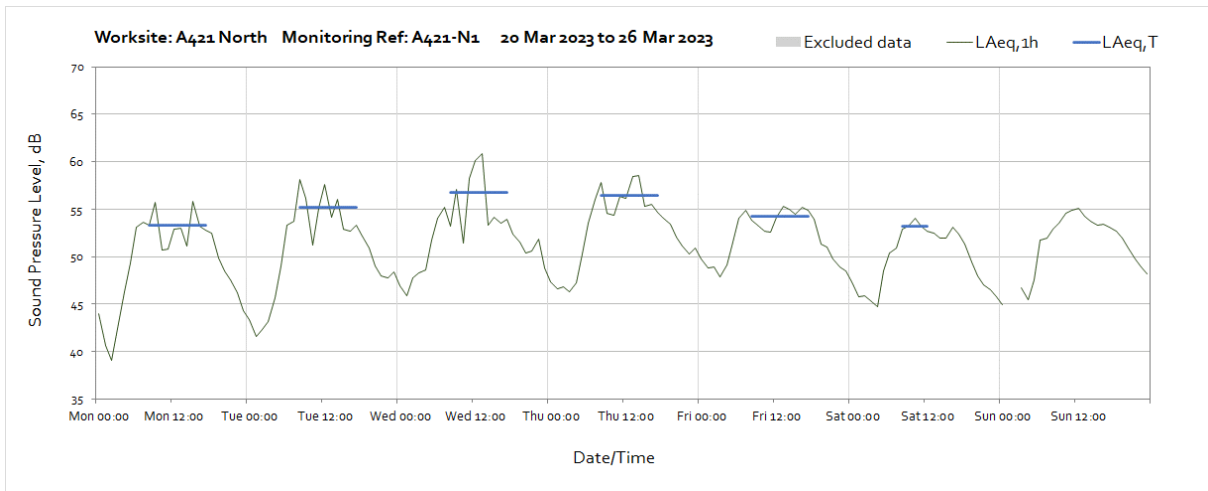
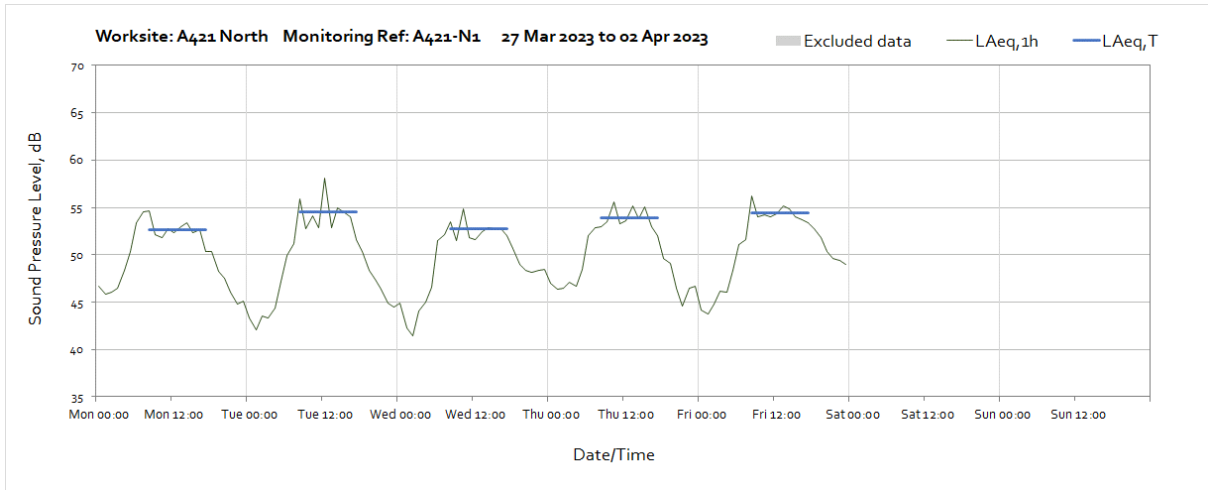
### Worksite: A421 North – Monitoring Ref: A421-N1

2.2.6 Exceedances of the LOAEL were recorded at one (1) monitoring location during the month of March 2023. LOAEL exceedances were recorded during weekday daytime periods.

The following graphs show the hourly measured ambient noise level  $L_{Aeq,1h}$  and, where relevant, the averaged noise level  $L_{Aeq,T}$  values, where the time period T is as specified in Table 1 of HS2 Information Paper E23. Periods with adversely weather affected noise levels are greyed out and have been excluded from the calculation of the  $L_{Aeq,T}$  values in Table 3 of the main report.

Note: Missing data between 00:00 and 01:00 on Sunday 19<sup>th</sup> March was due to a monitor system diagnostic check.

Note: Missing data between 01:00 and 03:00 on Sunday 26<sup>th</sup> March was due to a monitor time adjustment at the start of British Summertime.

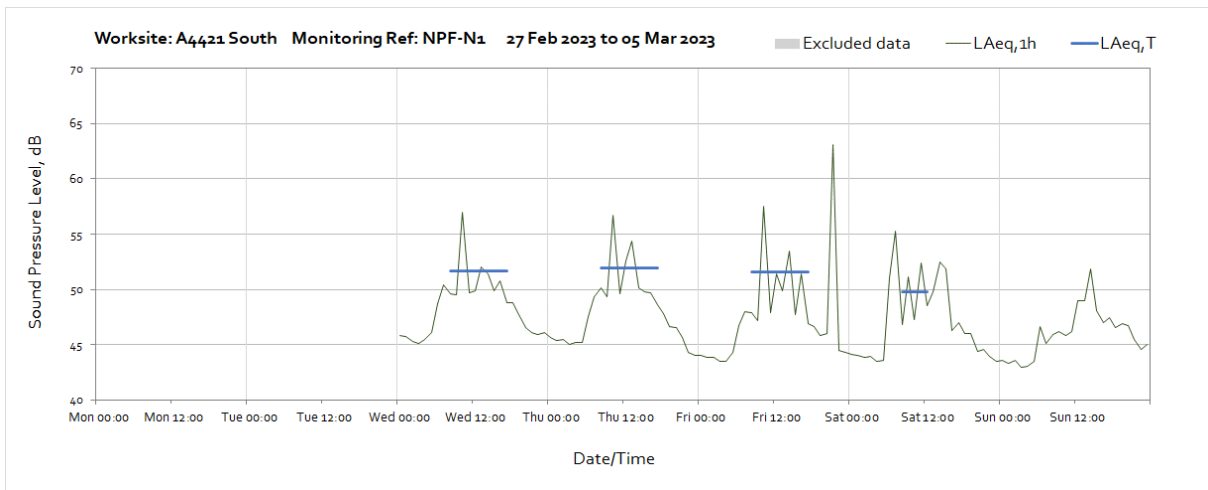
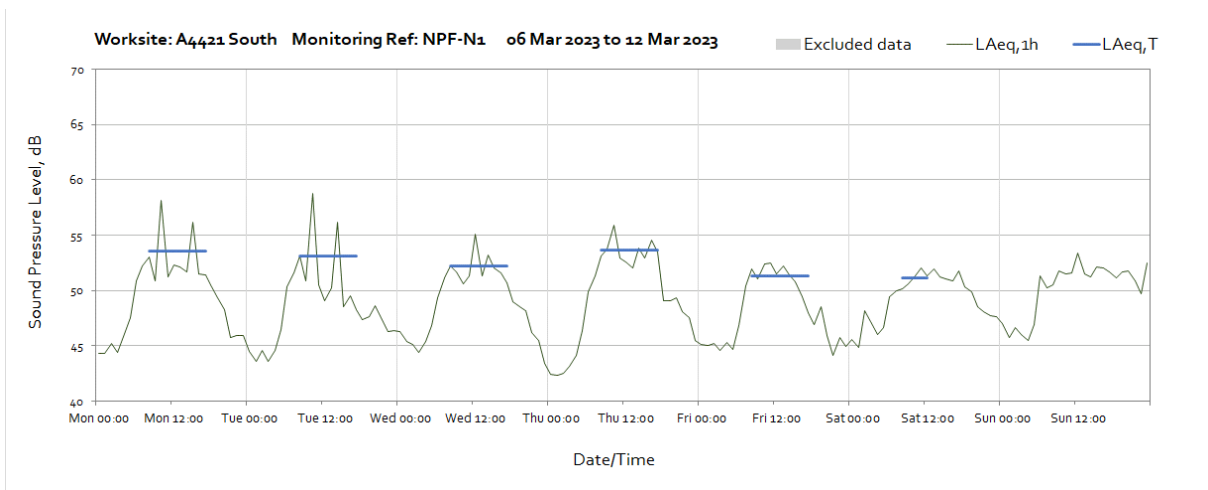
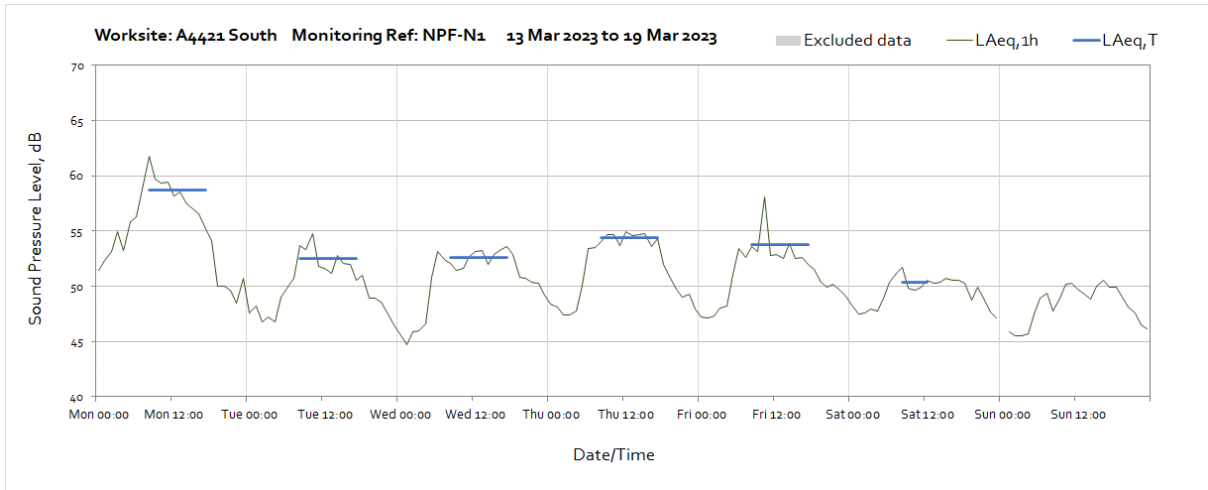
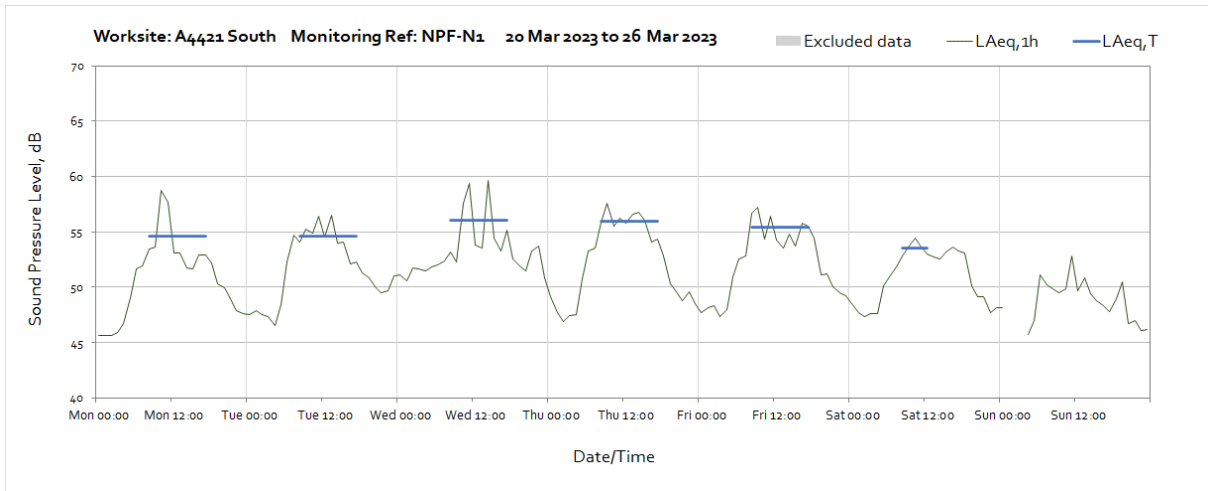
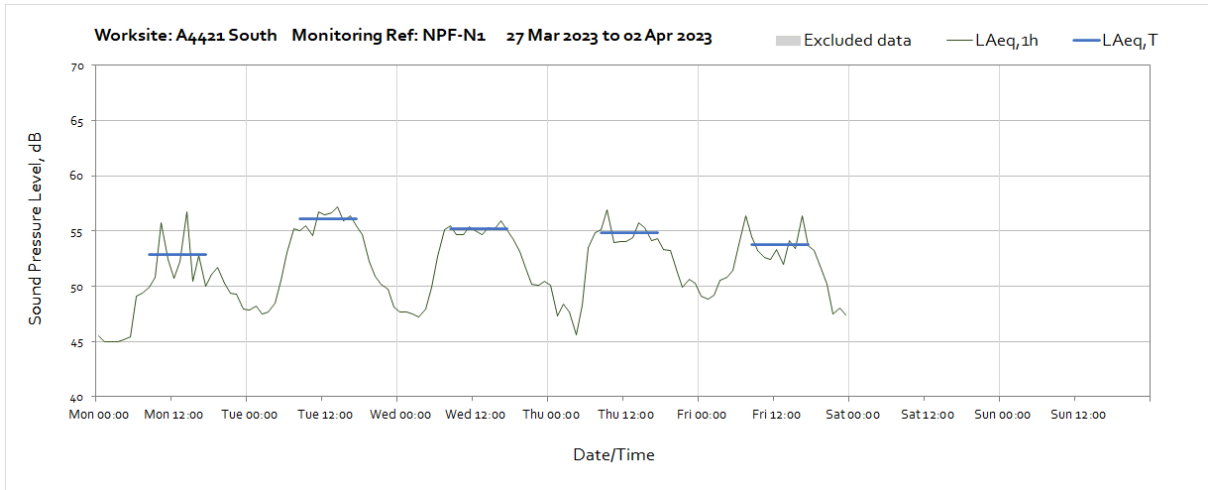
**Worksite: A4421 South – Monitoring Ref: NPF-N1**

Note: Missing data between 00:00 and 01:00 on Sunday 19<sup>th</sup> March was due to a monitor system diagnostic check.

Note: Missing data between 01:00 and 03:00 on Sunday 26<sup>th</sup> March was due to a monitor time adjustment at the start of British Summertime.
