## **Construction noise and vibration Monthly Report – March 2023**

**London Borough of Hillingdon**

# Non-Technical Summary

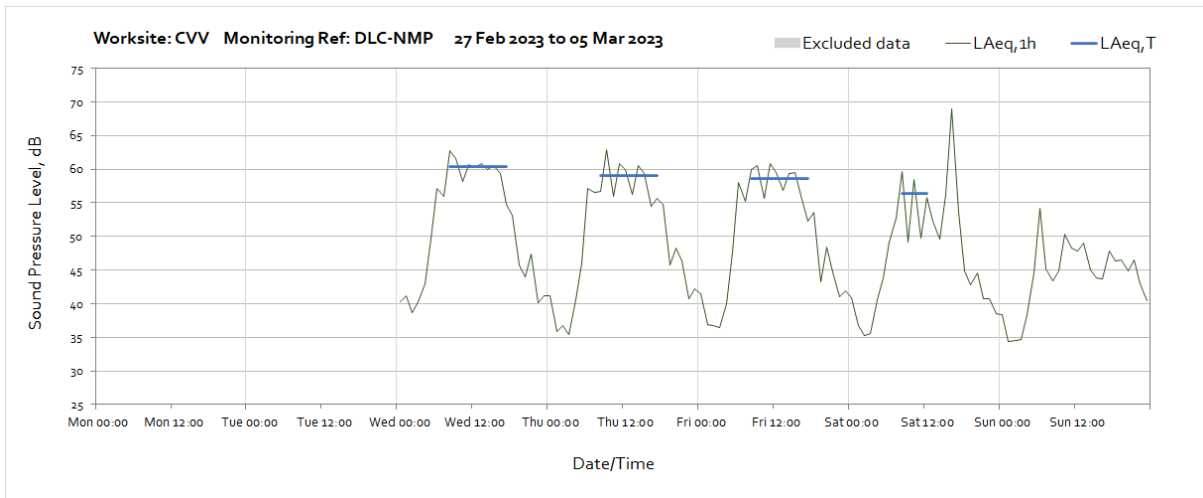
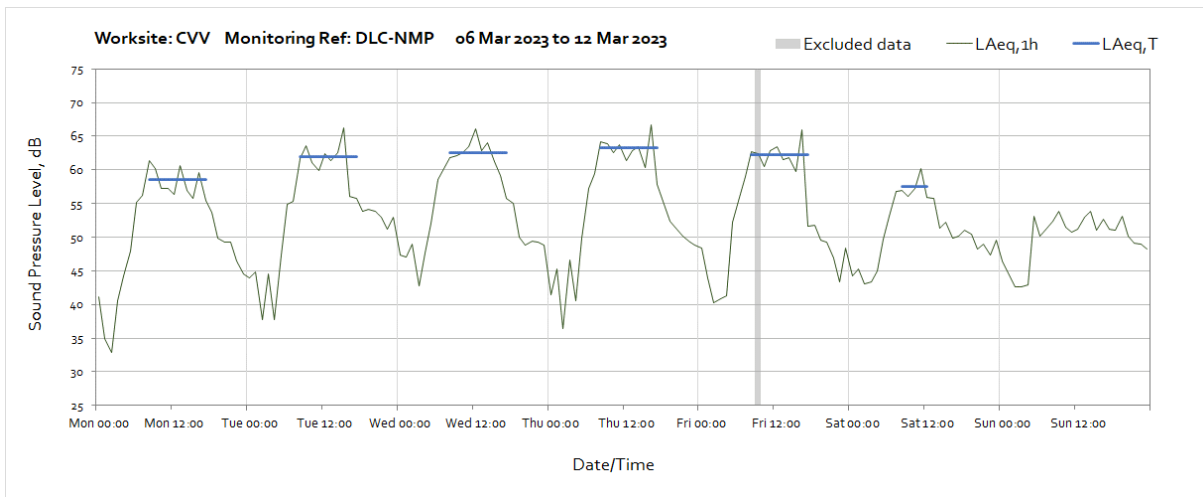
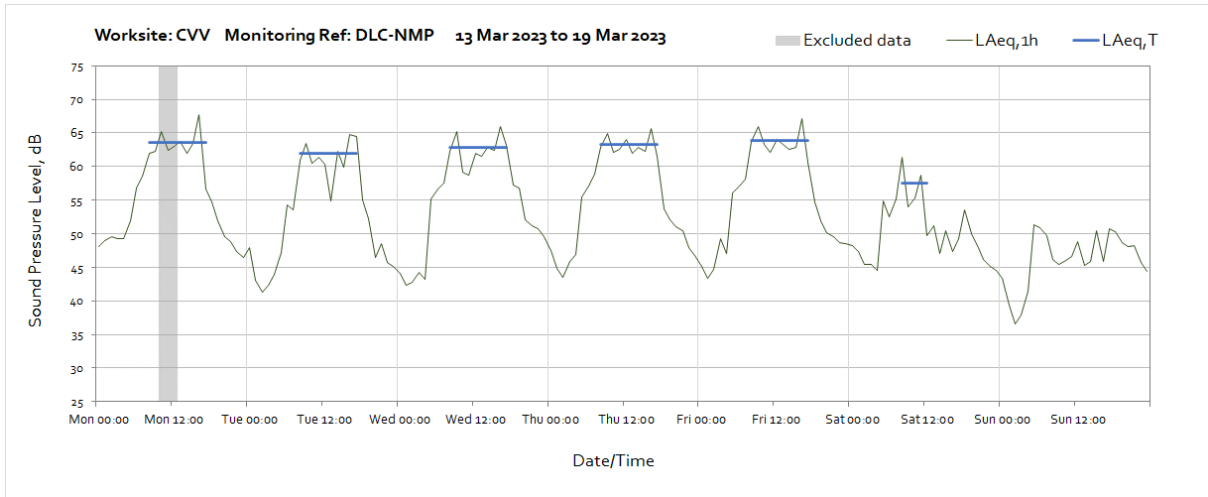
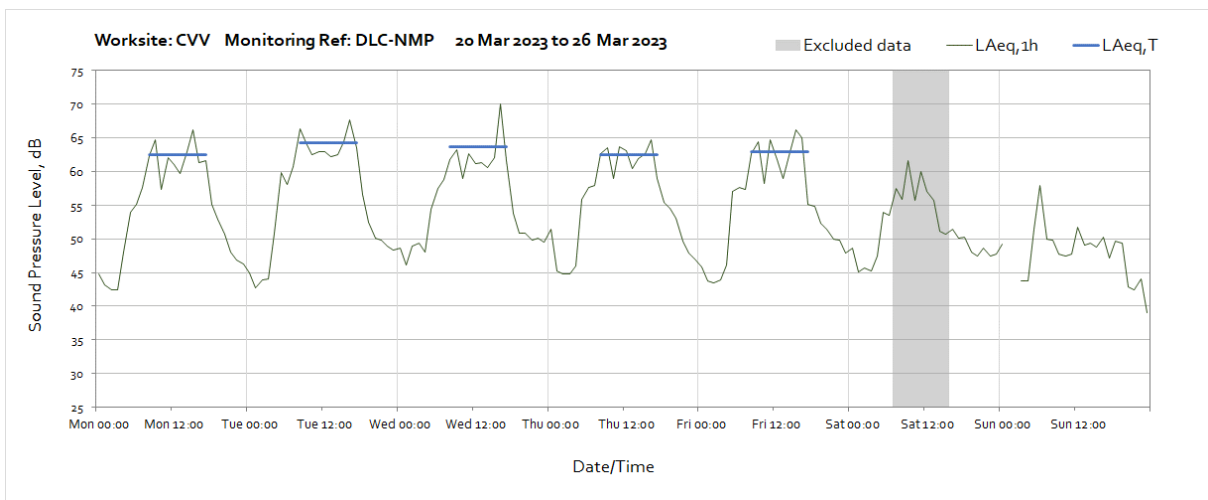
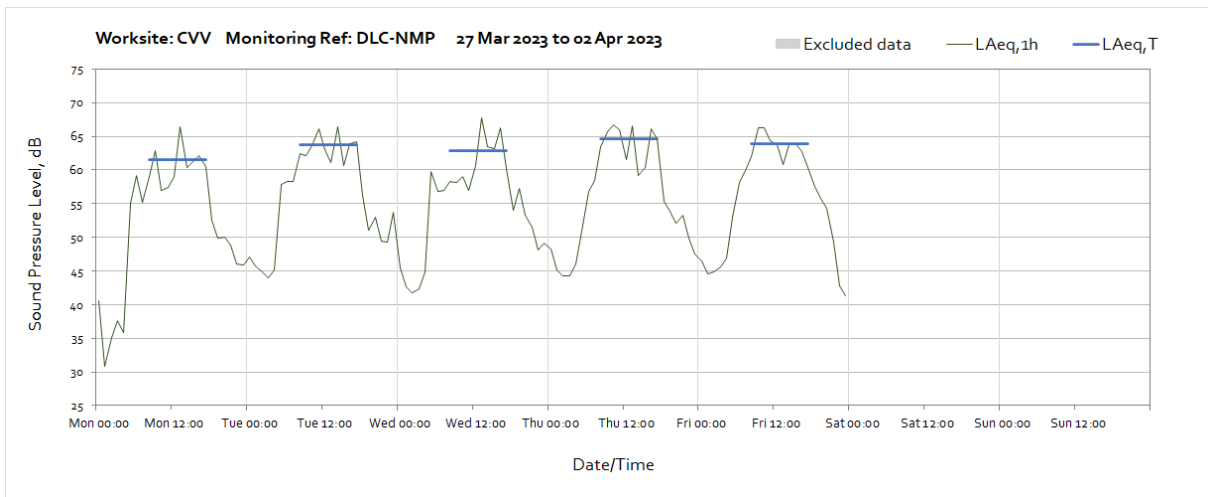
### Worksite: CVV – Monitoring Ref: DLC-NMP

The following graphs show the hourly measured ambient noise level  $L_{Aeq,1h}$  and, where relevant, the averaged noise level  $L_{Aeq,T}$  values, where the time period T is as specified in Table 1 of HS2 Information Paper E23. Periods with adversely weather affected noise levels are greyed out and have been excluded from the calculation of the  $L_{Aeq,T}$  values in Table 3 of the main report.

Note: Missing data between 01:00 and 03:00 on Sunday 26<sup>th</sup> March was due to a monitor time adjustment at the start of British Summer Time.

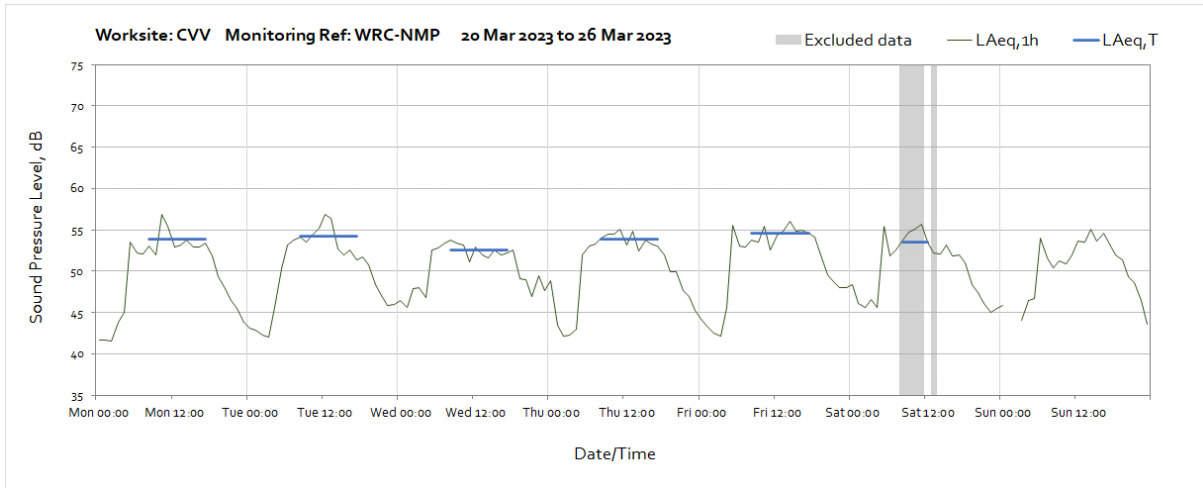
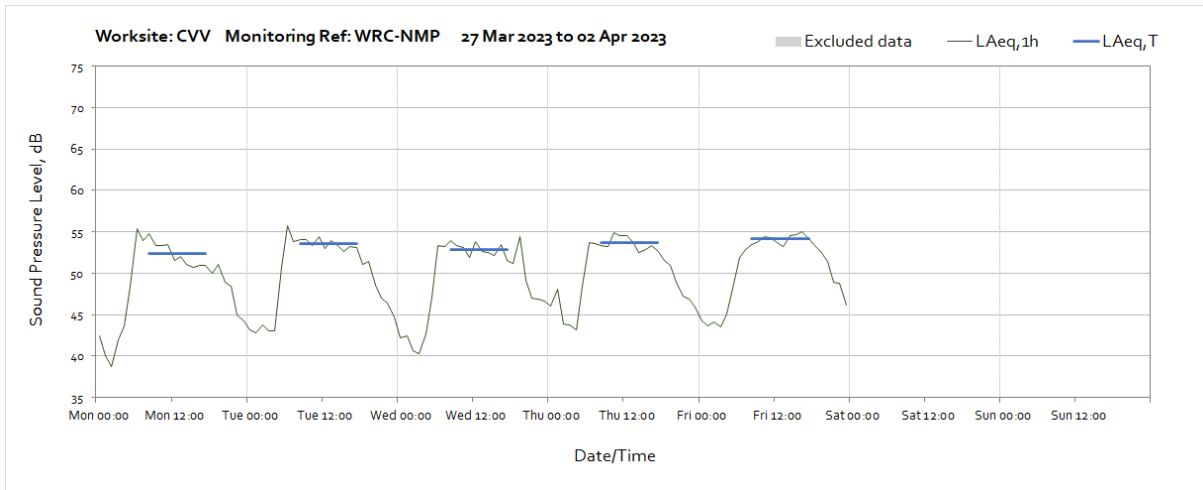
## Worksite: CVV – Monitoring Ref: WRC-NMP

Note: Missing data between 01:00 and 03:00 on Sunday 26<sup>th</sup> March was due to a monitor time adjustment at the start of British Summer Time.

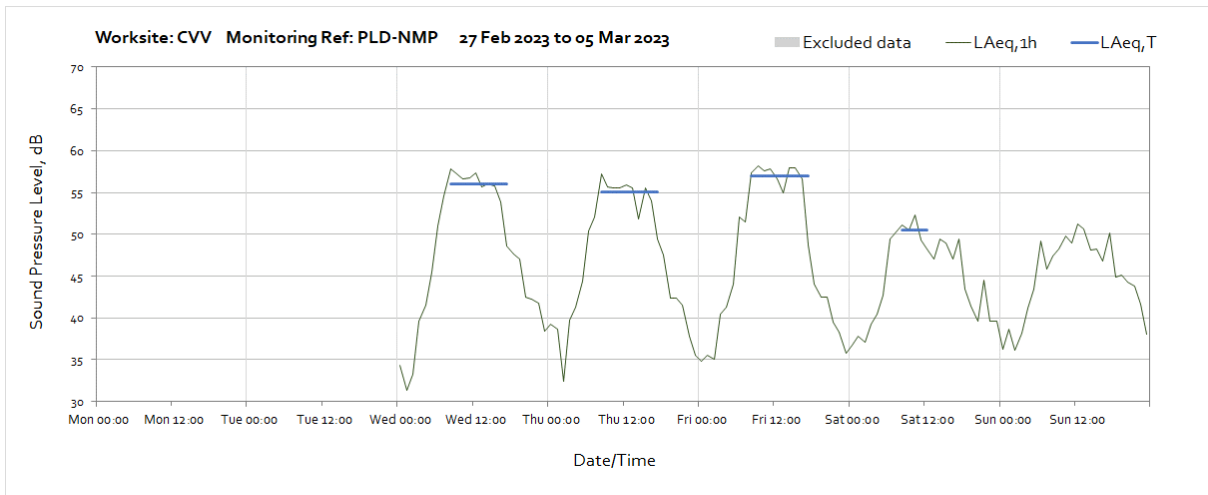
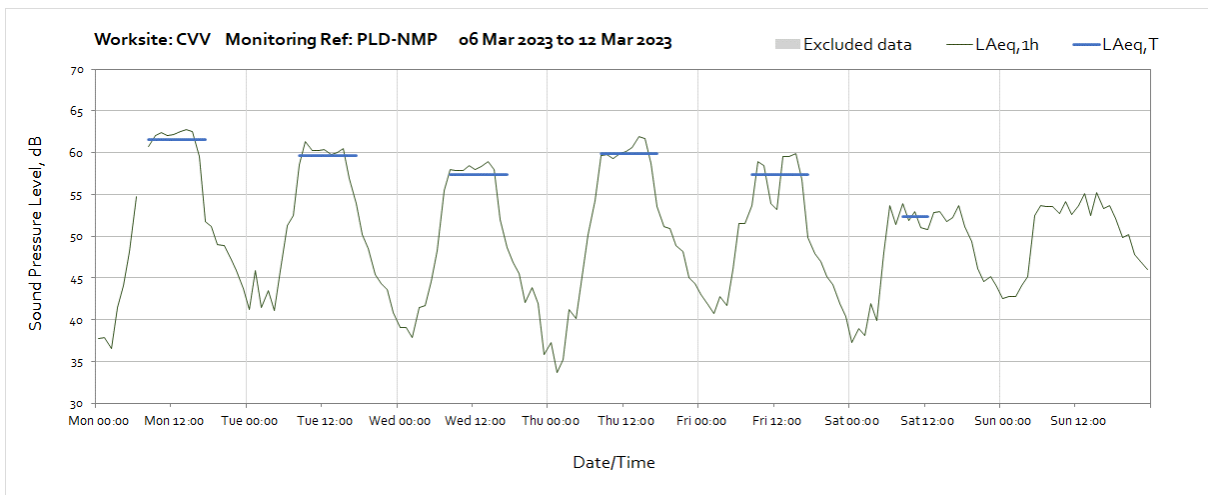
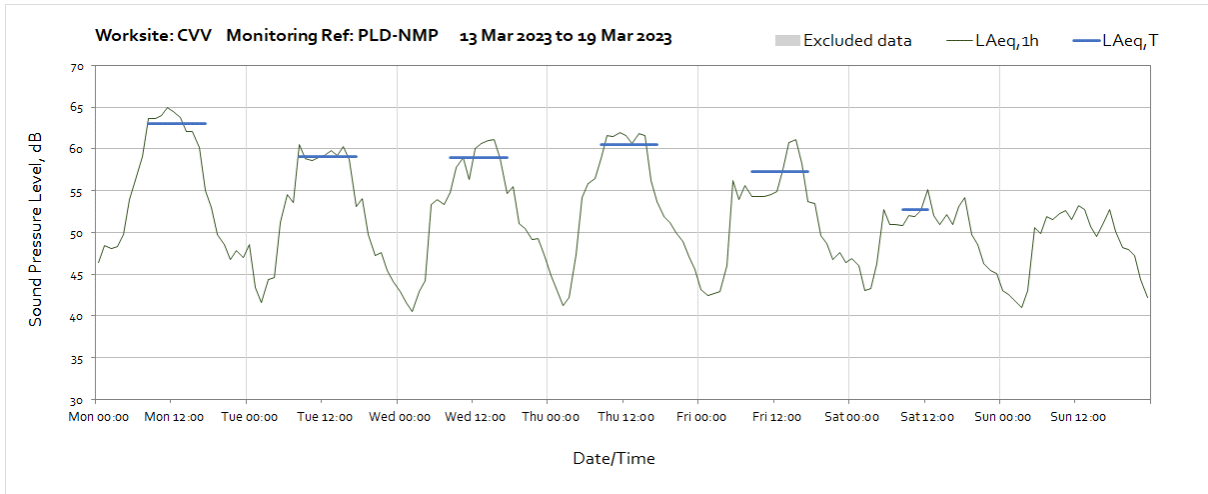
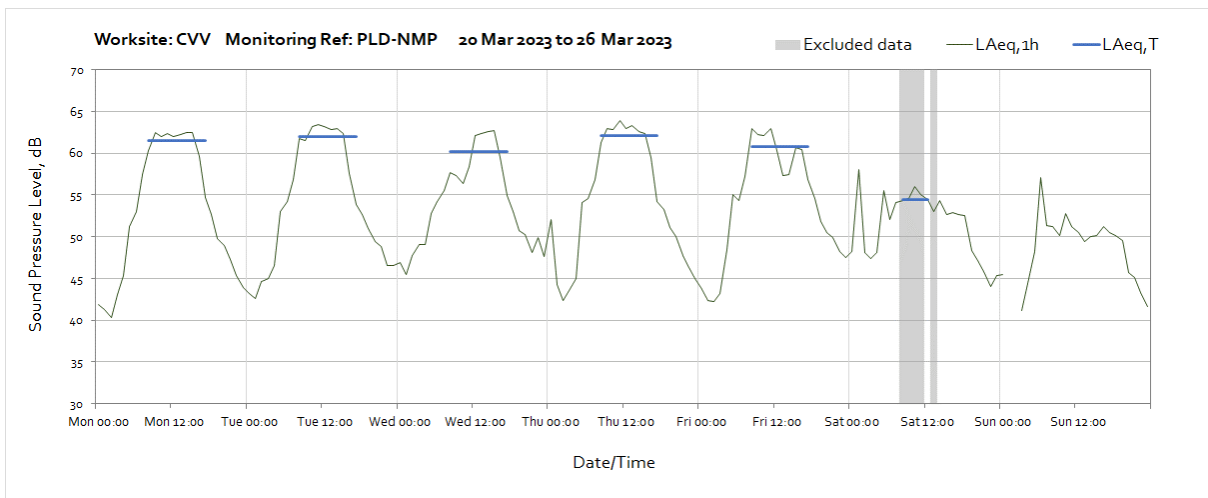
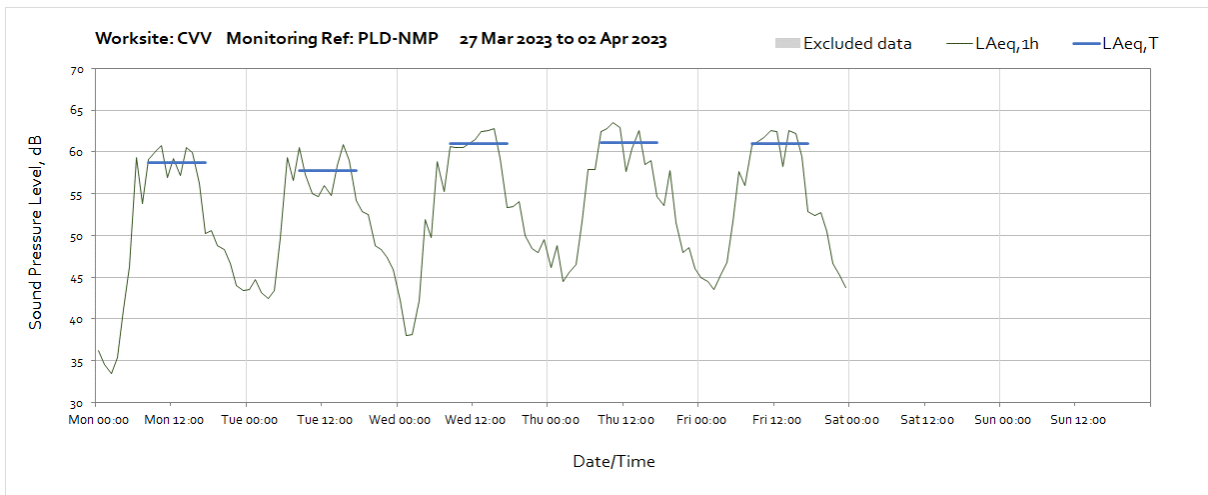
**Worksite: CVV - Monitoring Ref: PLD-NMP**

Note: Missing data between 07:00 and 08:00 on Monday 6<sup>th</sup> March was due to monitor power supply issues.

Note: Missing data between 01:00 and 03:00 on Sunday 26<sup>th</sup> March was due to a monitor time adjustment at the start of British Summer Time.

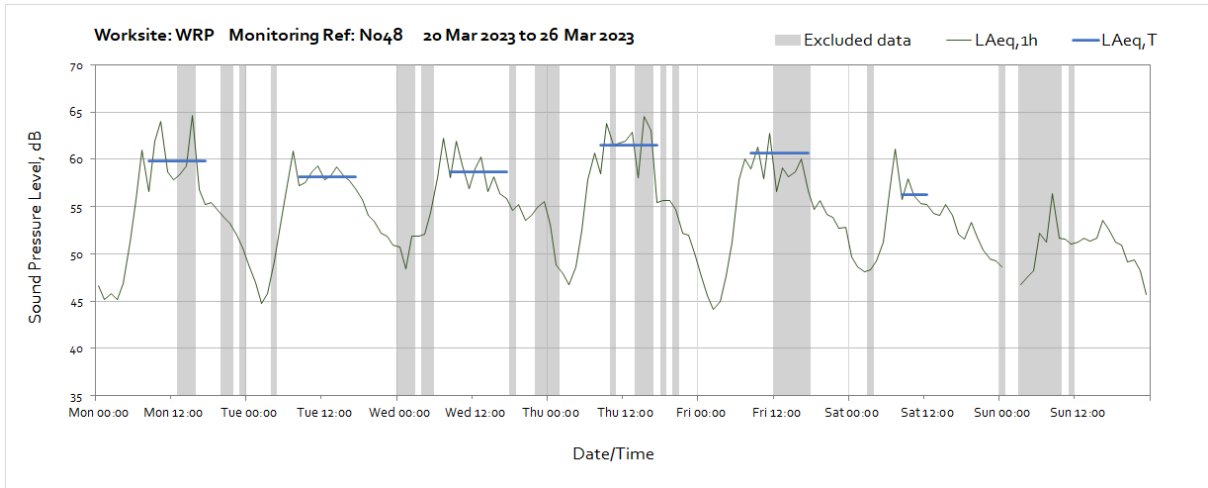
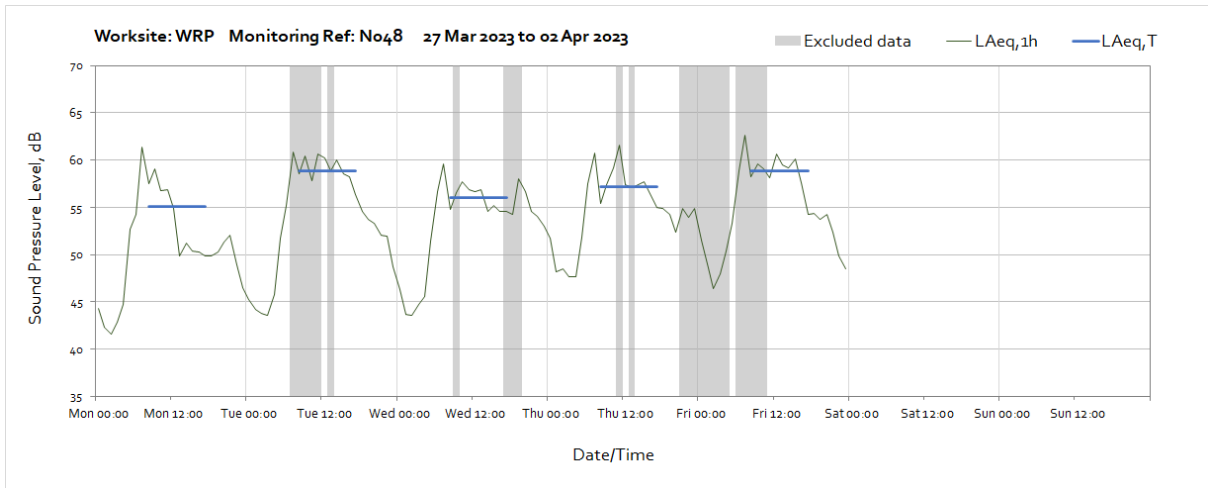
# Worksite: WRP – Monitoring Ref: N048

Note: Missing data between 01:00 and 03:00 on Sunday 26<sup>th</sup> March was due to a monitor time adjustment at the start of British Summer Time.

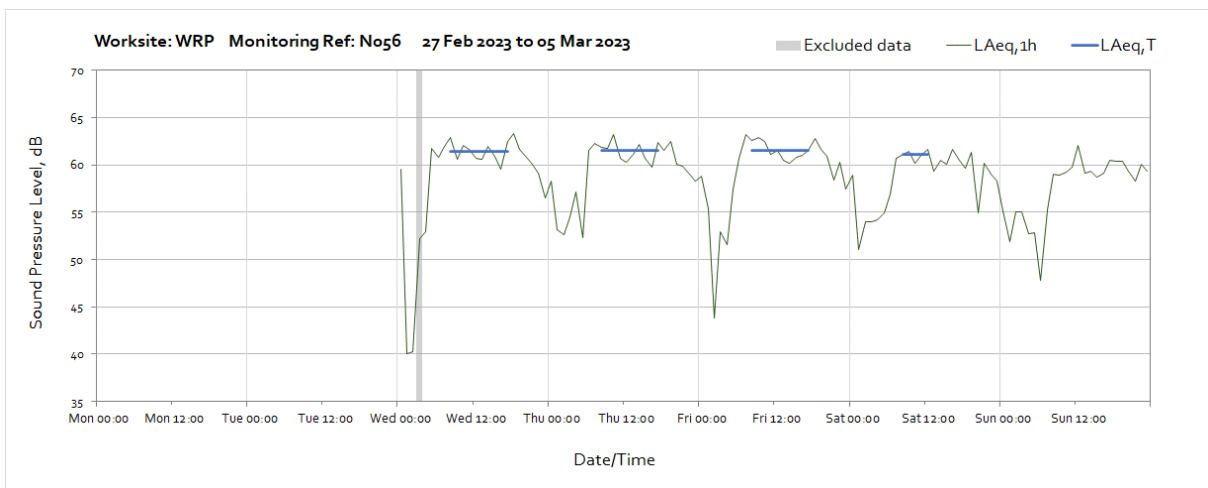
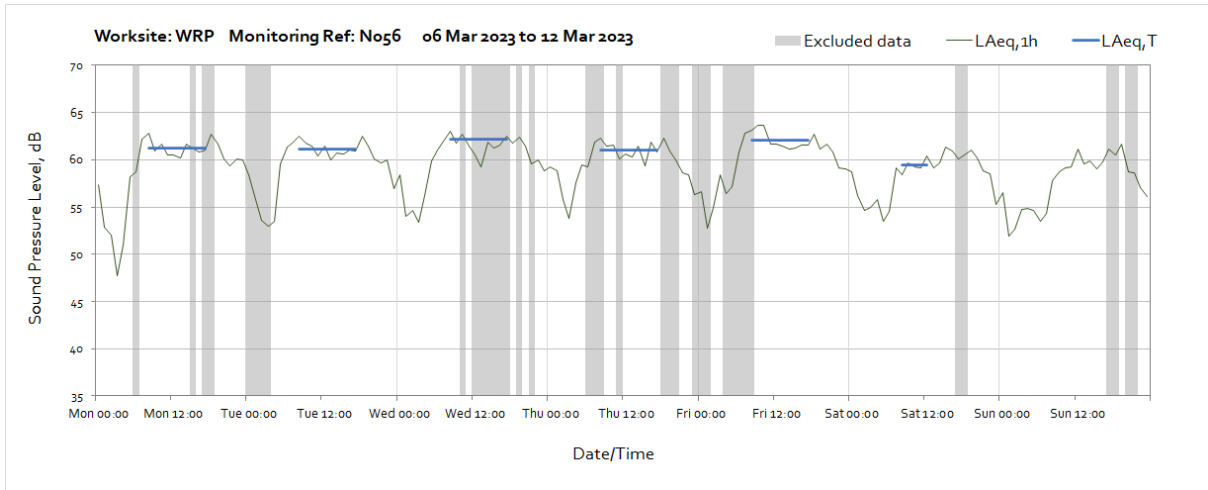
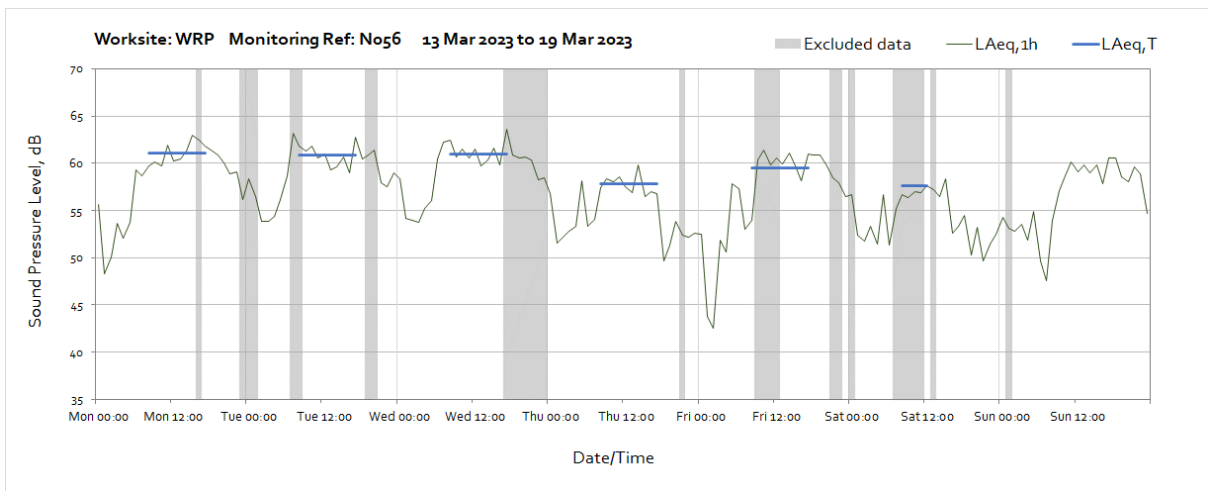
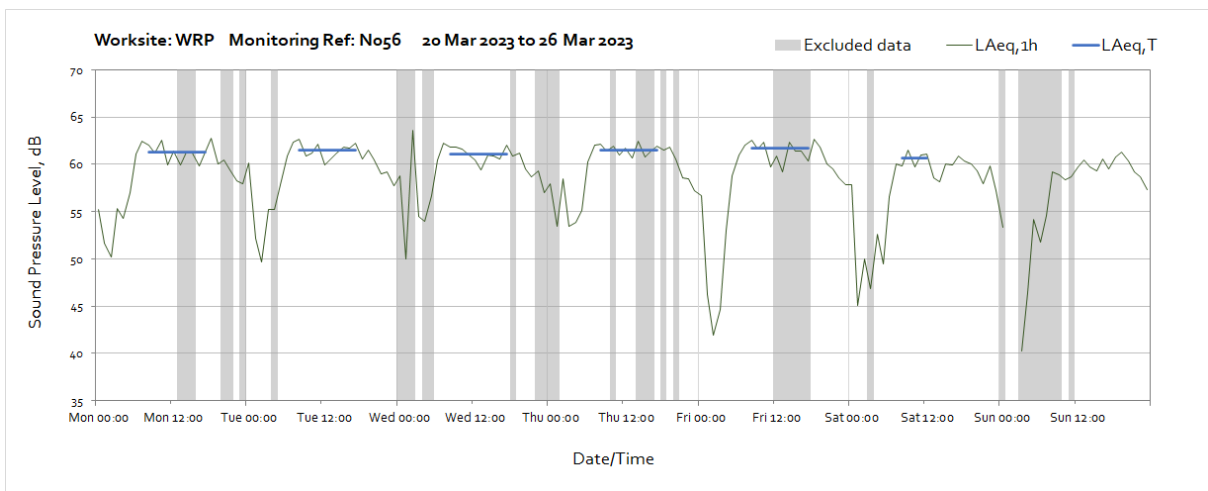
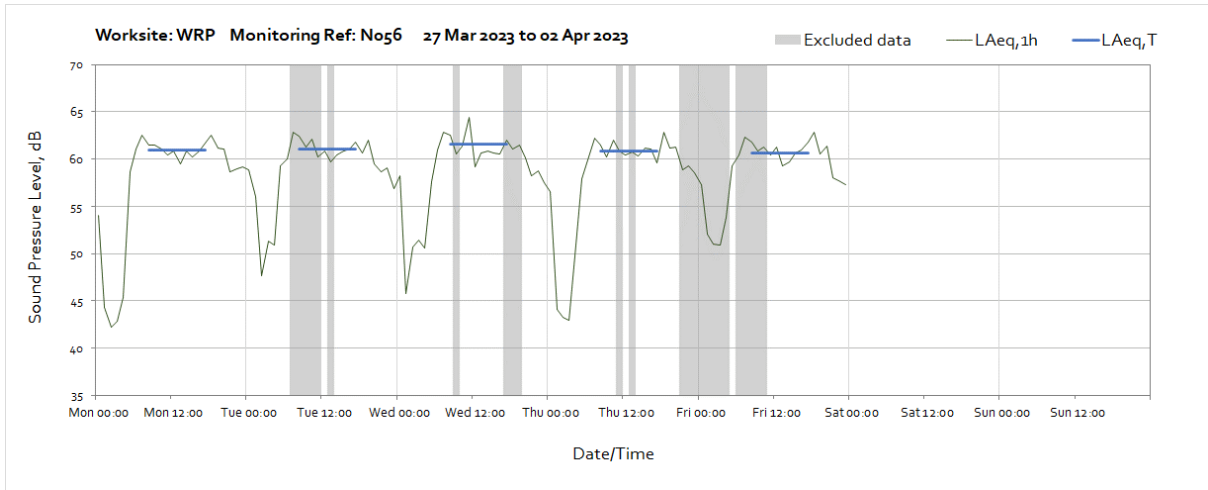
### Worksite: WRP – Monitoring Ref: N056

Note: Missing data between 01:00 and 03:00 on Sunday 26<sup>th</sup> March was due to a monitor time adjustment at the start of British Summer Time.

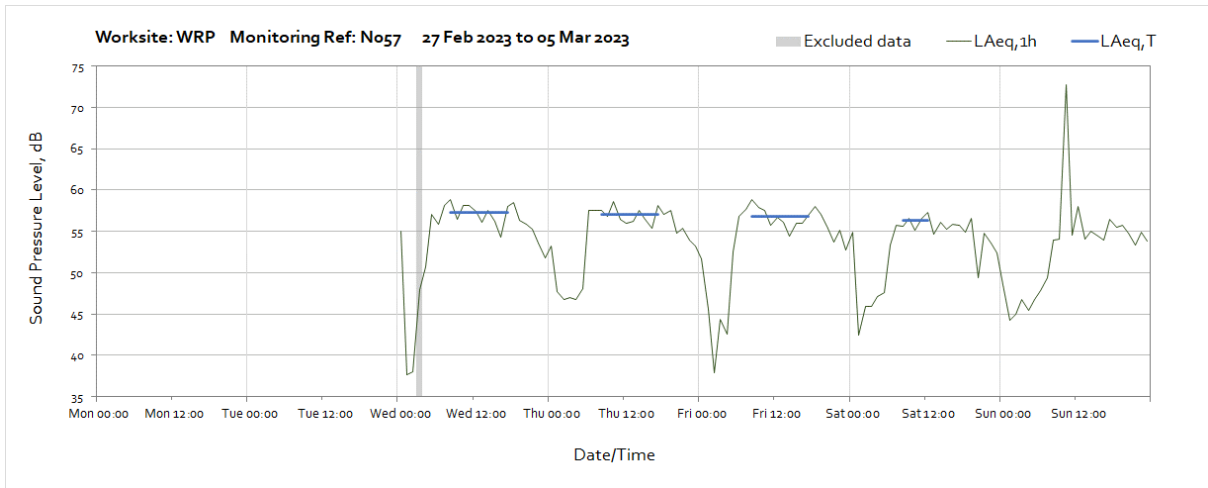
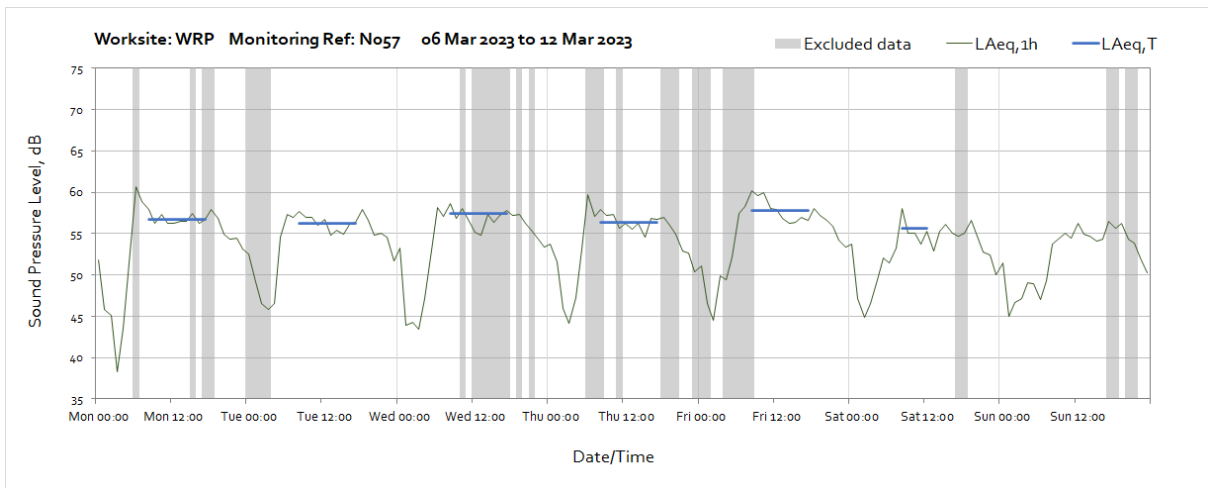
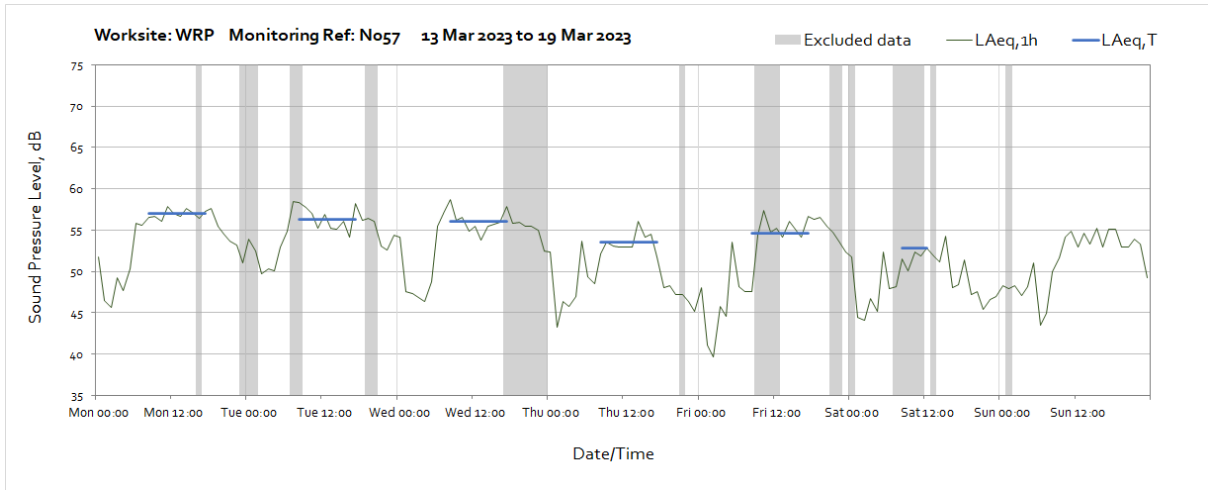
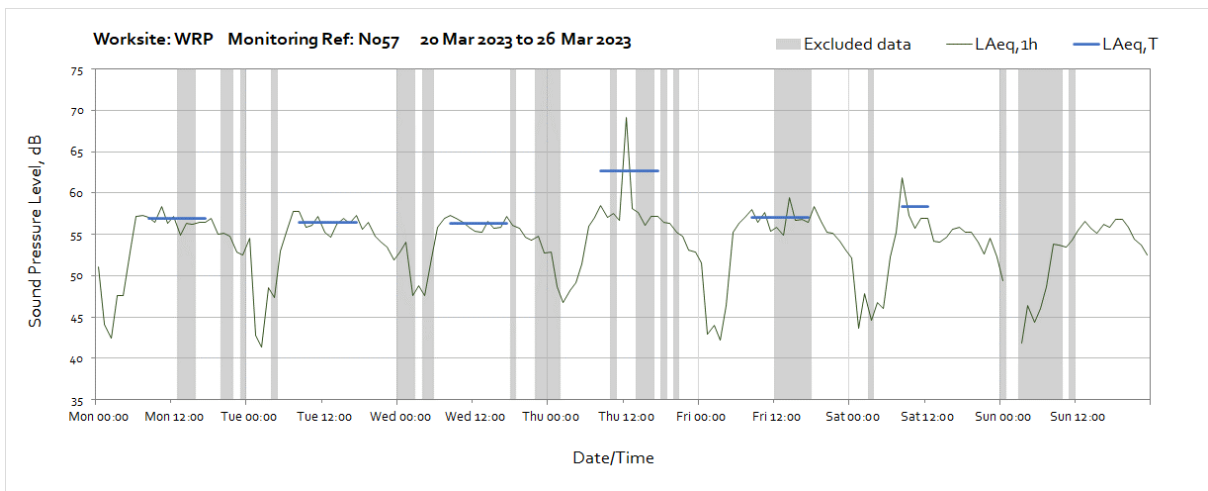
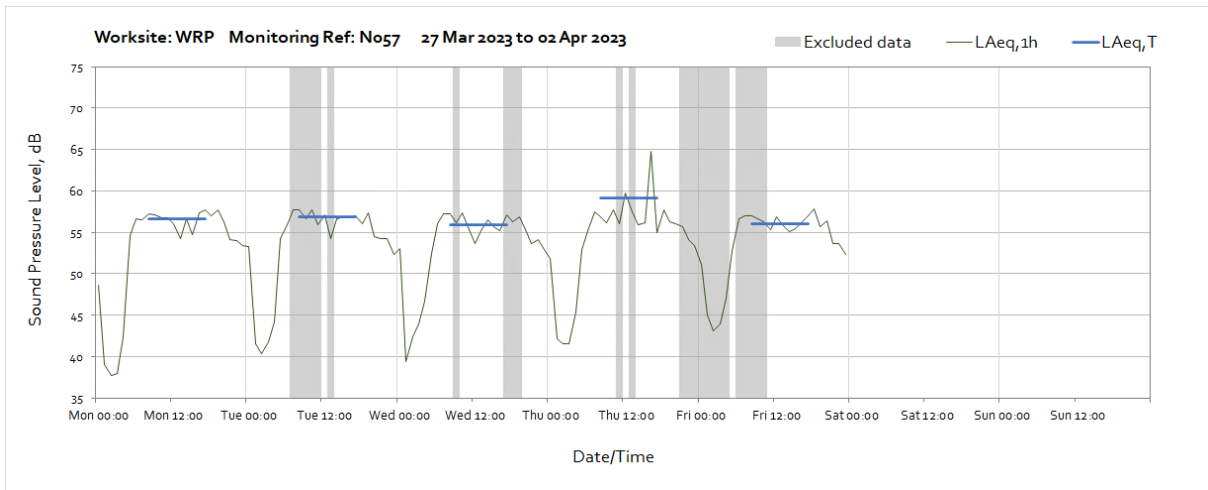
**Worksite: WRP – Monitoring Ref: N057**

Note: Missing data between 01:00 and 03:00 on Sunday 26<sup>th</sup> March was due to a monitor time adjustment at the start of British Summer Time.

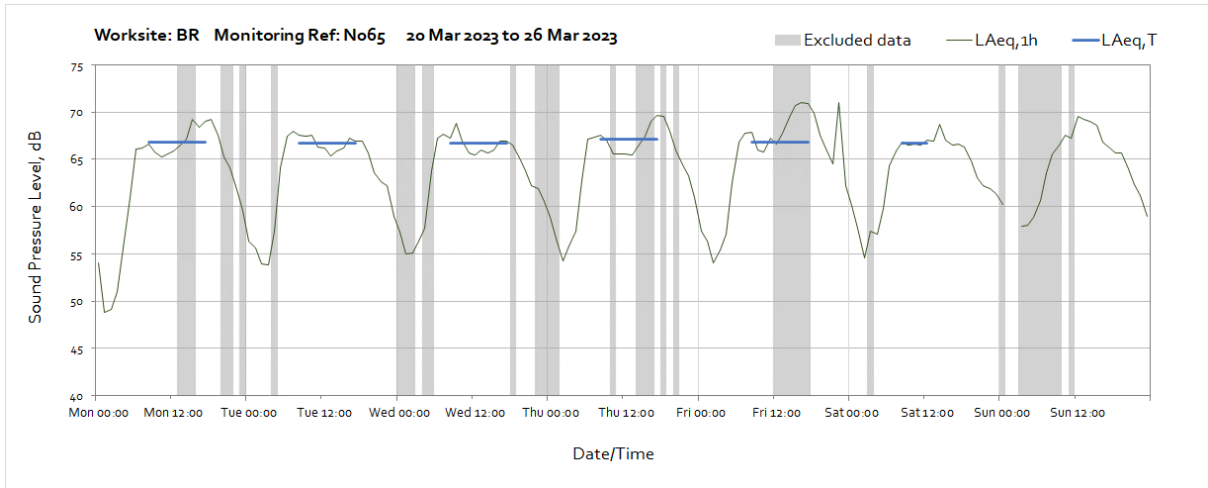
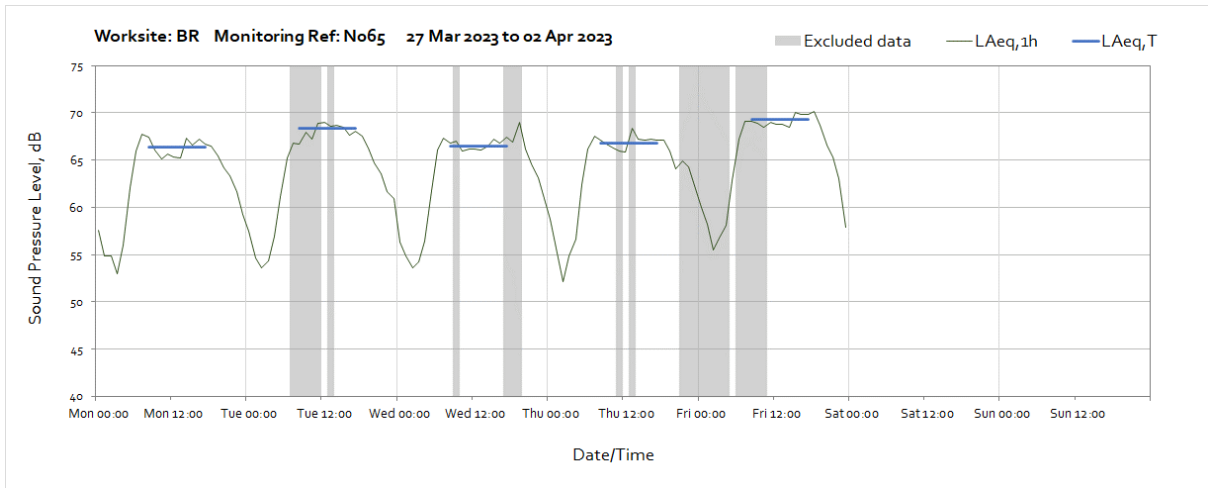
## Worksite: BR – Monitoring Ref: N065

Note: Missing data between 01:00 and 03:00 on Sunday 26<sup>th</sup> March was due to a monitor time adjustment at the start of British Summer Time.

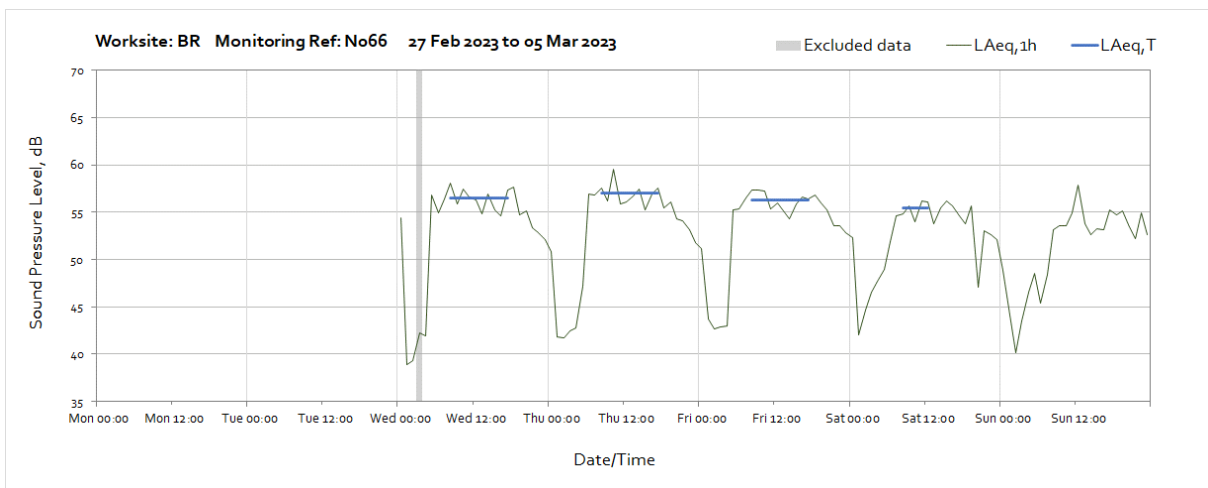
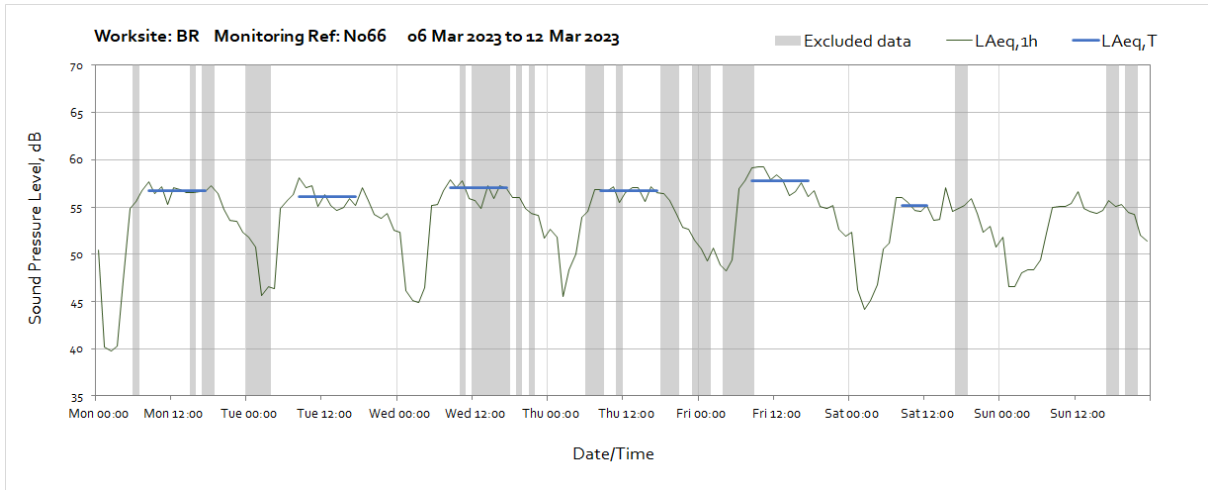
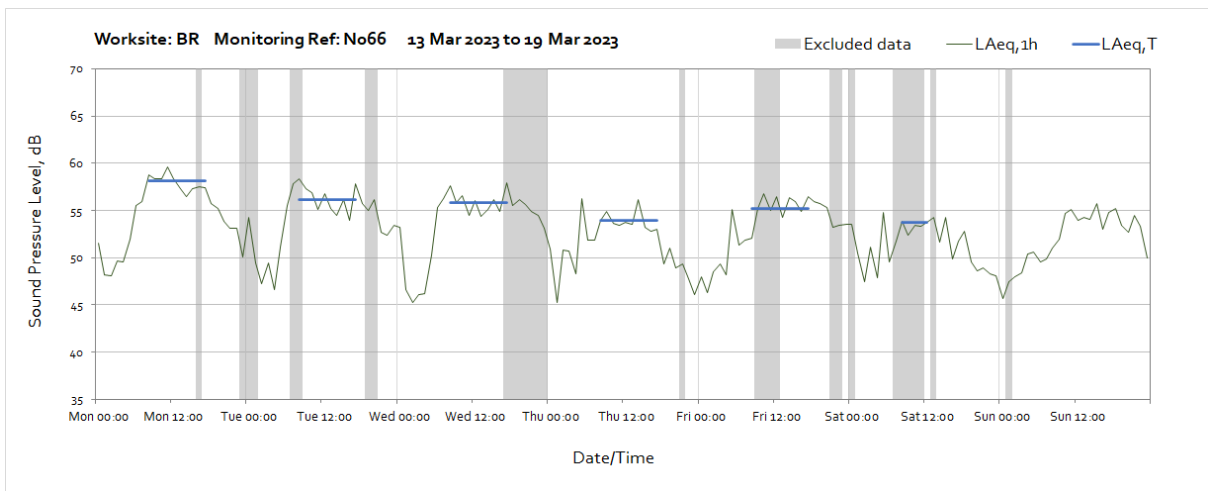
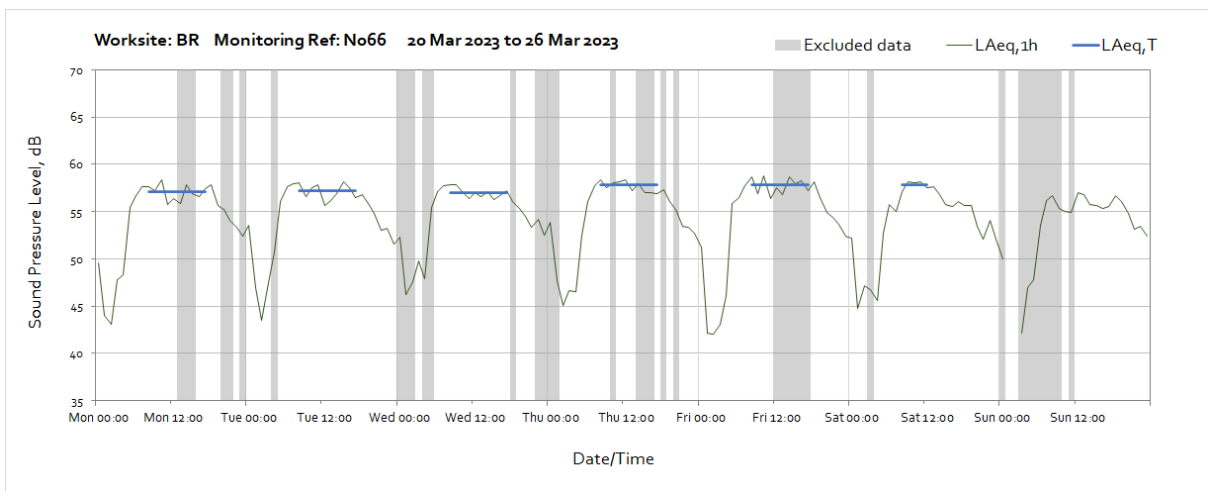
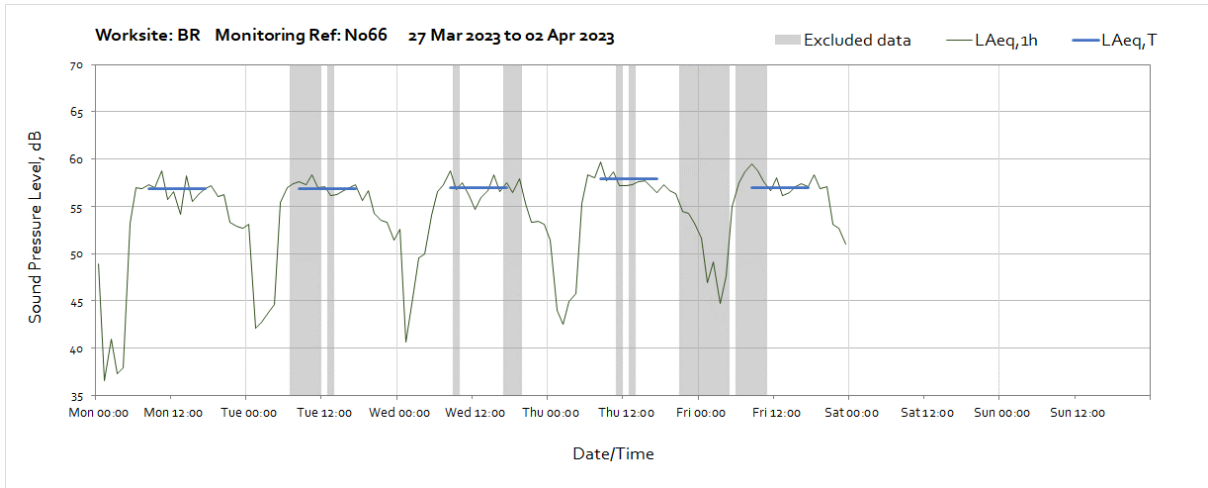
### Worksite: BR – Monitoring Ref: N066

Note: Missing data between 01:00 and 03:00 on Sunday 26<sup>th</sup> March was due to a monitor time adjustment at the start of British Summer Time.

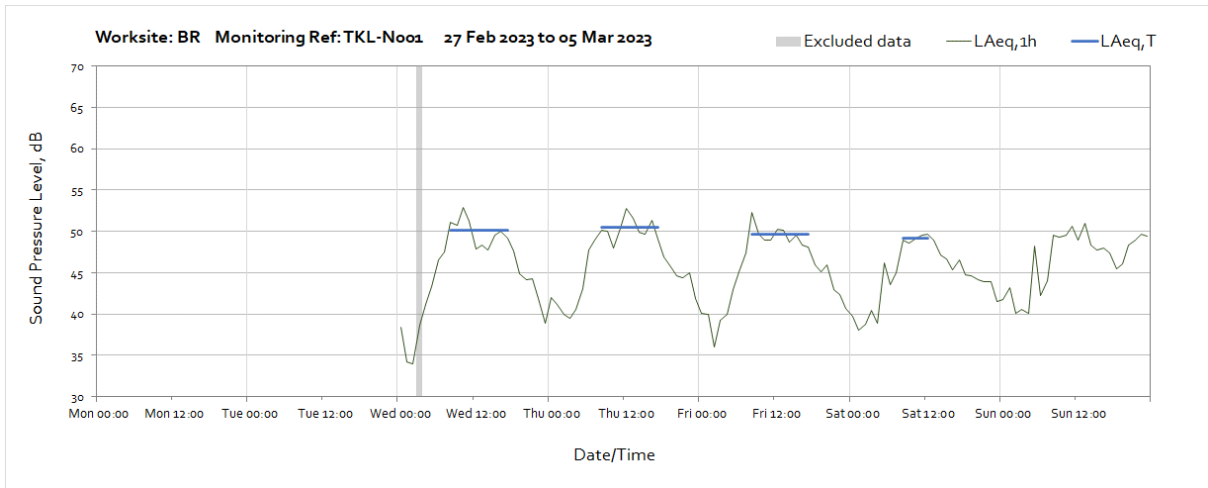
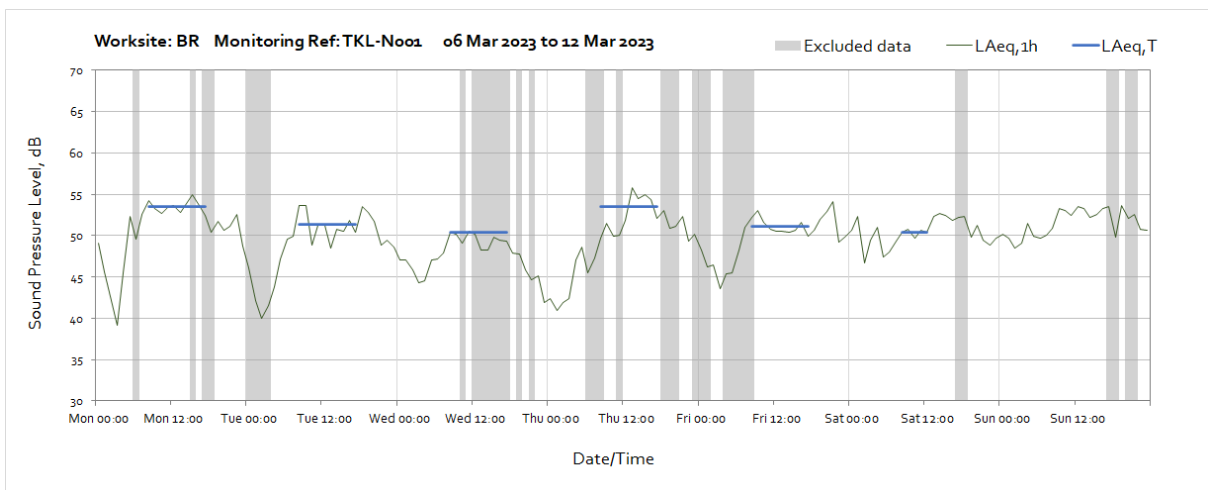
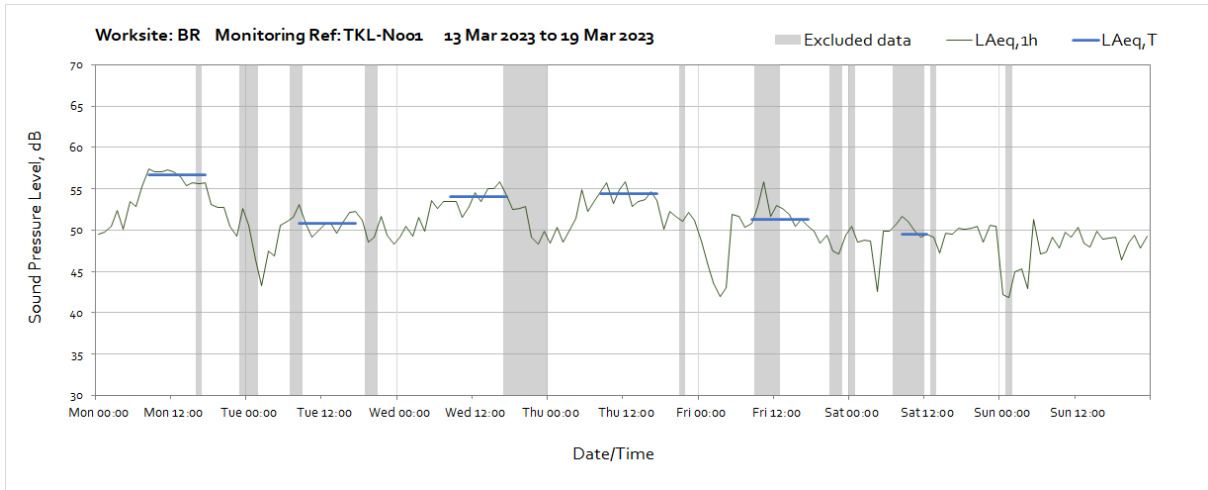
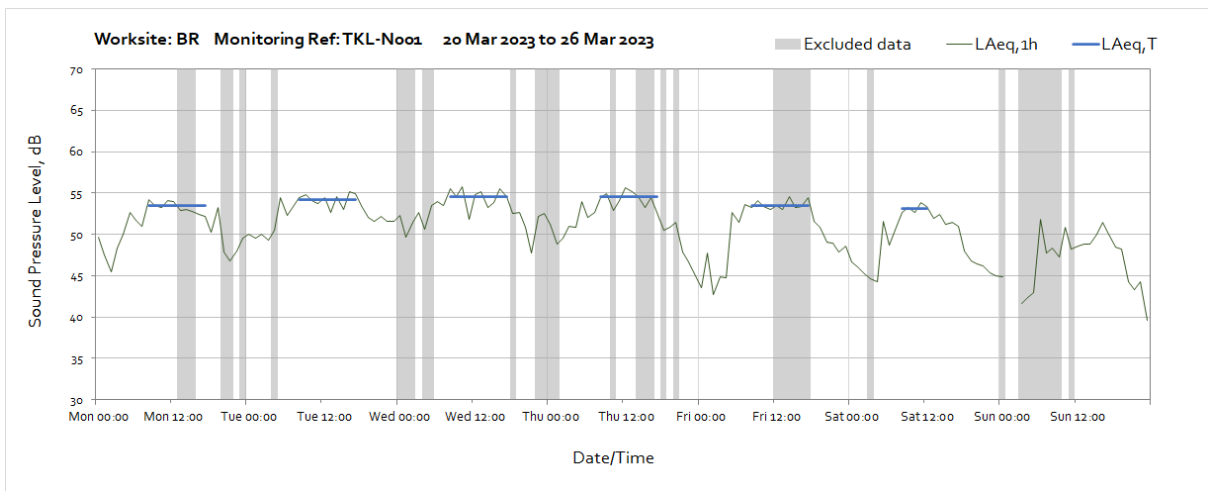
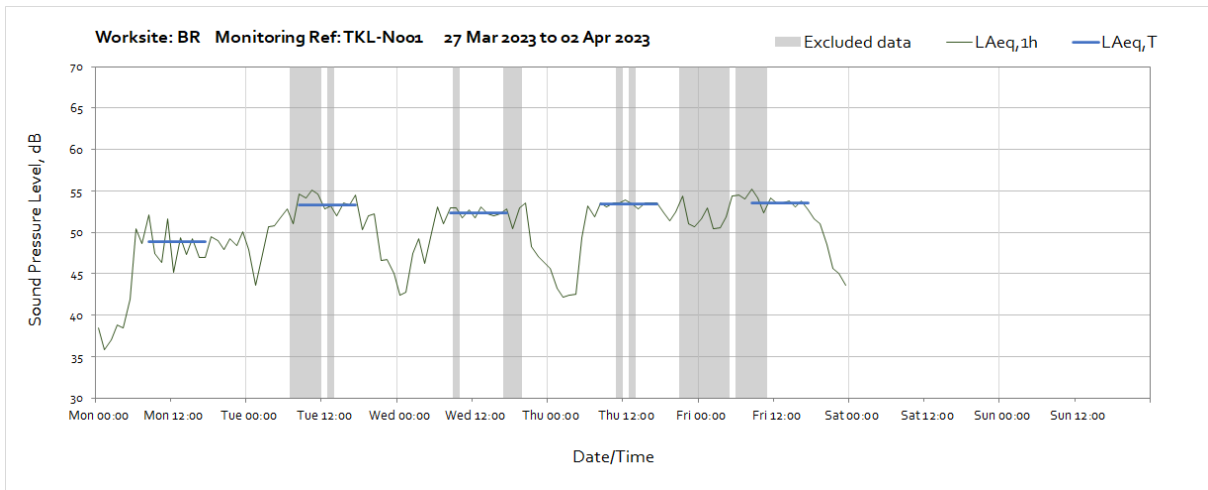
**Worksite: BR – Monitoring Ref: TKL-N001**

Note: Missing data between 01:00 and 03:00 on Sunday 26<sup>th</sup> March was due to a monitor time adjustment at the start of British Summer Time.

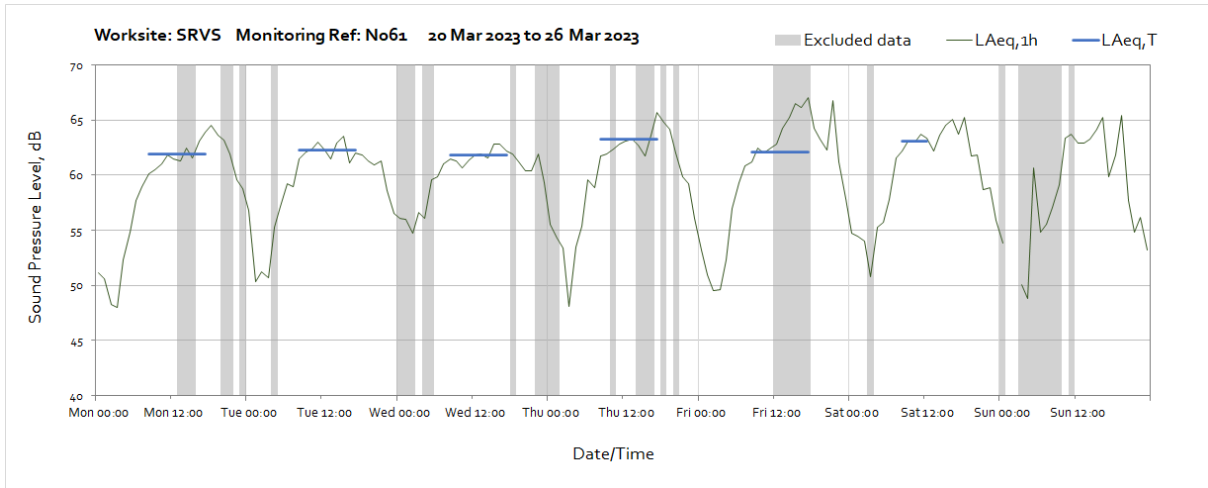
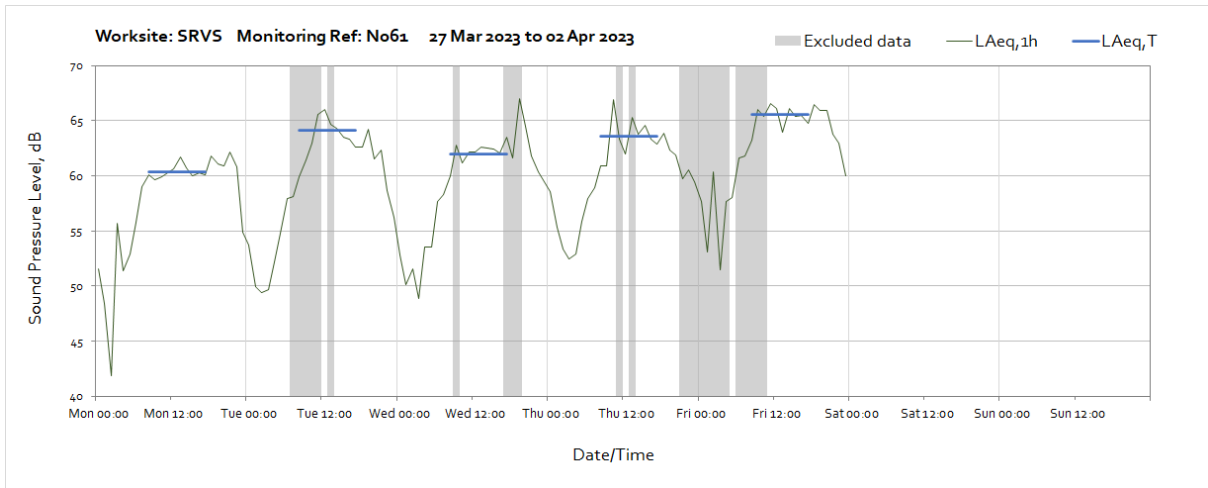
## Worksite: SRVS – Monitoring Ref: N061

Note: Missing data between 01:00 and 03:00 on Sunday 26<sup>th</sup> March was due to a monitor time adjustment at the start of British Summer Time.
