## **Construction noise and vibration Monthly Report – March 2023**

**London Borough of Hillingdon**

# Non-Technical Summary

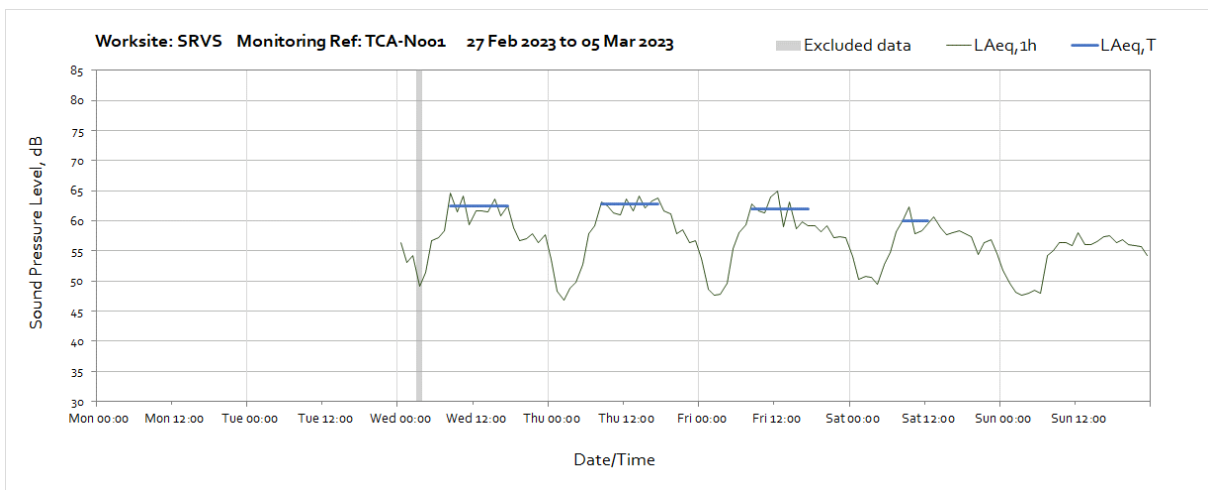
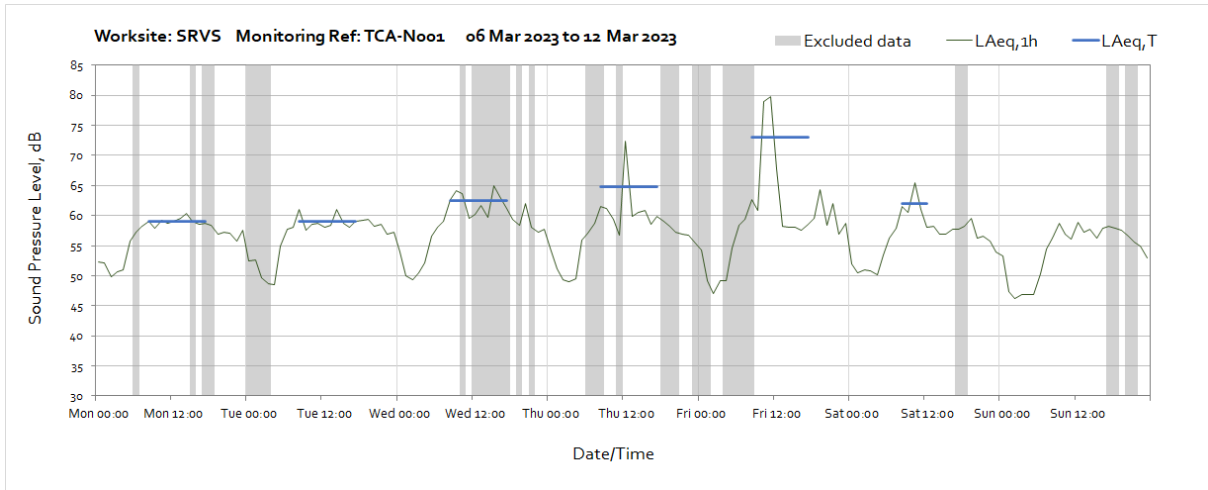
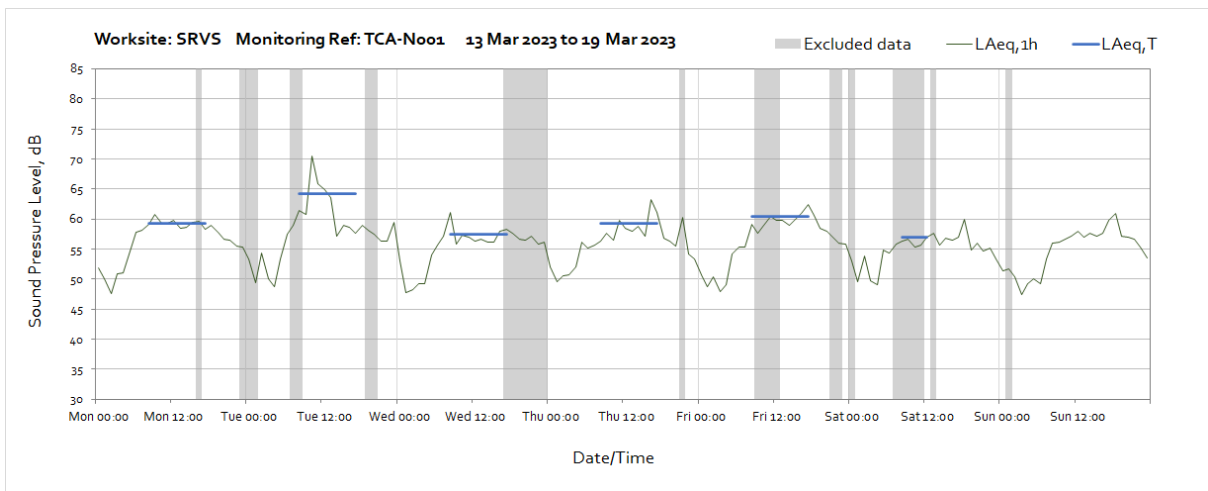
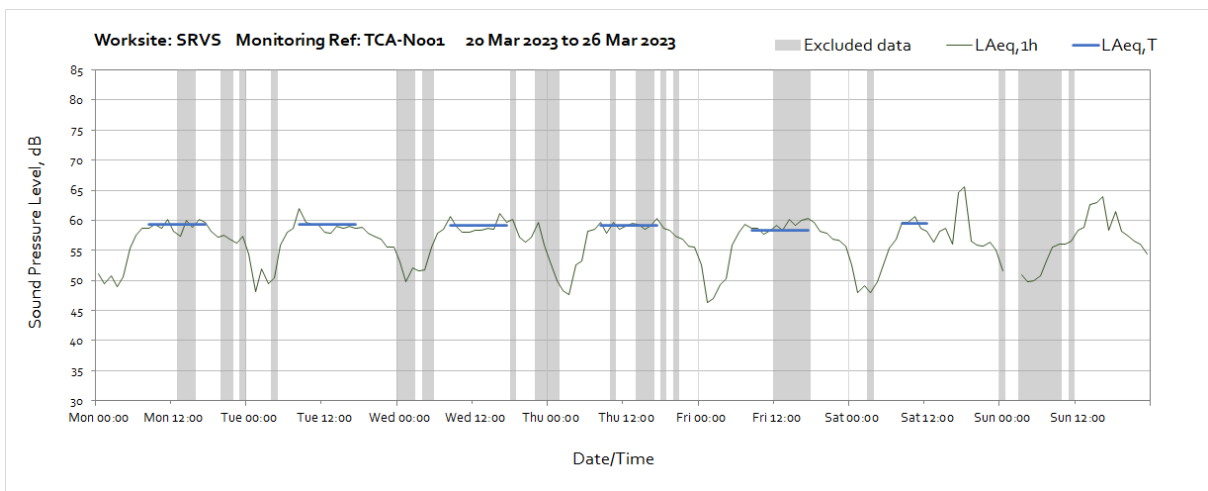
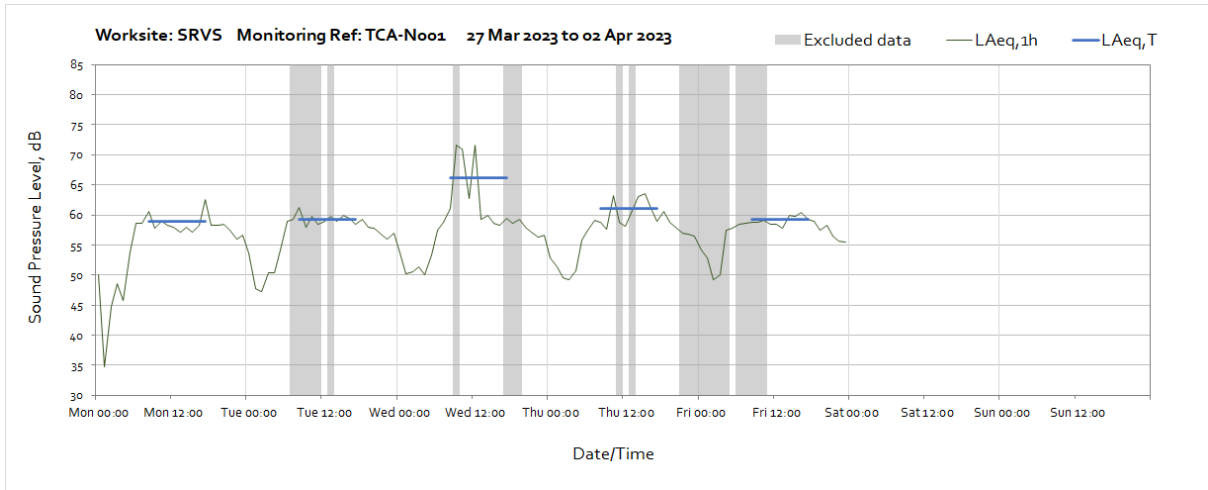
### Worksite: SRVS – Monitoring Ref: TCA-N001

Note: Missing data between 01:00 and 03:00 on Sunday 26<sup>th</sup> March was due to a monitor time adjustment at the start of British Summer Time.

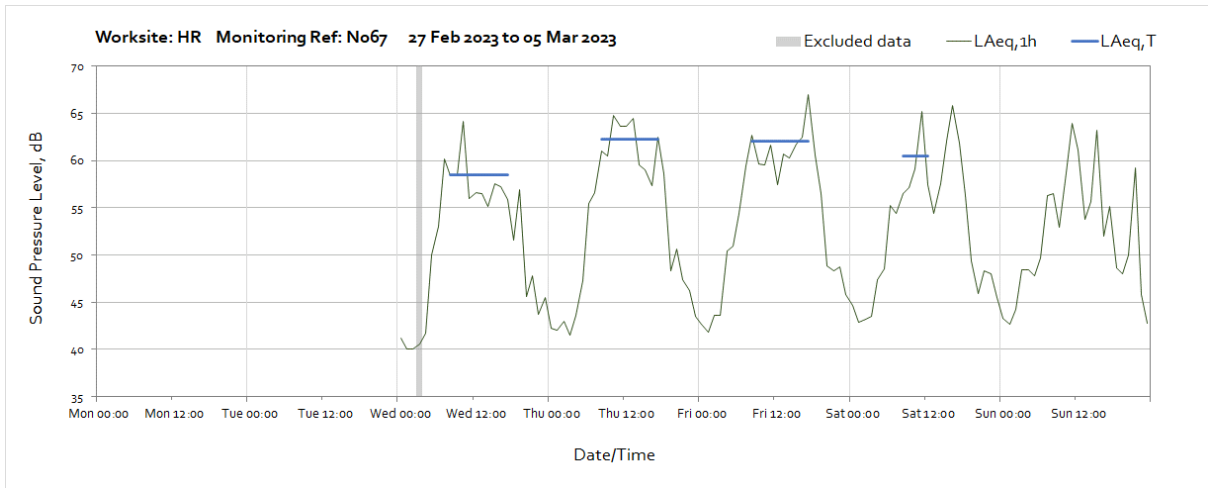
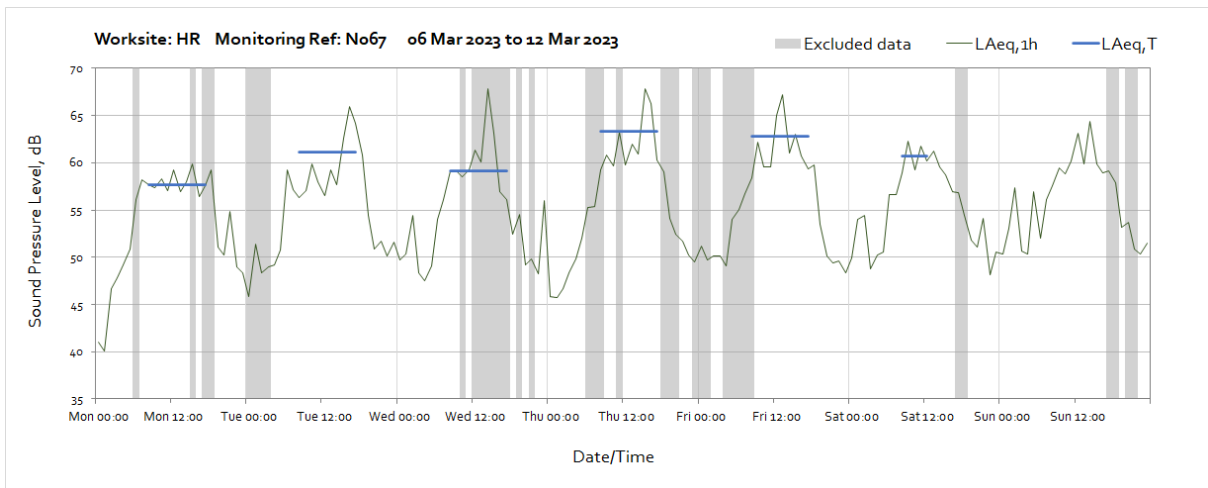
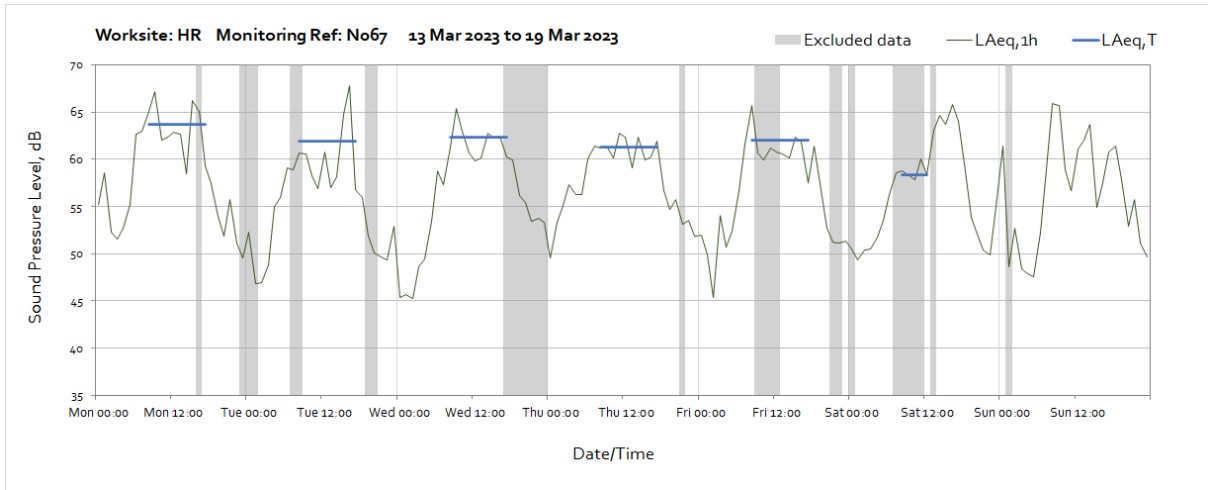
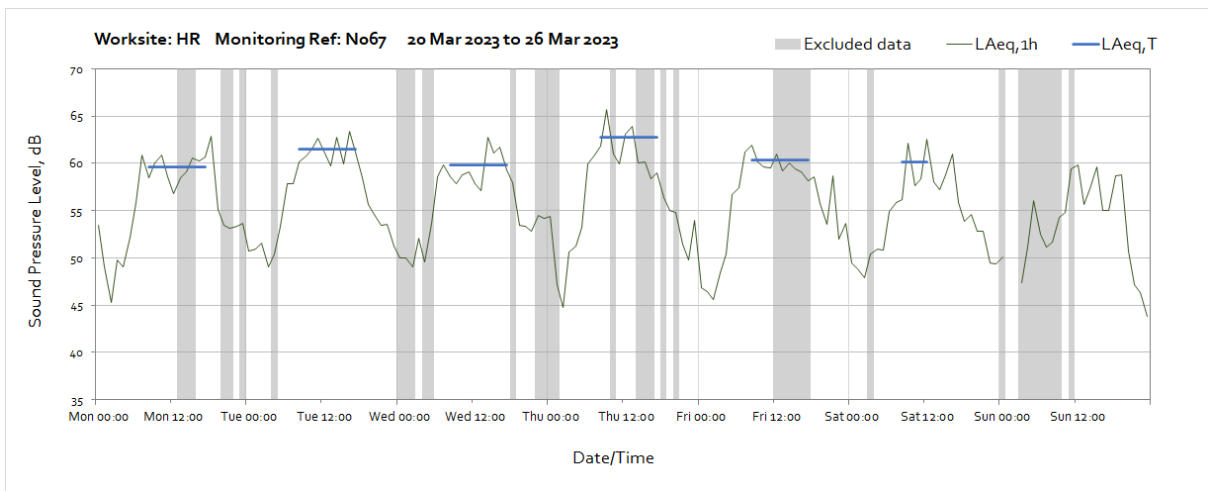
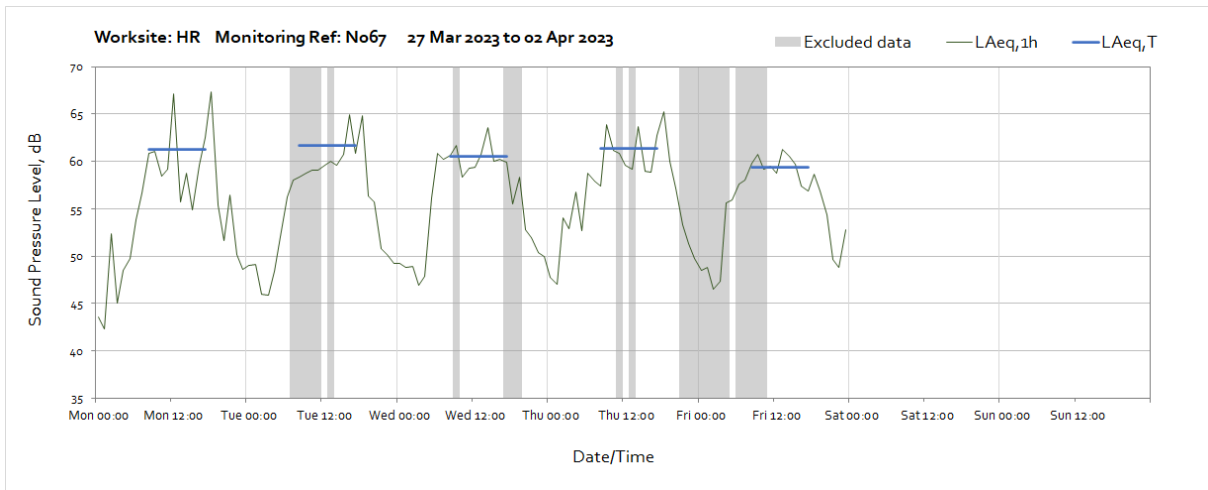
**Worksite: HR - Monitoring Ref: N067**

Note: Missing data between 01:00 and 03:00 on Sunday 26<sup>th</sup> March was due to a monitor time adjustment at the start of British Summer Time.

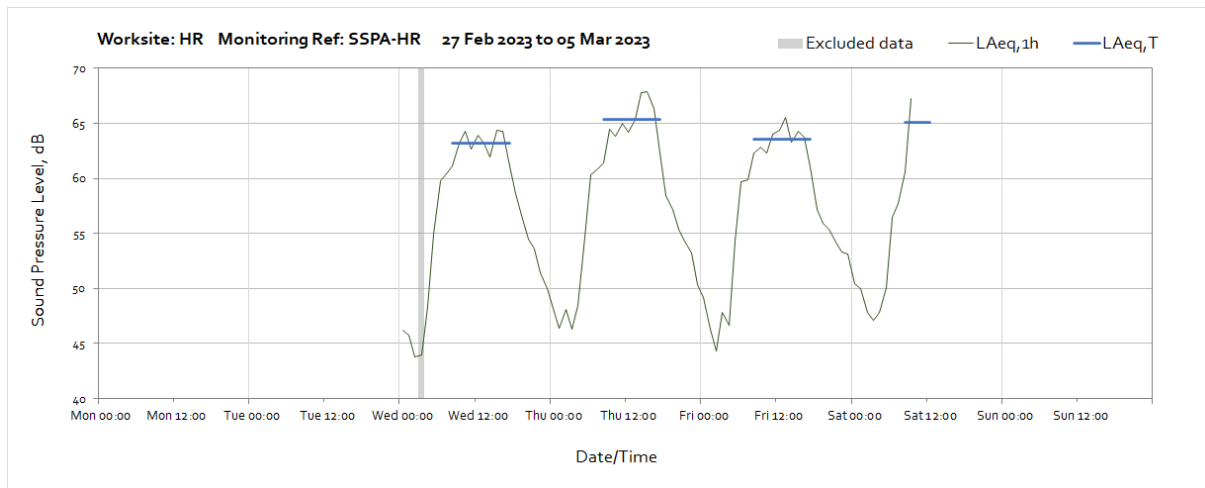
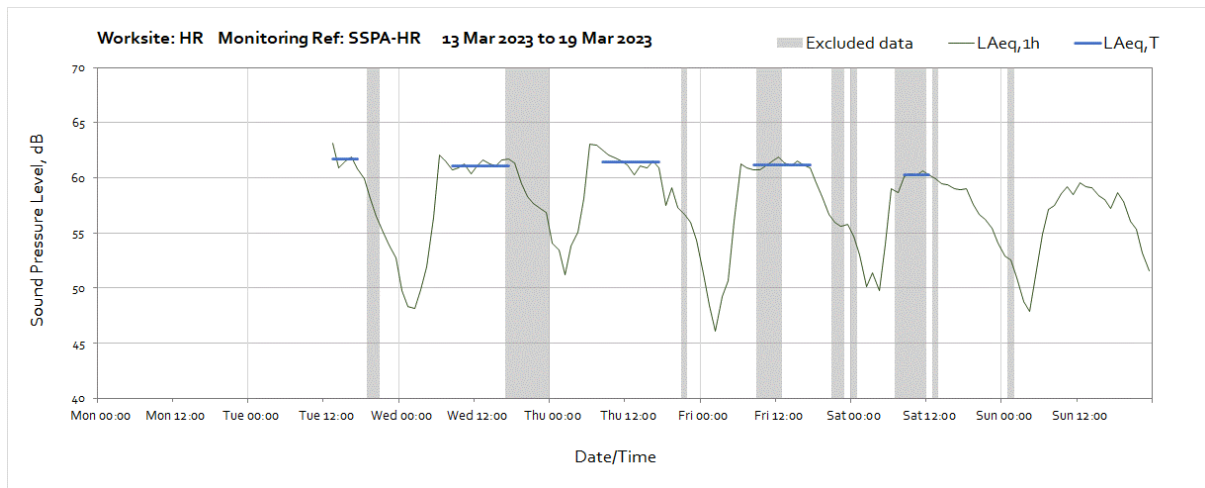
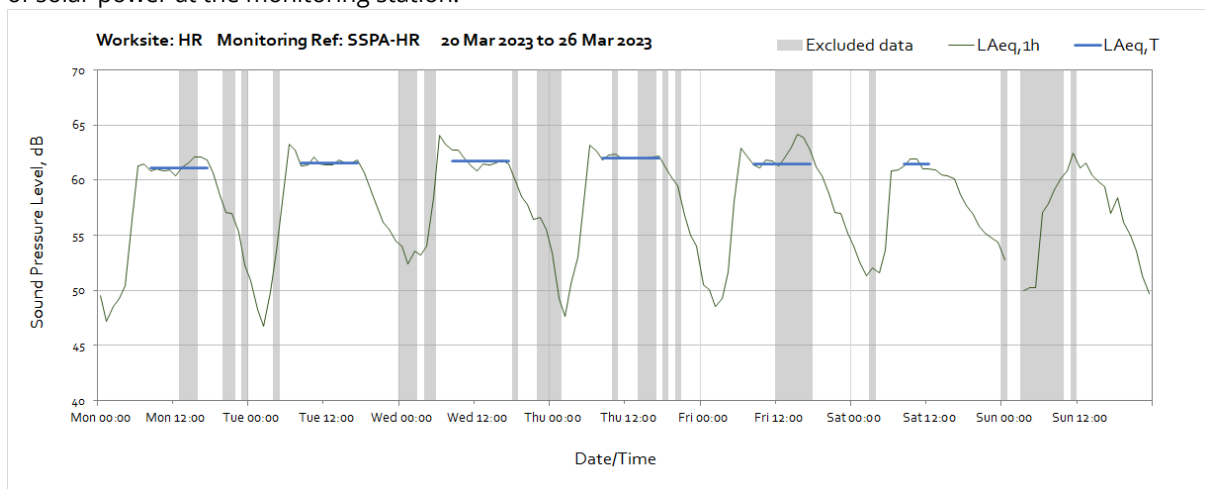
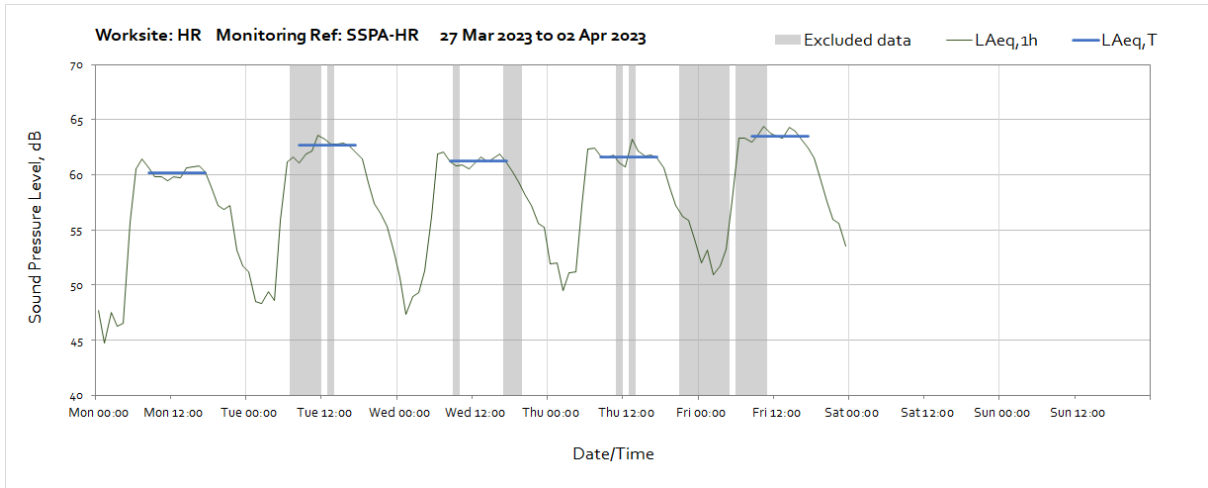
## Worksite: HR – Monitoring Ref: SSPA-HR

Note: Missing data between 10:00 on Saturday 4<sup>th</sup> March and 13:00 on Tuesday 14<sup>th</sup> March was due to loss of solar power at the monitoring station.

Note: Missing data between 01:00 and 03:00 on Sunday 26<sup>th</sup> March was due to a monitor time adjustment at the start of British Summer Time.

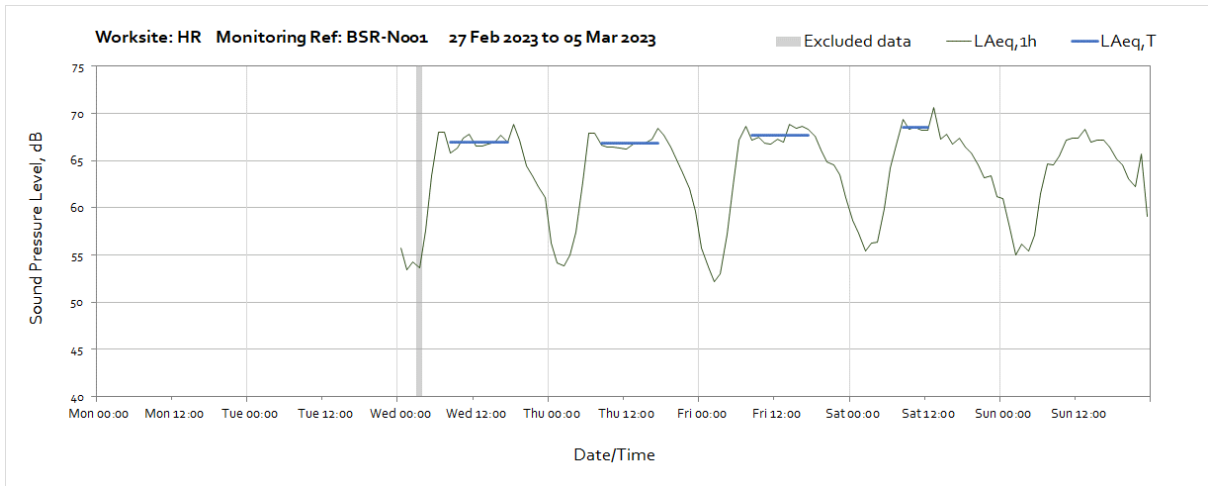
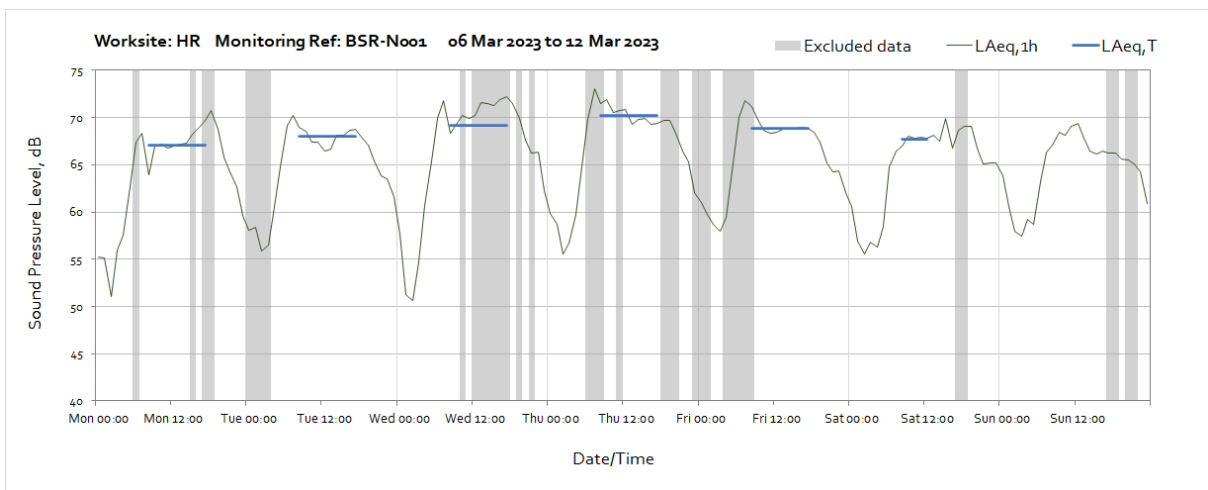
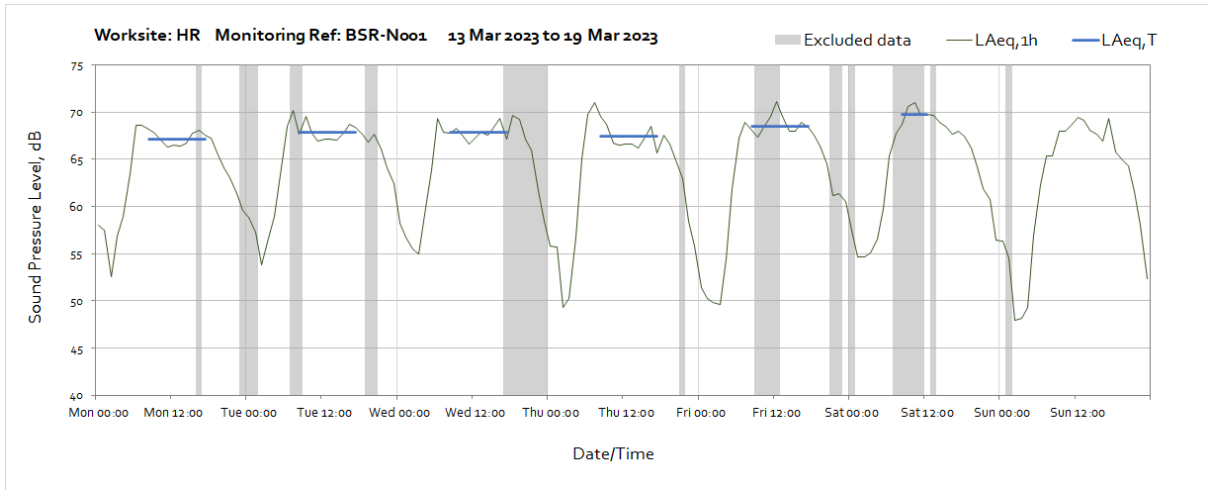
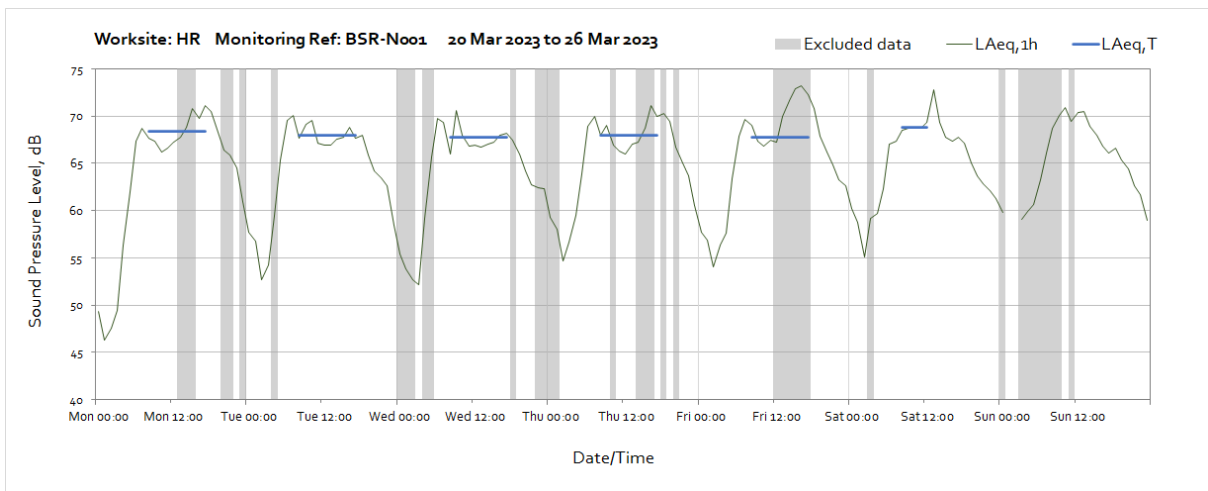
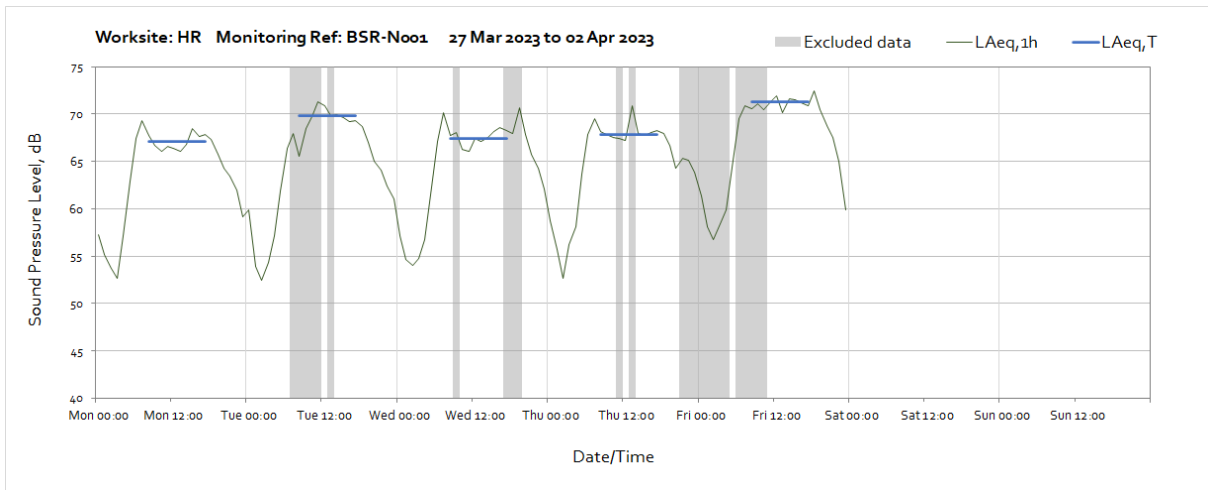
**Worksite: HR - Monitoring Ref: BSR-N001**

Note: Missing data between 01:00 and 03:00 on Sunday 26<sup>th</sup> March was due to a monitor time adjustment at the start of British Summer Time.

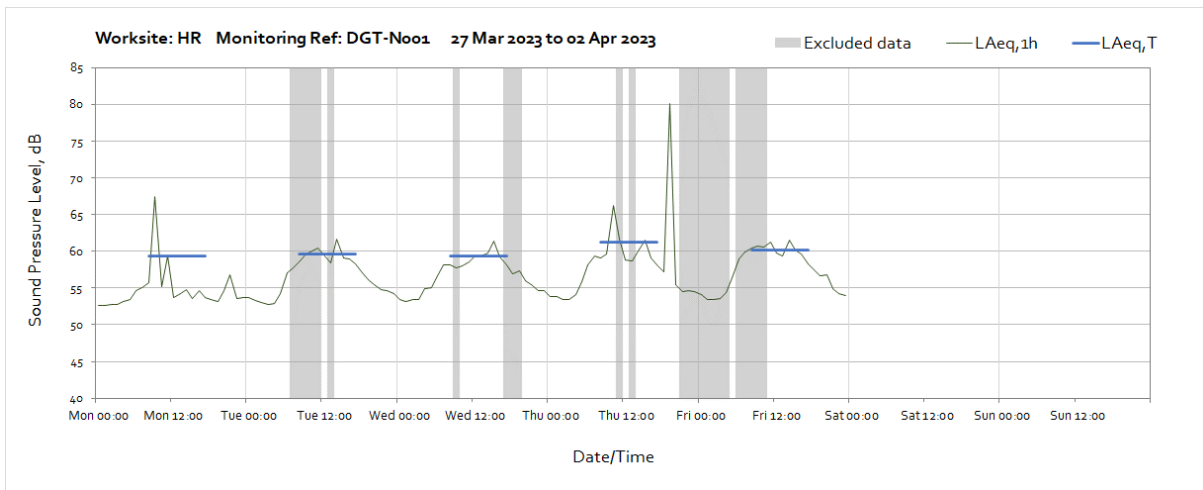
## Worksite: HR – Monitoring Ref: DGT-N001

Note: Missing data between 01:00 and 03:00 on Sunday 26<sup>th</sup> March was due to a monitor time adjustment at the start of British Summer Time.

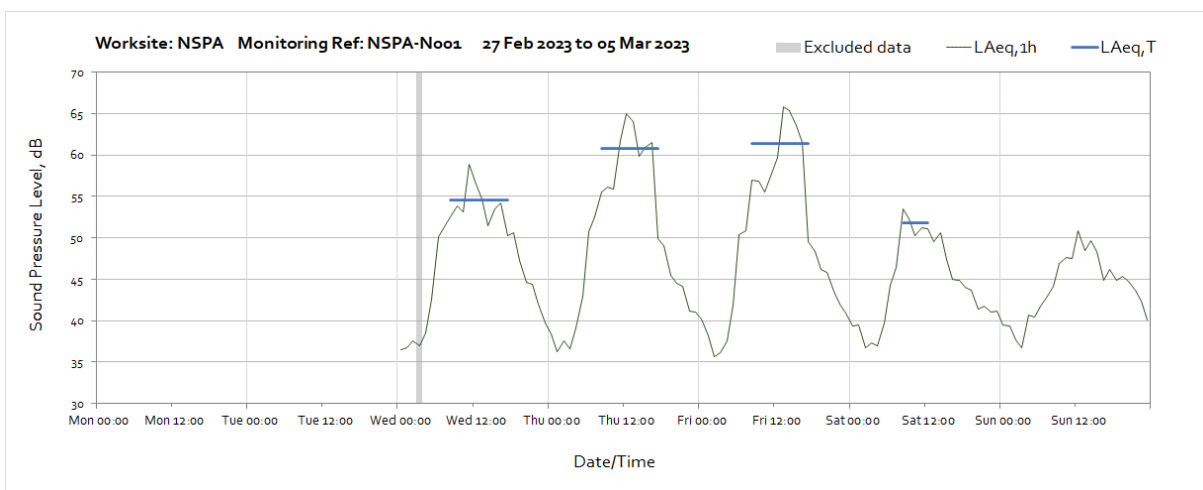
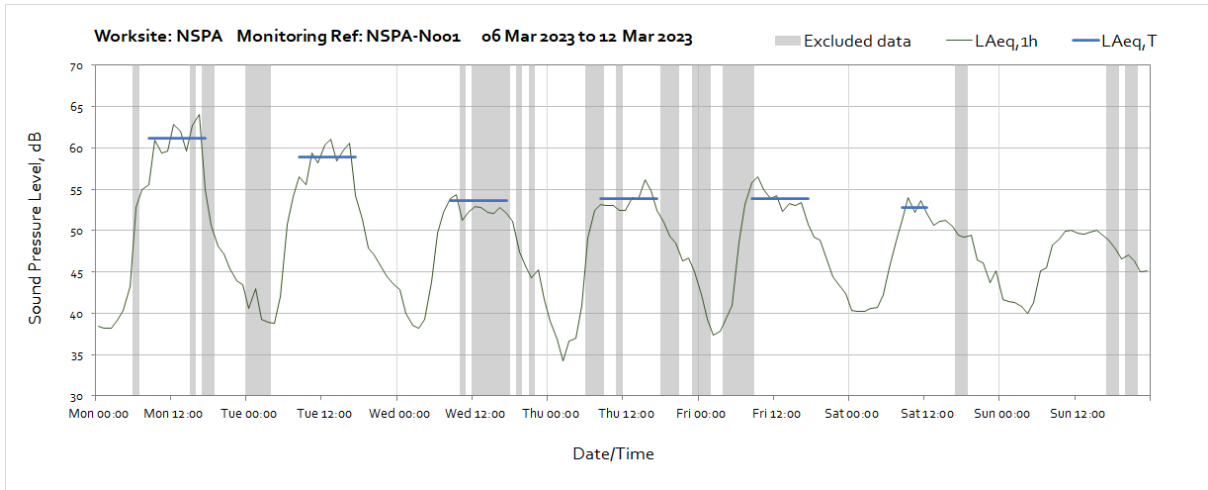
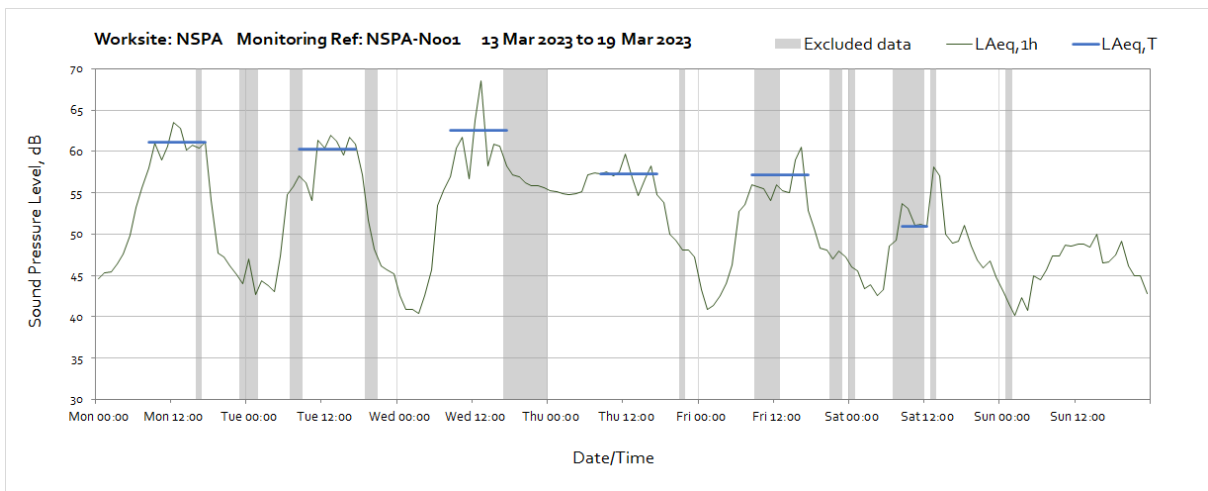
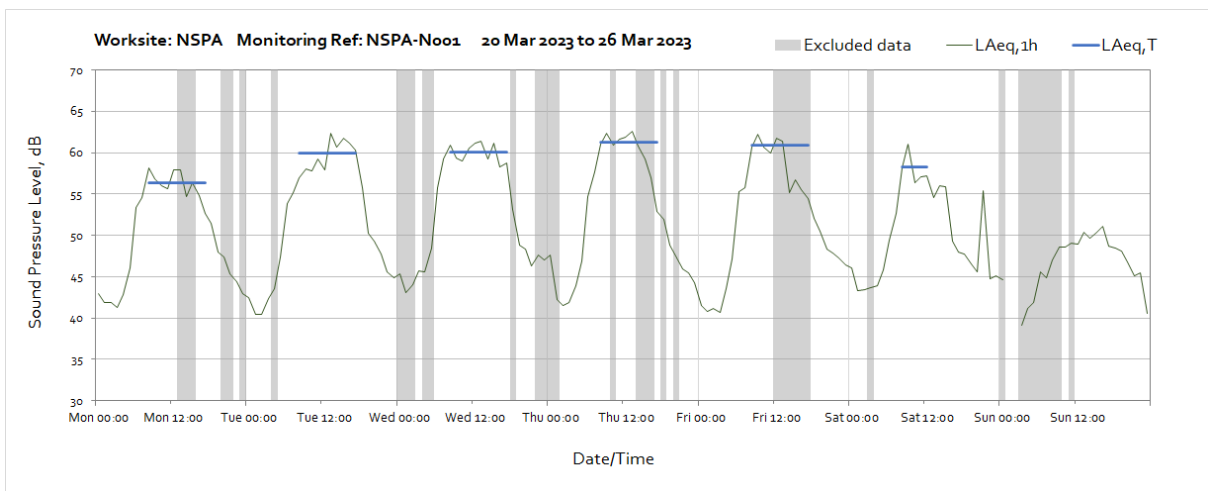
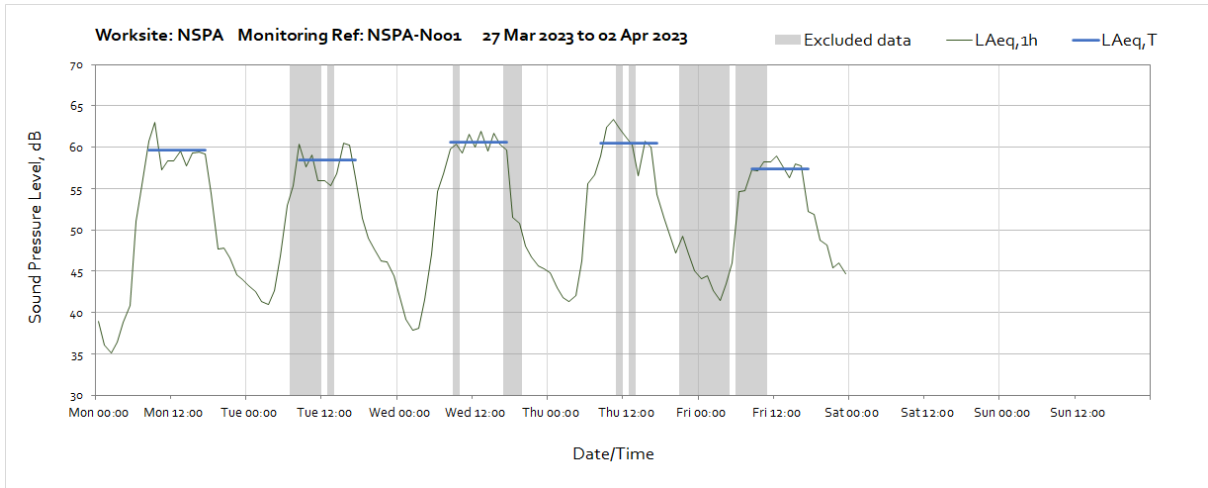
### Worksite: NSPA - Monitoring Ref: NSPA-N001

Note: Missing data between 01:00 and 03:00 on Sunday 26<sup>th</sup> March was due to a monitor time adjustment at the start of British Summer Time.

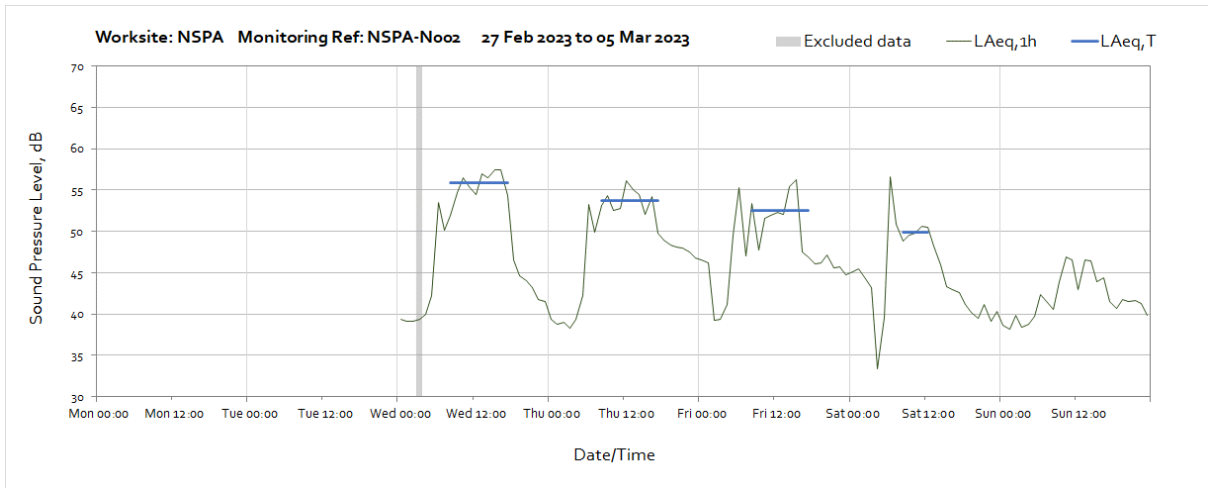
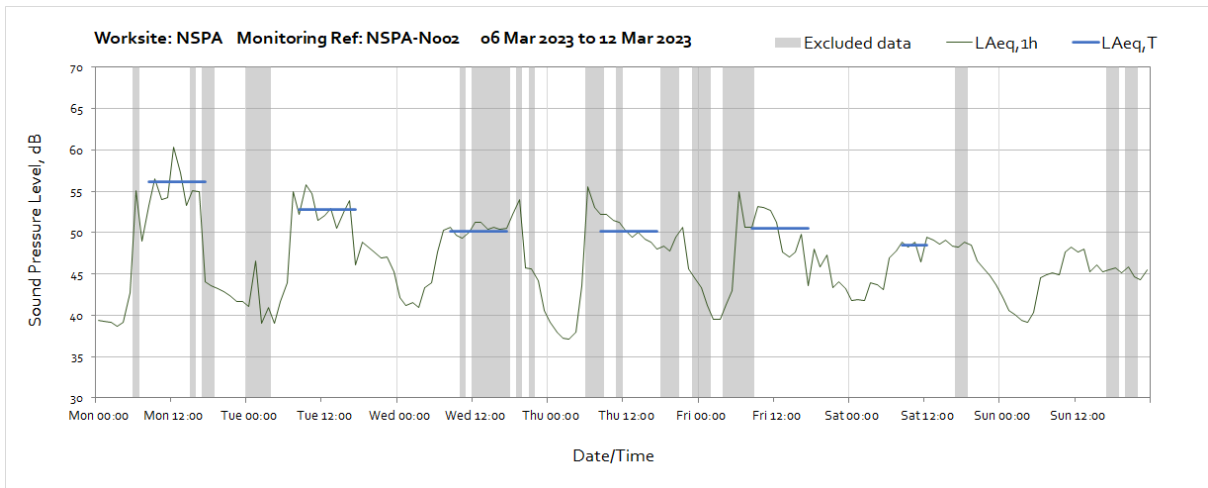
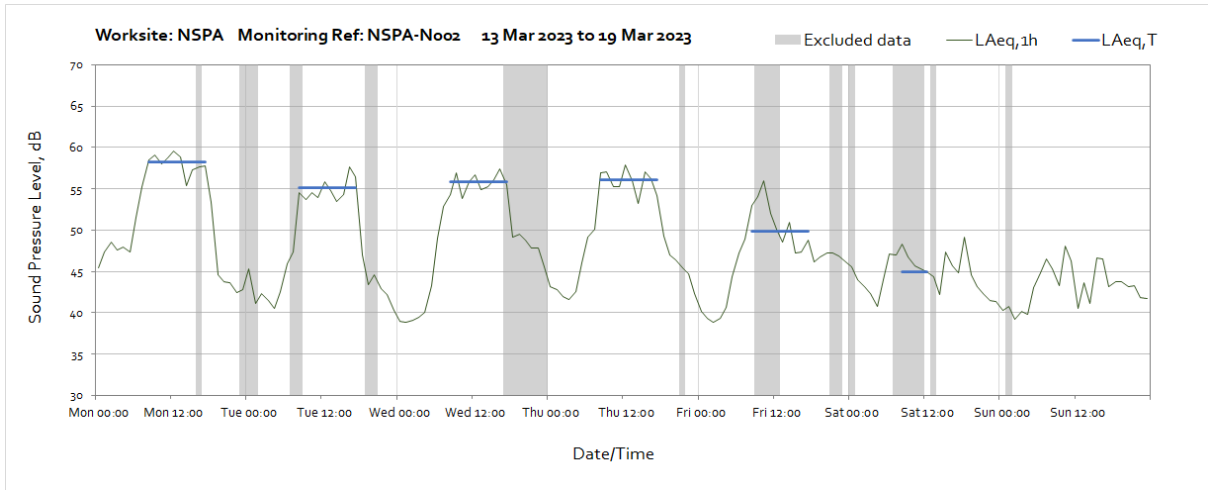
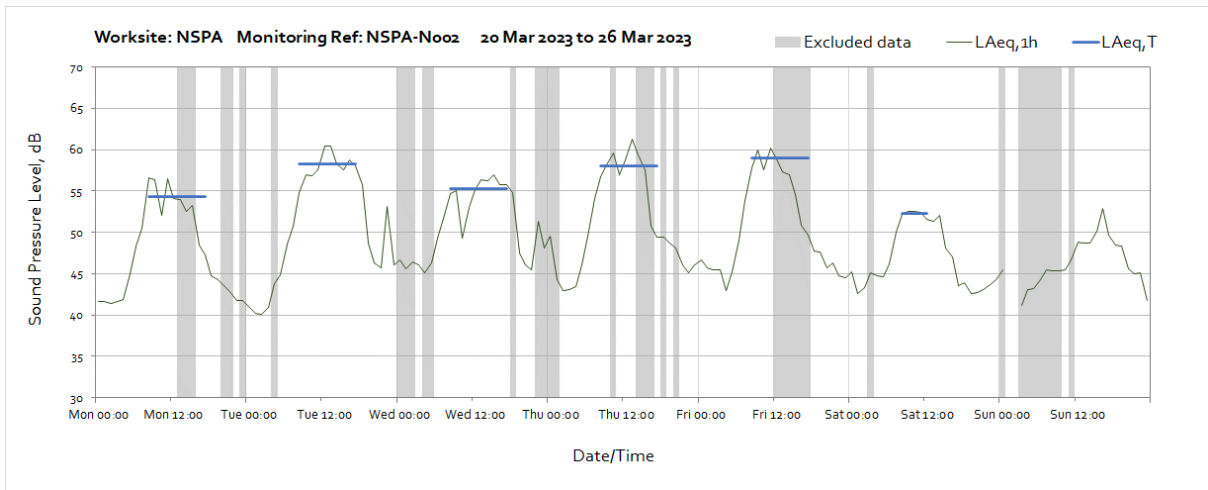
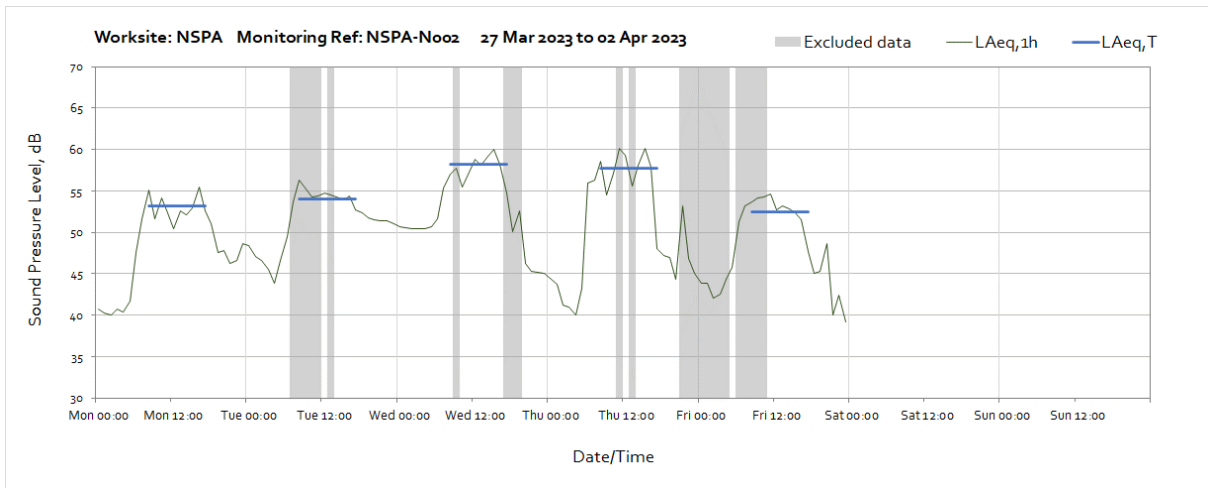
**Worksite: NSPA – Monitoring Ref: NSPA-N002**

Note: Missing data between 01:00 and 03:00 on Sunday 26<sup>th</sup> March was due to a monitor time adjustment at the start of British Summer Time.

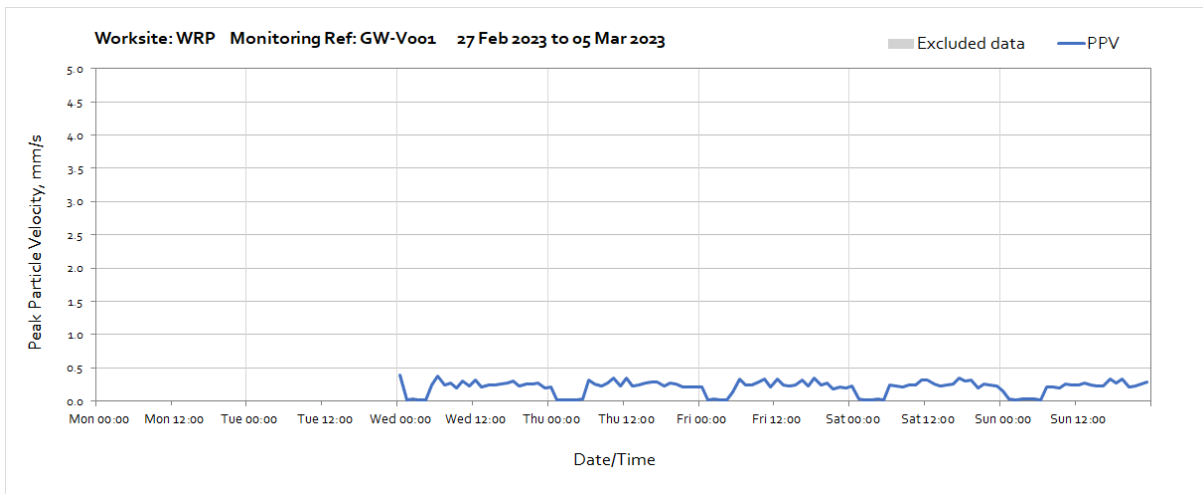
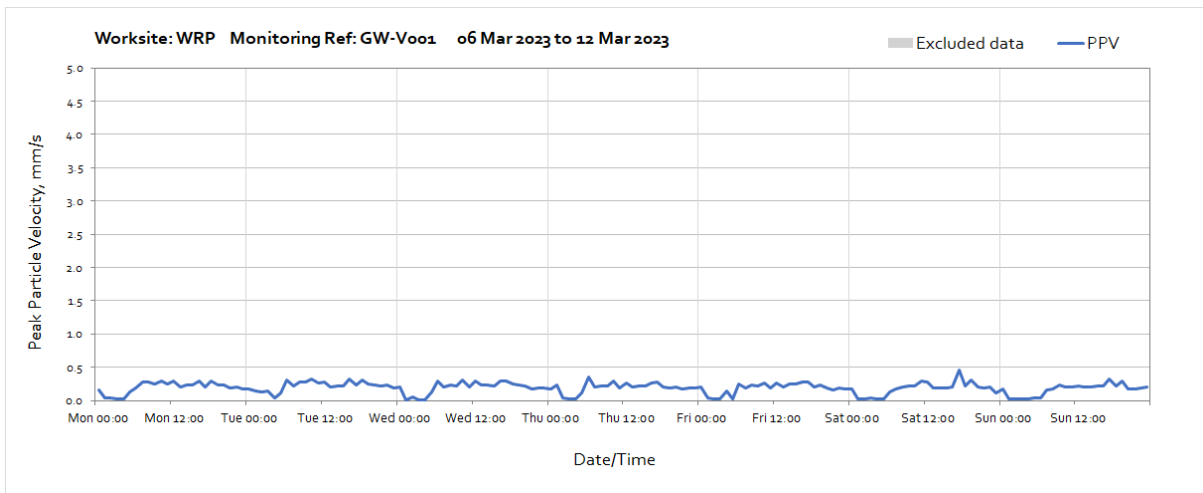
## Worksite: WRP – Monitoring Ref: GW-V001

The following graphs show the hourly measured peak particle velocity PPV recorded during the monitoring period. The graphs show the highest PPV of the three orthogonal axis x, y and z. Where high values of PPV were caused by local interference with the vibration monitor, which are not representative of HS2 construction works, these values have been greyed out in the following charts and have been excluded to calculate values in Table 4 of the main report.
