Construction Noise and Vibration Monthly Report – March 2023

Stratford-on-Avon District Council

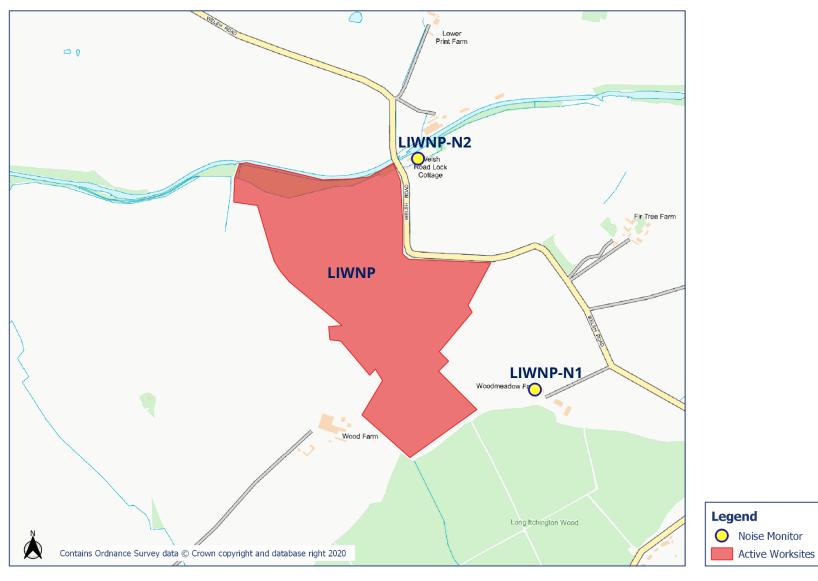
HS2 Noise and Vibration Monitoring Plan - 1

- 1.2.1 Six (6) noise and one (1) vibration monitoring installation were active in March 2023 in the SADC area.
- 1.2.2 Table 2 summarises the position of noise and vibration monitoring installations within the SADC area in March 2023.
- 1.2.3 Maps showing the position of noise monitoring installations are presented in Appendix B.

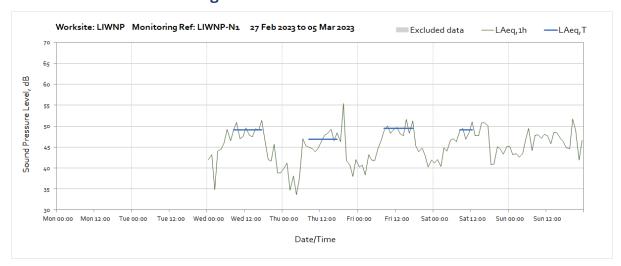
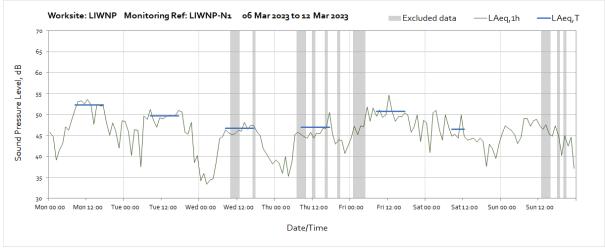
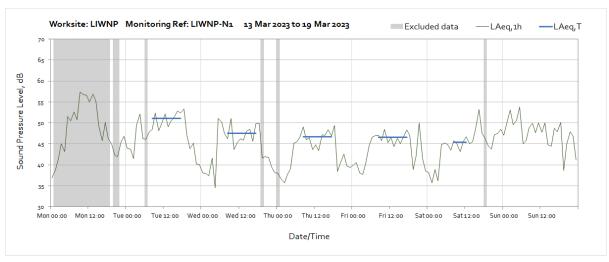
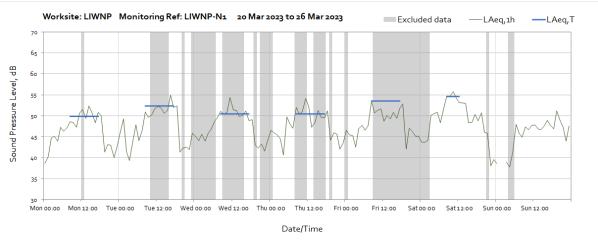
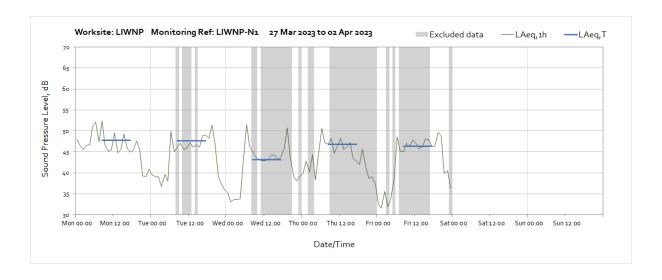
Worksite: LIWNP Monitoring Ref: LIWNP-N1

The following graphs show the hourly measured ambient noise level $L_{Aeq,1h}$ and, where relevant, the averaged noise level $L_{Aeq,T}$ values, where the time period T is as specified in Table 1 of HS2 Information Paper E23. Periods with adversely weather affected noise levels are greyed out and have been excluded from the calculation of the $L_{Aeq,T}$ values in Table 3 of the main report.

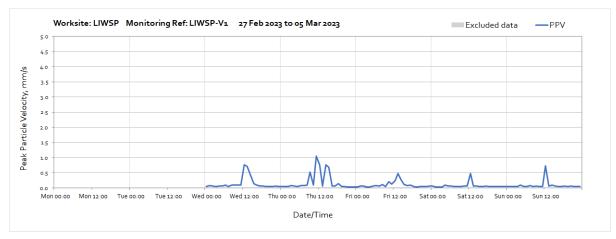
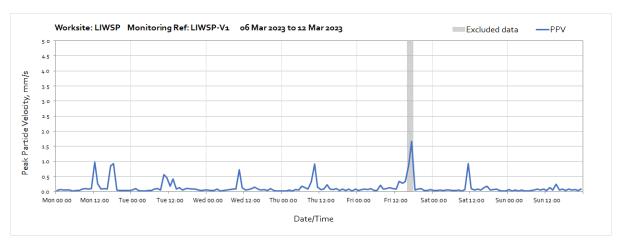
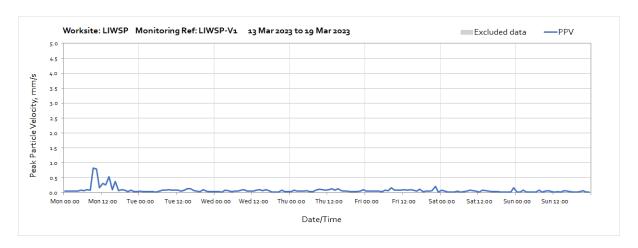
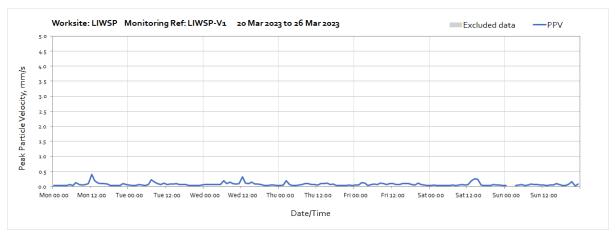
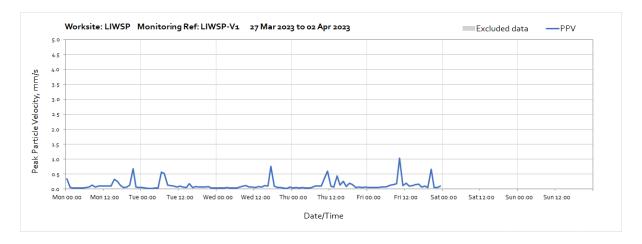
Worksite: LIWSP Monitoring Ref: LIWSP-V1

The following graphs show the hourly measured peak particle velocity PPV recorded during the monitoring period. The graphs show the highest PPV of the three orthogonal axes x, y and z. Where high values of PPV were caused by local interference with the vibration monitor, which are not representative of HS2 construction works, these values have been greyed out in the following charts and have been excluded to calculate values in Table 4 of the main report.
