Construction Noise and Vibration Monthly Report – May 2023

Stratford-on-Avon District Council

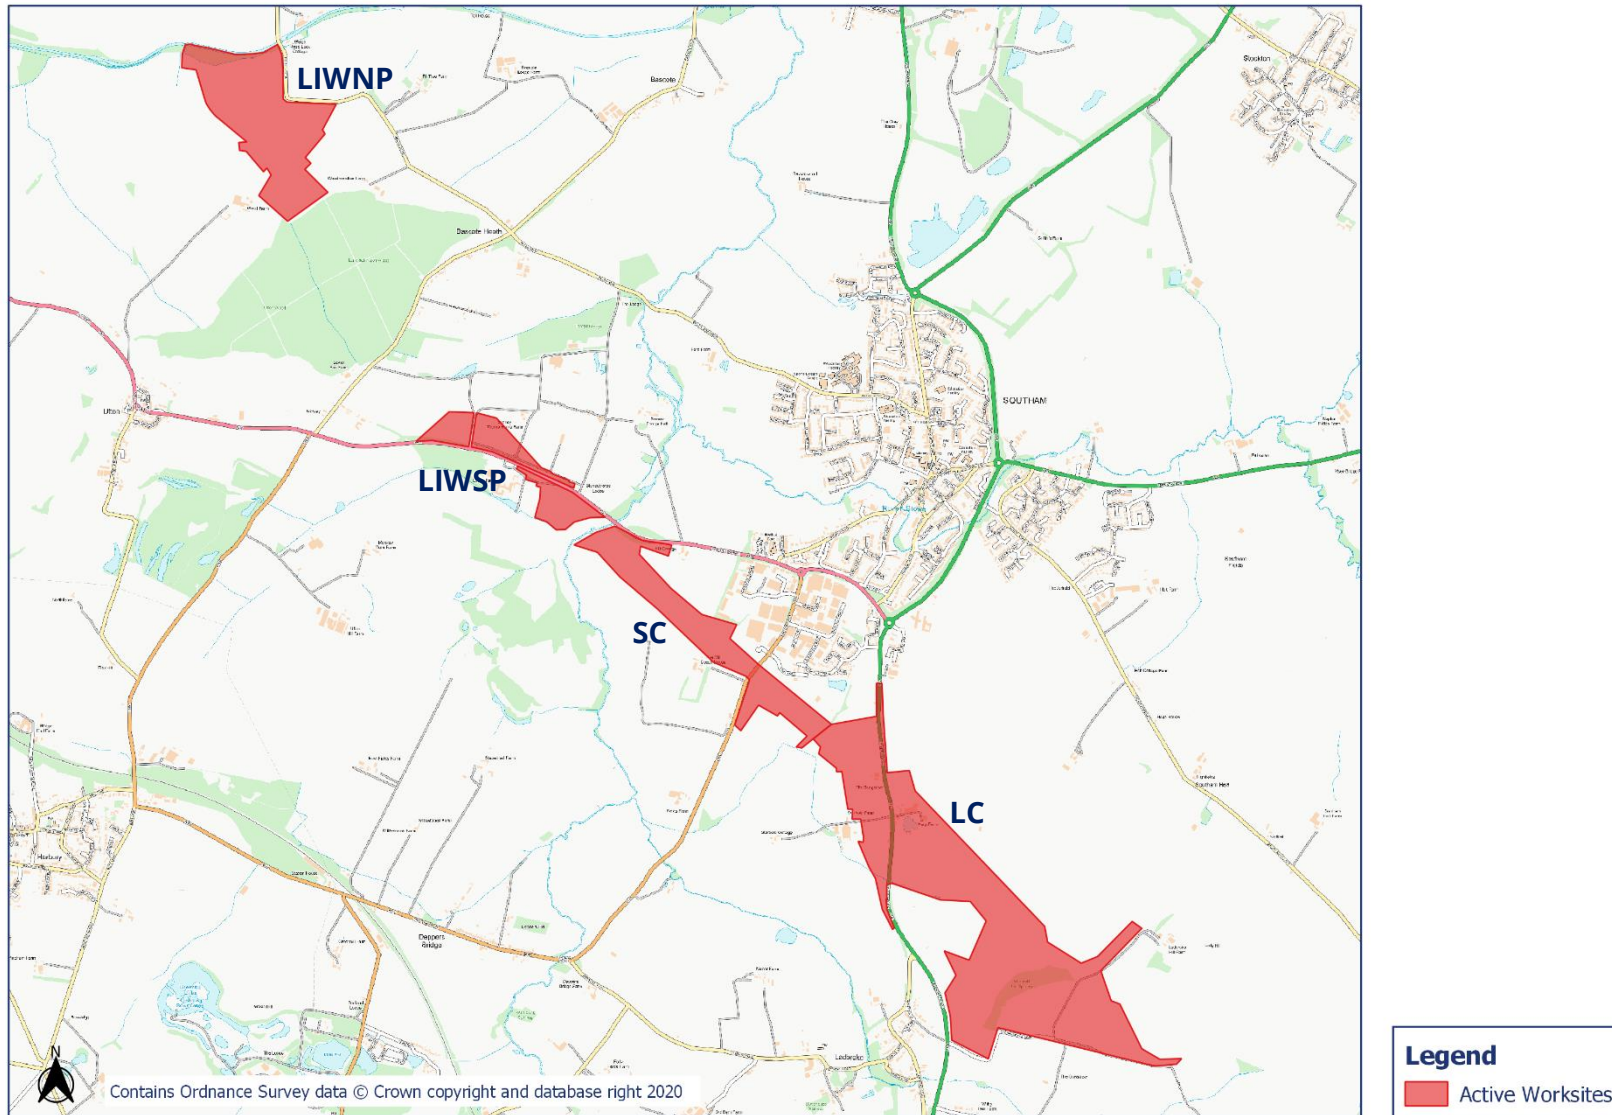
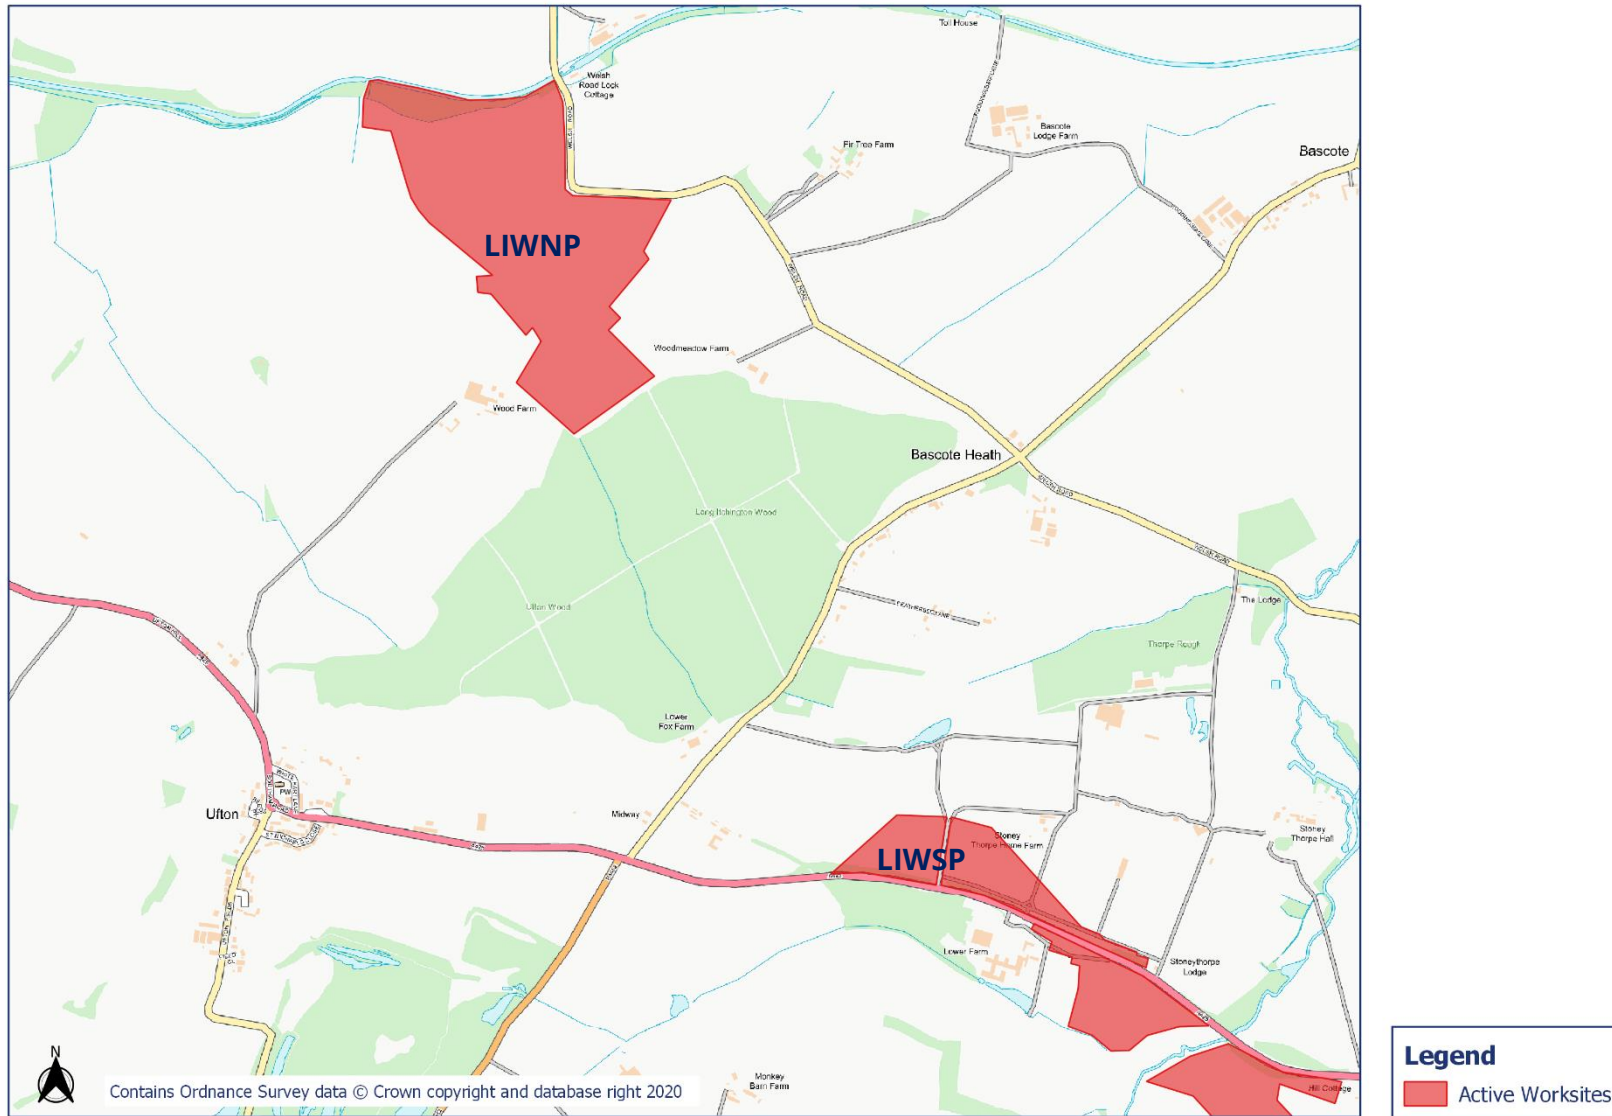
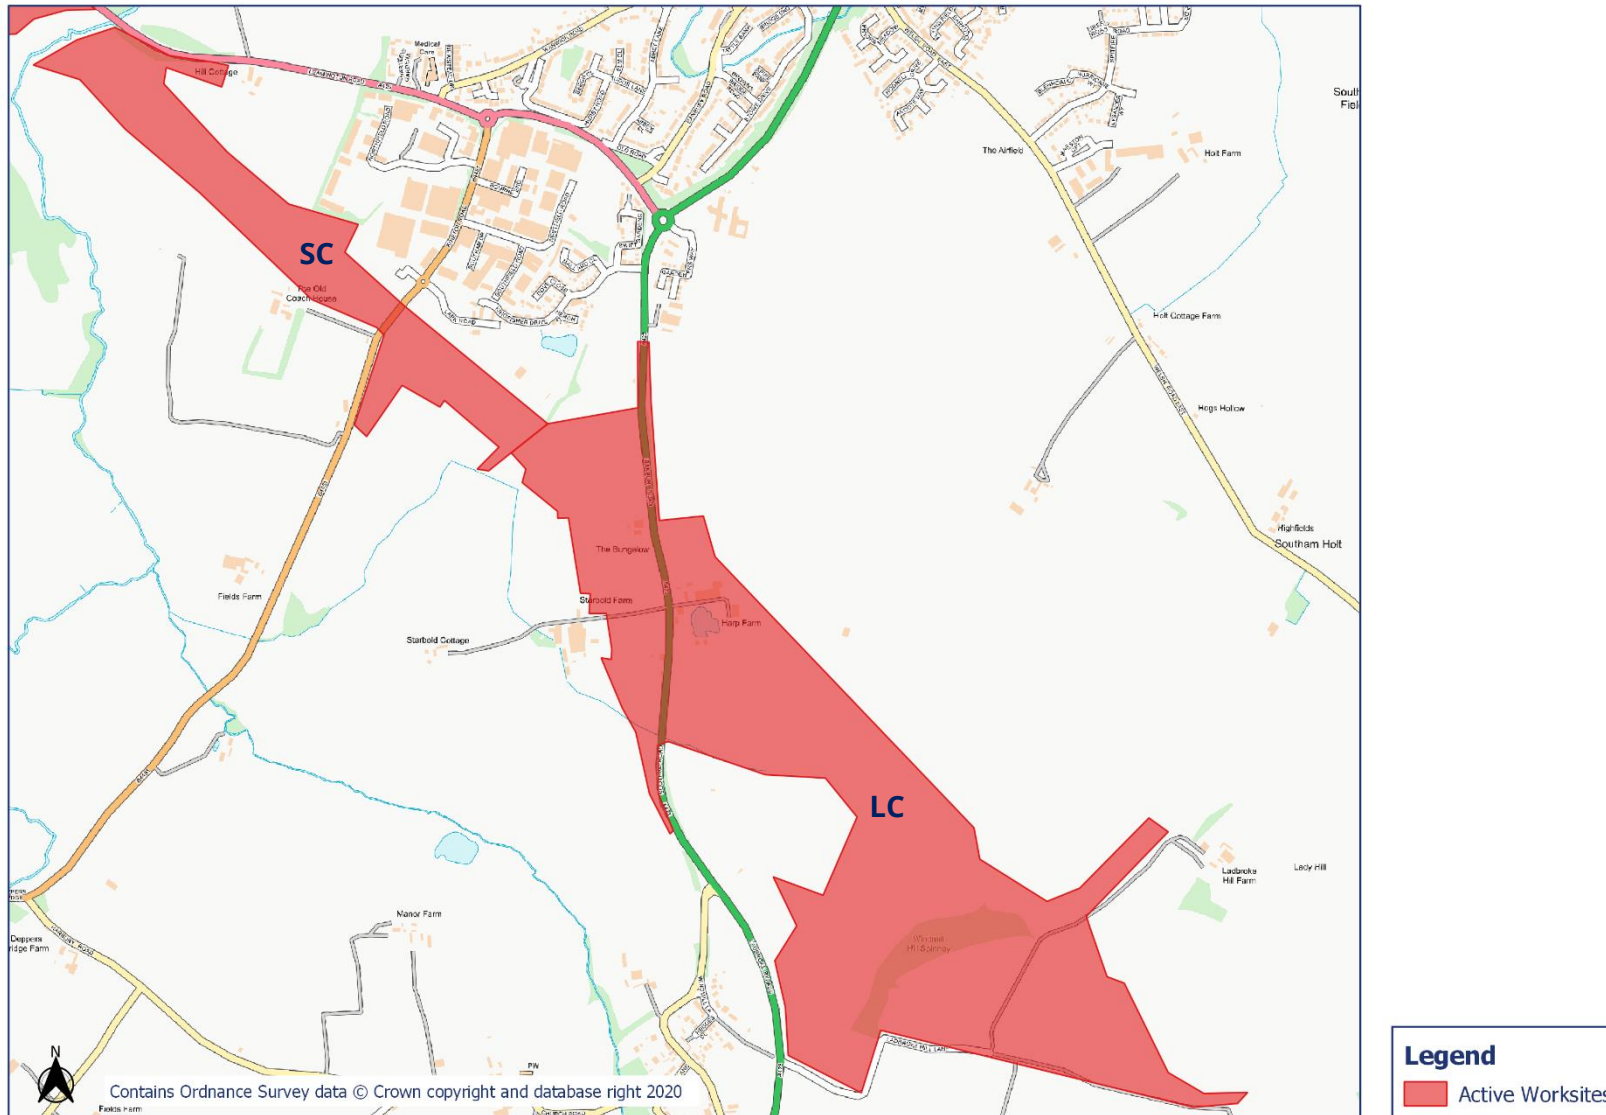
Appendix A Site Locations

Worksite Identification Plan - Overview

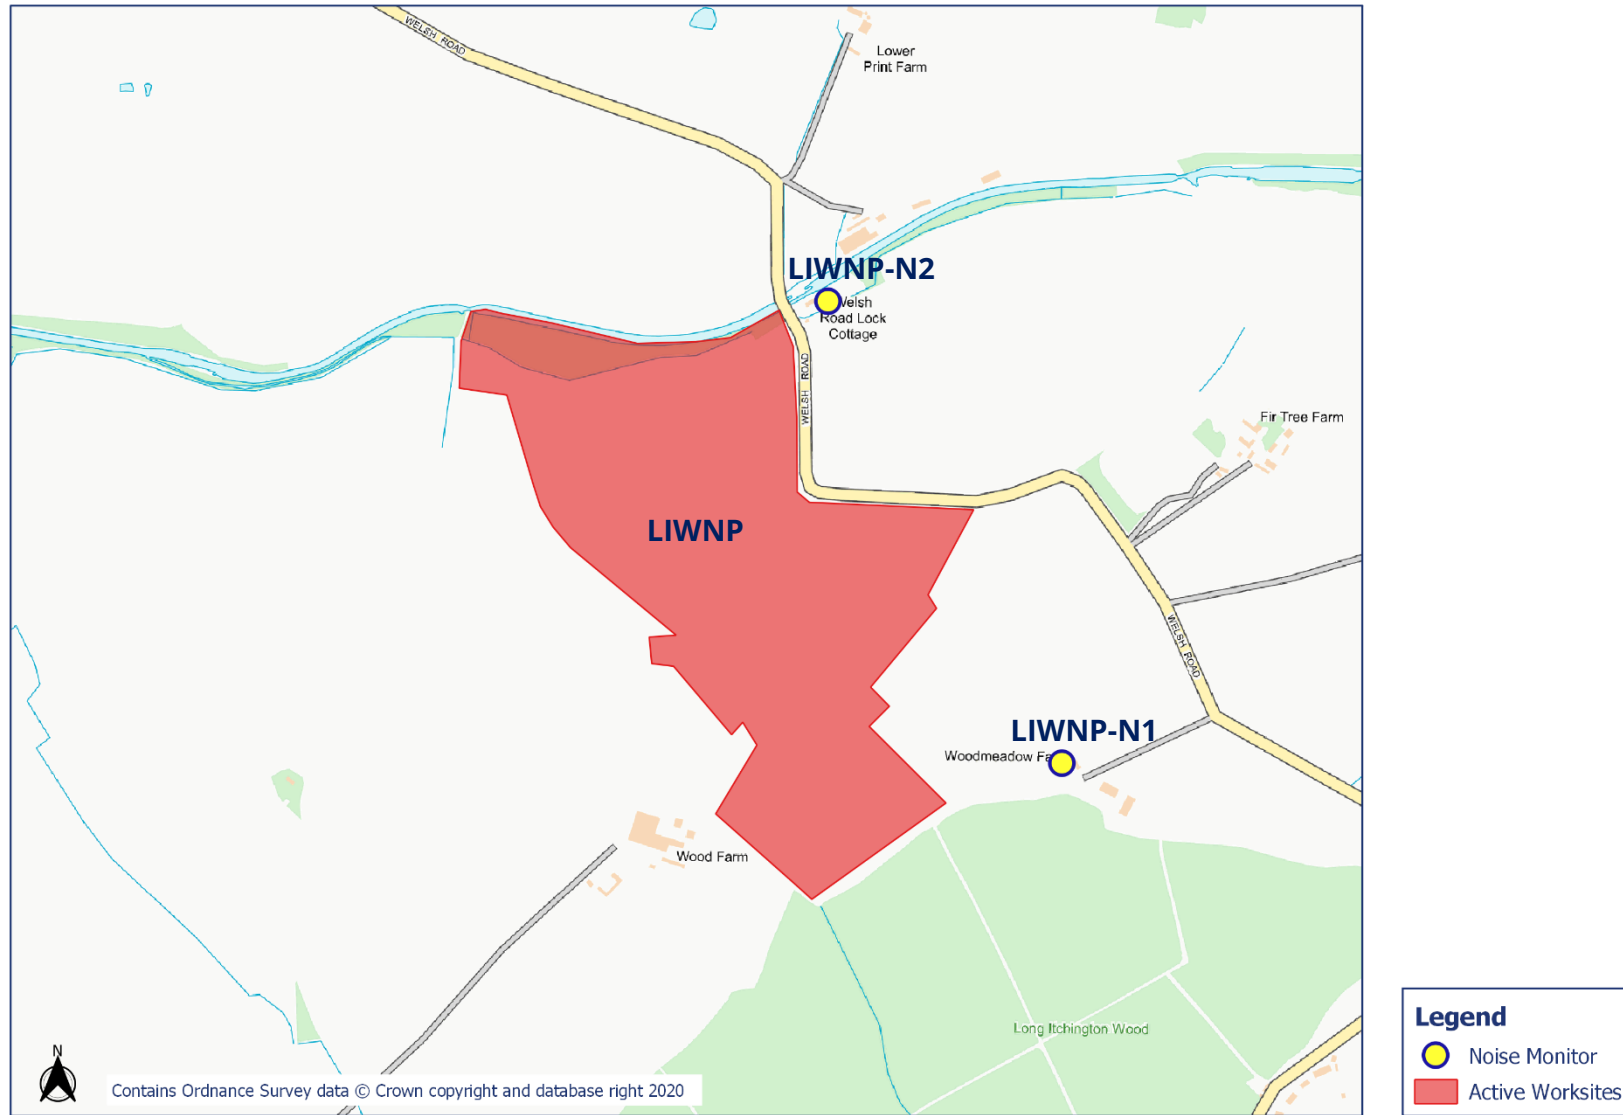
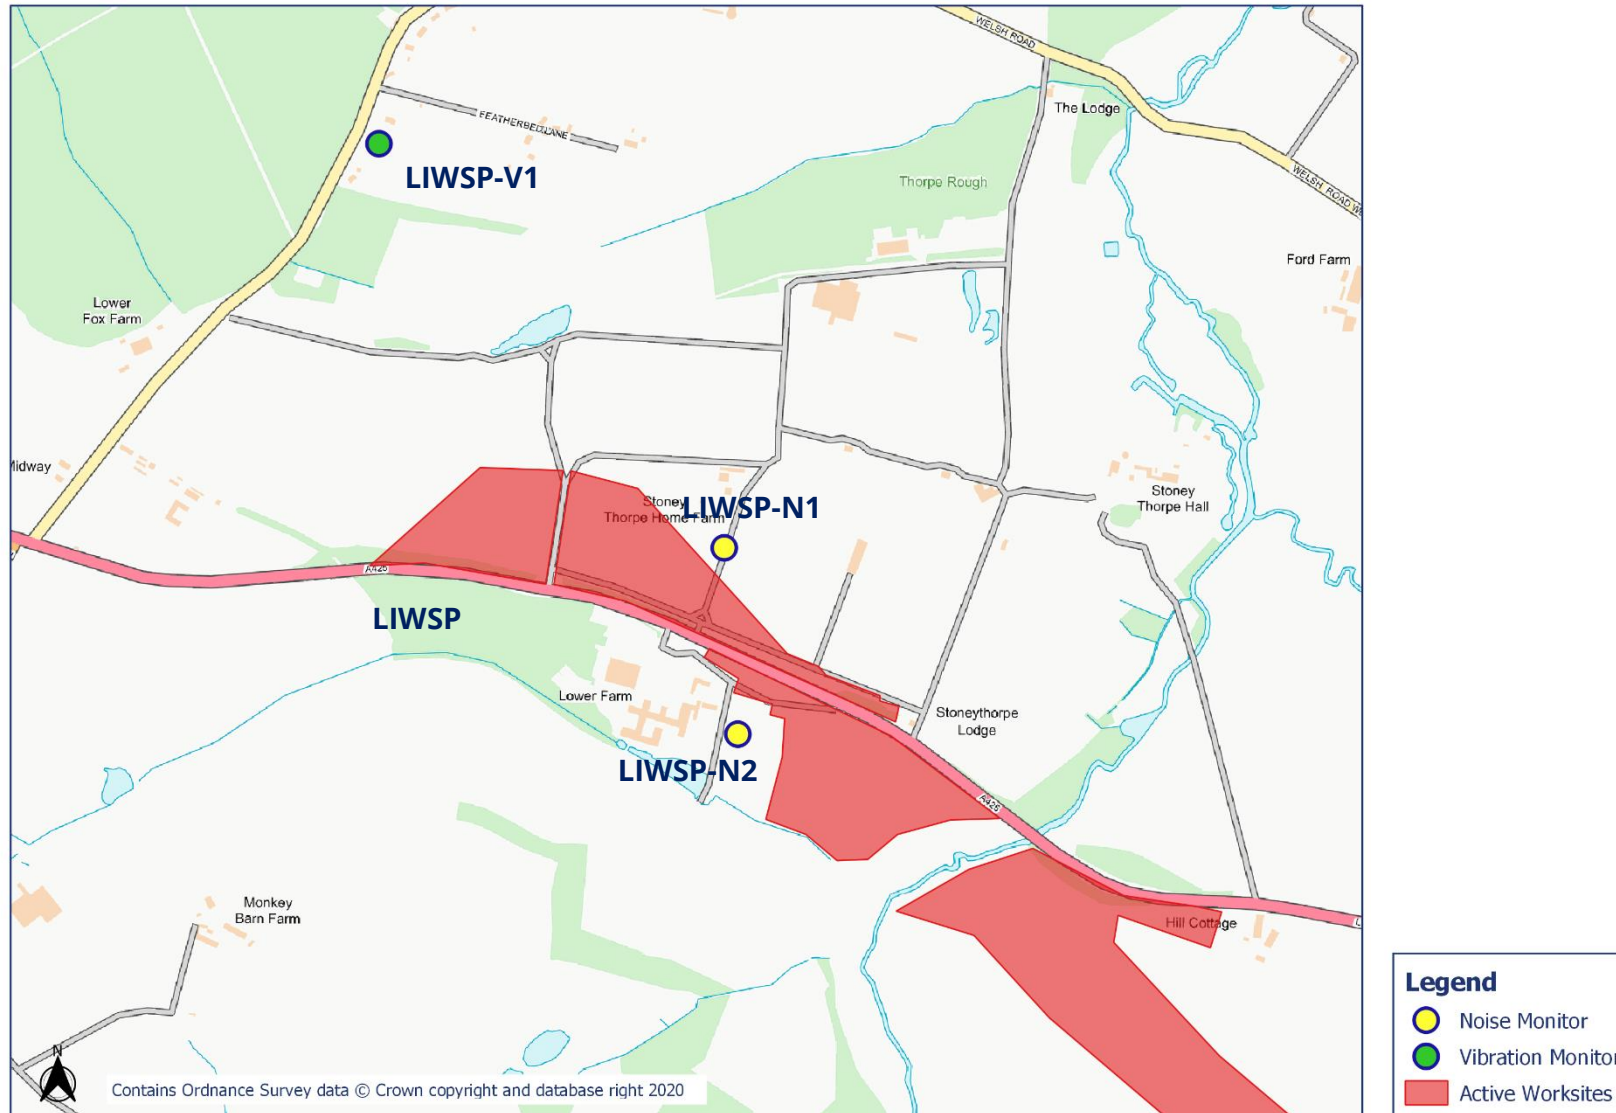
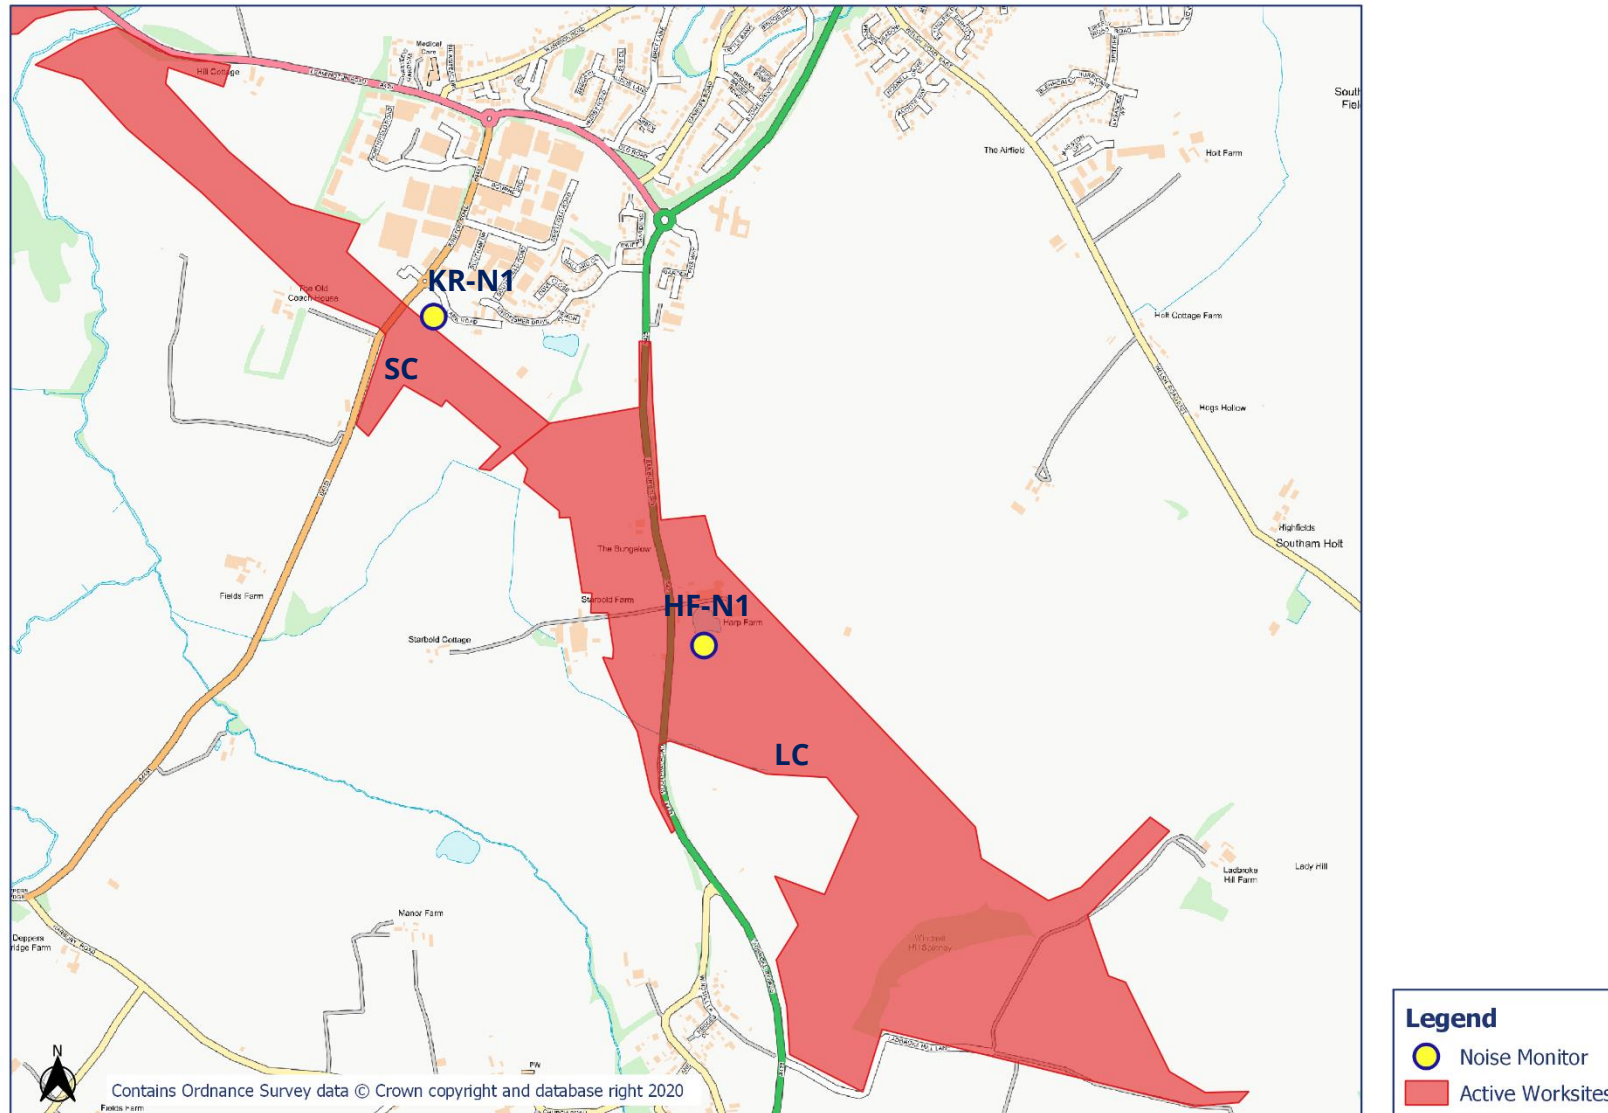
Appendix B Monitoring Locations

- 1.2.1 Six (6) noise and one (1) vibration monitoring installation were active in May 2023 in the SADC area.
- 1.2.2 Table 2 summarises the position of noise and vibration monitoring installations within the SADC area in May 2023.
- 1.2.3 Maps showing the position of noise monitoring installations are presented in Appendix B.

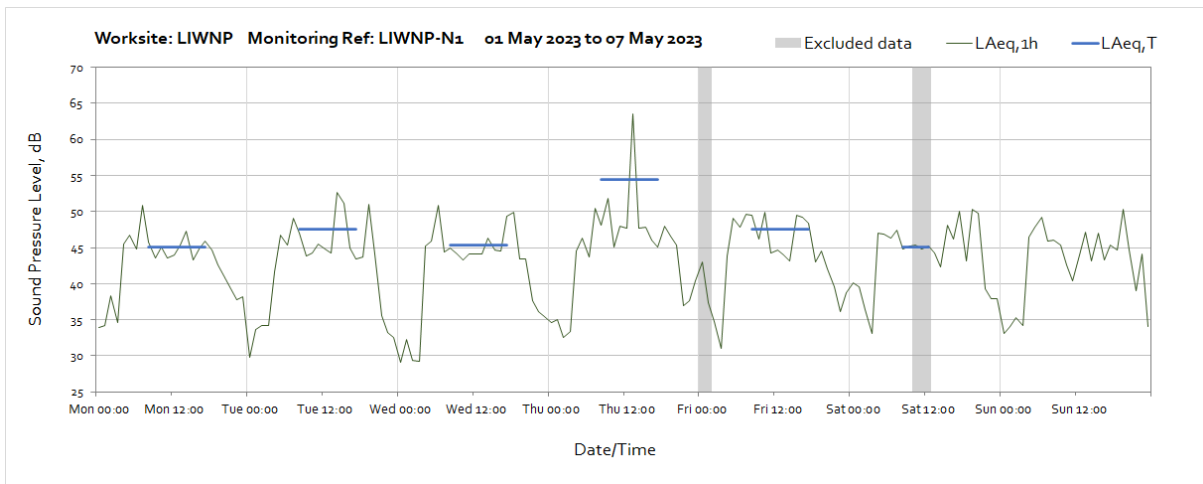
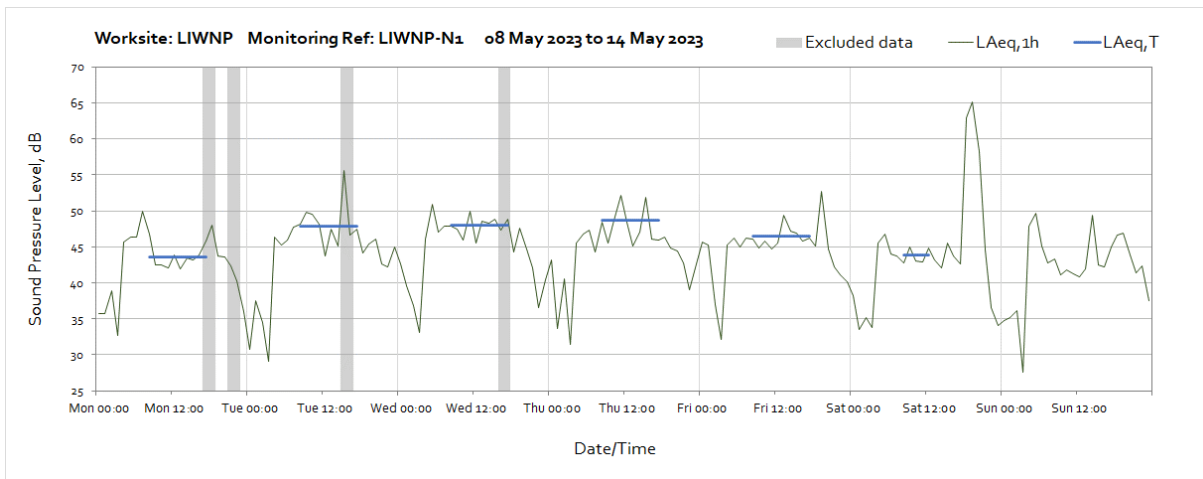
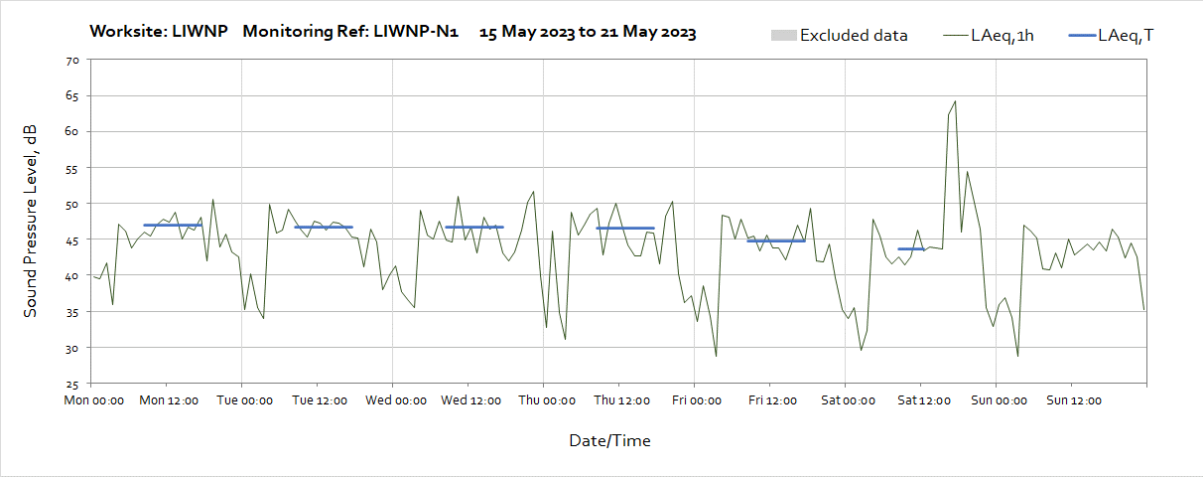
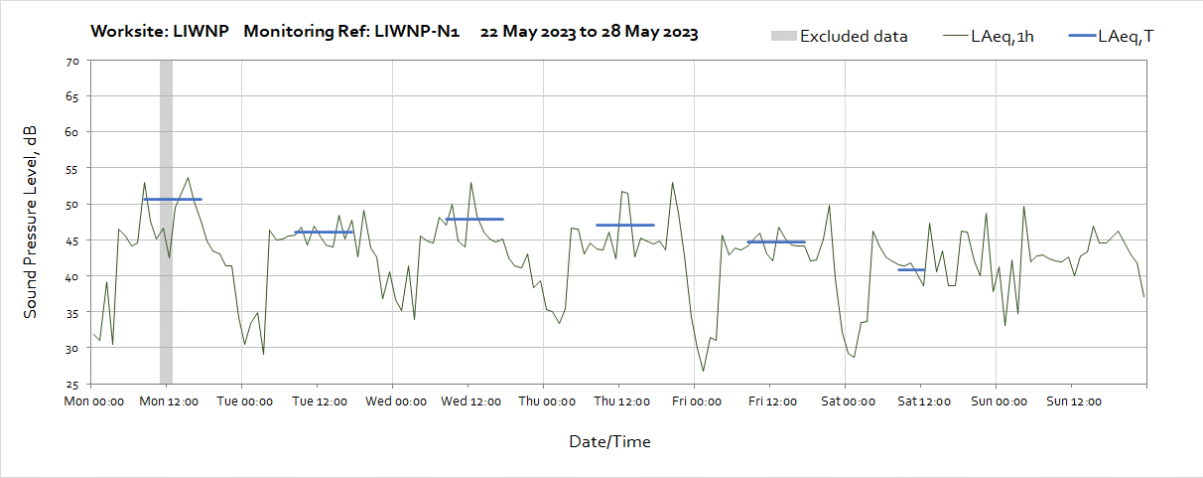
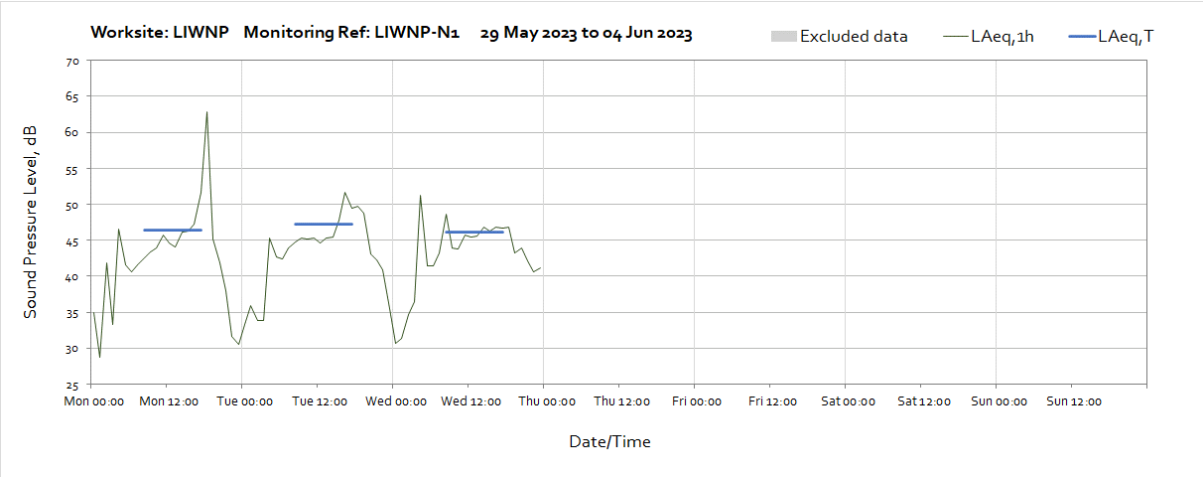
Worksite: LIWNP Monitoring Ref: LIWNP-N1

The following graphs show the hourly measured ambient noise level $L_{Aeq,1h}$ and, where relevant, the averaged noise level $L_{Aeq,T}$ values, where the time period T is as specified in Table 1 of HS2 Information Paper E23. Periods with adversely weather affected noise levels are greyed out and have been excluded from the calculation of the $L_{Aeq,T}$ values in Table 3 of the main report.

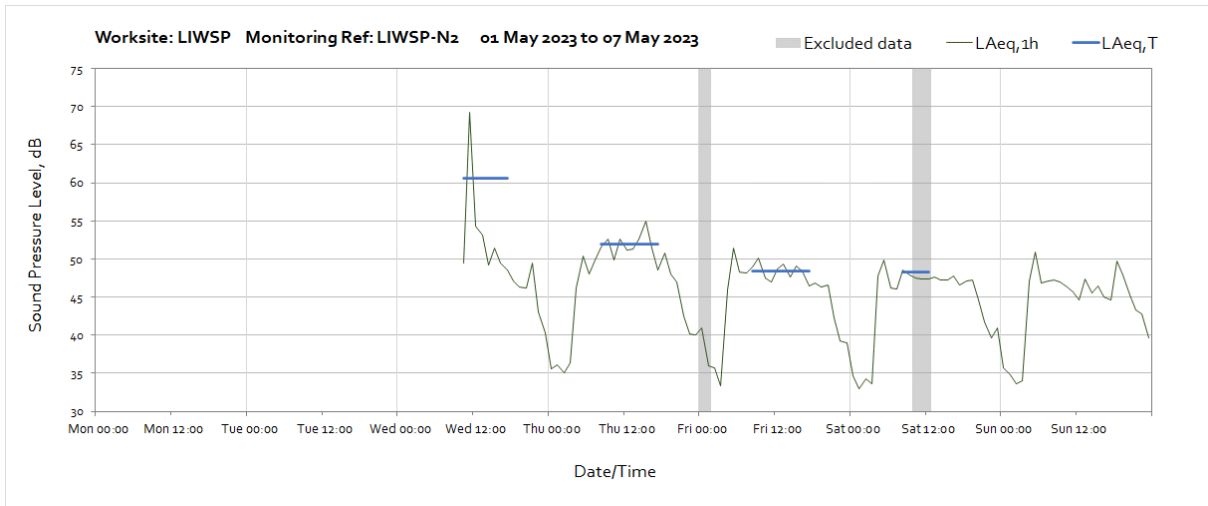
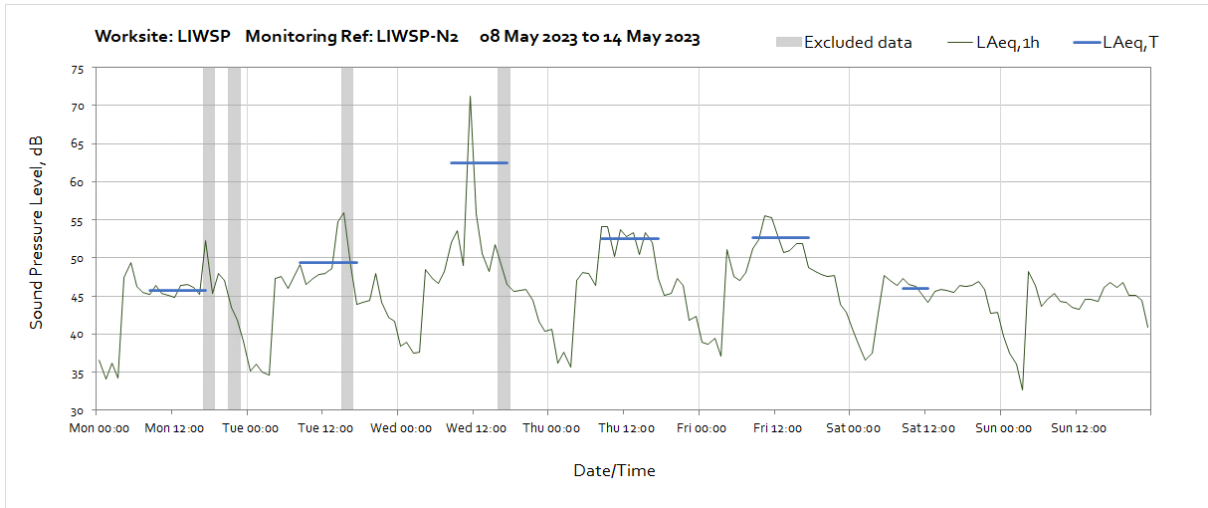
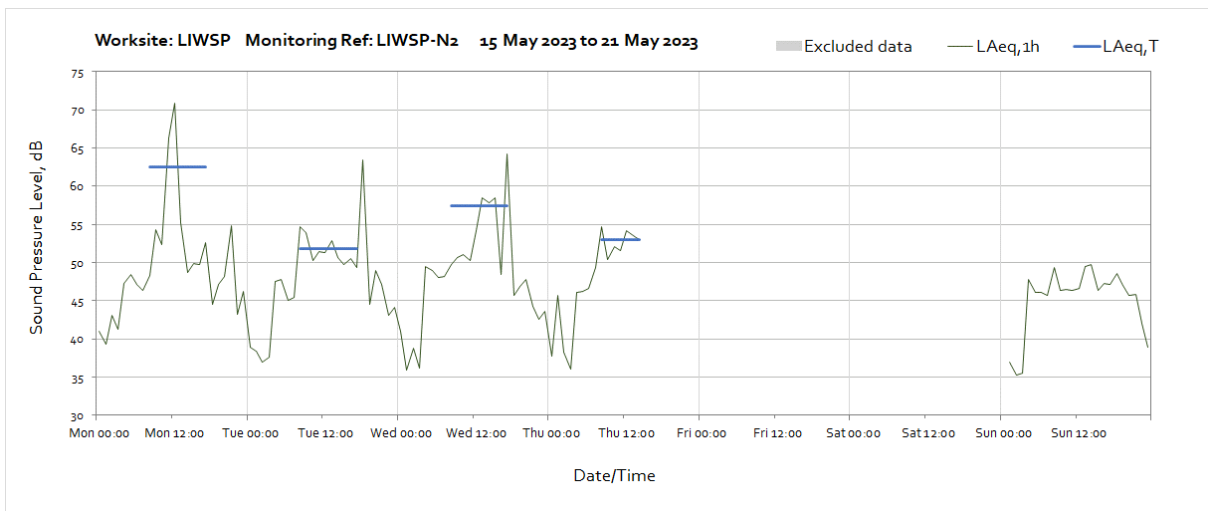
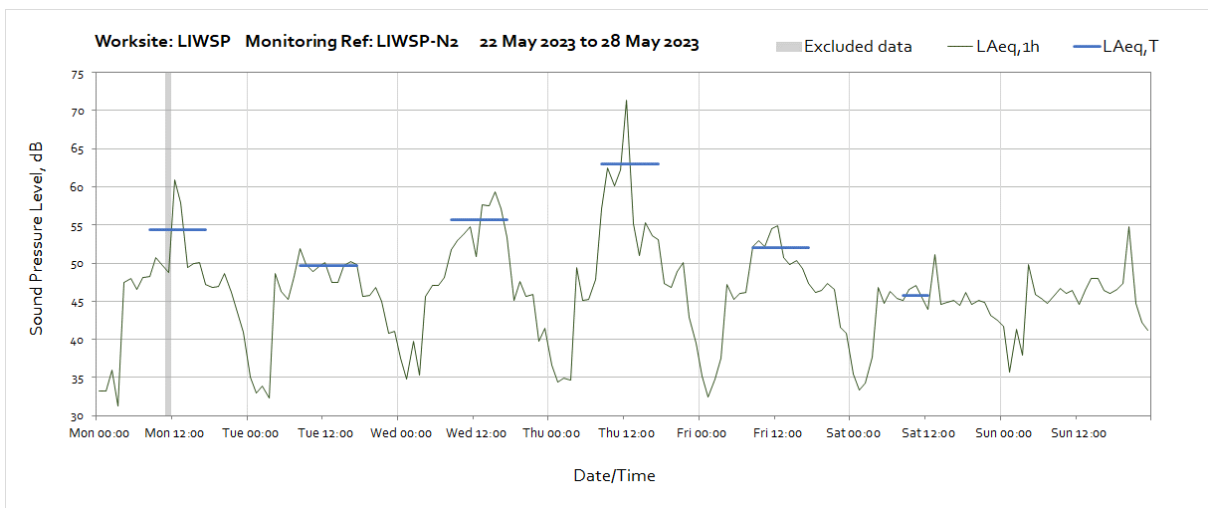
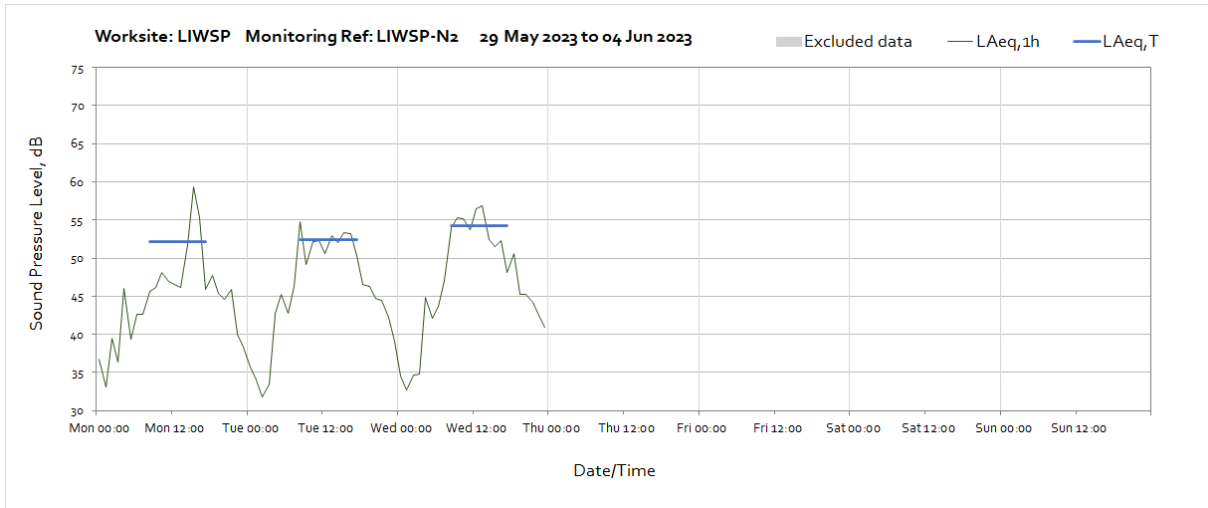
Worksite: LIWSP Monitoring Ref: LIWSP-N2

Note: Missing data between 00:00 Monday 1st and 10:00 Wednesday 3rd May was due to a monitor data storage issue.

Note: Missing data between 15:00 Thursday 18th and 01:00 Sunday 21st May was due to a monitor data storage issue

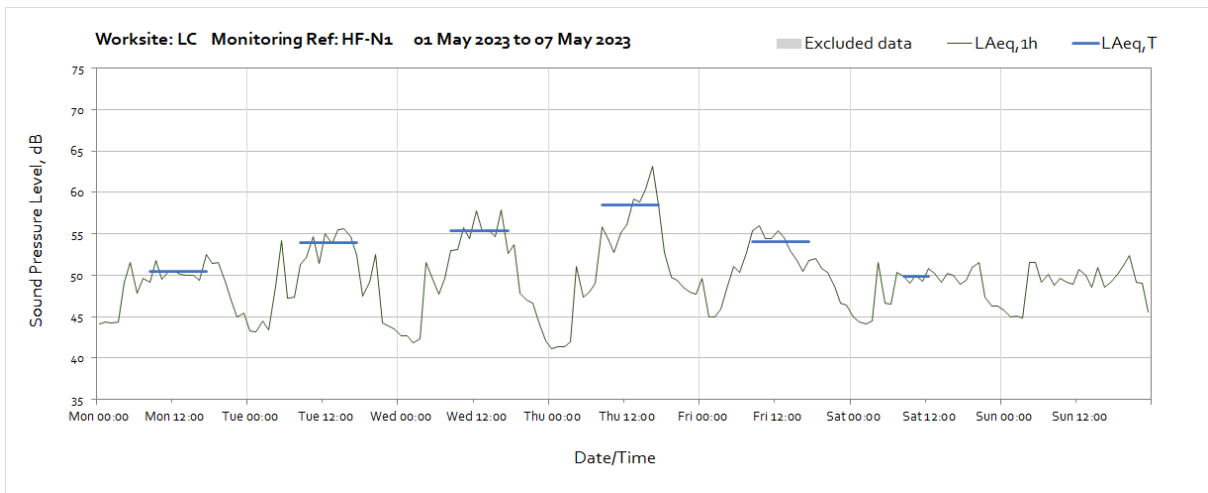
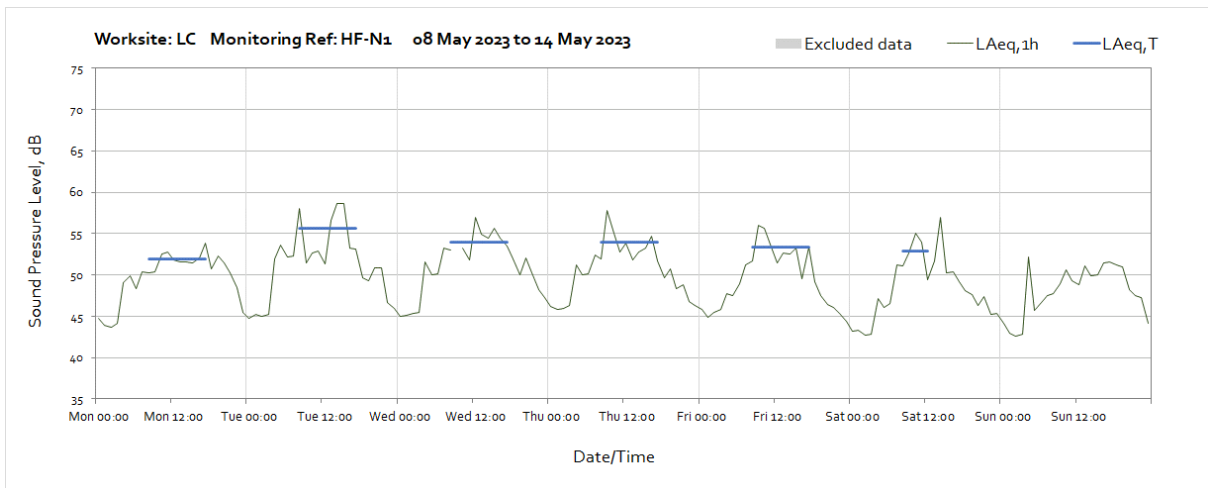
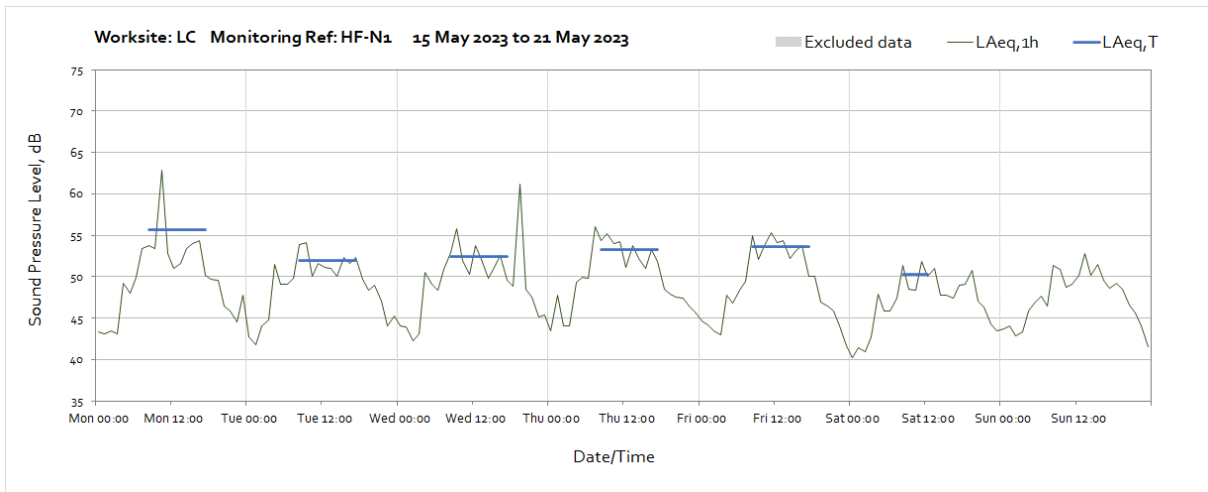
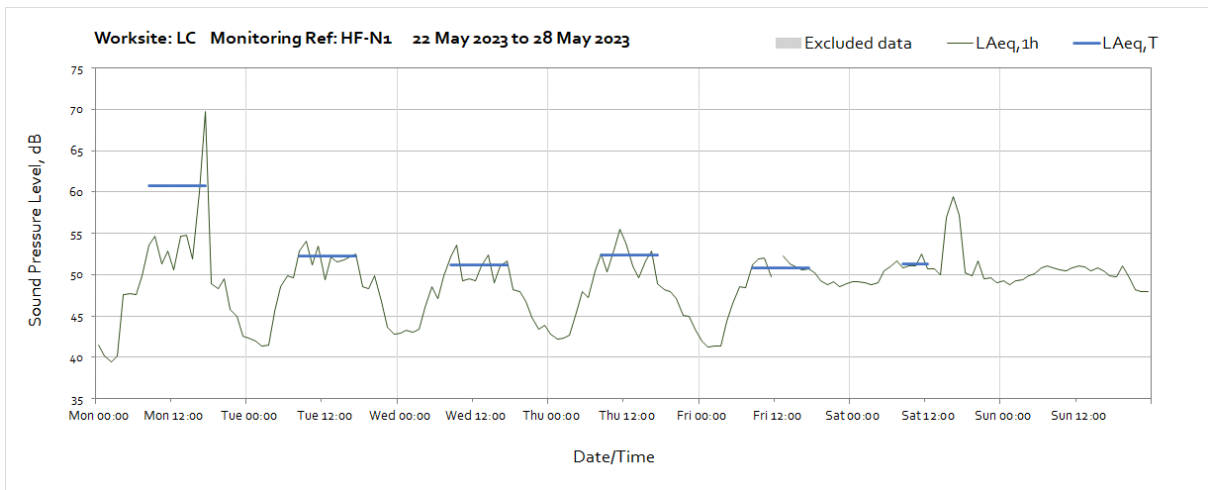
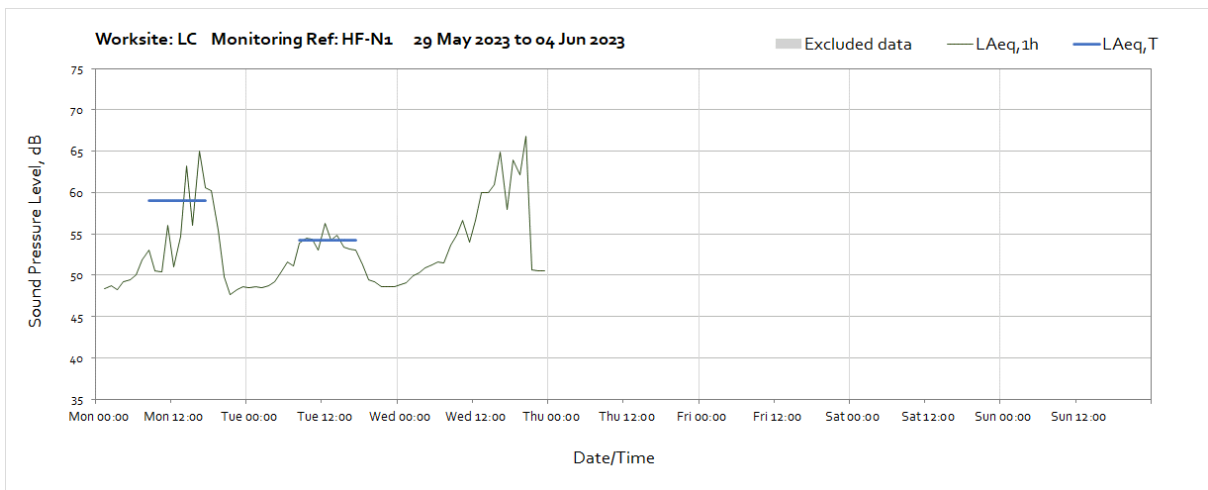
Worksite: LC Monitoring Ref: HF-N1

Note: Missing data between 09:00 and 10:00 on Wednesday 10th May was due to monitor maintenance.

Note: Missing data between 12:00 and 13:00 on Friday 26th May was due to monitor maintenance.

Note: Missing data between 00:00 and 01:00 on Monday 29th May was due to a monitor system check.

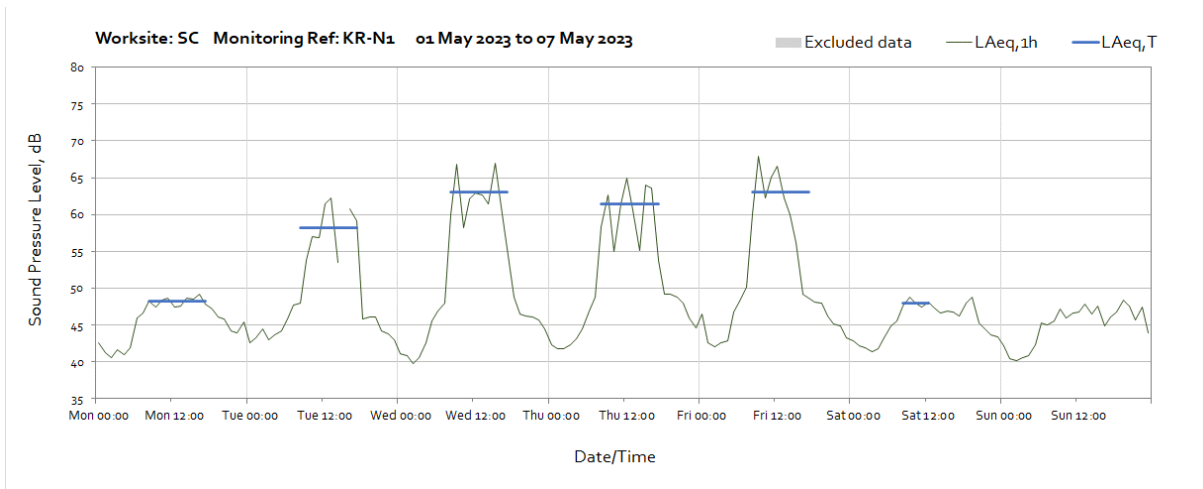
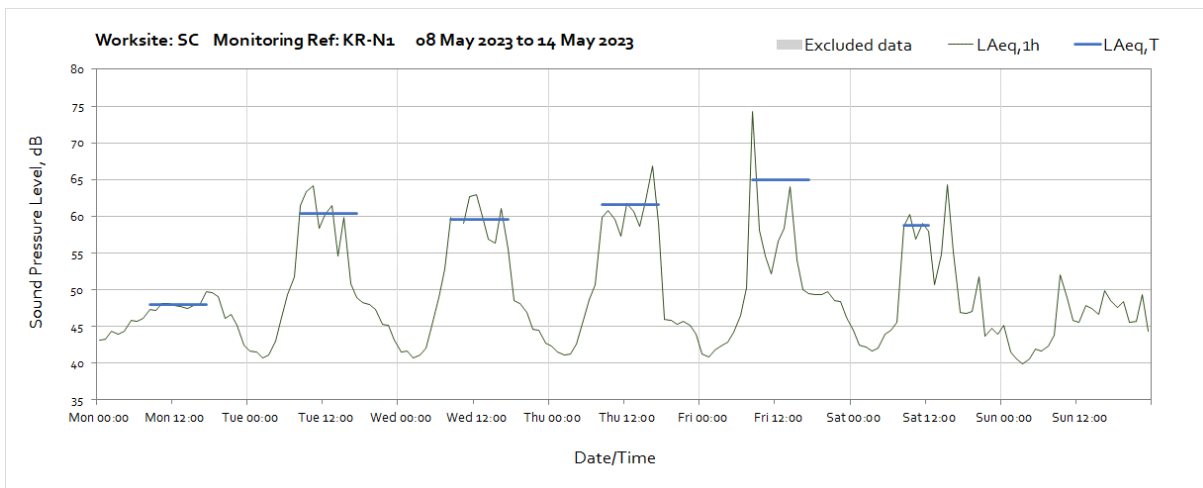
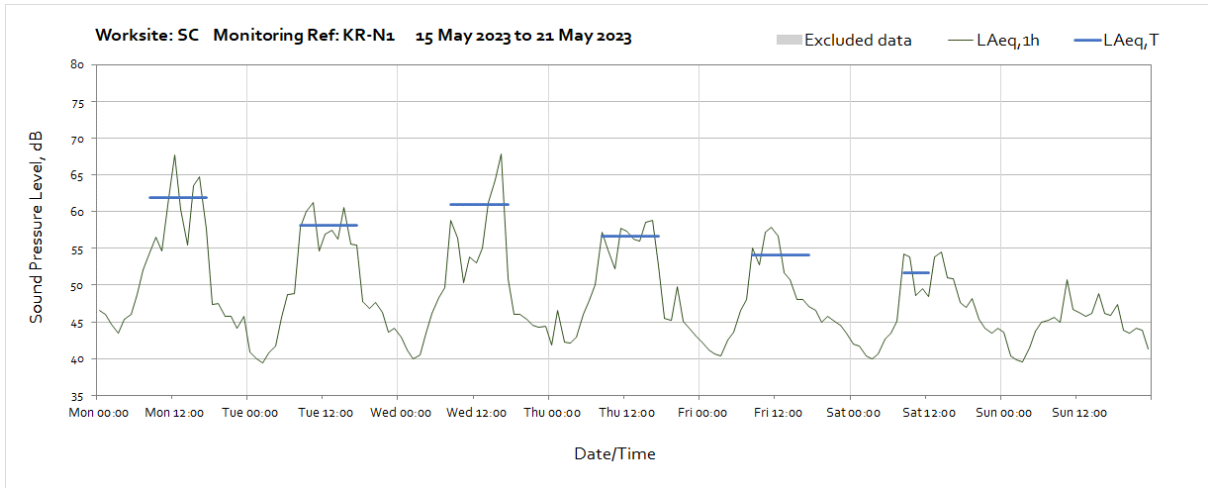
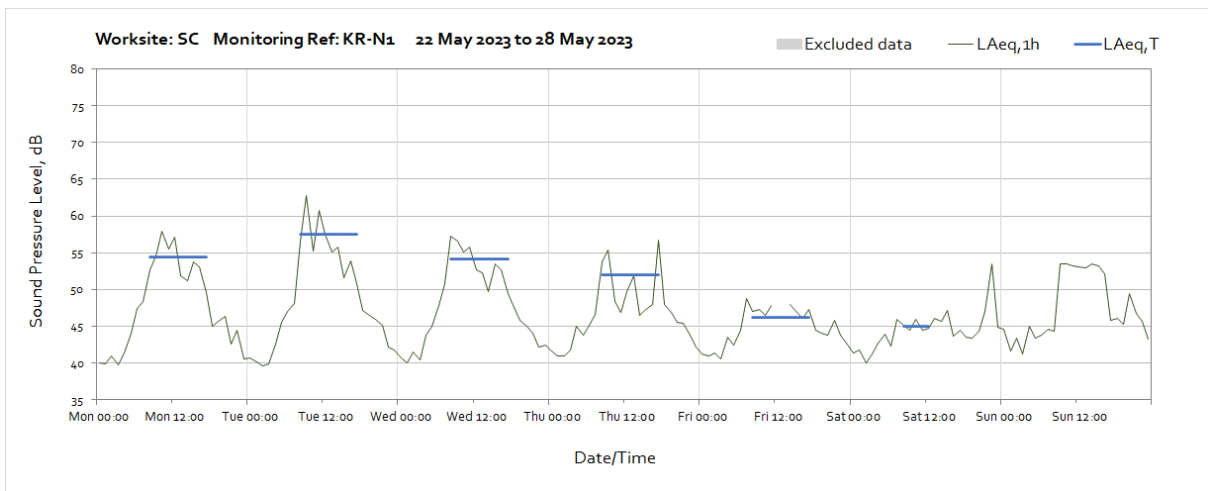
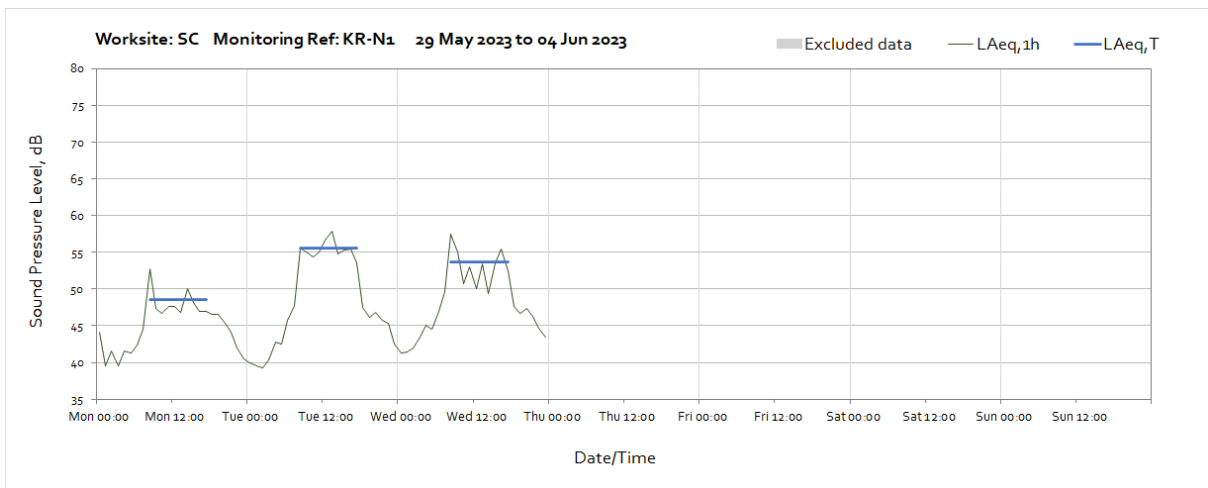
Worksite: SC Monitoring Ref: KR-N1

Note: Missing data between 15:00 and 16:00 on Tuesday 2nd May was due to monitor maintenance.

Note: Missing data Between 09:00 and 10:00 on Wednesday 10th May was due to monitor maintenance.

Note: Missing data between 12:00 and 14:00 on Friday 26th May was due to monitor maintenance.
