Construction Noise and Vibration Monthly Report – May 2023

Stratford-on-Avon District Council

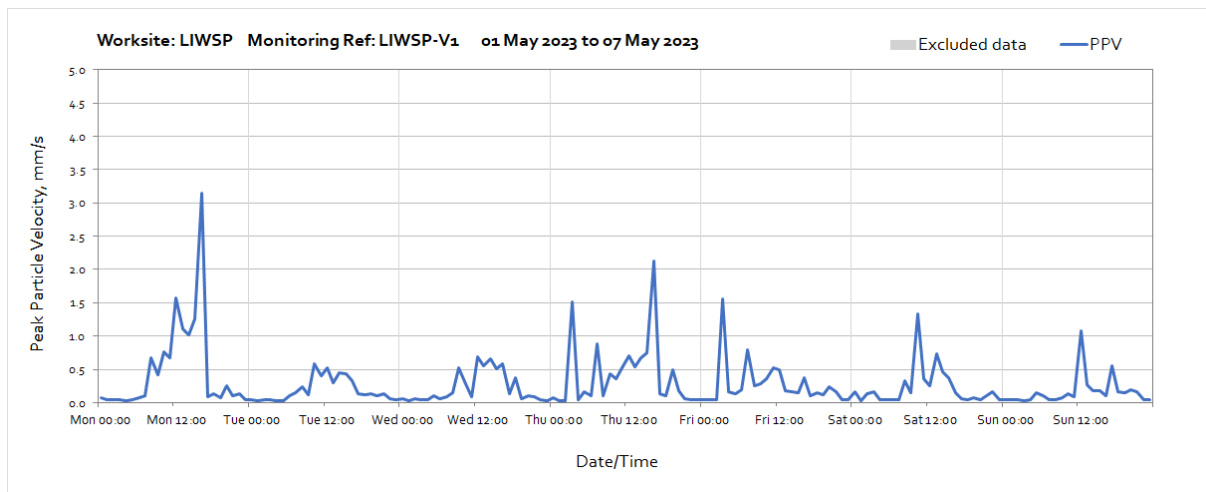
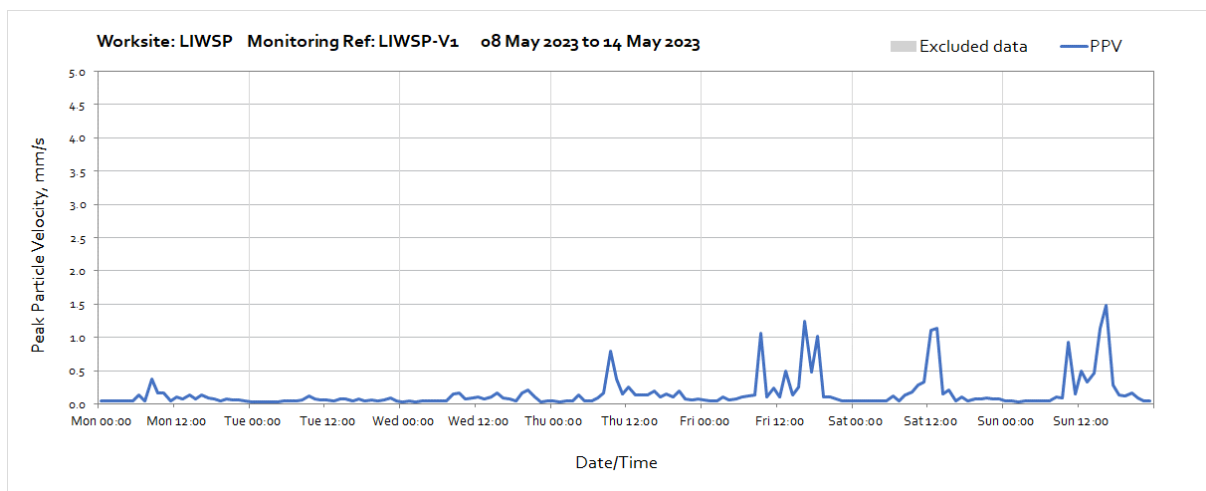
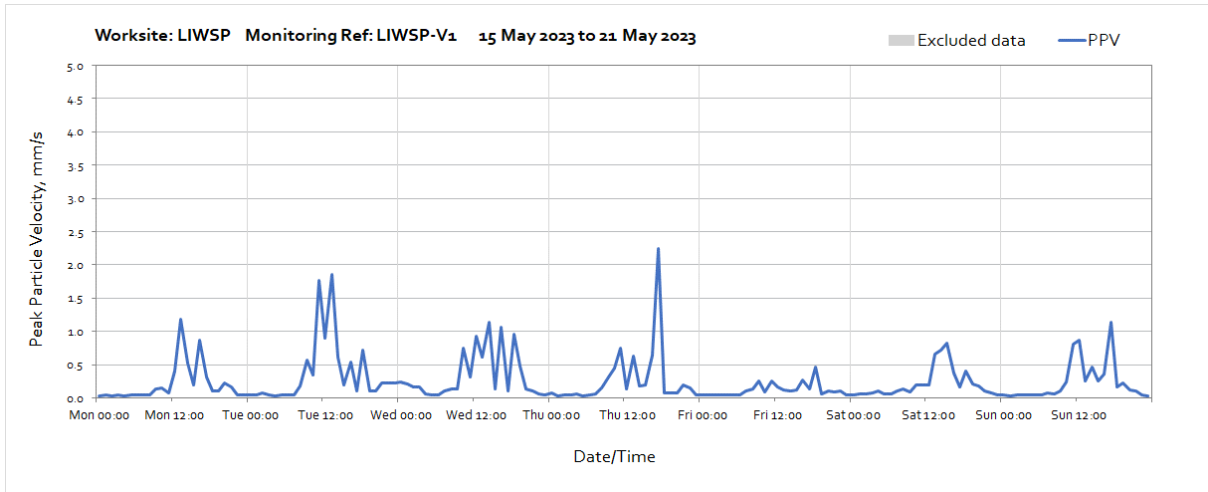
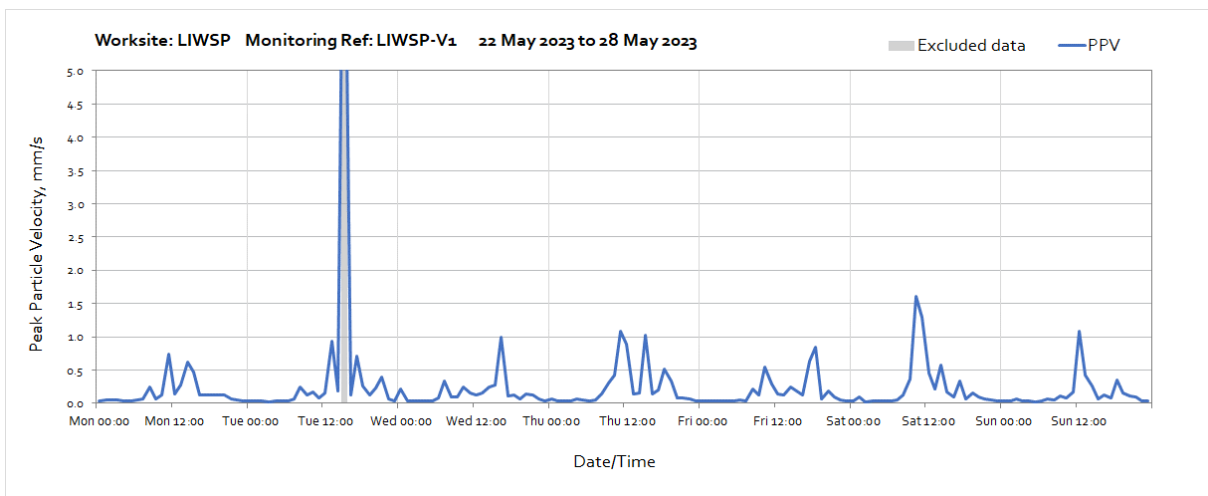
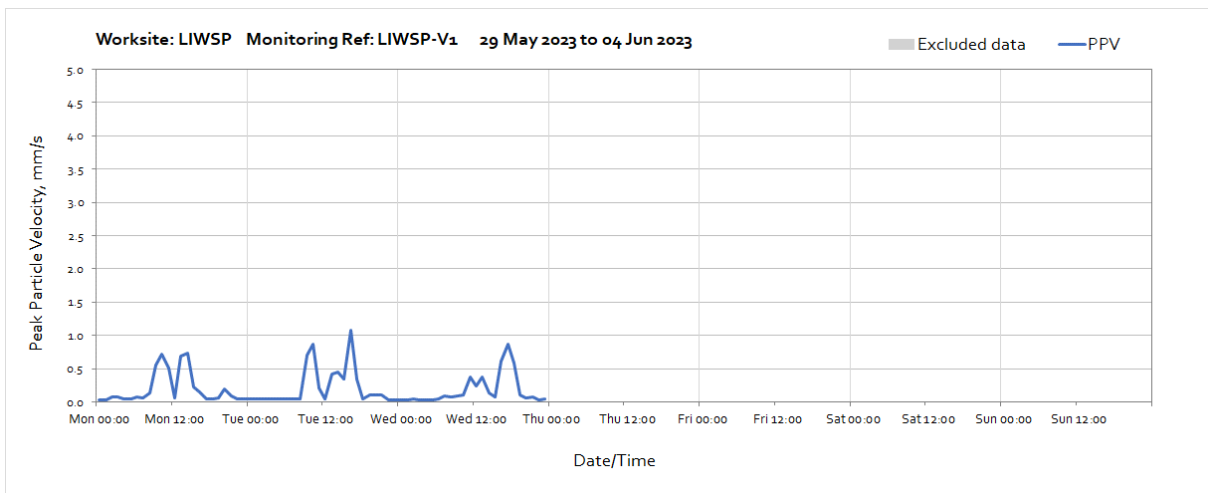
Worksite: LIWSP Monitoring Ref: LIWSP-V1

The following graphs show the hourly measured peak particle velocity PPV recorded during the monitoring period. The graphs show the highest PPV of the three orthogonal axes x, y and z. Where high values of PPV were caused by local interference with the vibration monitor, which are not representative of HS2 construction works, these values have been greyed out in the following charts and have been excluded to calculate values in Table 4 of the main report.

Worksite Reference	Measurement Reference	Monitor Address	Highest PPV measured in any axis, mm/s
LIWSP - Long Itchington Wood South Portal	LIWSP-V1	Woodside House, Bascote Heath, Southam	2.14 (X-axis)
