Construction Noise and Vibration Monthly Report – June 2023

Stratford-on-Avon District Council

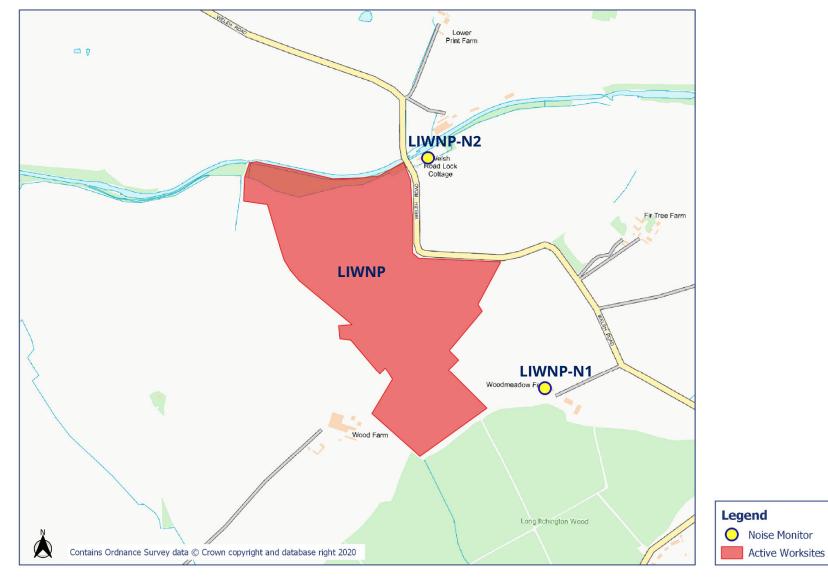
HS2 Noise and Vibration Monitoring Plan - 1

- 1.2.1 Six (6) noise and one (1) vibration monitoring installation were active in June 2023 in the SADC area.
- 1.2.2 Table 2 summarises the position of noise and vibration monitoring installations within the SADC area in June 2023.
- 1.2.3 Maps showing the position of noise monitoring installations are presented in Appendix B.

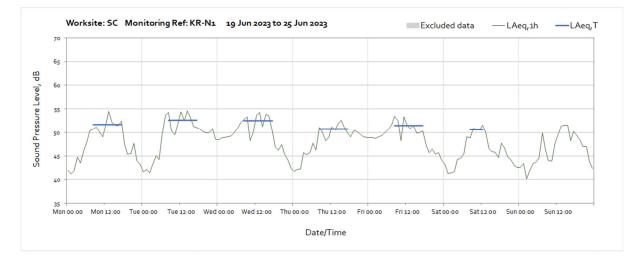
Worksite: SC Monitoring Ref: KR-N1

- 2.2.6 Exceedances of the LOAEL was recorded at one (1) monitoring location. The LOAEL exceedances were recorded during weekend daytime periods.
- 2.2.7 No exceedances of SOAEL were recorded due to HS2 construction works during June 2023.

The following graphs show the hourly measured ambient noise level $L_{Aeq,1h}$ and, where relevant, the averaged noise level $L_{Aeq,T}$ values, where the time period T is as specified in Table 1 of HS2 Information Paper E23. Periods with adversely weather affected noise levels are greyed out and have been excluded from the calculation of the $L_{Aeq,T}$ values in Table 3 of the main report.

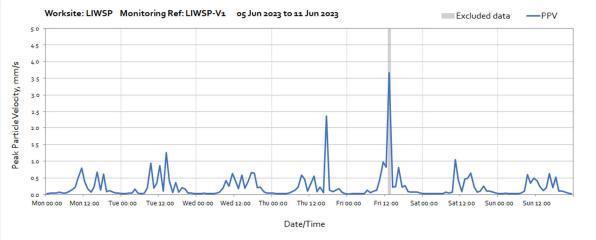
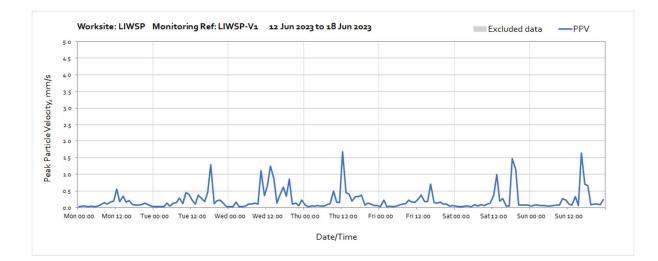
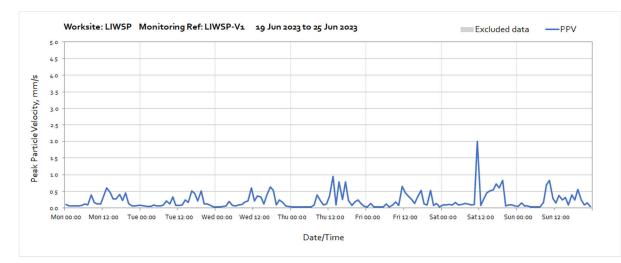
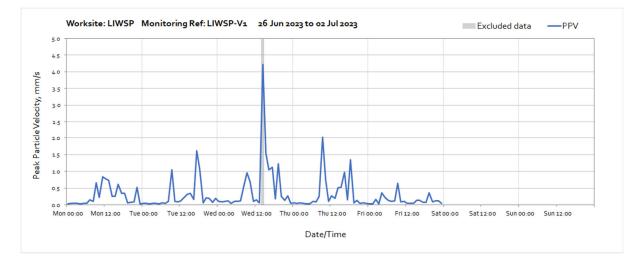
Worksite: LIWSP Monitoring Ref: LIWSP-V1

| Worksite | Measurement | Monitor Address | Highest PPV measured in any axis, |
|---|---|--|---|
| LIWSP - Long Itchington Wood South Portal | LIWSP-V1 | Woodside House, Bascote Heath, Southam | 2.15 (Z-axis) |

The following graphs show the hourly measured peak particle velocity PPV recorded during the monitoring period. The graphs show the highest PPV of the three orthogonal axes x, y and z. Where high values of PPV were caused by local interference with the vibration monitor, which are not representative of HS2 construction works, these values have been greyed out in the following charts and have been excluded to calculate values in Table 4 of the main report.
