## **Construction Noise and Vibration Monthly Report – June 2023**

**North Warwickshire Borough Council**

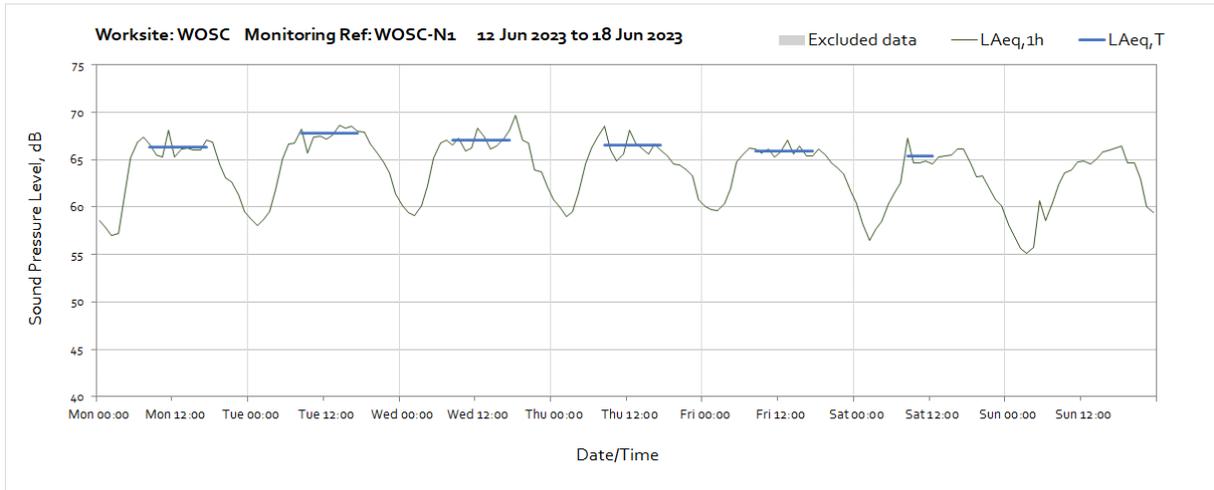
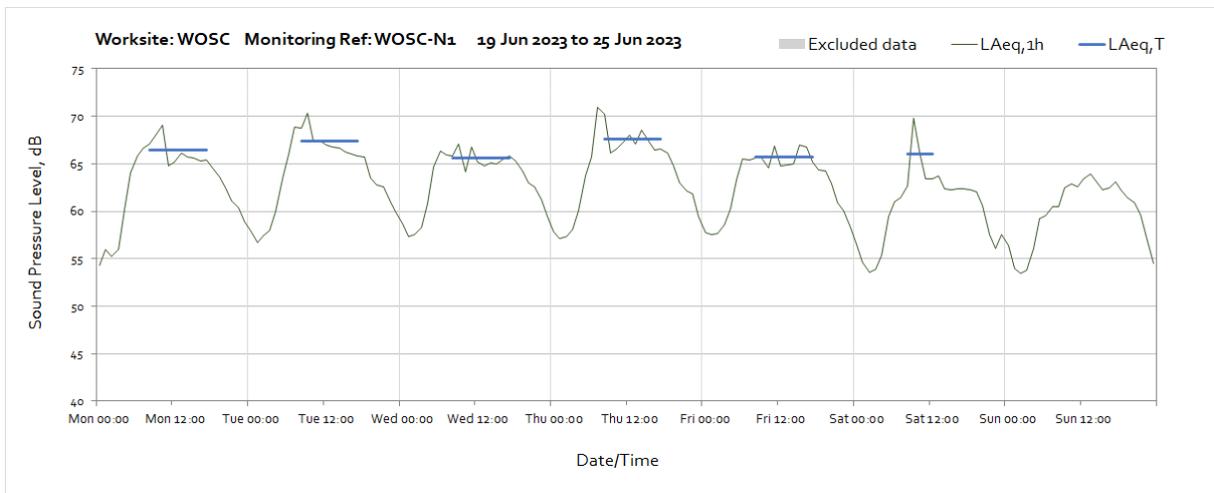
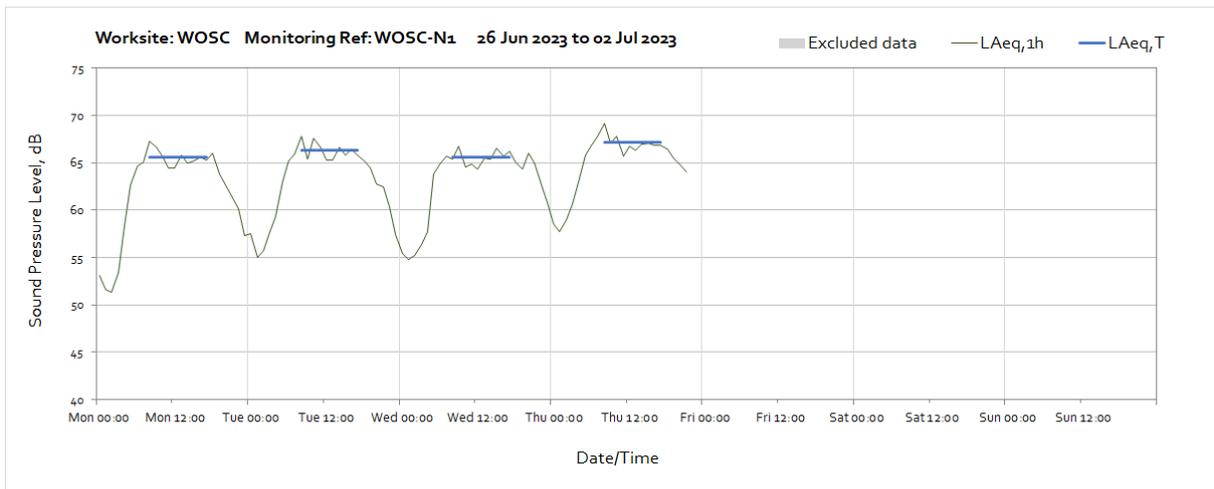
**Worksite: WOSC – Monitoring Ref: WOSC-N1**

Note: Missing data from 20:00 Thursday 29<sup>th</sup> June until the end of the month was due to power issue with the monitor solar panels.
