**The travel of errant vehicles after leaving the
carriageway**

by D A Lynam and J V Kennedy

**PPR298
3/372/R14**

PUBLISHED PROJECT REPORT

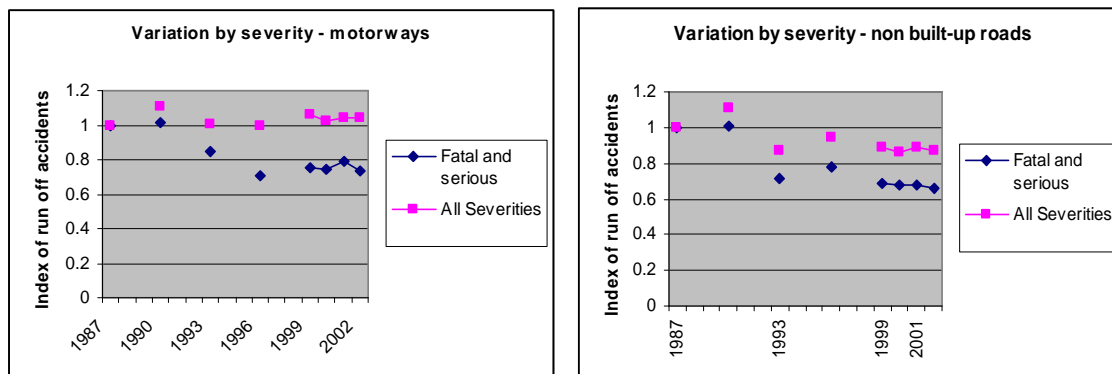
Figure 1 Variation in number of run off accidents between 1987 and 2001

Fig 1 shows how the numbers of vehicles hitting different objects has varied between 1987 and 2002. On motorways, all injury run off accidents remained at a similar level while fatal and serious accidents reduced by about 25% between 1987 and 1996 but have since remained fairly constant. In comparison, there has been a similar reduction in all injury accidents but fatal and serious run off accidents have also reduced by about 10%.

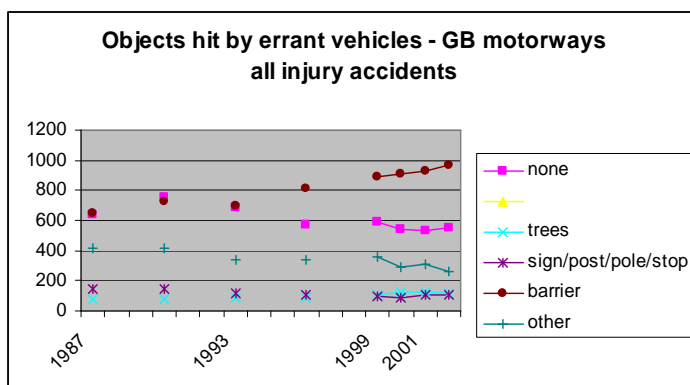
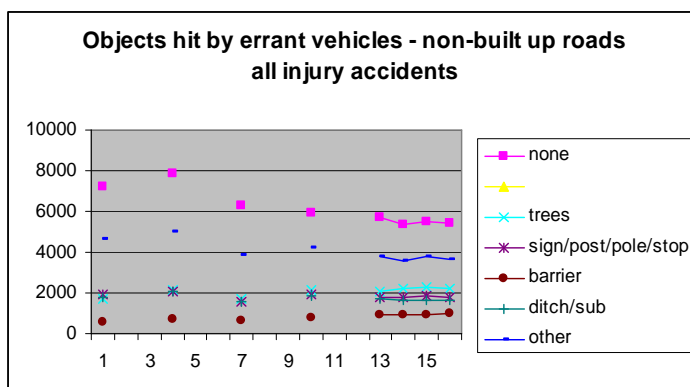
Figure 2 Variation in number of different types of run off accidents between 1987 and 2001

These changes are different for accidents involving hitting different objects, partly reflecting changes in the incidence of these objects over time. Figure 2 shows that accidents involving safety barriers on motorways have increased over this period, probably reflecting the increasing use of barriers, while run off accidents involving no impacts have decreased. The same change is not so apparent on other non built-up roads, although accidents involving no impacts have also decreased on these roads.

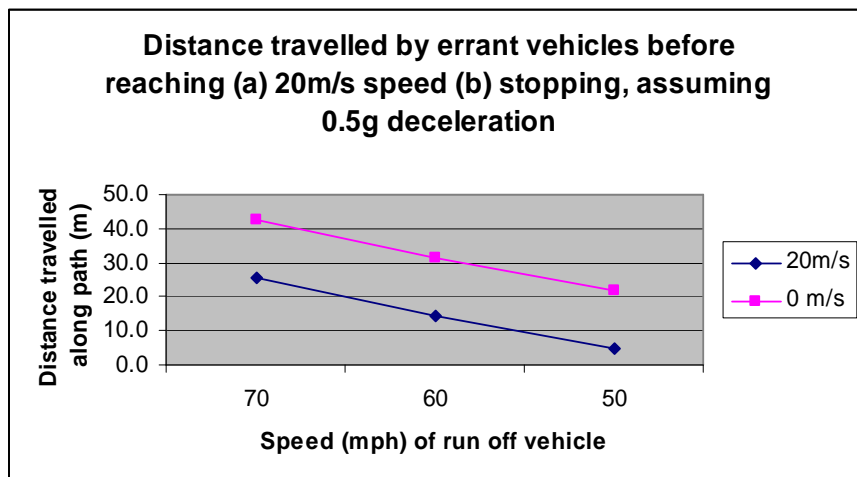
Figure 4 Distance travelled by errant vehicles along their path

Basic calculations can be made of the distances that vehicles are likely to travel when leaving the road as a function of initial vehicle speed and deceleration. The latter will depend on the friction provided by the ground over which the vehicle travels, and the extent of any braking by the driver. Figure 4 shows the distances reached with different initial speeds, assuming a deceleration equivalent to 0.5g (4.55 m/s/s). Distances are shown for the vehicle coming completely to rest, and also for the vehicle speed reducing to 60kph (20m/s); the latter is the speed at which a car which has a good NCAP rating can be expected to protect its occupants from fatal injury.

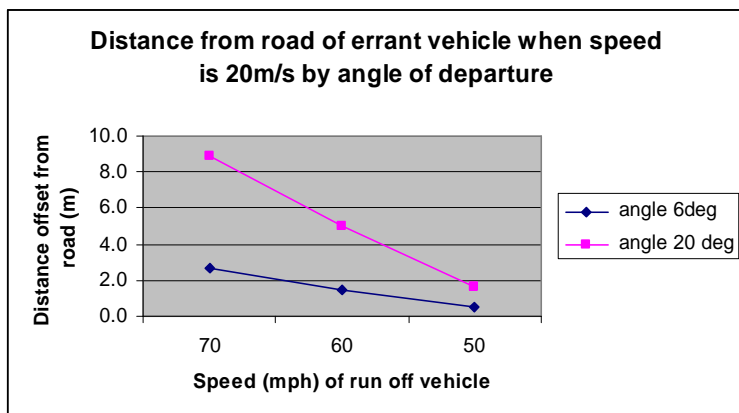
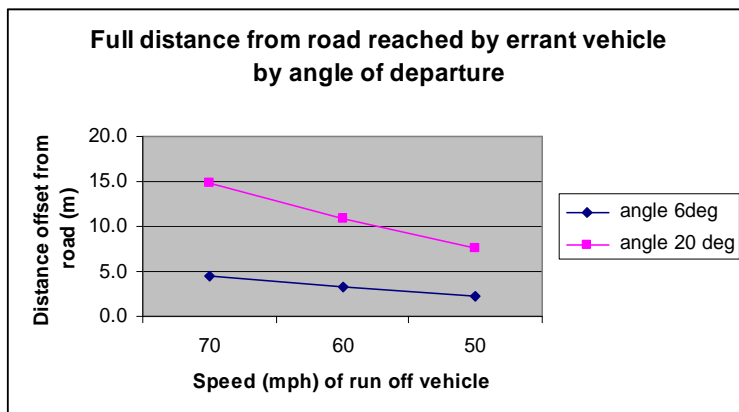
Figure 5 Example of variation in encroachment distance by angle of departure and final vehicle speed

For any particular assumption of initial speed and deceleration, the distance that the vehicle will encroach into the roadside area will depend on the angle at which it leaves the road. Figure 5 shows these encroachment distances for different angles, again based on the two “final” speeds used above.

For situations where the main risk arises to the car occupants, the distance of interest will be that required to bring the vehicle within an impact speed of 20m/s. Where there is additional risk of impact with third parties or of reaching a road, railway or water hazard after leaving the road, the distance required to bring the vehicle to a standstill is likely to be of more relevance.

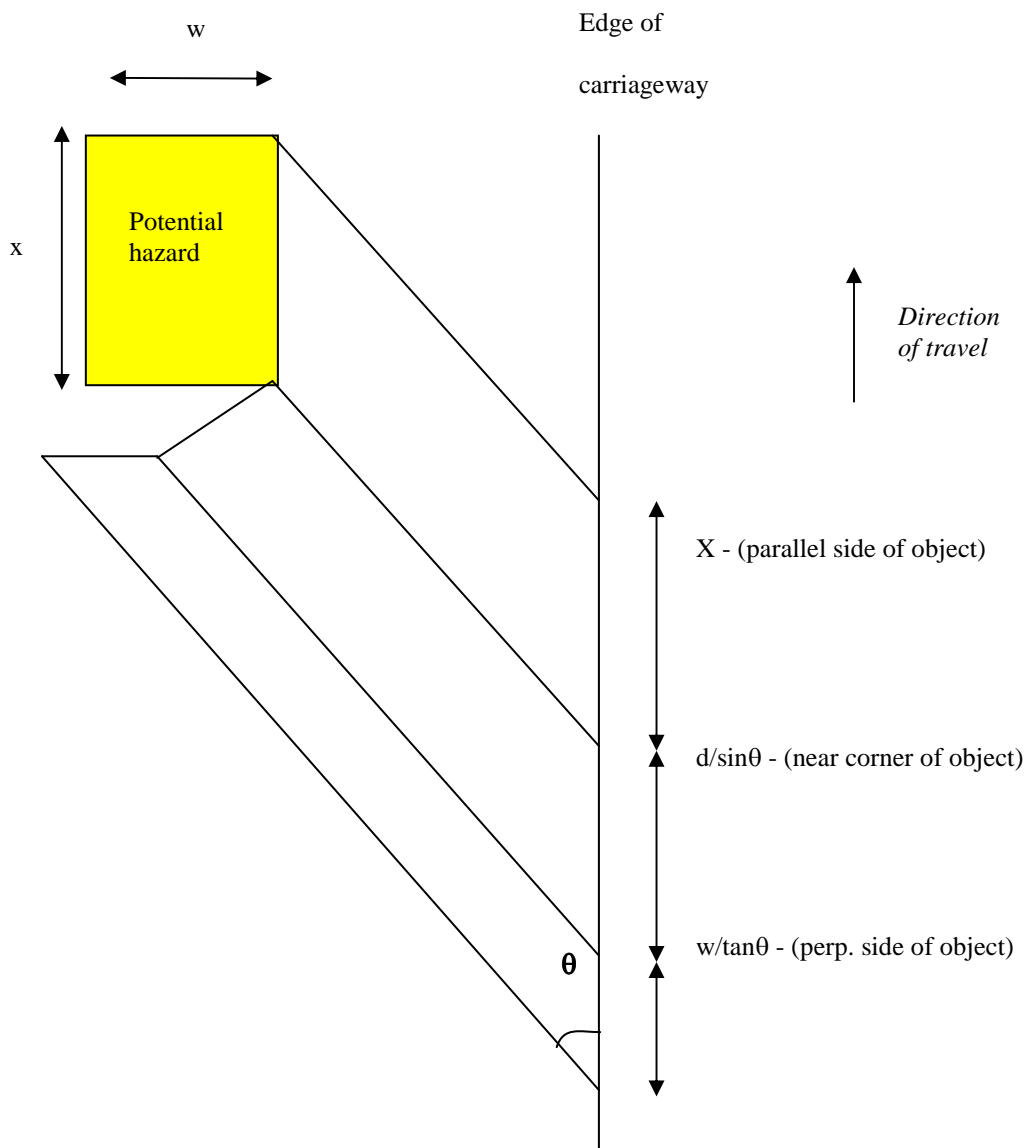
Figure 6: Envelope of potential hazard, based on trace of left front corner of vehicle

The probability that, given an encroachment, an impact is possible was obtained from the effective length of the hazard. This is shown in Figure 6 and depends on the angle of departure, the length and width of the object, and the width of the encroaching vehicle. The departure angle was assumed to be 6.1 degrees nearside and 11.5 degrees offside (based on a circle of 1000 ft diameter).

- θ Angle of departure
- w Width of object hit
- x length of object hit
- $d/\sin\theta$ Effective width of hitting vehicle
- $w/\tan\theta$ Effective width of object hit
