**Whole Life Cost-Benefit Analysis for
Median Safety Barriers**

PPR 279

HA Task Ref No. 3/372/R22

Client: Safety Standards and Research Department, Highways Agency (Mr Daniel Ruth)

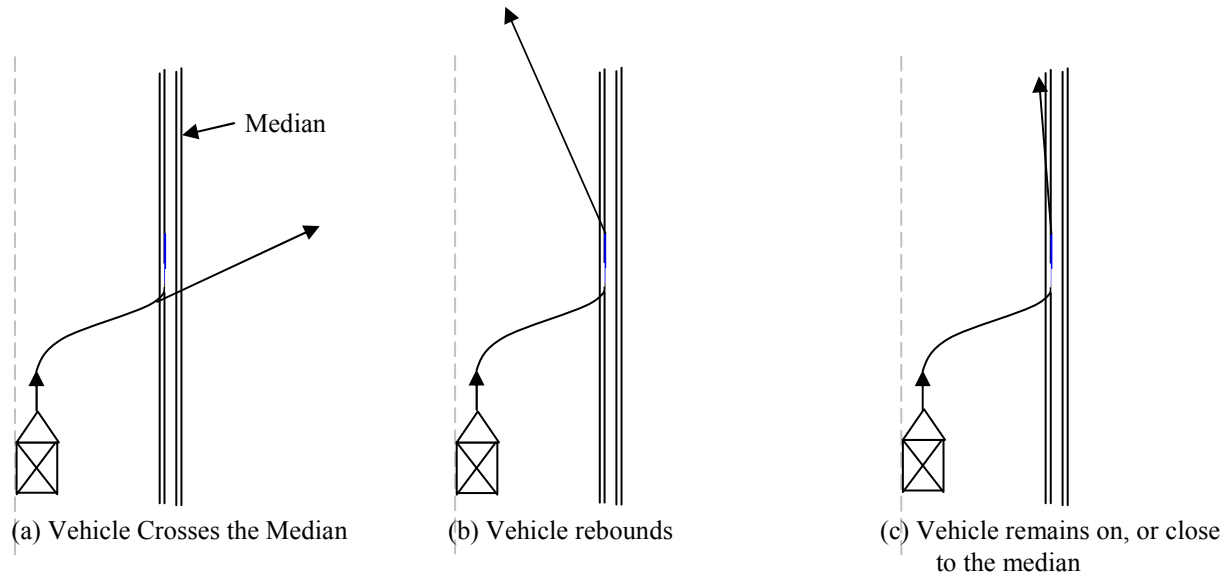
As referred to in Section 3.1.3, eighteen data sets have been examined for the purpose of this report. They concern accidents involving a car, HGV or ‘other vehicle’, impacting an object the median (and in nine data sets, the specific case of a median safety barrier). The impacting vehicle then either crosses the median into the opposite carriageway, rebounds back into the original carriageway, or remains on, or close to the median. These vehicle trajectories are shown in Figure 2 below:

Figure 2: Vehicle trajectories examined within the STATS19 accident data

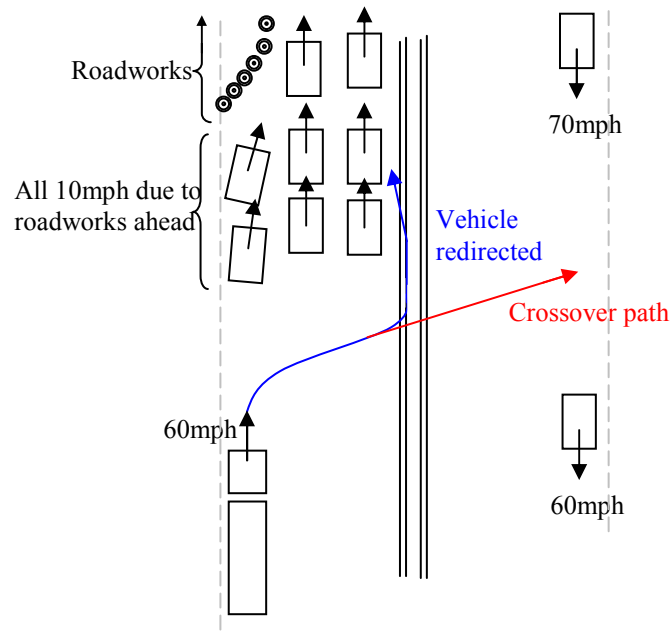
Figure 3 shows a simple, single HGV scenario. The HGV is travelling along the carriageway with roadworks ahead. As a result of the roadworks, traffic ahead has slowed on the carriageway and congestion is developing. The driver of the HGV has not anticipated this, and hence brakes sharply, and swerves to the offside to avoid the queuing traffic. The HGV strikes a very high containment safety fence or barrier in the median and is contained and redirected in accordance with CEN validation tests [5]. The HGV is however, redirected towards the queuing traffic, increasing the probability of impact with other vehicles and hence, of casualties. The traffic on the opposite carriageway was light and free moving at the time of the accident. Therefore the number of casualties may have been lower had the HGV been allowed to cross the median and enter the opposite carriageway, as other drivers may have had enough time to recognise and assess the danger, and take appropriate avoidance action.

Figure 3: Hypothetical Example of a Single HGV Crossover Scenario where allowing a crossover may reduce the probability of casualties

To help in the avoidance of this hypothetical example, it is reasonable to expect that warning signs would have been placed sufficiently in front of the roadworks to warn the HGV driver of the roadworks ahead. However for this example, it is assumed that either the HGV driver has chosen to disregard these signs, or that the traffic congestion is sufficiently long in length that the road signs have not yet begun, or that the driver has been distracted.

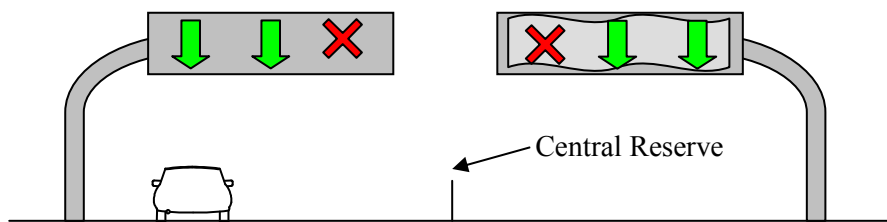
'Re-tensioning of metal safety barriers is carried out under static traffic management layouts. Near side work is carried out within either hard shoulder, or lane one closures. The closures are affected purely for this function. Central reservation re-tensioning is carried out within single or double lane closures. Seventy to eighty percent of this work is undertaken within planned closures for other maintenance works, with the balance requiring additional closures. A number of exit/entry slip require total closures with diversion routes to carry out maintenance works', i.e.

Figure 4: Lane Closures Due to Maintenance Work in the Median

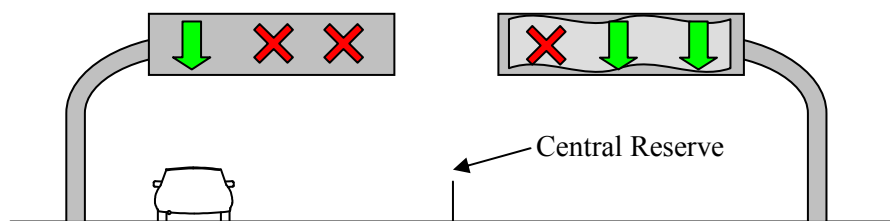
‘The TCB and OBB barriers require inspection and usually repairs after vehicle impact. Repairs take place within a few days of the damage being incurred and take place during weekday nights (generally between 22:00 and 04:30) and involve temporary traffic management (TTM) being applied to both carriageways using cones. Two lanes are closed in the primary direction (the side on which damage occurred) and one lane in the secondary direction’, i.e.

Figure 5: Lane Closures Due to Repair Work in the Median (Accident on left hand carriageway)

‘Speed restrictions of 50mph are signed and the coning normally extends over 1.8 km. In certain instances the damaged incurred or the location may represent a particular hazard and repairs need to be undertaken at other times of day.’

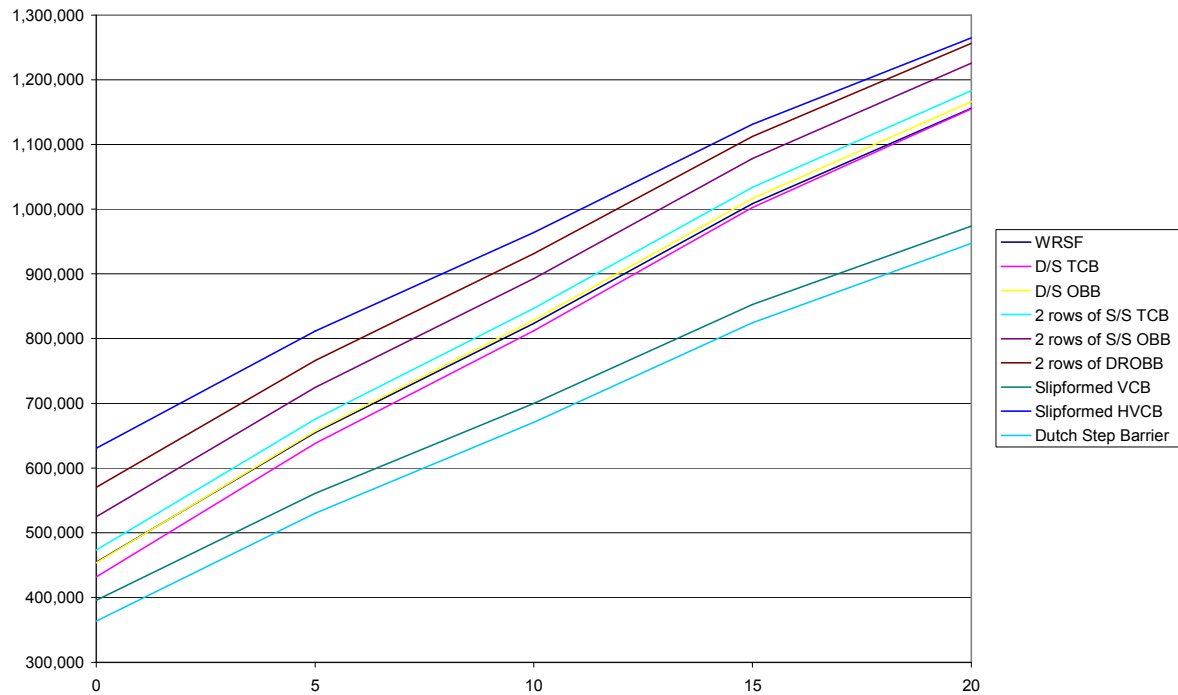
Graph 1: Whole Life Costs Associated with Accidents in which a Car is the errant vehicle

Graphs 1 and 2 indicate that whilst the use of slipformed HVCB may not be economically viable in areas where they are predominately struck by cars, significant savings could be made if such barriers were introduced in areas where there are high densities of HGVs. This is partly due to the reduced accident costs resulting from rebound and retained vehicle accidents when compared to those in which a vehicle crosses the median. This shows the dominance of the accident costs. These greatly outweigh all of the other costs associated with a median barrier system during its whole life. As a result, the gradient of the lines in Graphs 1 and 2 are highly dependant on the accident rates derived from historical STATS19 data and subsequently used in Table 14.

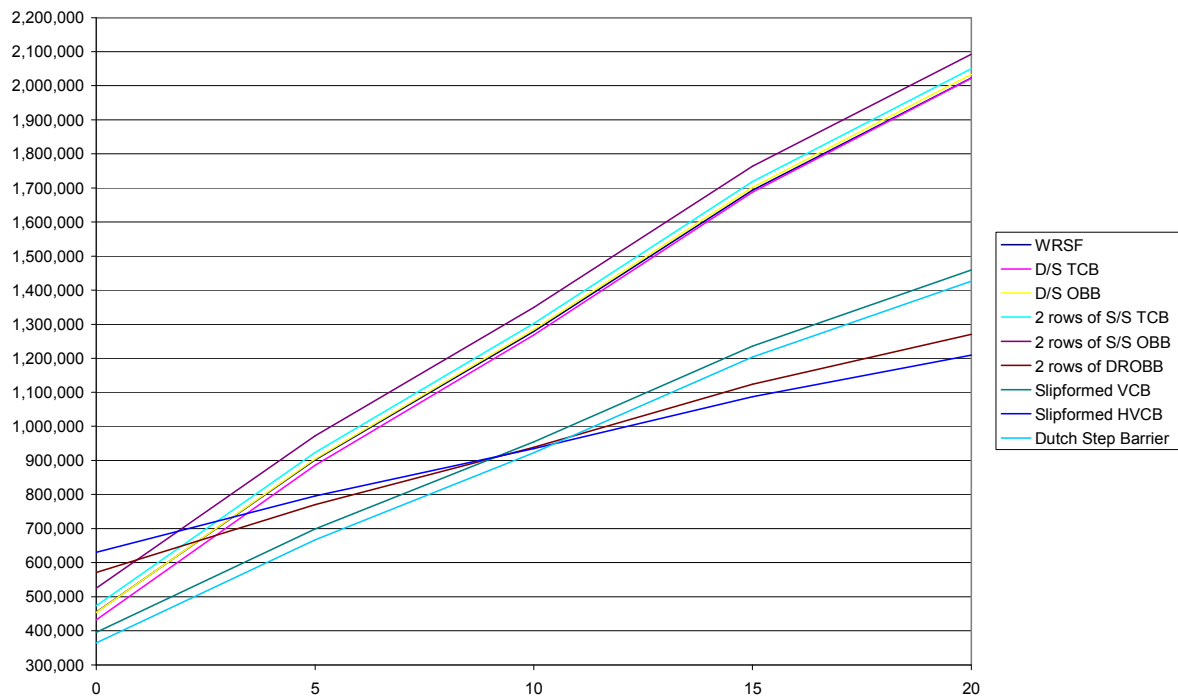
Graph 2: Whole Life Costs Associated with Accidents in which a HGV is the errant vehicle.

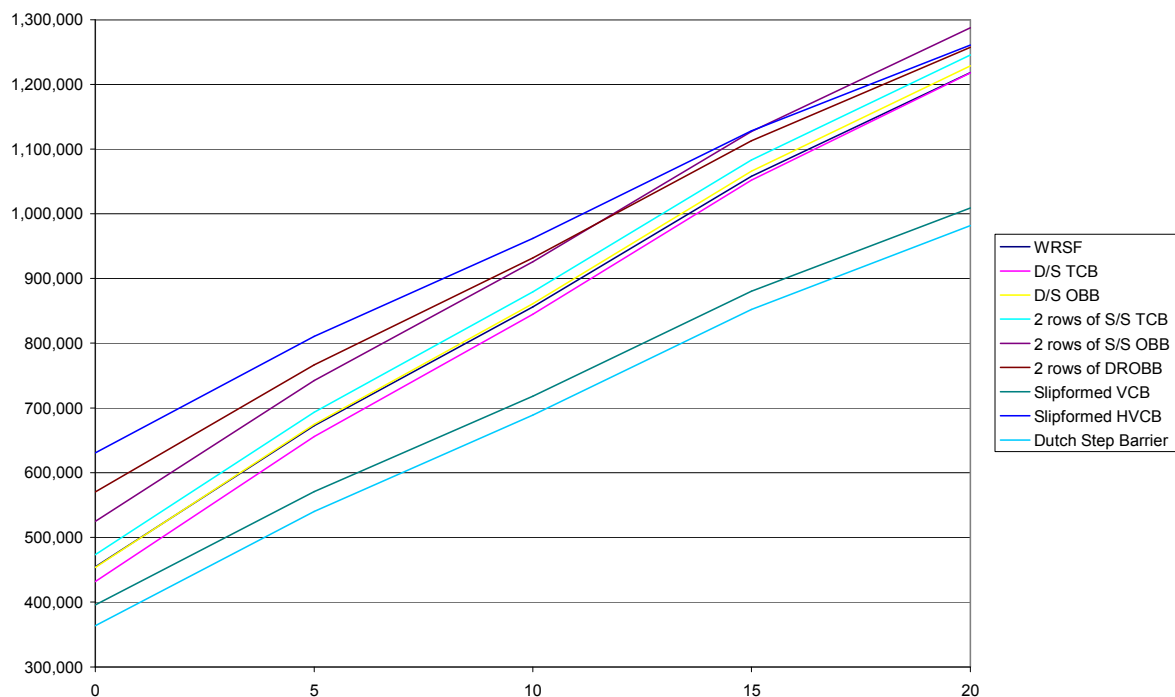
In addition to examining the Whole Life Costs for each vehicle type individually, knowing the probability of vehicles striking a median barrier, one can incorporate these probabilities into the calculations, and recalculate the whole life costs. Hence, we have seen in Section 3.2.1.2 that of those incidents in which a median barrier accident occurred, 82.5% of the accidents involved a car, and 6.4% involved an HGV. (The remaining 11.1% is attributable to 'other vehicles'). If one incorporates the relative proportion of cars and HGVs involved in the accidents, the whole life cost figures are summarised as follows. Graph 3 therefore demonstrates the most probable whole life costs for median barriers installed on UK roads (assuming accident rates and proportionality of car to HGV accidents remains similar to that currently seen in the STATS19 data).

Graph 3: Whole Life Costs incorporating the proportion of Car and HGV accident rates.

This graph demonstrates that both the Dutch Step and Vertical Concrete Barriers have the lowest whole life costs. This is due to a number of factors:

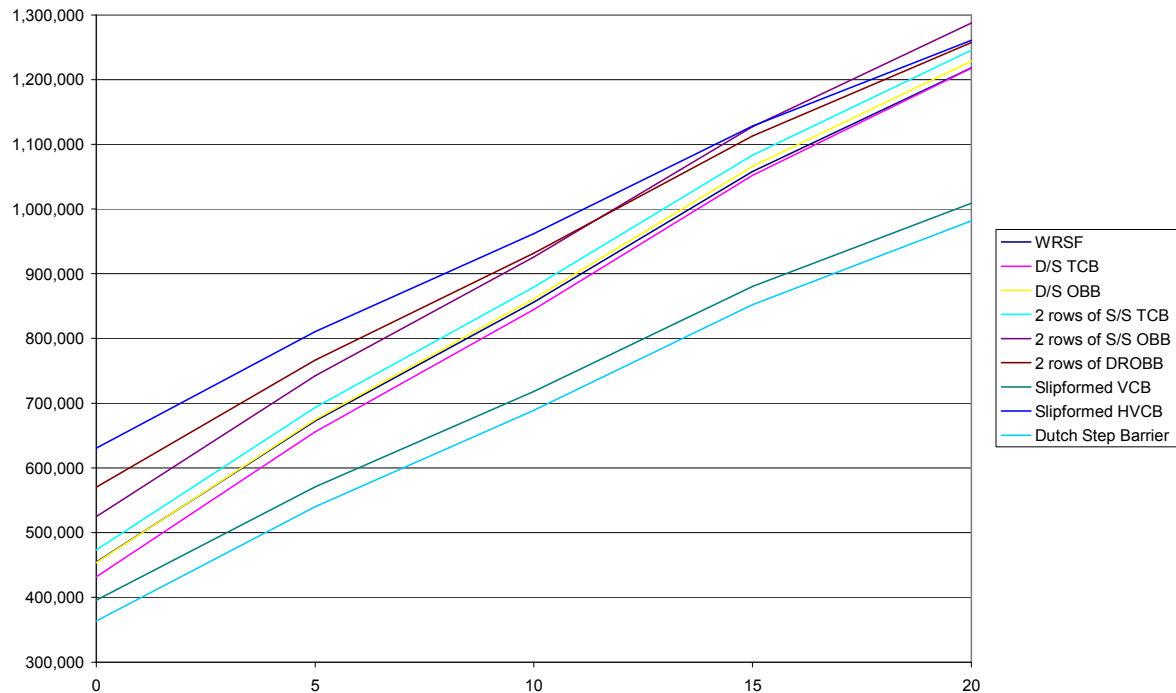
- This graph demonstrates that both the Dutch Step and Vertical Concrete Barriers have the lowest whole life costs. (Refer to Section 7.4.4)
- This is due to a number of factors:

- Lower accident costs as a result of reducing crossover accidents (which generally have a higher fatal and serious injury rate, and hence accident cost)

- However, if factors such as accident rates, repairs, accident compensation and likely vehicle reaction to the barrier and the relative percentage of Car and HGV traffic are also incorporated, the WLCs for 1km of safety fence or barrier more closely resemble the following (Refer to Section 7.4.4):
