# Sewage-related contaminants in Isles of Scilly groundwater: concentrations, spatial distribution, sources and risk

Project ENVRESW001361

September 2016

Part 2 of 4

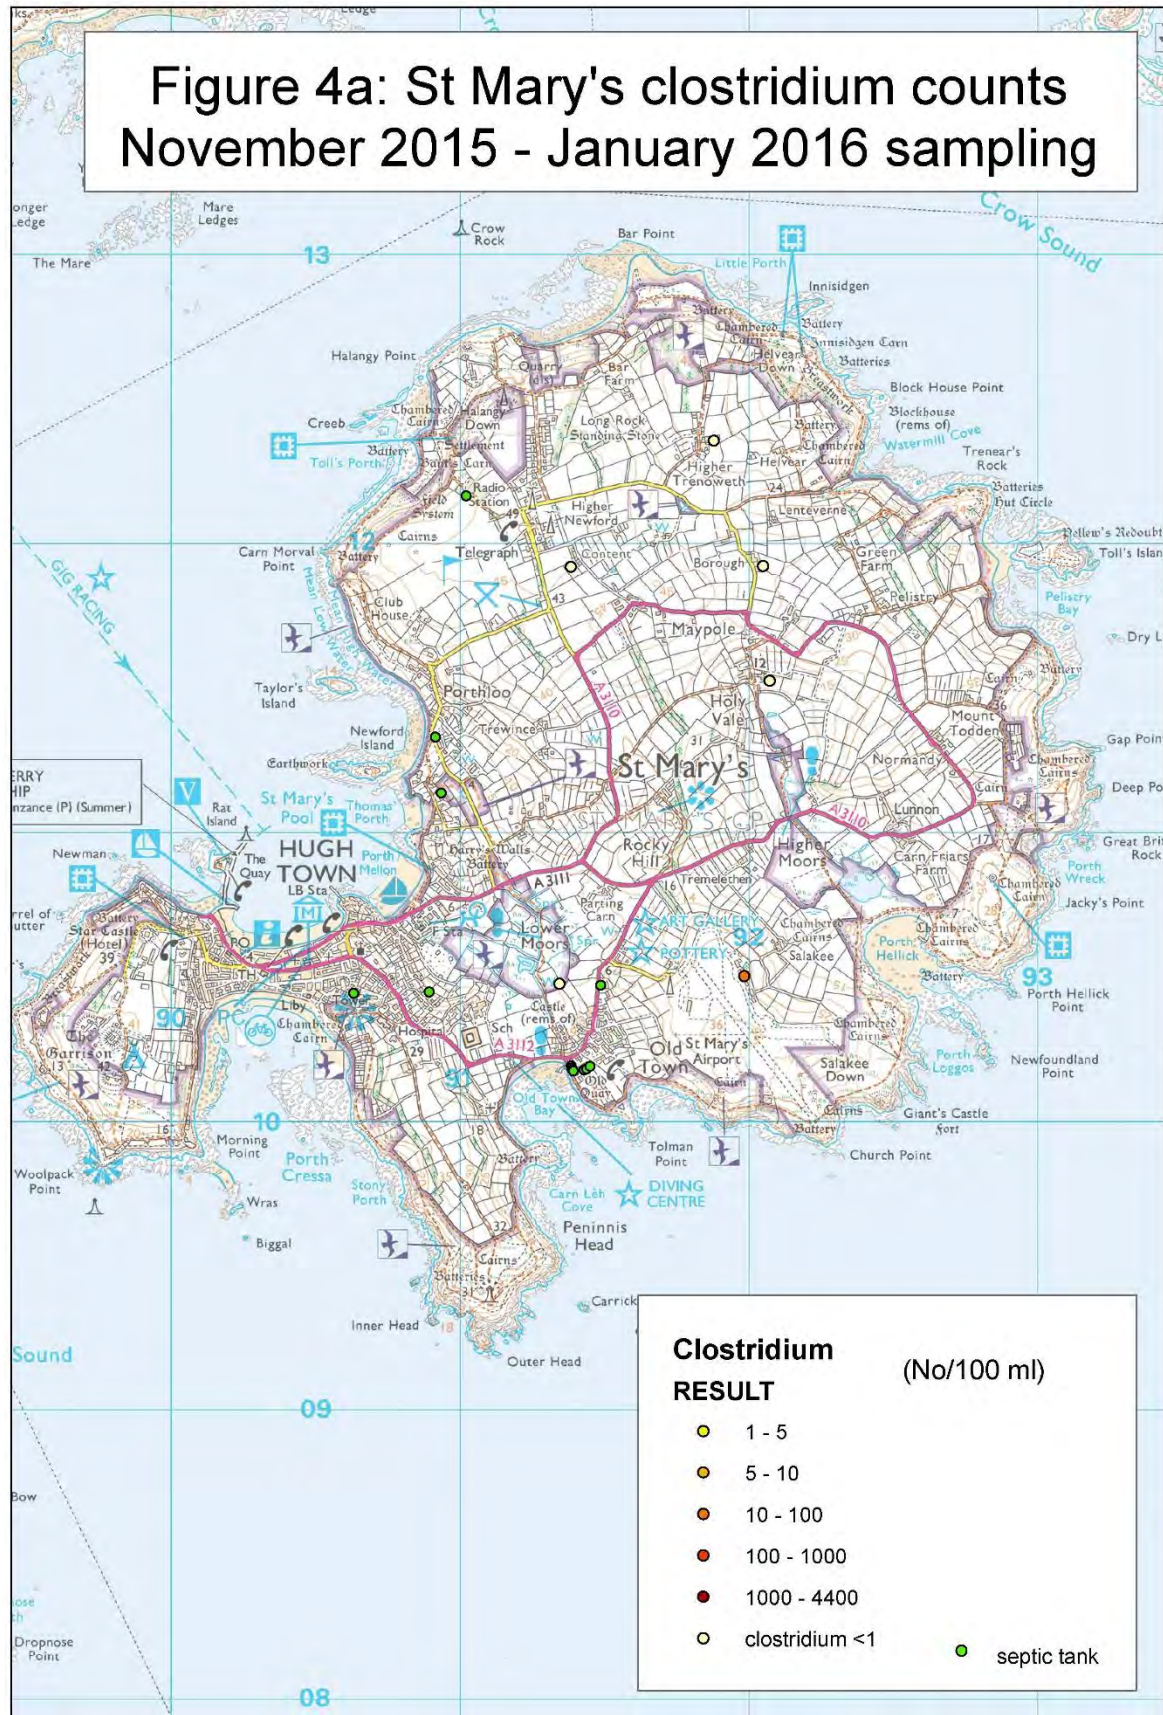
Figure 4a: St Mary's clostridium counts  
November 2015 - January 2016 sampling

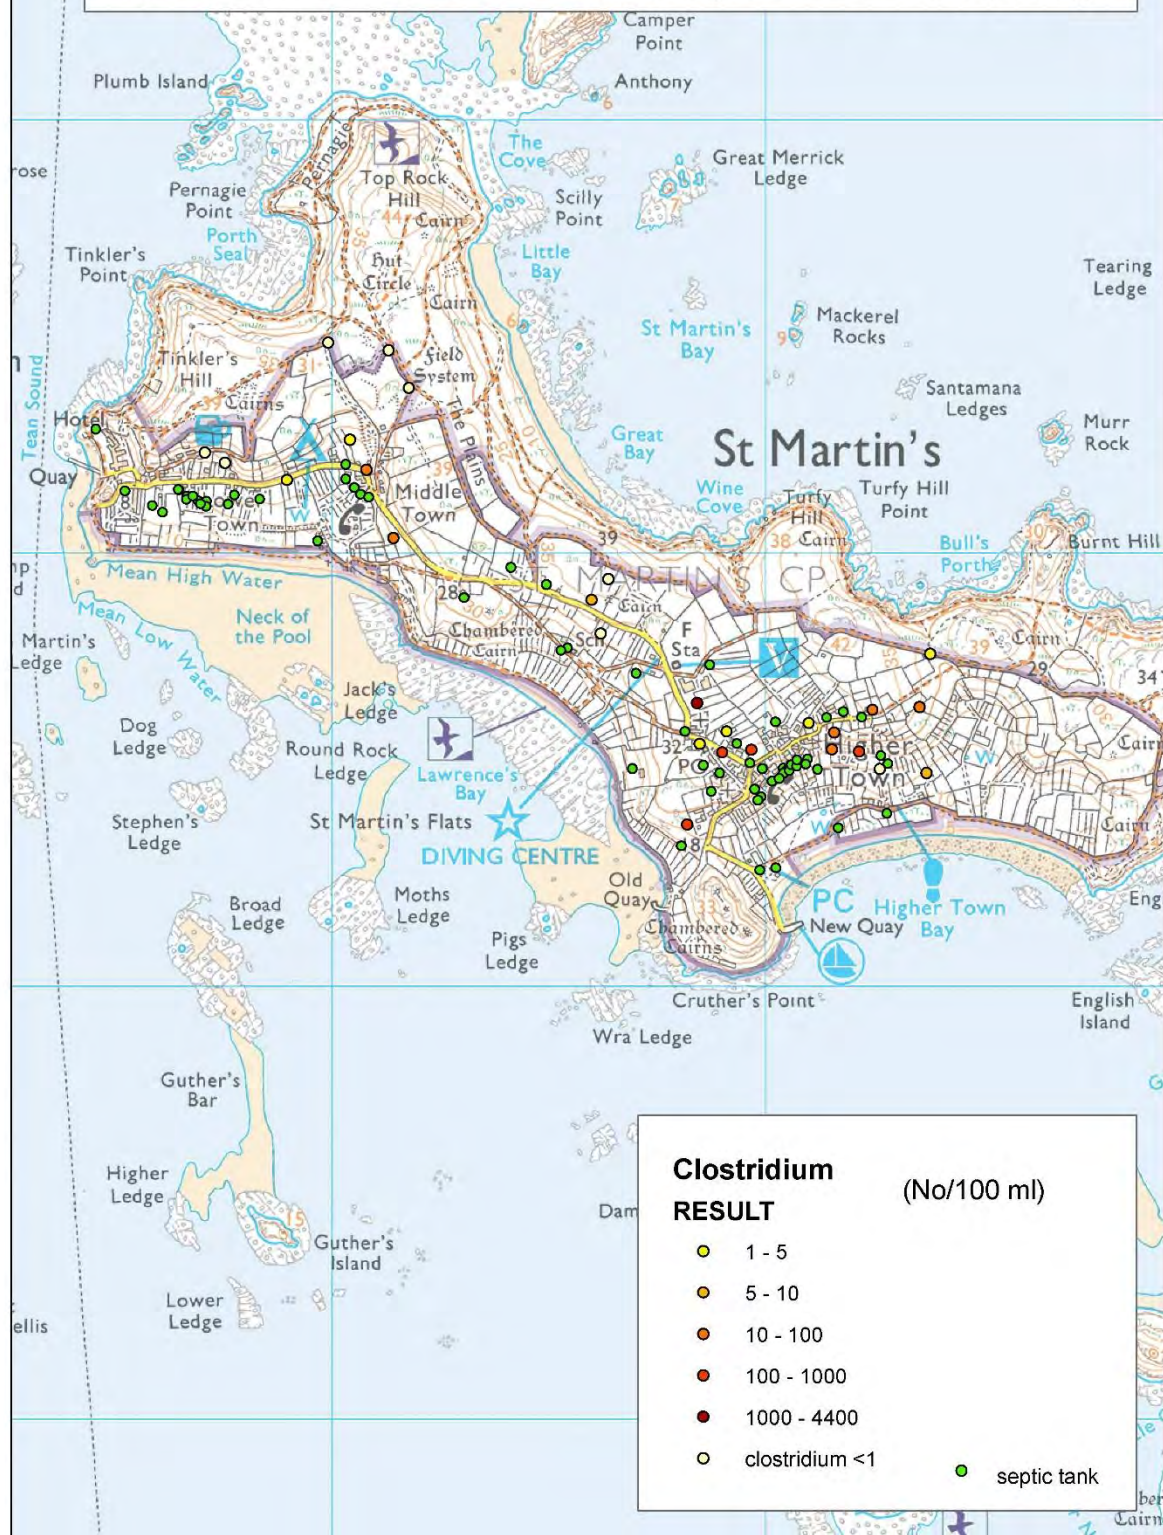
**Figure 4b: St Martin's clostridium counts  
November 2015 - January 2016 sampling**

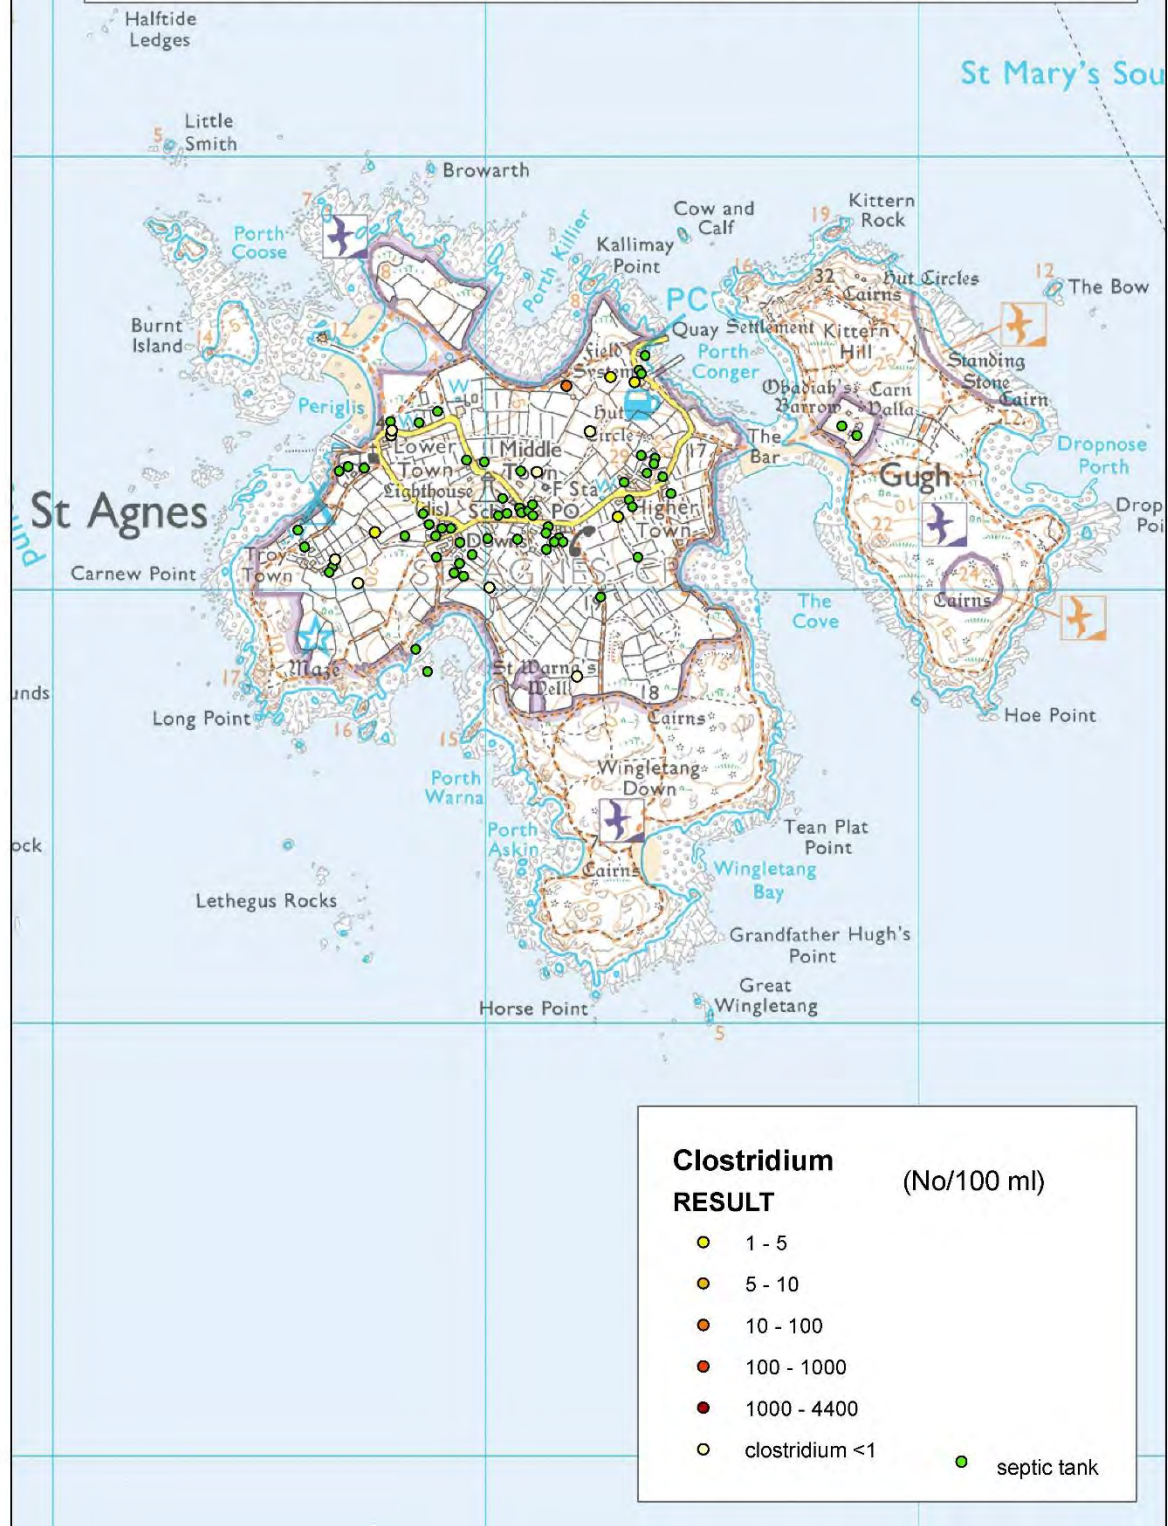
Figure 4c: St Agnes clostridium counts  
November 2015 - January 2016 sampling

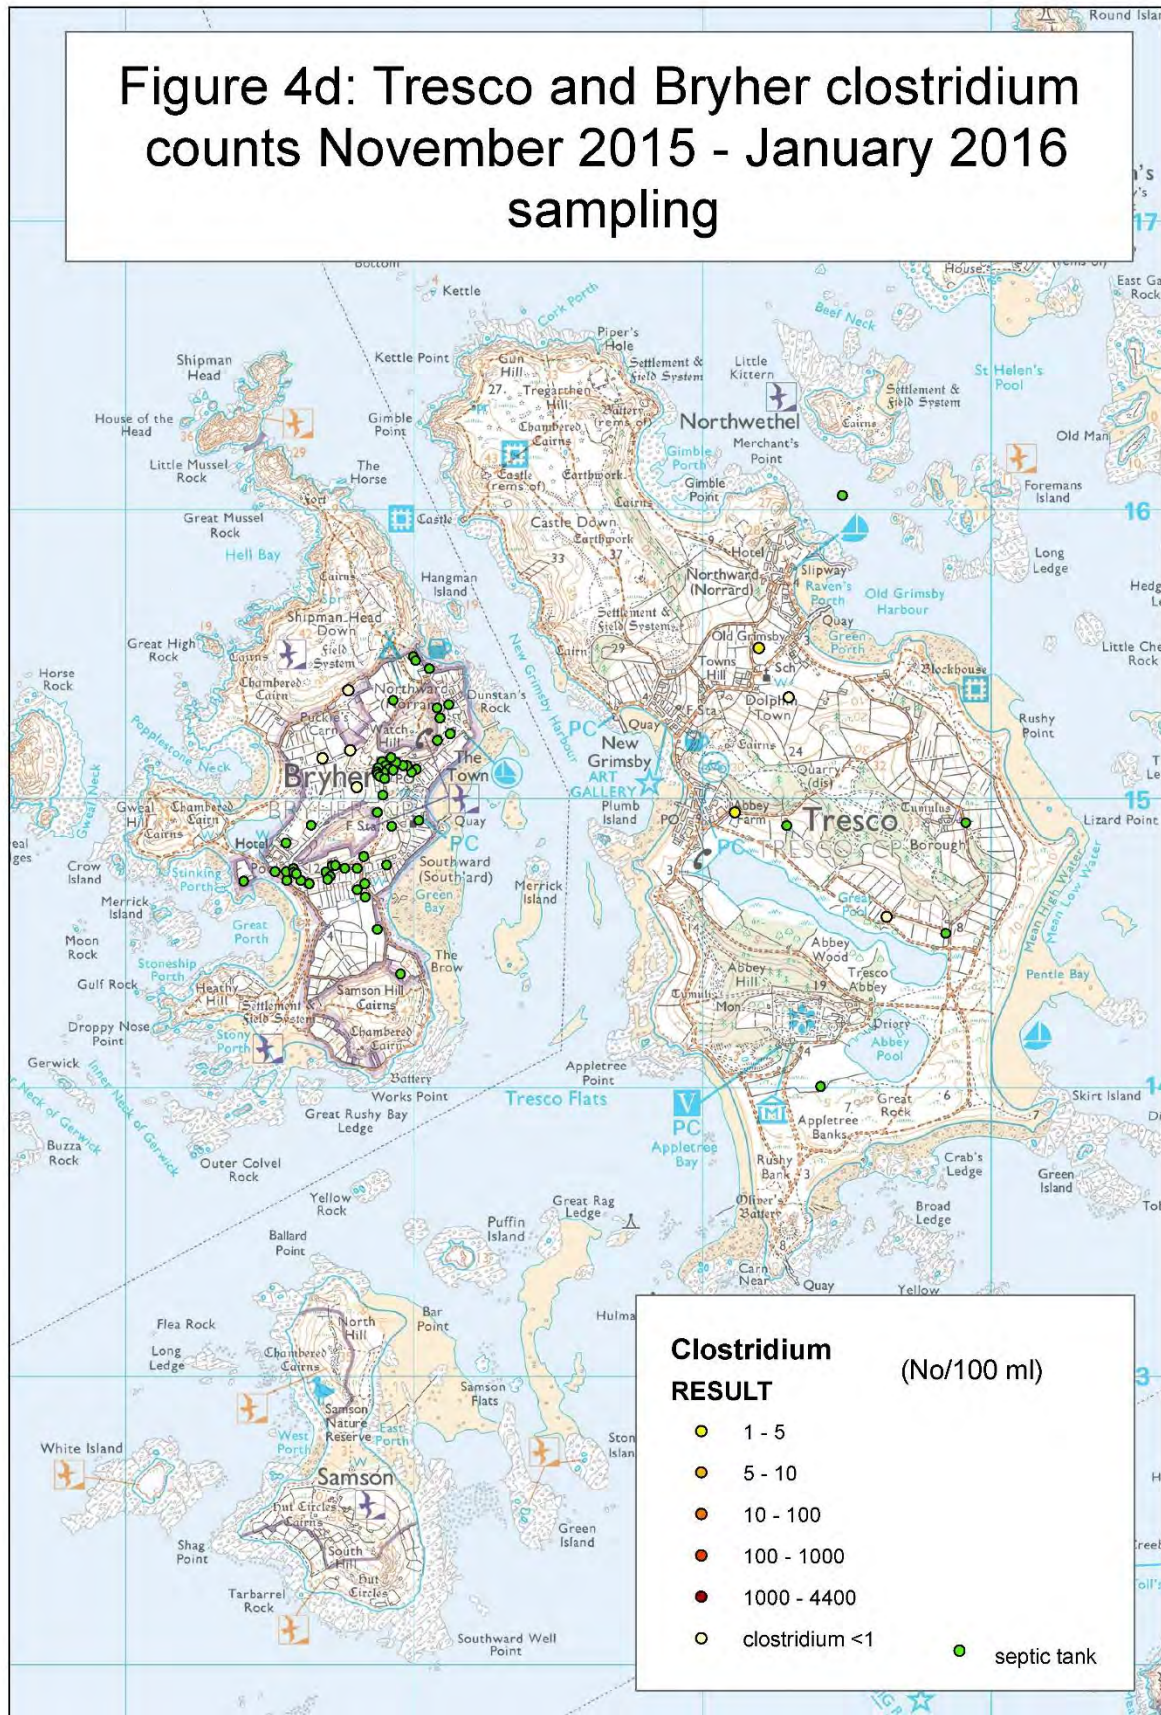
Figure 4d: Tresco and Bryher clostridium counts November 2015 - January 2016 sampling

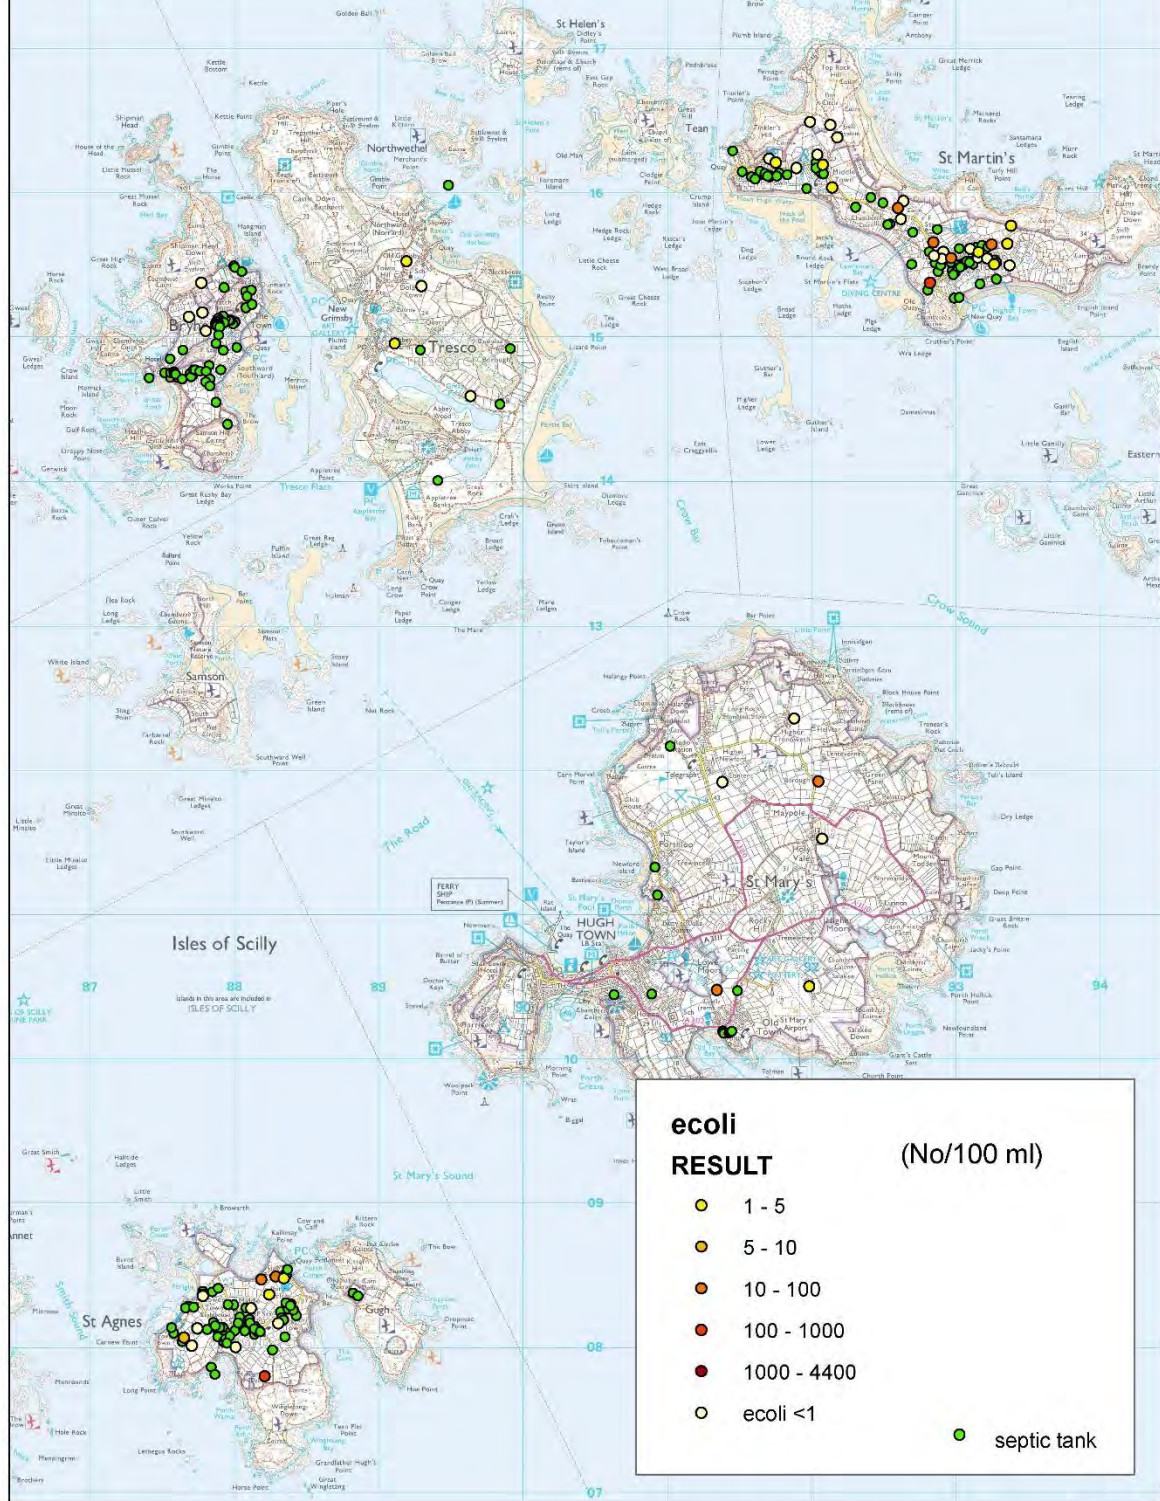
Figure 5: Isles of Scilly e-coli counts  
November 2015 - January 2016 sampling

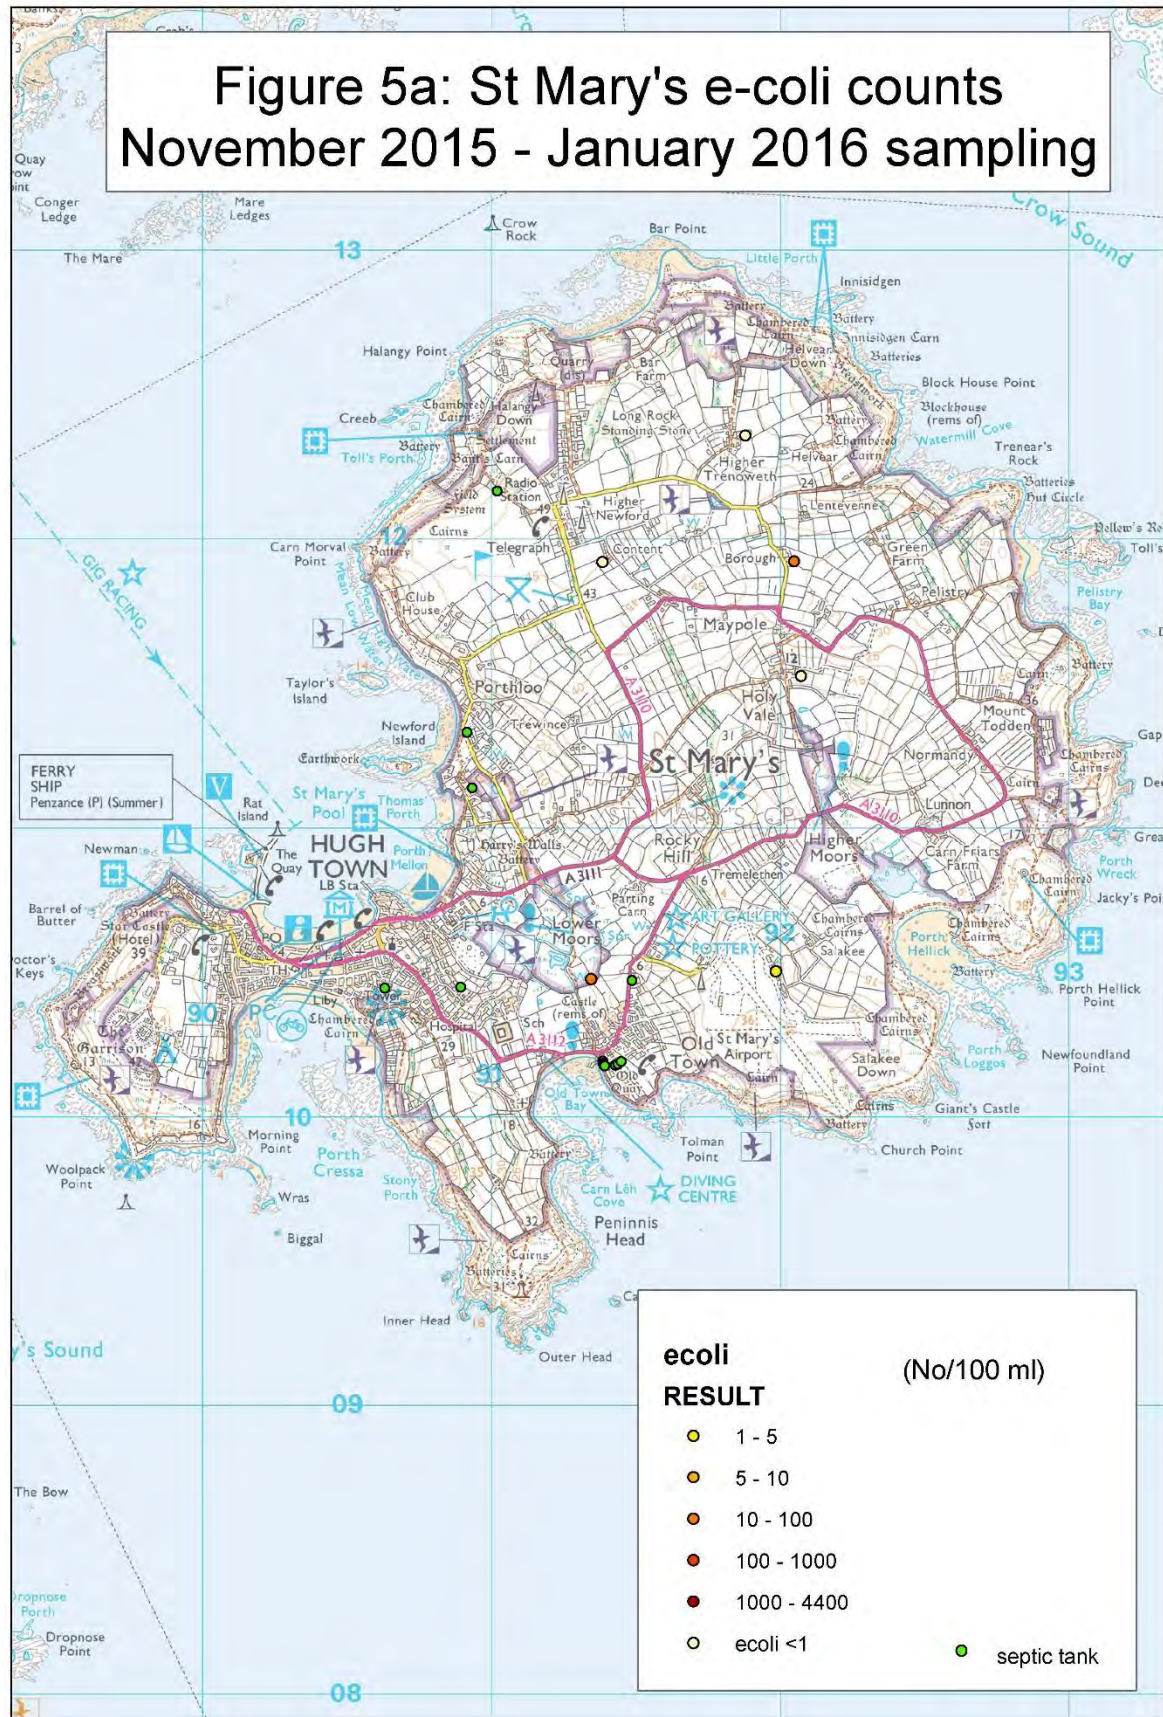
Figure 5a: St Mary's e-coli counts  
November 2015 - January 2016 sampling

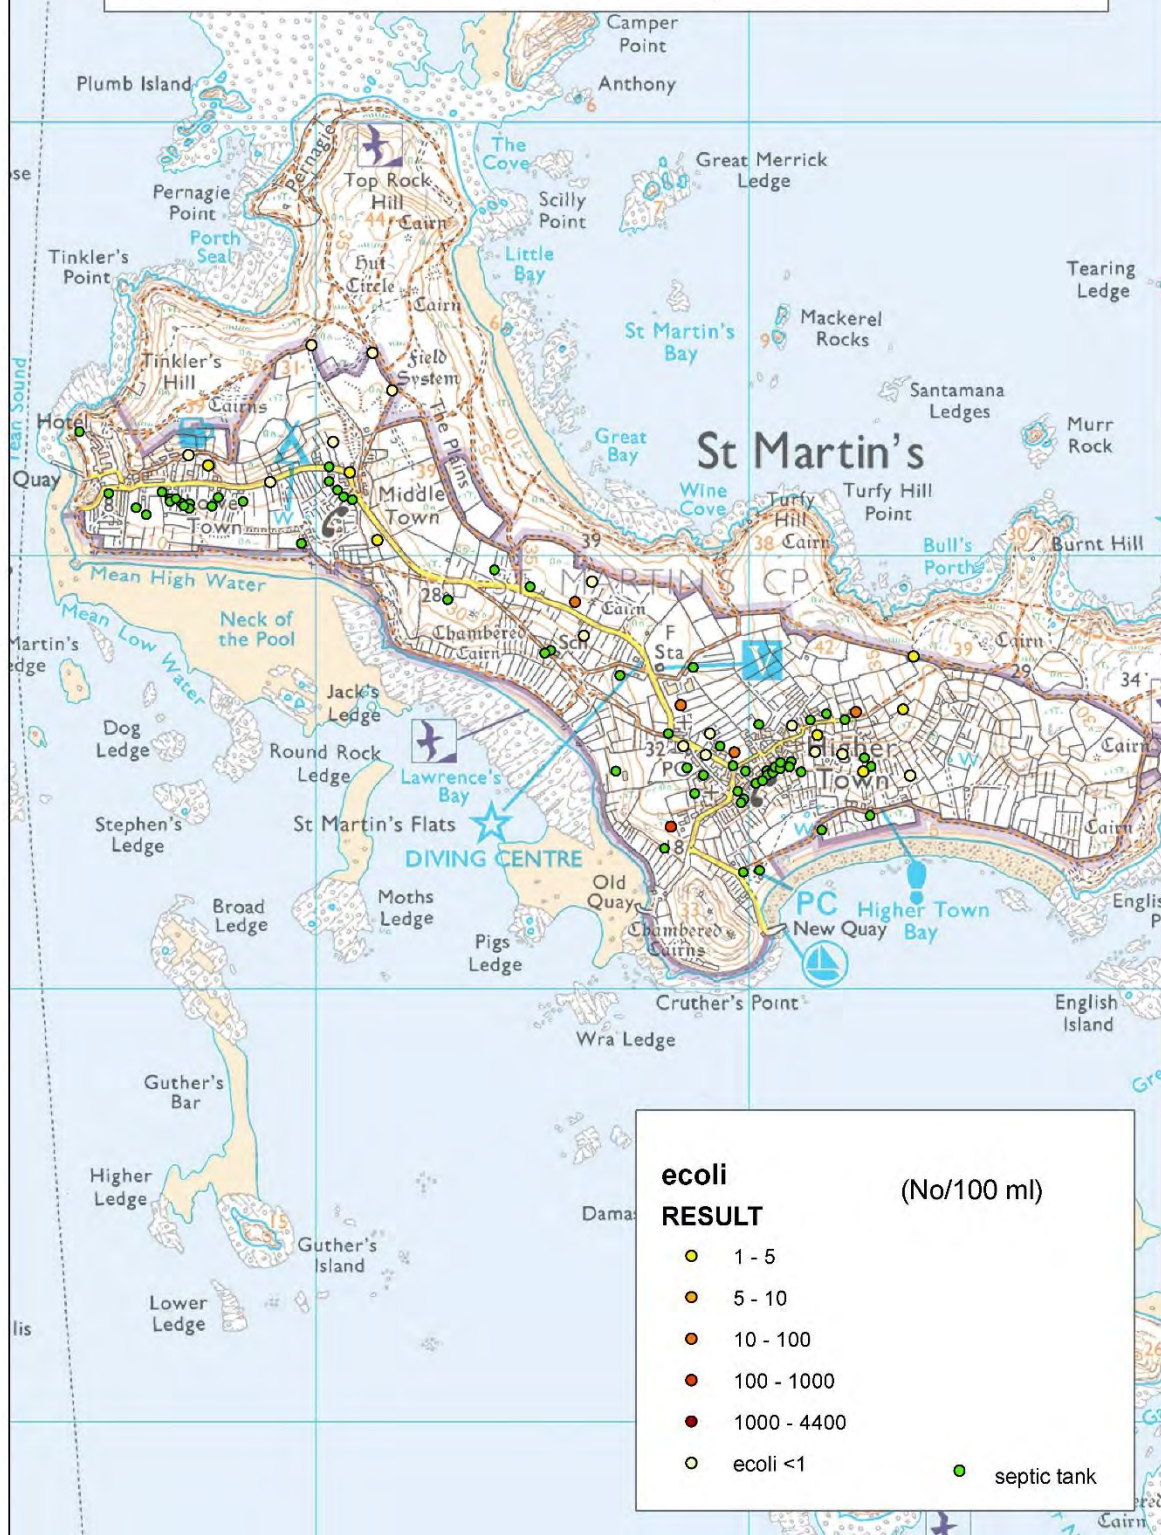
**Figure 5b: St Martins e-coli counts  
November 2015 - January 2016 sampling**

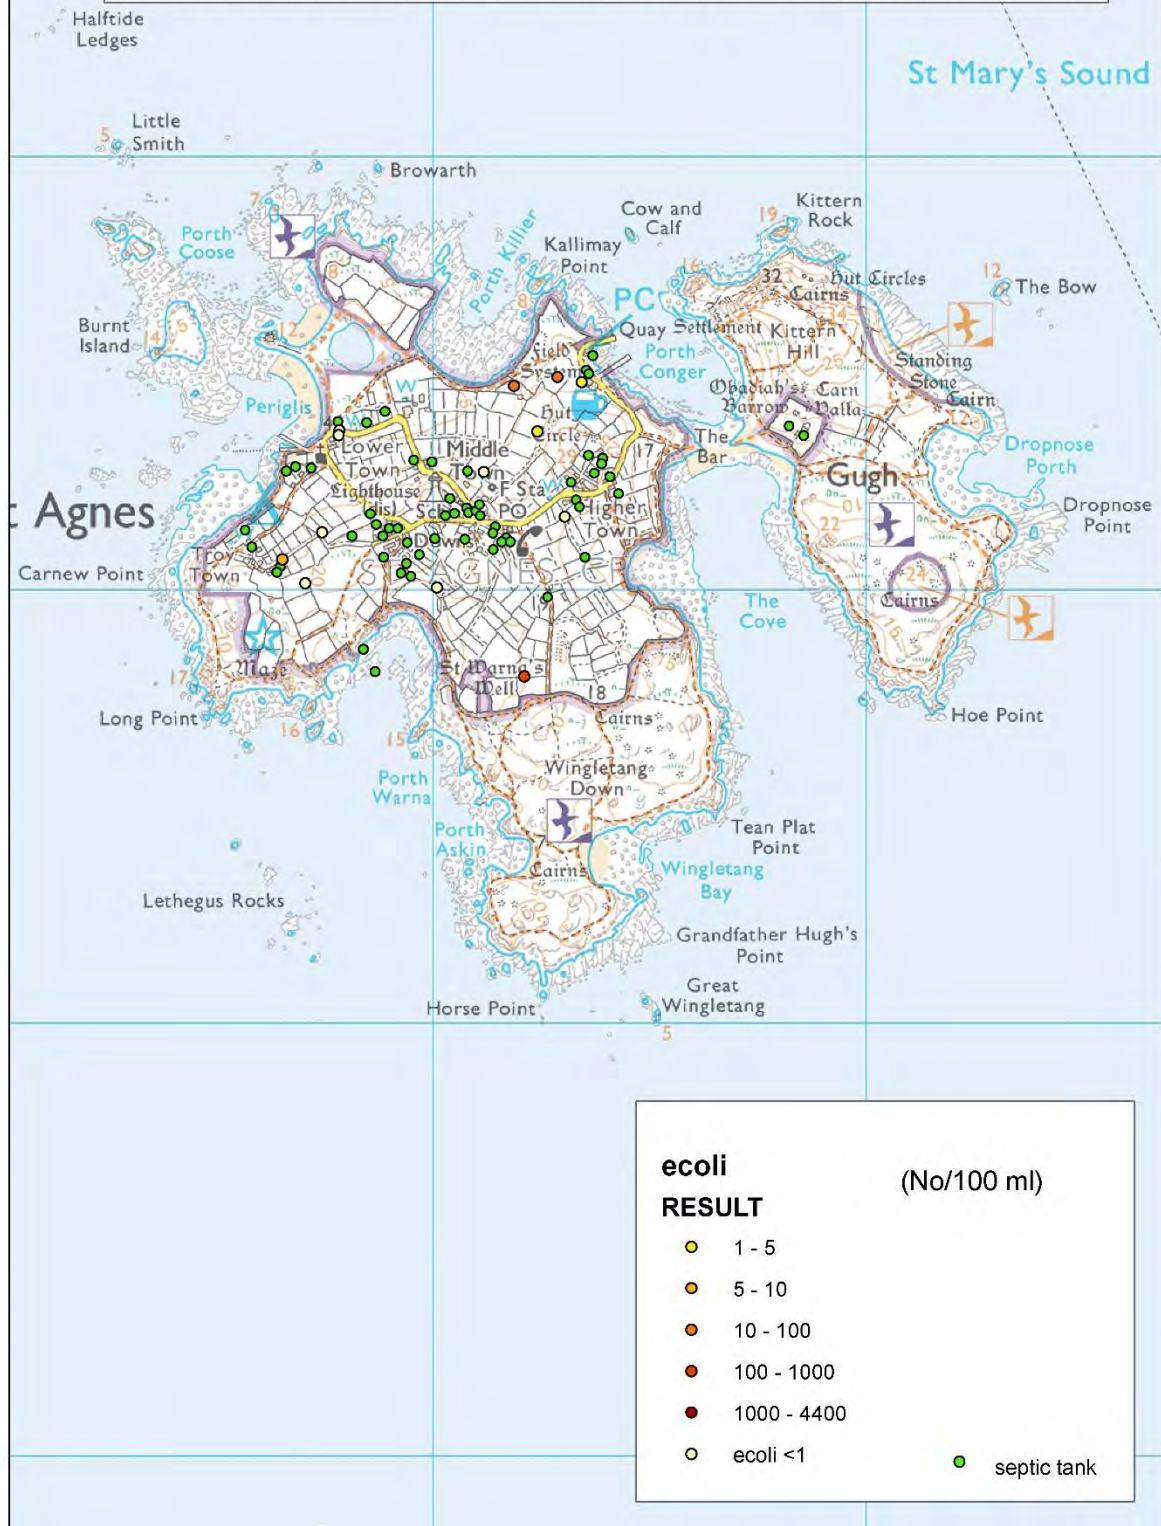
Figure 5c: St Agnes e-coli counts  
November 2015 - January 2016 sampling

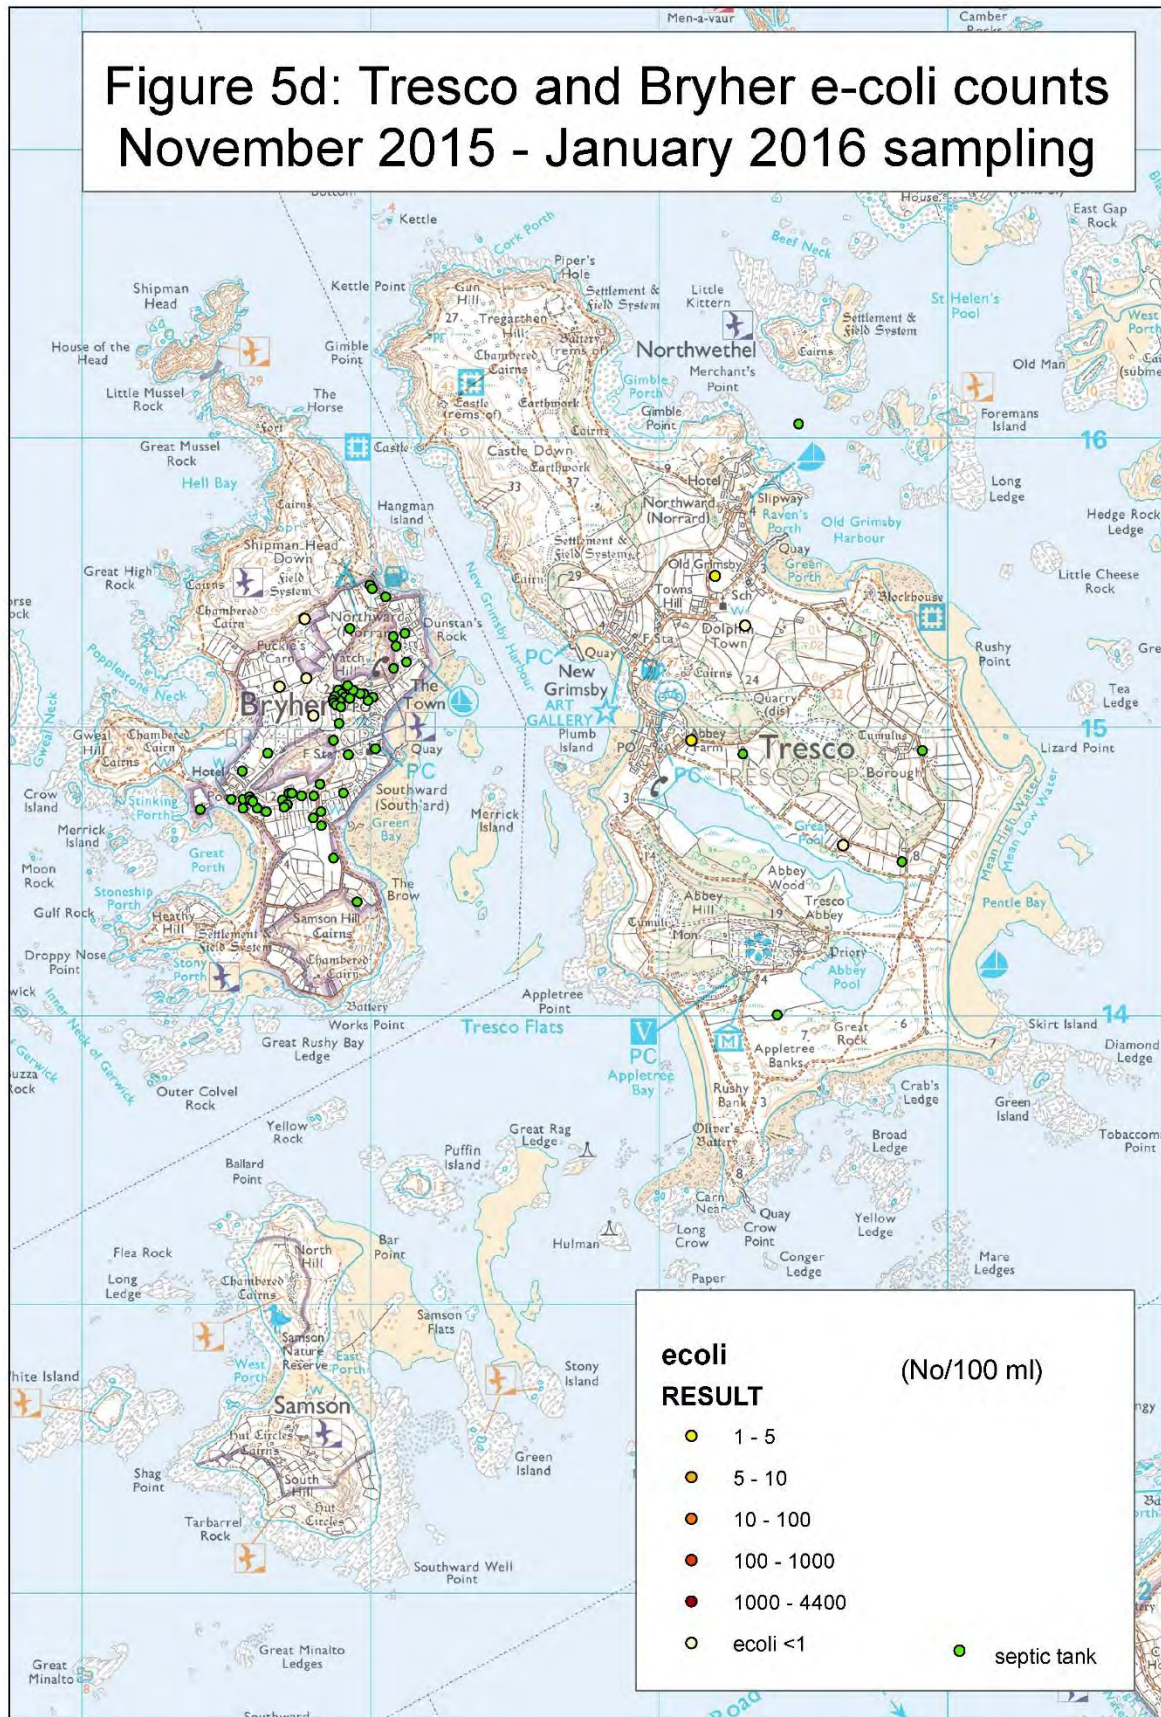
Figure 5d: Tresco and Bryher e-coli counts  
November 2015 - January 2016 sampling

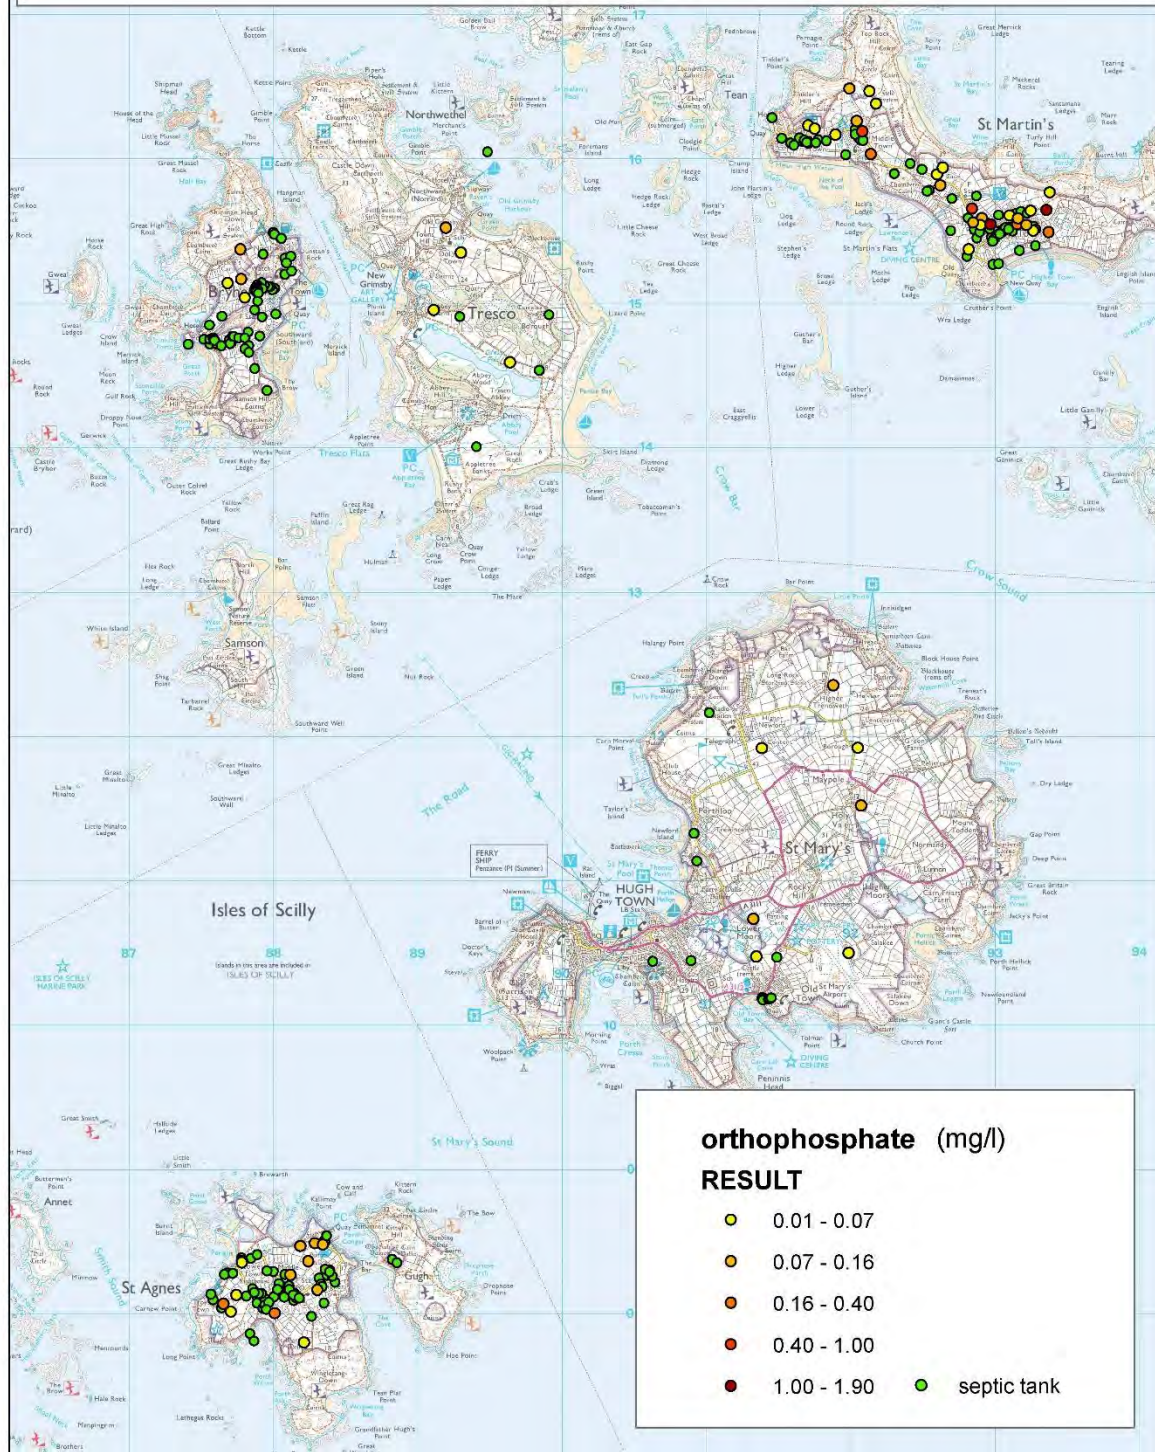
Figure 6: Isles of Scilly orthophosphate concentrations. November 2015 - January 2016 sampling

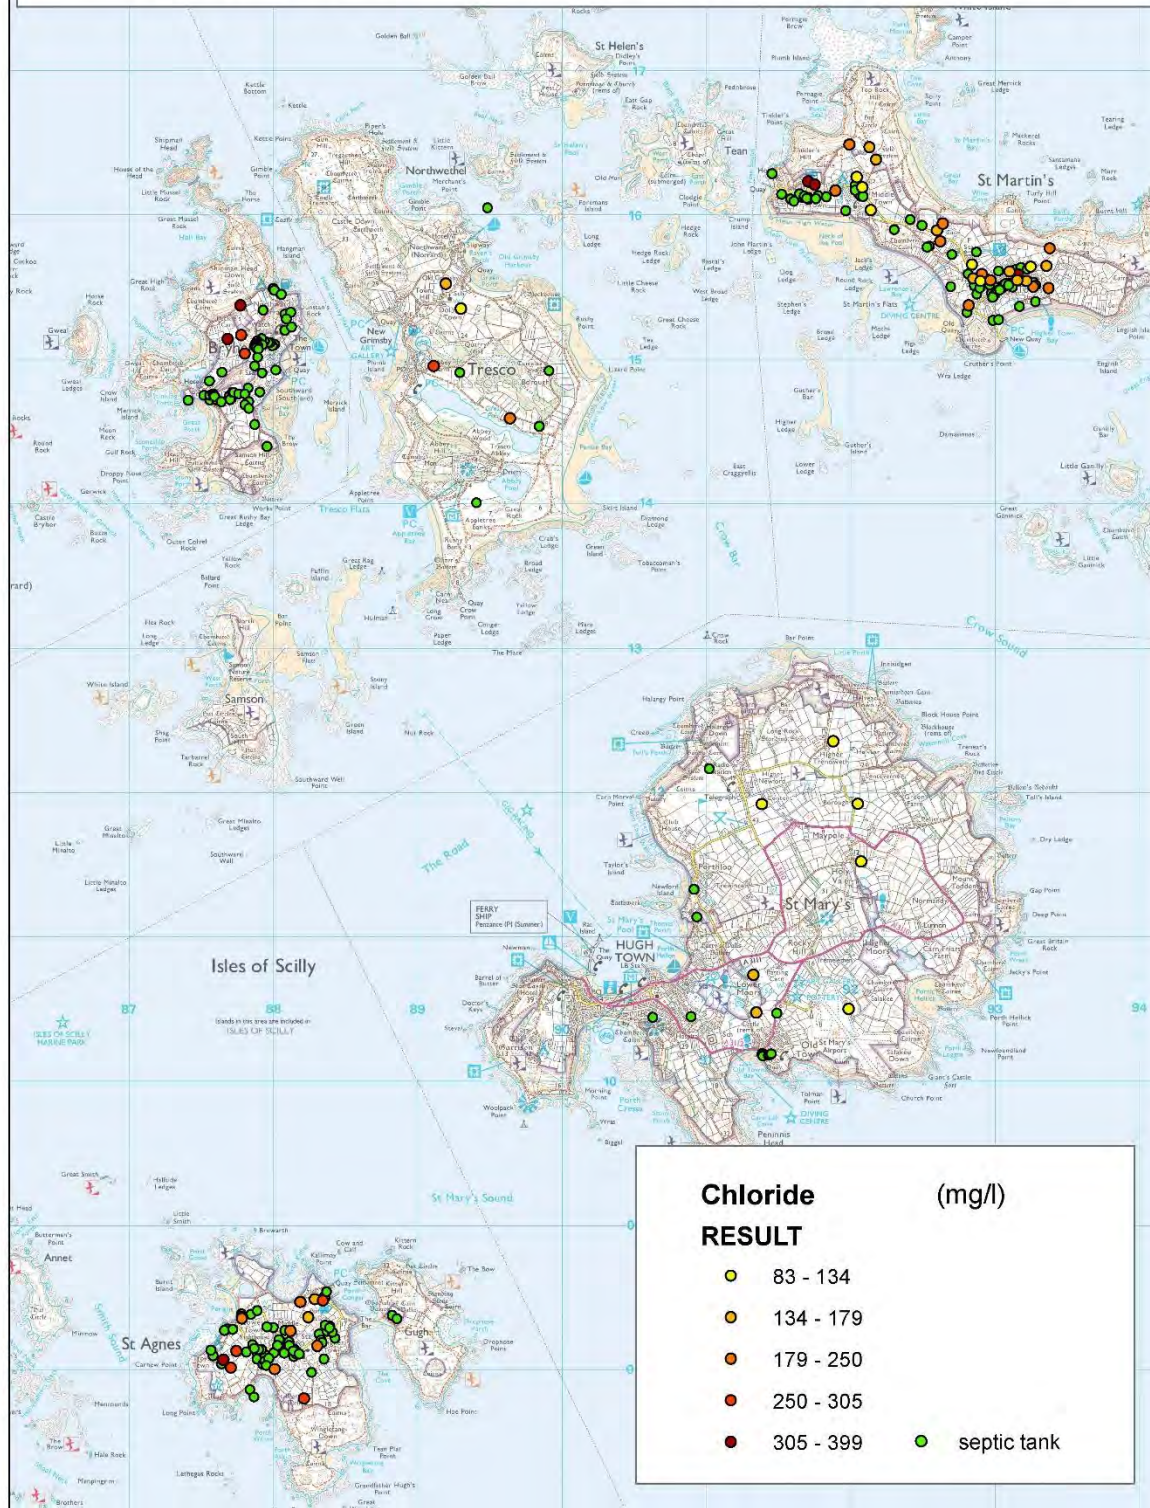
Figure 7: Isles of Scilly chloride concentrations  
November 2015 - January 2016 sampling

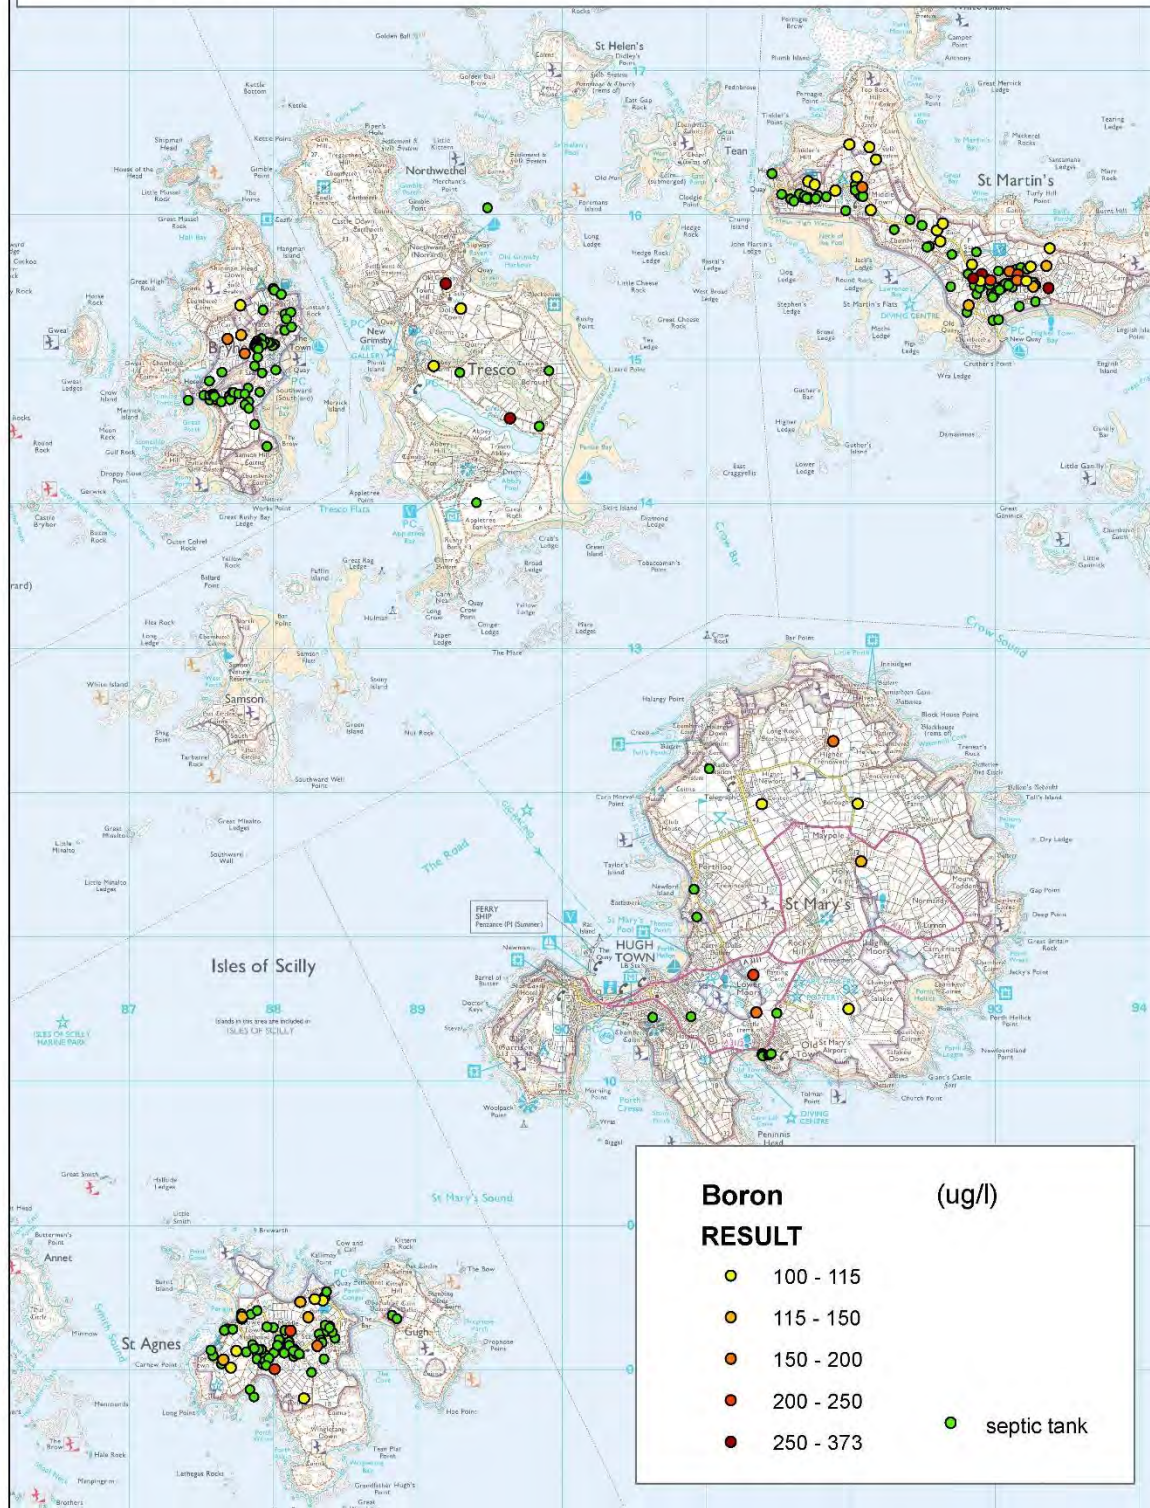
Figure 8: Isles of Scilly boron concentrations  
November 2015 - January 2016 sampling
