# Sewage-related contaminants in Isles of Scilly groundwater: concentrations, spatial distribution, sources and risk

Project ENVRESW001361

September 2016

Part 2 of 4

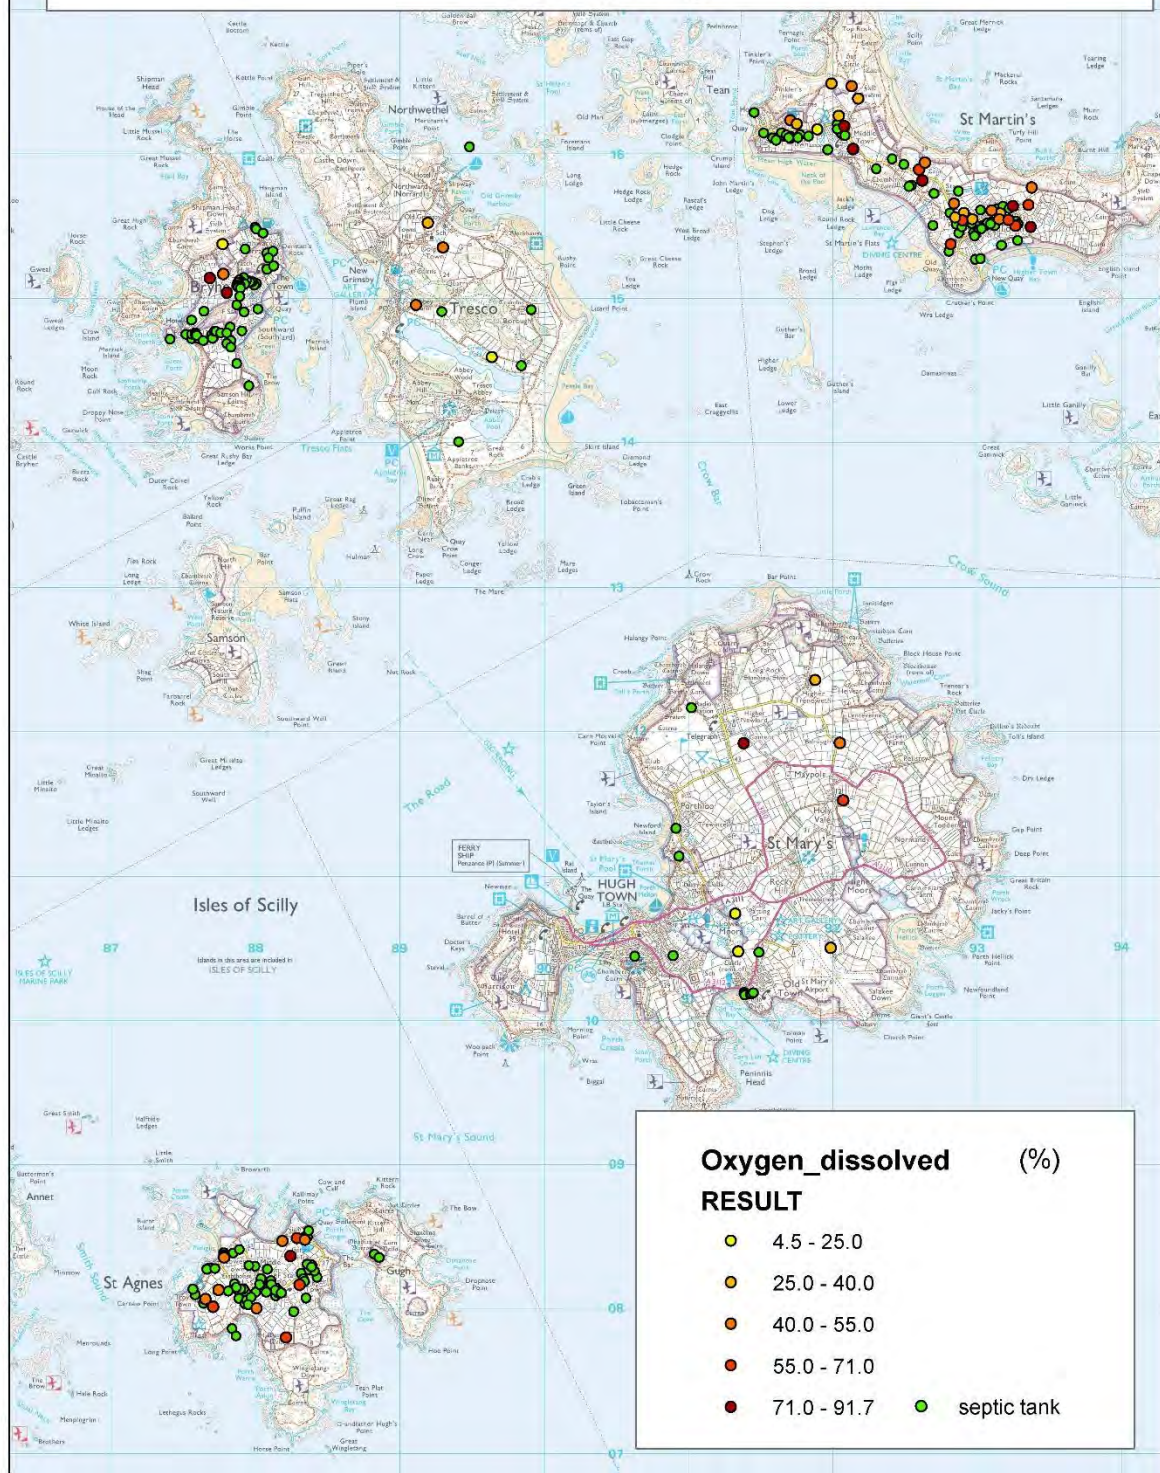
Figure 9: Isles of Scilly dissolved oxygen percentages, November 2015 - January 2016 sampling
