SAFETY FLYER TO THE FISHING INDUSTRY

**Fishing boat Constant Friend (N83) fatal man overboard while boarding,
23 September 2017**

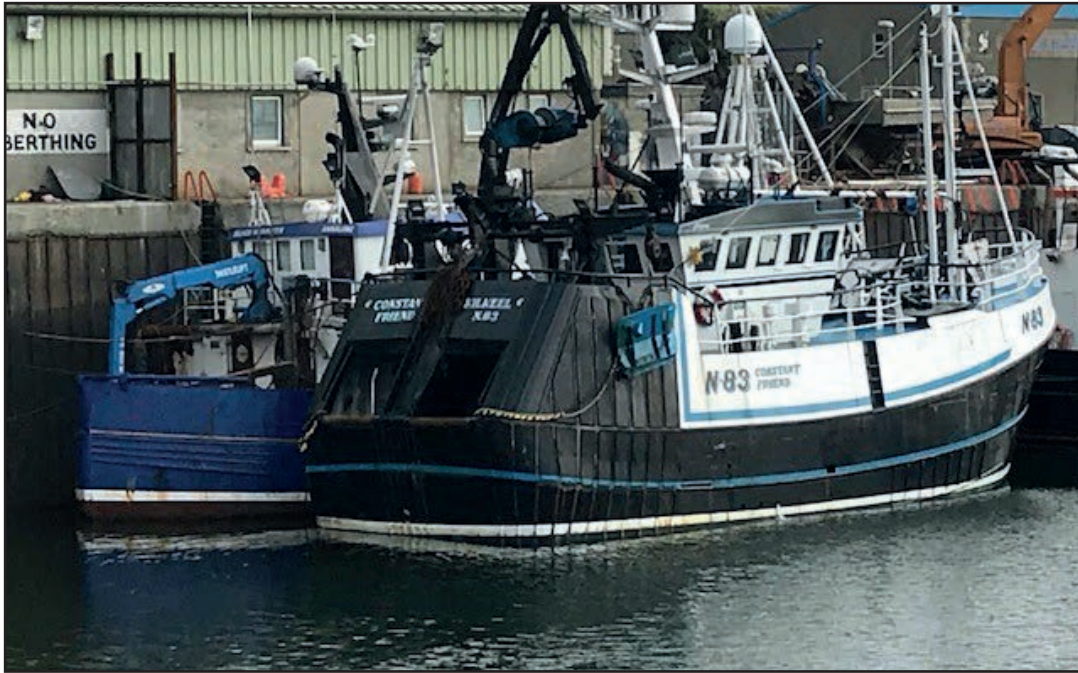
Constant Friend alongside another fishing vessel

The crewman had been socialising ashore with other members of the crew and had stayed drinking alcohol when his colleagues returned to the boat. *Constant Friend* was berthed outboard of another fishing boat adjacent to the fish market buildings in the harbour. Access to the boat was by climbing over guardrails onto the deck of the first boat and then repeating this procedure to access *Constant Friend*. The fisherman was recovered from the water by his crewmates, who commenced CPR. Resuscitation efforts were suspended while he was carried to the Fishermen's Mission where RNLI lifeboat crew and coastguard rescue team (CRT) members arrived and resumed CPR until an ambulance arrived. The crewman was transferred to hospital but died in intensive care on 28 September.

The MAIB investigation identified that climbing over the guardrails to cross between the two vessels was inherently hazardous. The risk of a slip or fall was further increased because it was dark, the surfaces were wet, and the vessels were moving significantly. Additionally, the crewman's consumption of alcohol had probably adversely affected his reaction time, co-ordination and perception of risk. Had the risk assessment focused more thoroughly on the need to prevent crew falling in when boarding or leaving the boat, it might have recognised that the existing boarding arrangements were inherently dangerous and, therefore, might have prompted more appropriate controls to be developed. Such controls include the provision of guardrail gates and a formal arrangement for a nominated crewman to monitor and assist individuals boarding the boat.

1. Risk assessments are a legal requirement, but they should also be a realistic means for ensuring the safety of the crew. Assessments, even of such things as boarding arrangements, need to be regularly reviewed and may need dynamic updates to reflect changing circumstances and environmental conditions.
