Air Quality and Dust Monitoring Monthly Report – April 2019

London Borough of Hillingdon

A report prepared by Costain Skanska on behalf of HS2 Ltd.

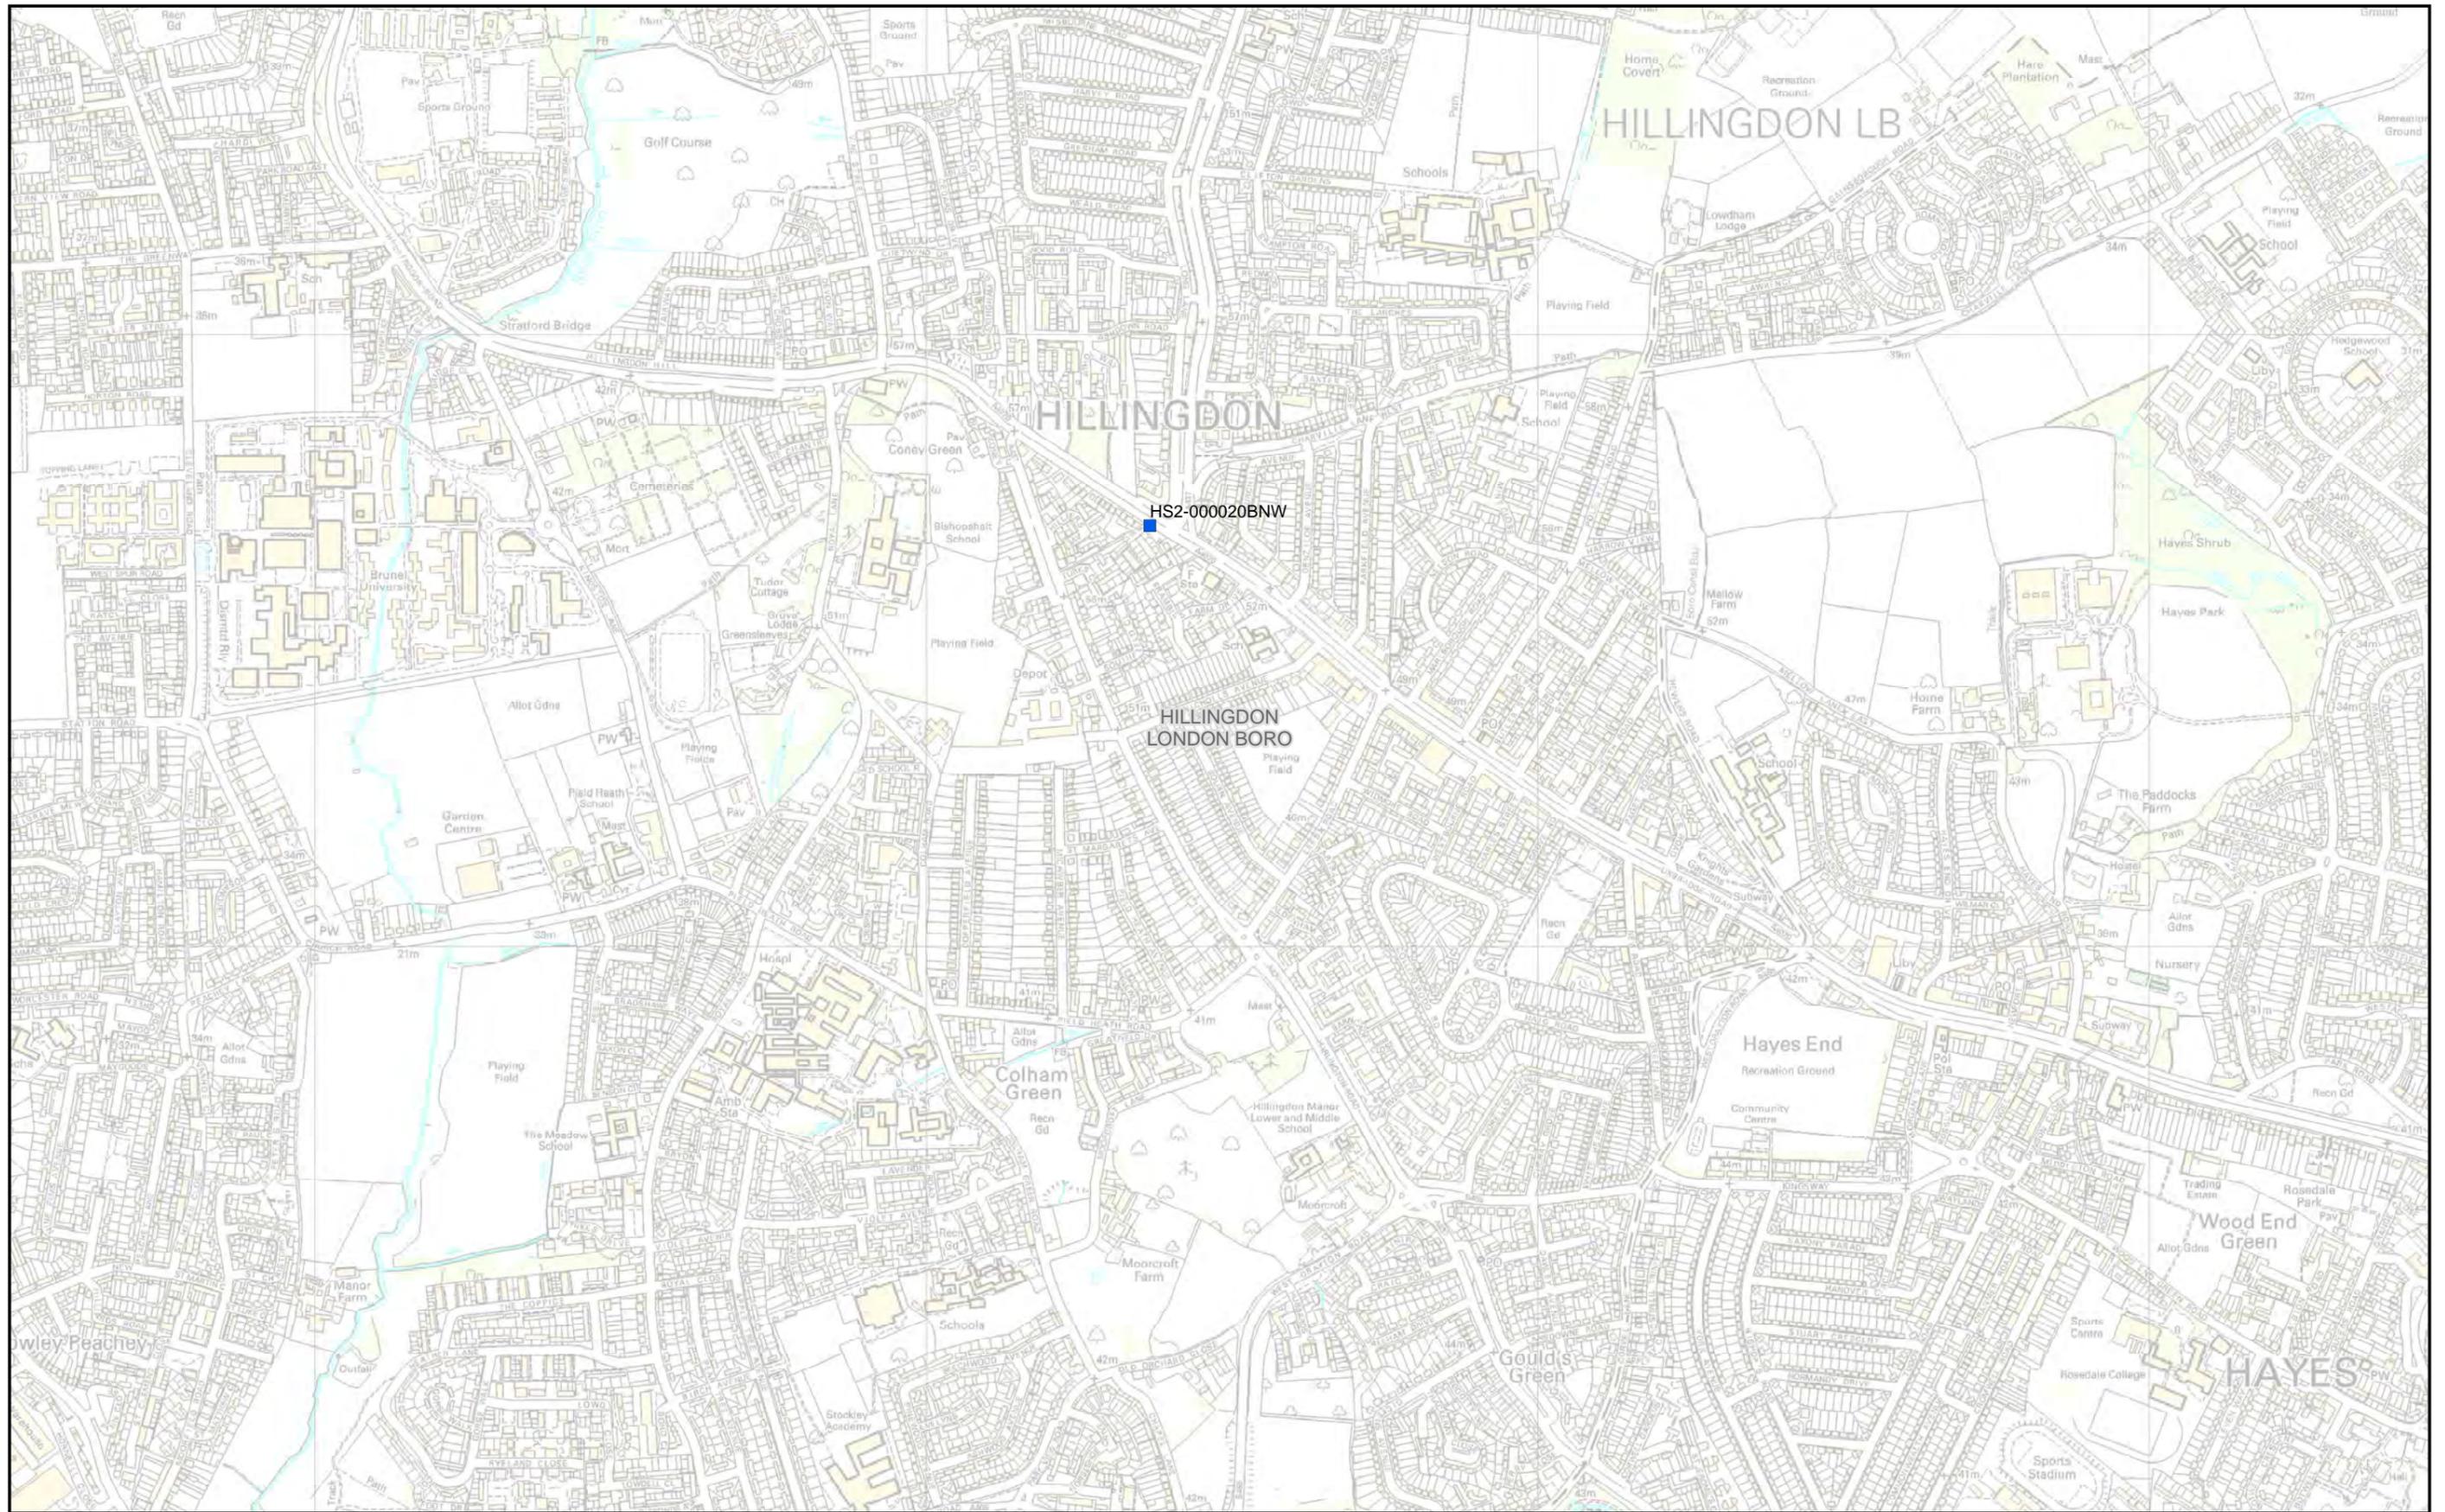
Figure Number	
Figure Name	Worksites and Monitoring locations in LBH (sheet 4)
London Borough of Hillingdon

Diffusion tube monitoring location

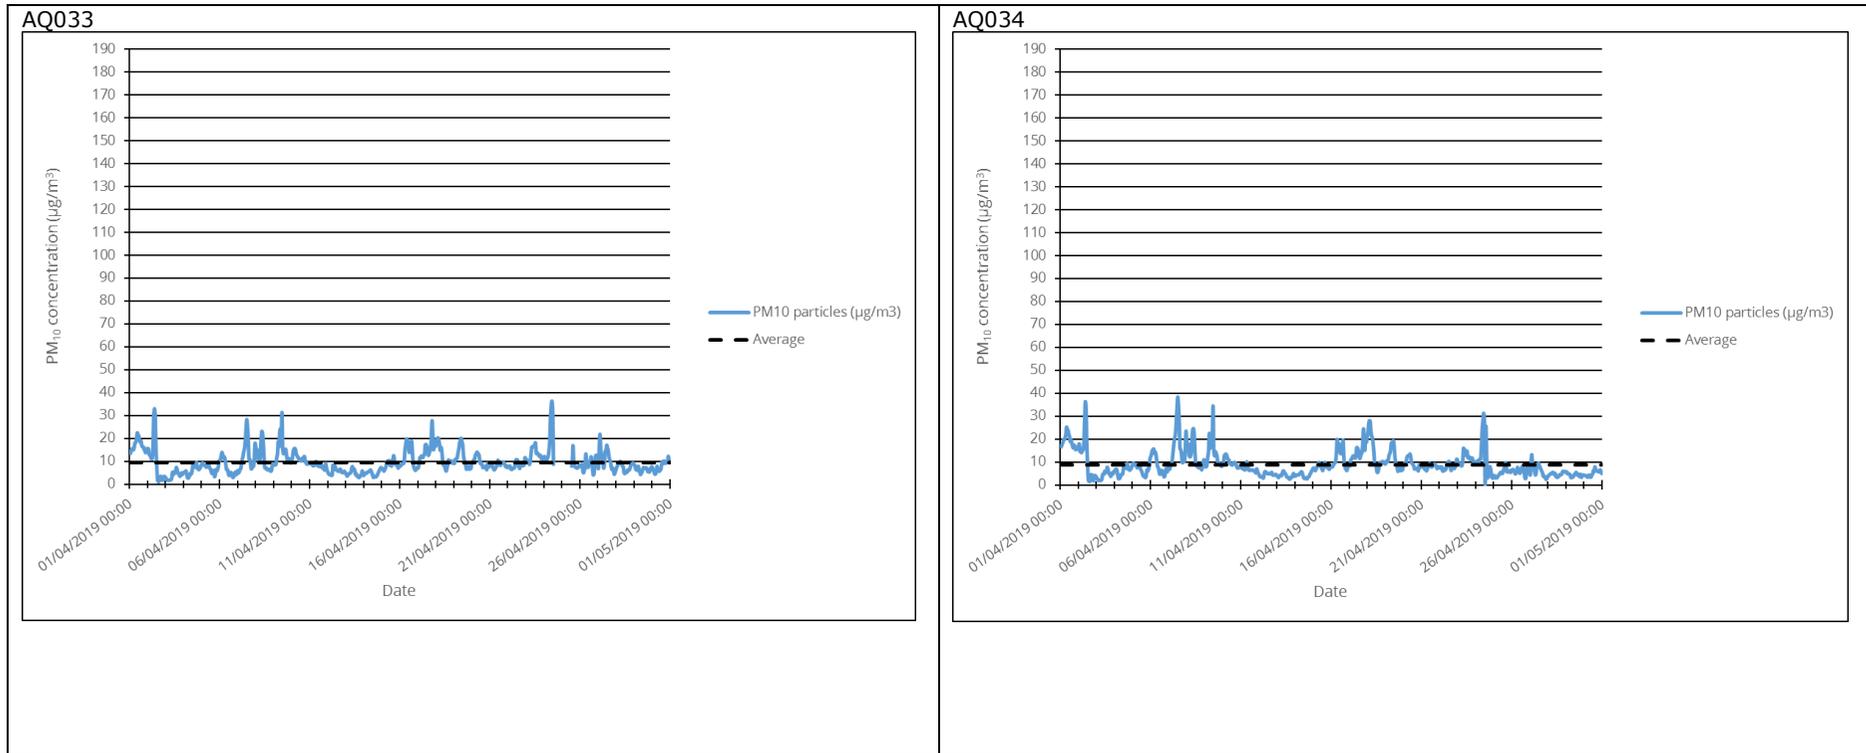
Figure 5: Construction dust 1-hour mean indicative PM₁₀ concentration for dust monitors

- 1.1.6 Dust monitoring locations and results are presented in Appendix B, Table 1 together with line charts of monthly data from each dust monitor.
- 1.1.7 There were no (0) exceedances of the dust trigger level recorded during the month of April 2019. All results were in line with the expected ranges.
