Air Quality and Dust Monitoring Monthly Report – **October** 2020

London Borough of Hammersmith and
Fulham

A report prepared by Costain Skanska on behalf of HS2 Ltd.

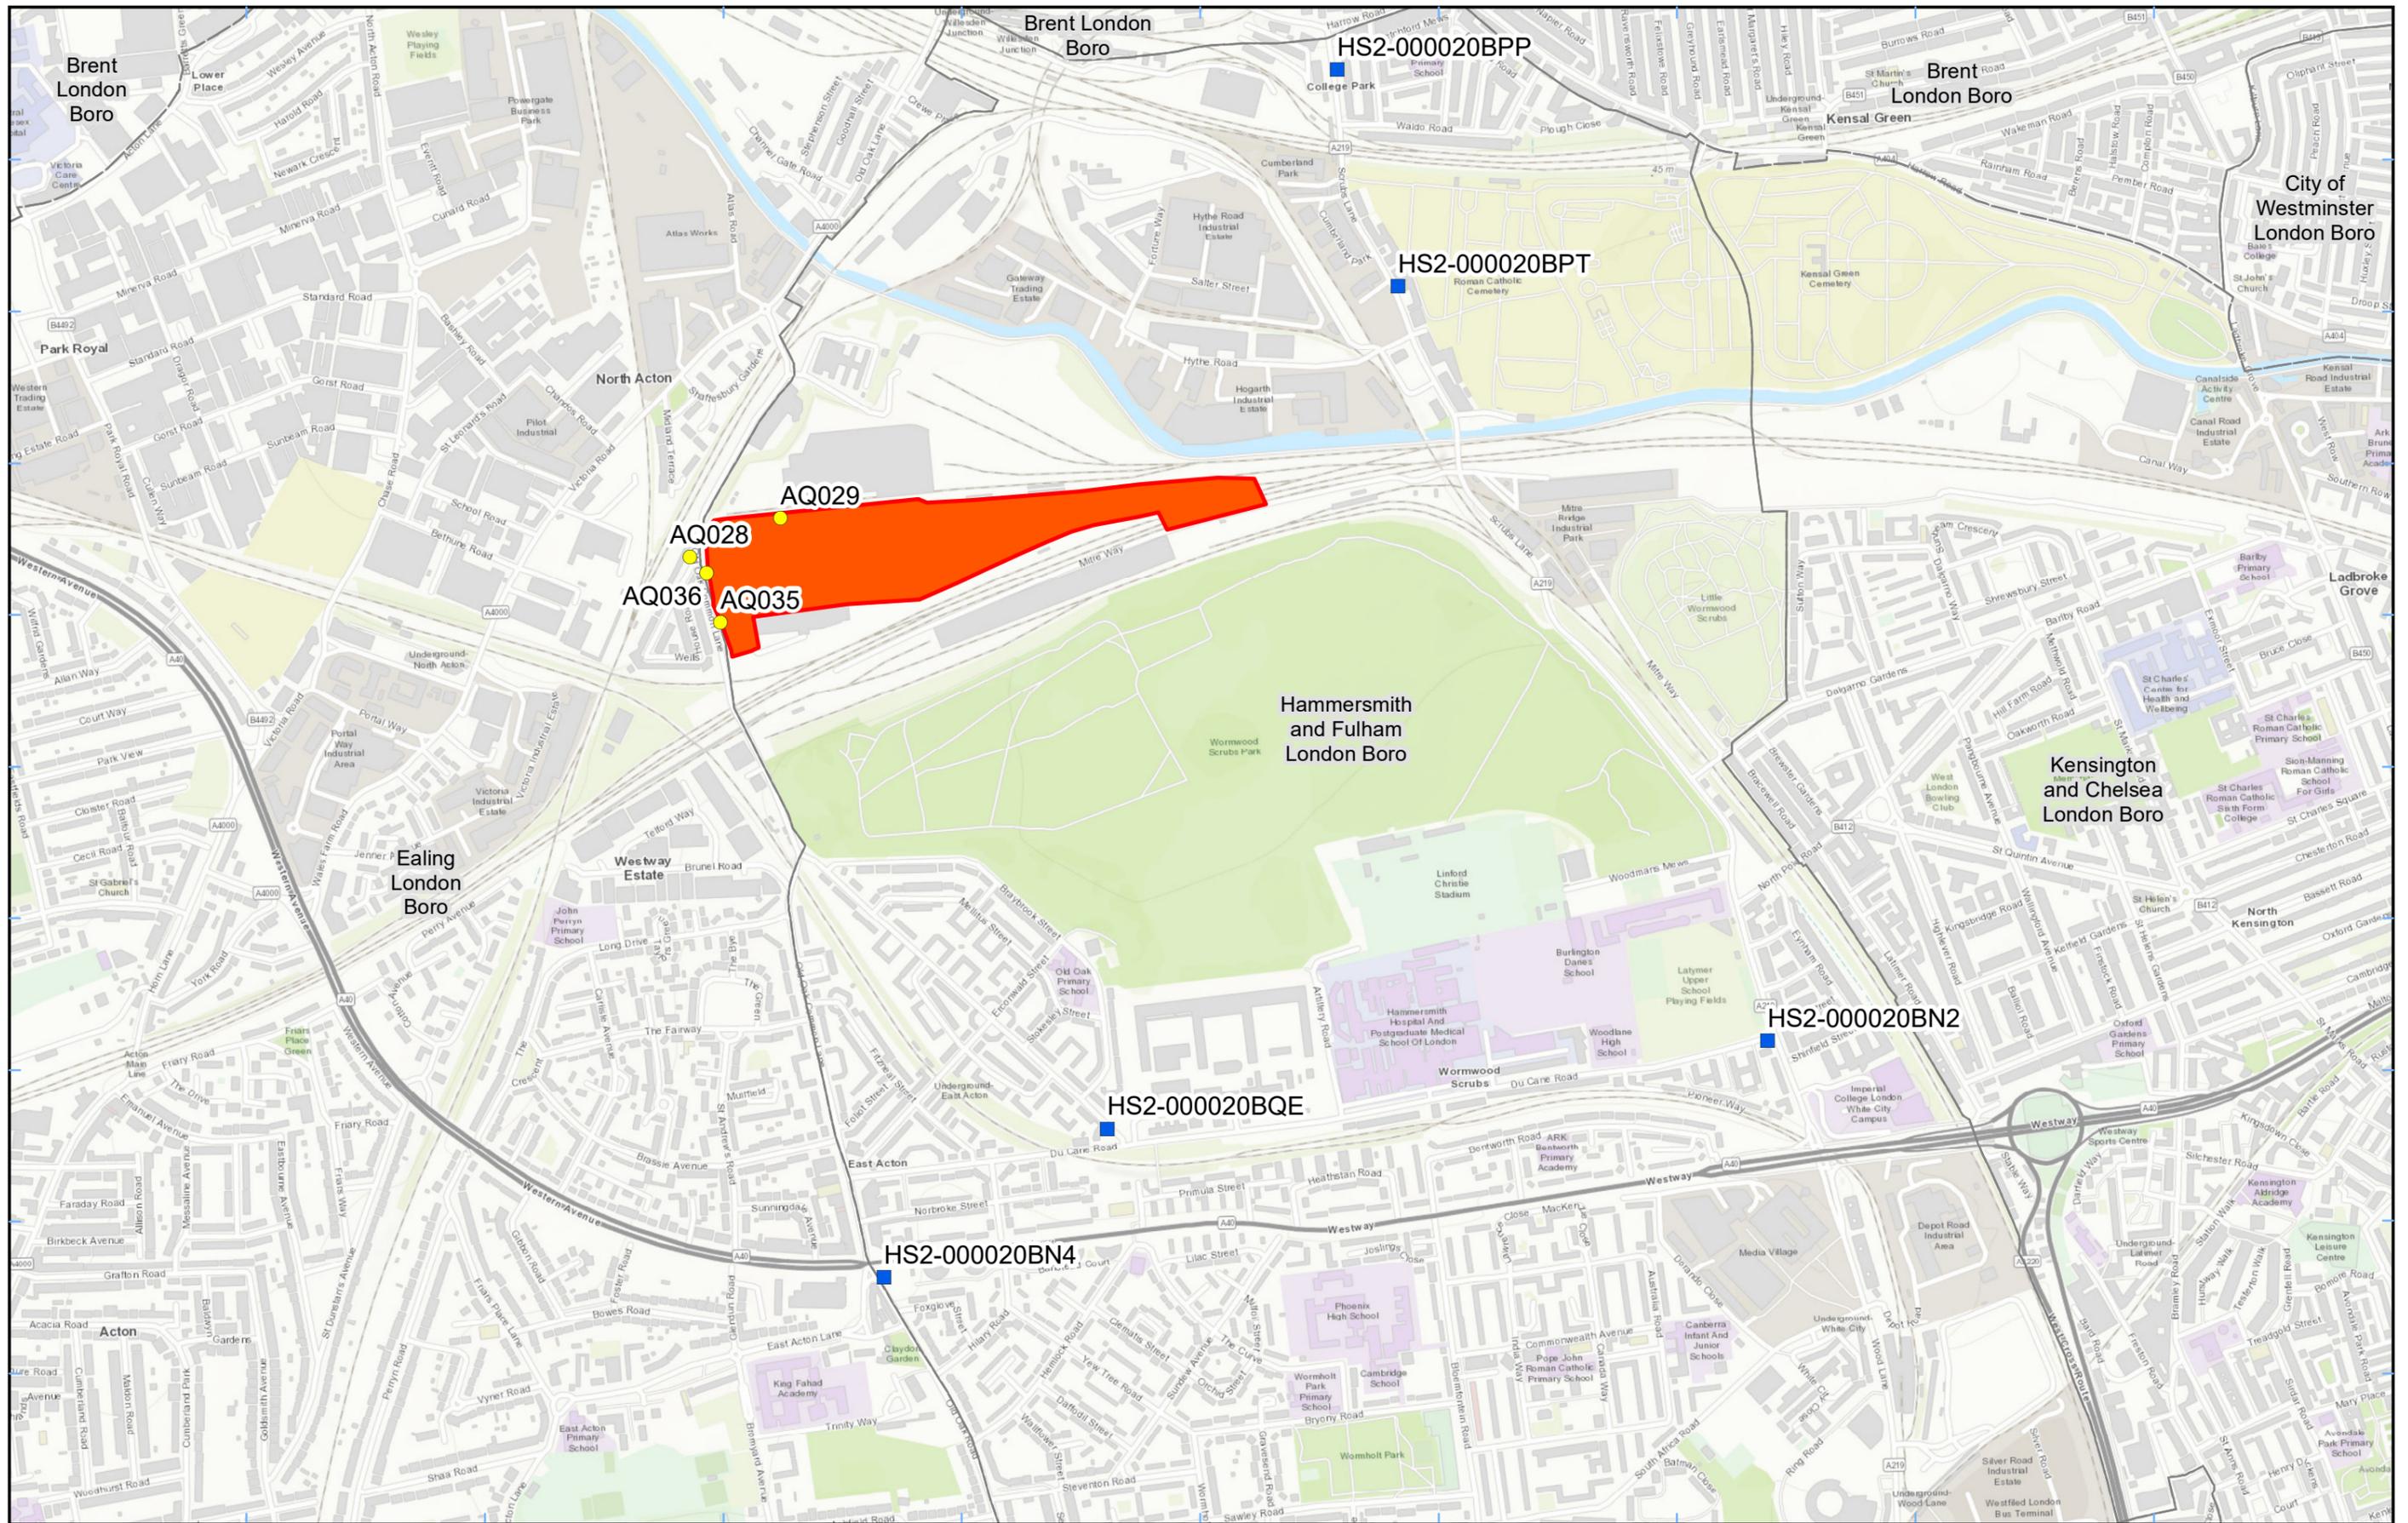
Figure 1 and 2: Worksites and monitoring locations within the LBHF

- 1.1.2 Figure 1 and Figure 2 in Appendix A indicate the current worksite together with air quality and dust monitoring locations.
- 1.1.3 This summary should be read in conjunction with the overview monitoring report available from www.gov.uk/government/collections/monitoring-the-environmental-effects-of-hs2, which highlights: the applicable standards and guidance, as well as the air quality and dust monitoring methodologies to be implemented by nominated undertakers throughout construction.

- 1.1.4 The current phase of works commenced within the LBHF during May 2018 and completed in August 2020. The next phase of construction works commenced in July 2020 and is expected to be completed by 2026. The current worksite, as presented in Appendix A, Figure 1 and Figure 2, includes:

Worksite and Monitoring Locations In LBHF (Sheet 1)

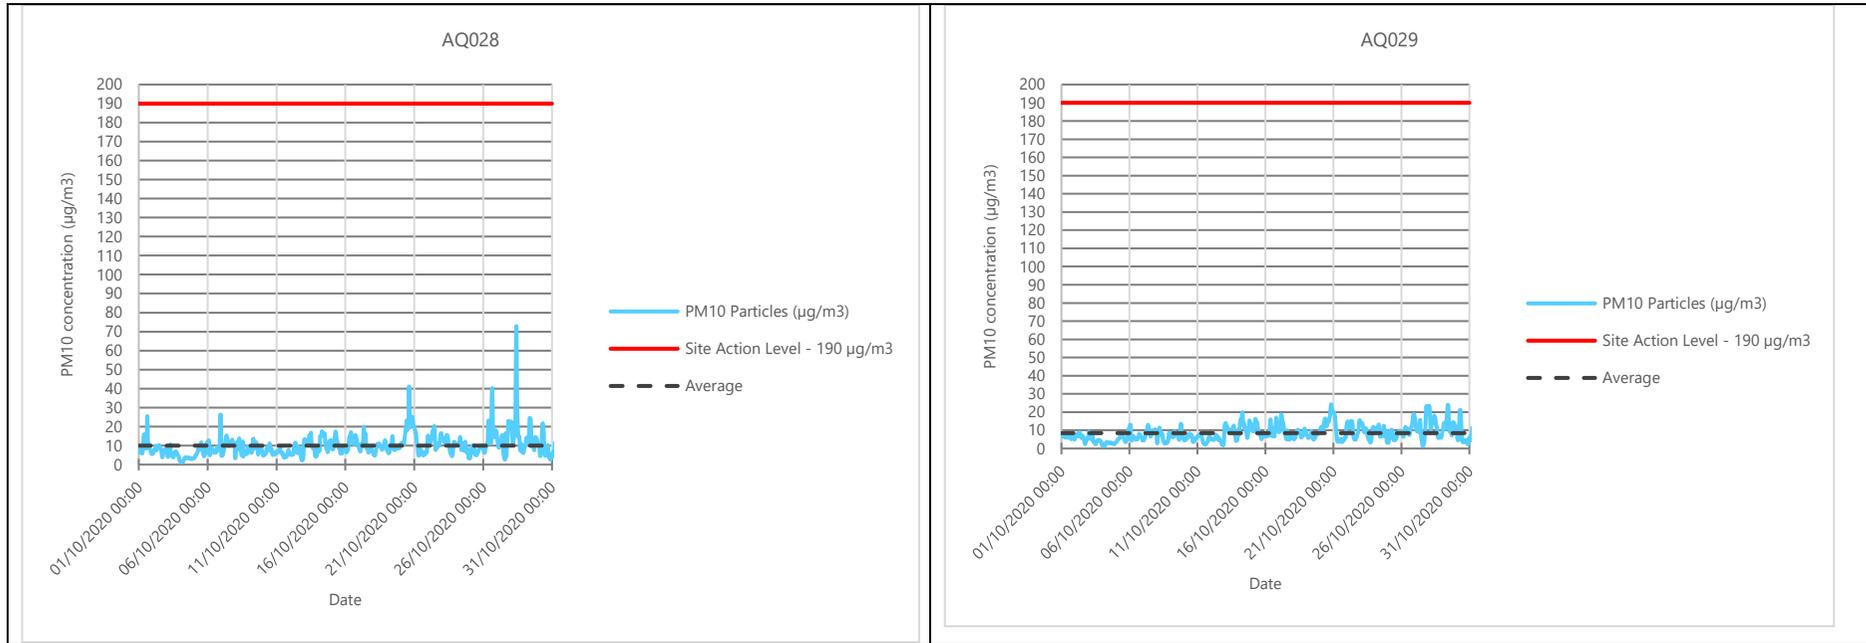
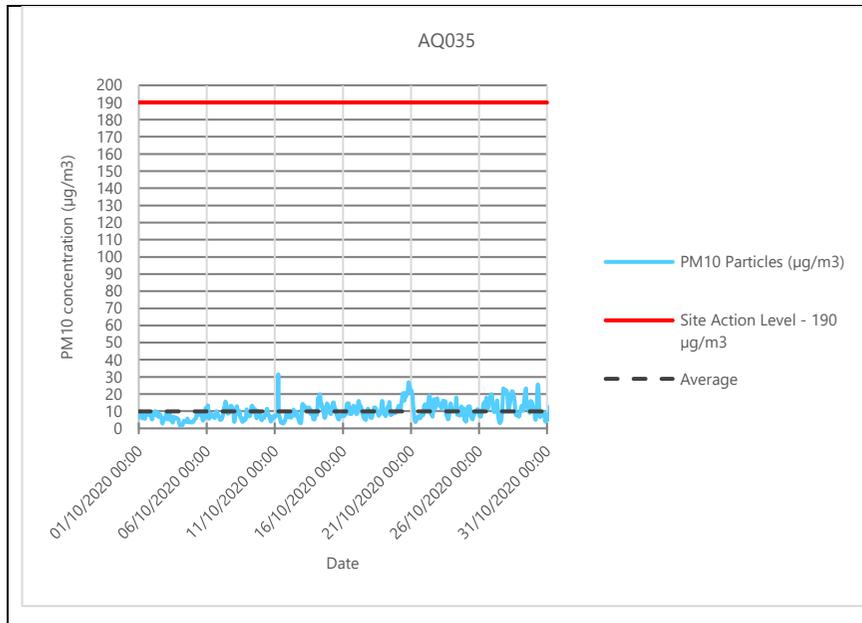
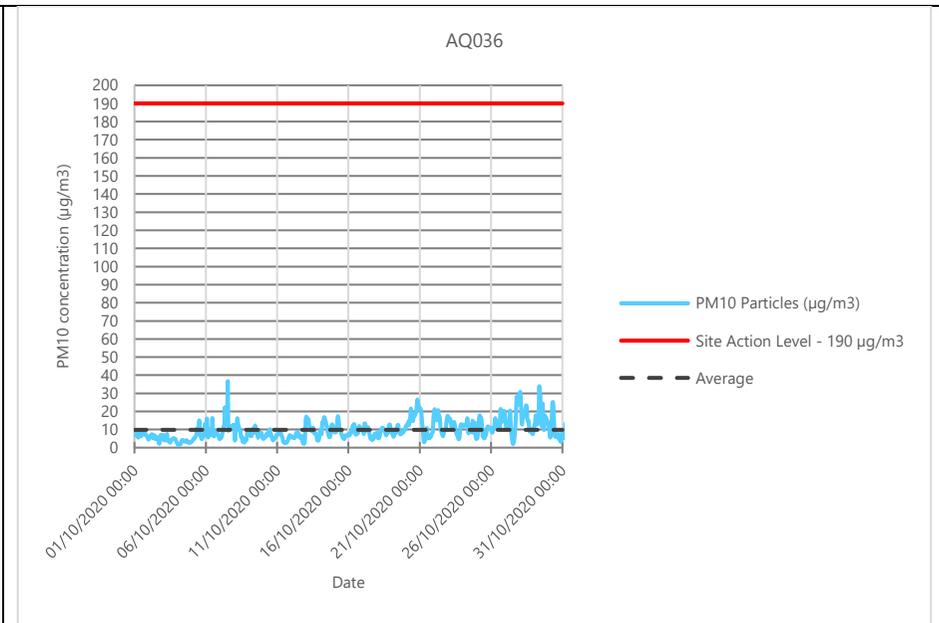
Figure 3: Construction dust 1-hour mean indicative PM₁₀ concentration for dust monitors

- 1.1.6 Dust monitoring locations and results are presented in Appendix B, **Error! Reference source not found.**, together with line charts of monthly data from each dust monitor in Figure 3. All continuous dust monitoring is undertaken using indicative monitors. Despite being Environment Agency (MCERTS) certified, indicative monitors carry a higher level of uncertainty than reference monitors, and therefore cannot be strictly compared with Air Quality Standards for human health and the environment. The purpose of the monitoring undertaken is to ensure the effectiveness of the on-site mitigation.

- 1.1.7 The trigger level for PM₁₀ concentrations of 190 µg/m³, over a 1-hour period, in accordance with the updated guidance document '*Guidance on Monitoring in the Vicinity of Demolition and Construction Sites – (October 2018)*' has been applied.

- 1.1.8 There were no (0) dust trigger alerts recorded during this monitoring period (October 2020).
- 1.1.9 Diffusion tube monitoring of Nitrogen Dioxide (NO₂) is undertaken at seven (7) locations around highways within the LBHF as part of the management of air quality where significant effects may occur as a result of the scheme. However, based on the results to date, no unexpected values were recorded during the monitoring period.
