# Safety bulletin 2/2004

## Quick release arrangements for the manual deployment of inflatable liferafts

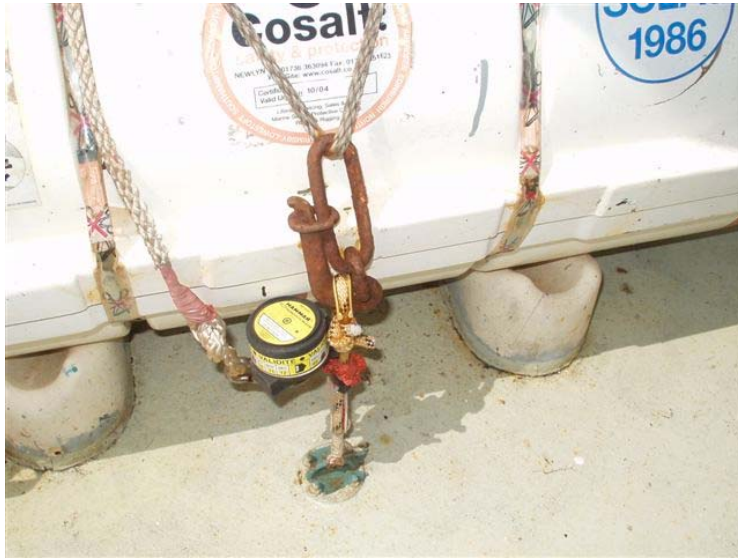
### Typical senhouse -slip arrangement

It is the custom to lash liferafts to the deck of fishing vessels using rope or webbing straps. Hydrostatic release mechanisms are fitted to the lashing to allow the raft to automatically float free and deploy from a sinking vessel, however, the rope or webbing lashing is also usually fitted with a quick release, senhouse-slip arrangement to facilitate rapid deployment of the raft in the event of an emergency.

When the *Julian Paul* began to flood, the crew of the fishing boat found it impossible to release the liferaft from its lashing using the senhouse-slip arrangement. The raft was eventually released by cutting the lashing with a knife.

*Paul*, the MAIB commissioned a survey of the lashing arrangements for liferafts on board a number of fishing boats docked in one of the busiest UK fishing ports. The results of the survey revealed that almost one third of the senhouse-slip release arrangements that were inspected could not be easily released to allow rapid deployment of the liferaft.

Owners and skippers of all fishing, merchant and pleasure vessels are recommended to urgently review the lashing arrangements for liferafts fitted to their vessels to ensure that any manual quick release arrangements can be easily operated as intended. In the event that, on inspection, difficulty is experienced in releasing the lashings from liferafts, the quick release arrangements should be examined and, if required replaced at the earliest opportunity with a more suitable release system. Ship chandlers or liferaft supplier should be able to provide you with advice or assistance in this respect.
