To our customers and users of the Dräger Oxylog 2000 disposable ventilation hoses Ventstar 2M86791

Important safety notice!!

Disposable ventilation hoses Ventstar for the Dräger emergency breathing device Batch numbers 330384.001 - 331661.002

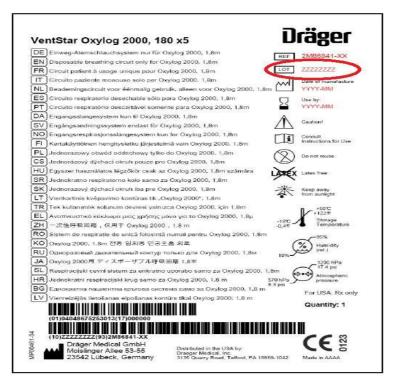
Illustration of the label on the packaging box set 2M86841:

Affected batch number: 330384.001 - 331661.002

Our records indicated that you received Disposable ventilation hoses Ventstar from an affected batch. Please check your stock in accordance with the batch number stated on the packaging label. An illustration of the packaging label with batch number is shown in appendix 1 of this letter.

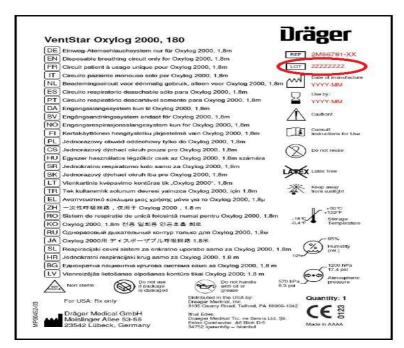
Illustration of the label on the packaging of the disposable hose 2M86791

Affected batch numbers: 330384.001 - 331661.002
