Urgent Field Safety Notice

Subject: Reminder for Product Safe Use—Dynamis™ and Gerialit™ Beds
manufactured between October 1995 and June 2001 with DEWERT electrical system
(not applicable to beds manufactured between June 2001 and January 2009 with SKF
electrical system)

FSCA-identifier: Mod 466

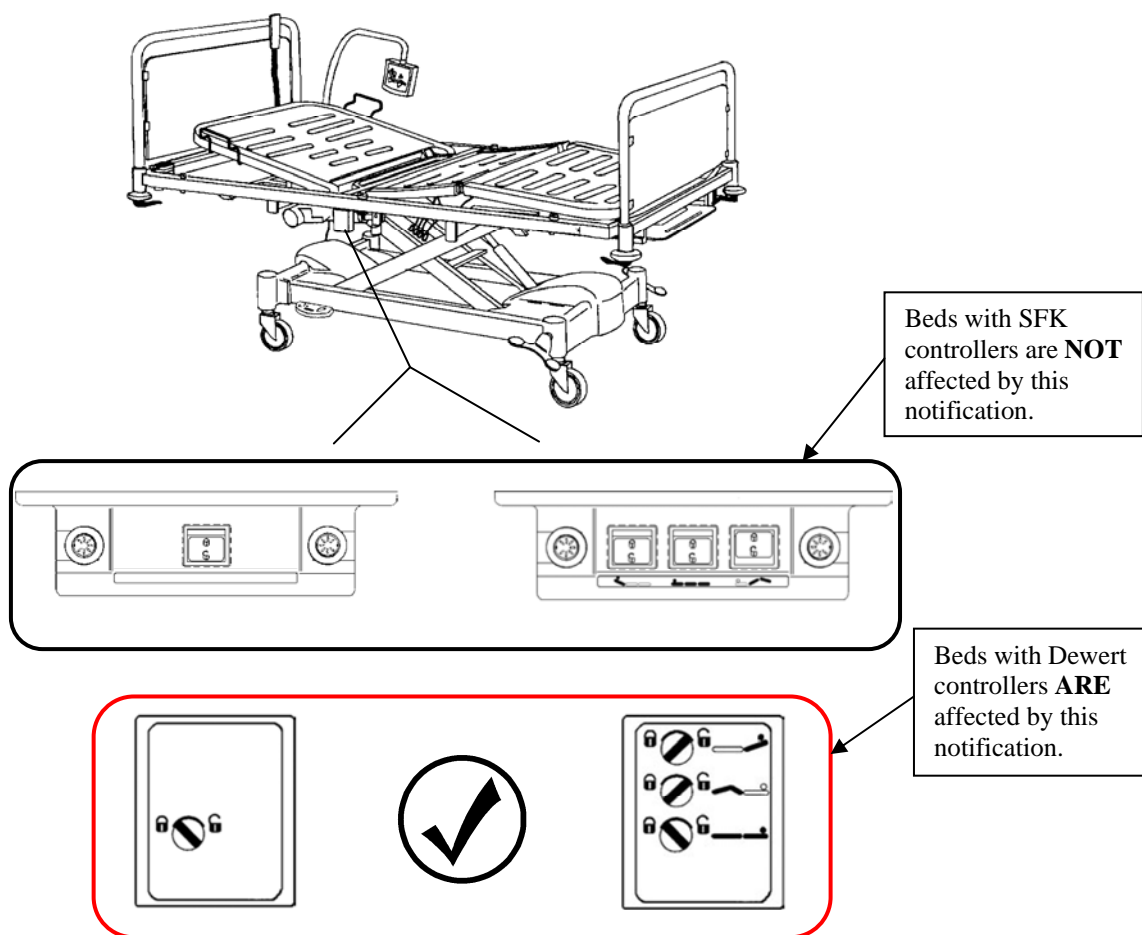
Dewert / SKF product identification :

As Dynamis™ and Gerialit™ beds have been manufactured with electrical systems manufactured by two different suppliers (Dewert or SKF), be advised that this notification applies **only to Dewert** (easy recognizable by the Lockout Unit Functions – see below).
