## **Chars Livelihoods Programme**

**A study to assess the performance of CLP raised plinths, low cost latrines and access to clean water during the July 2012 flood**

**Kenward, S., Cordier, L., Islam, R.**  
August 2012

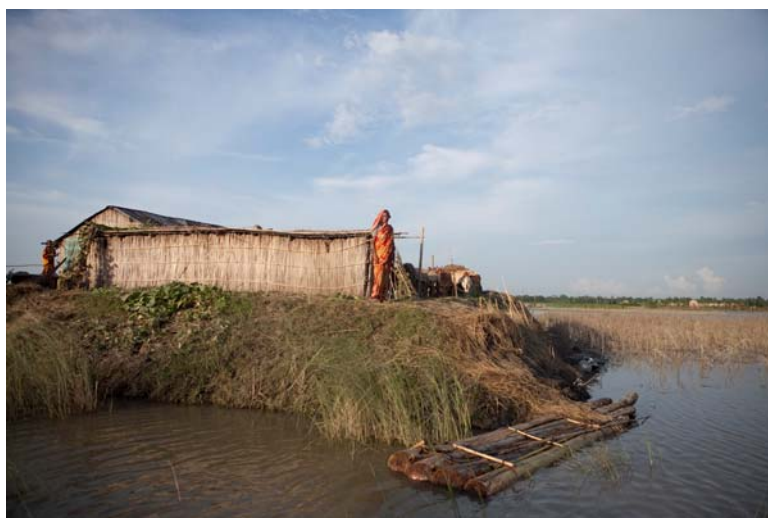
***Earthen plinth raised above flood levels***

The CLP seeks to provide environmental protection and alleviate the effects of flooding in the *chars*. As part of the CLP's package of interventions, the Programme raises households on earthen plinths 60 cm above the highest known flood level.

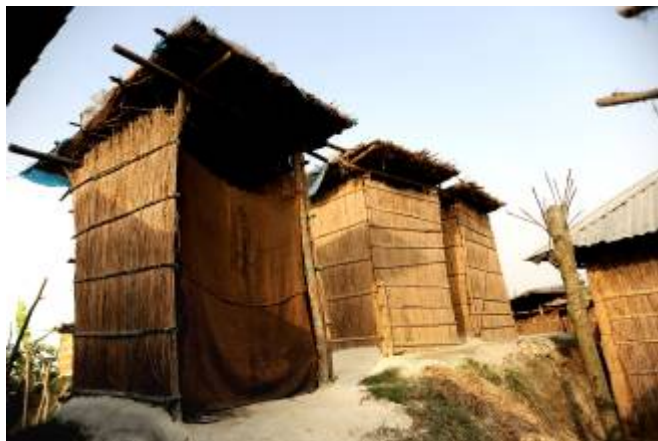
***Low cost latrines raised above flood levels***

cost sanitary latrine. The CLP provides a concrete slab (with plastic pan & water seal) and a cash subsidy, while the household is responsible for digging the pit, providing a suitable support structure and installing a suitable structure for privacy. For households on a raised plinth, the cash component is Tk 450 (about £4), while for all other households this increases to Tk 650, to cover the cost of raising the latrine on its own plinth. CLP-2 aims to install 50,000<sup>4</sup> low cost sanitary latrines. By June 2012 15,500 had been installed.
