Figure 1. Operational Catchments within the Wear Catchment.

Table 1. Summary of WFD Failing elements within the Wear Subcatchments. 2012 Assessment. (Mitigation Measures Ass. refers to 'heavily modified' Water Bodies requiring a programme of physical works to improve their status.)

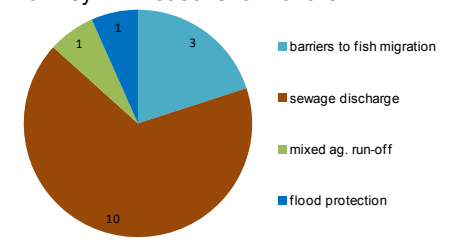
Browney: All Reasons for Failure

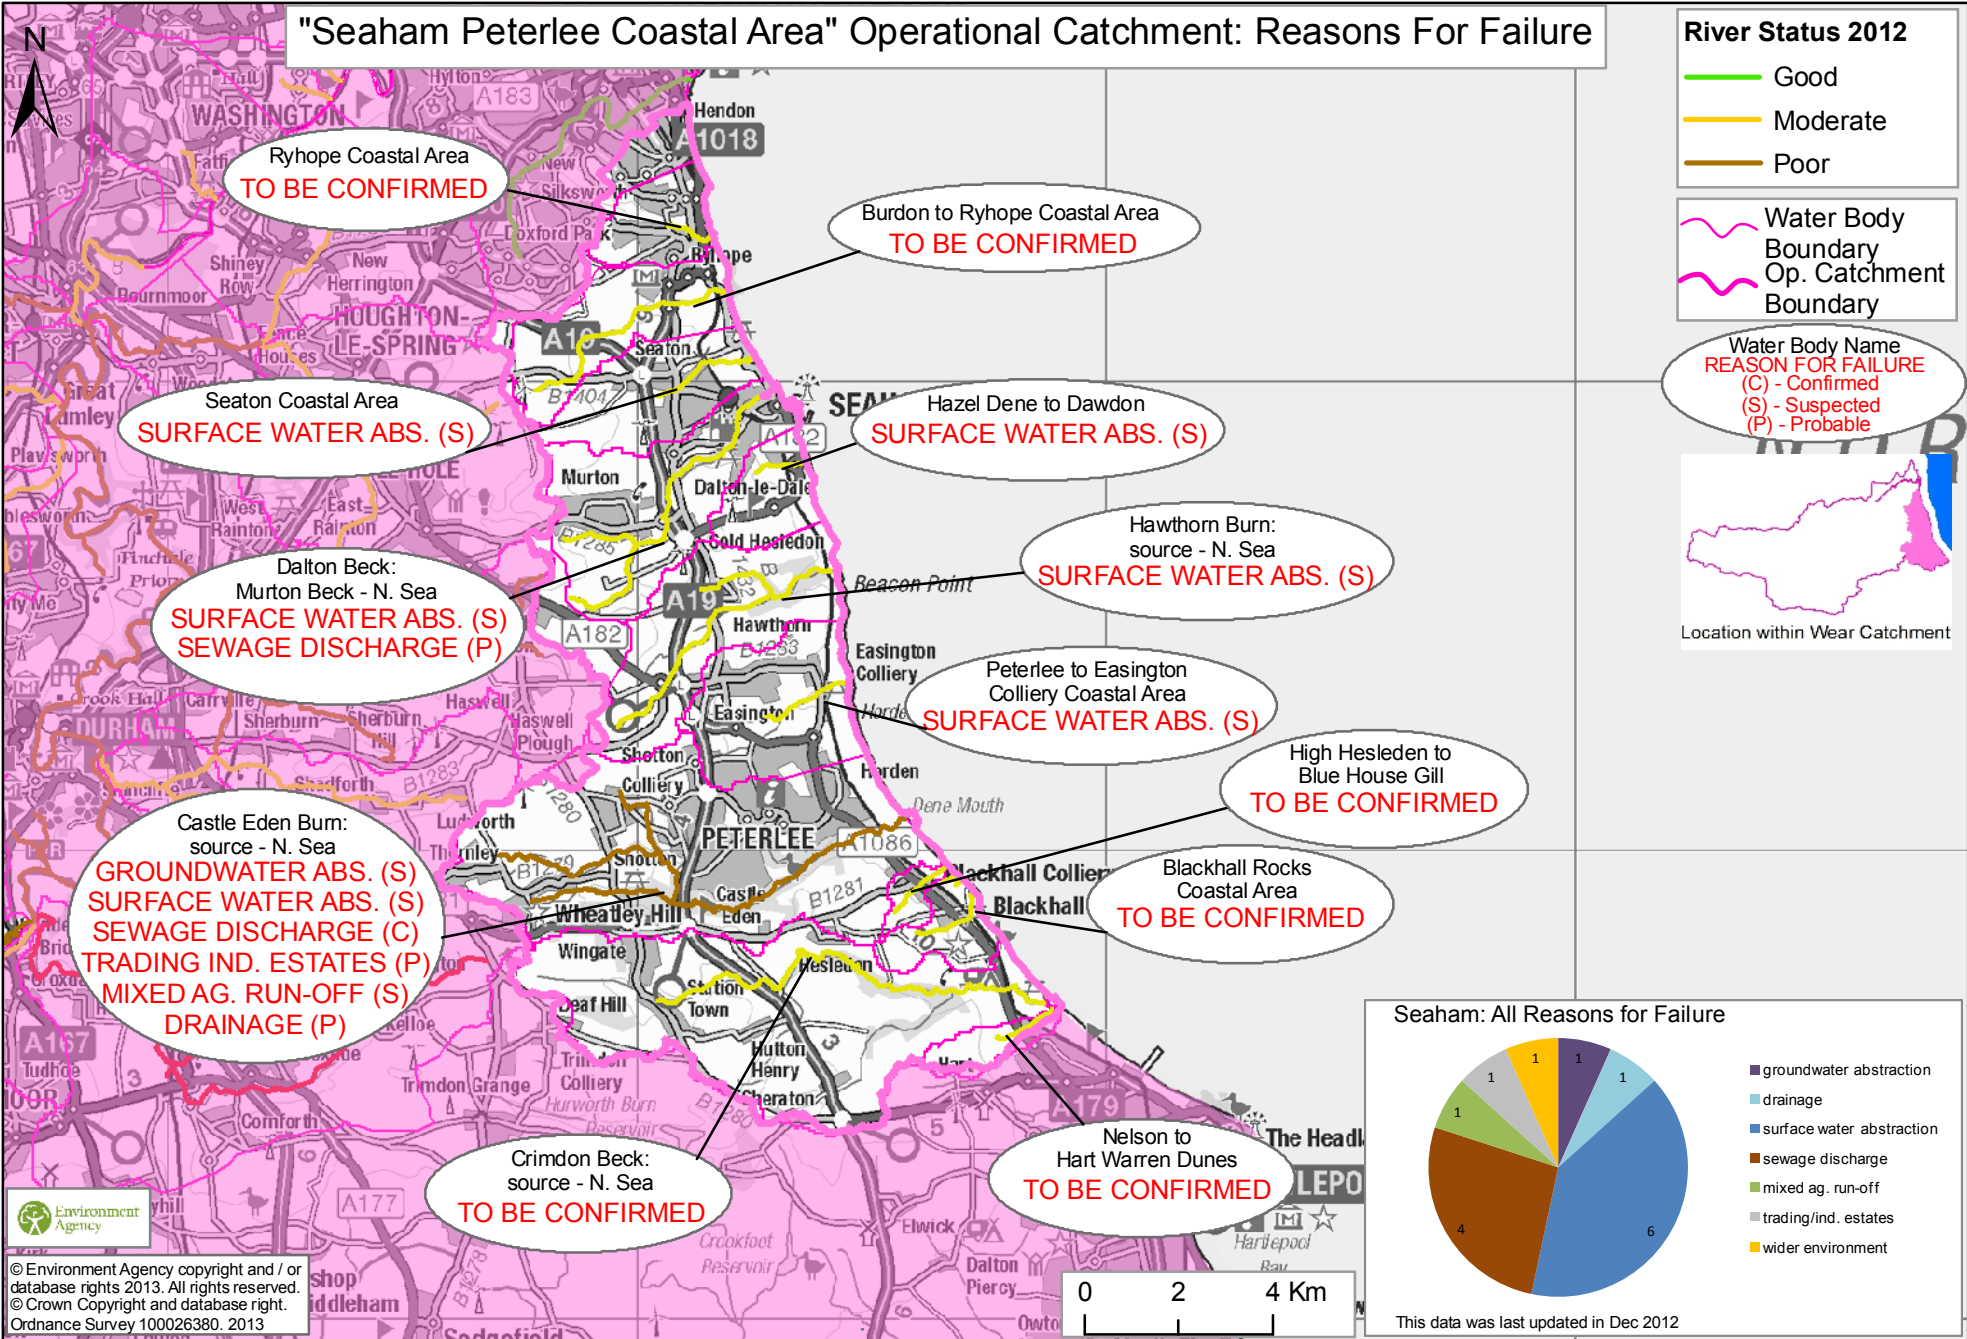
"Seaham Peterlee Coastal Area" Operational Catchment: Reasons For Failure
