## Dambach MS2x12 cantilever message sign

# SafetyAlert

July 2015

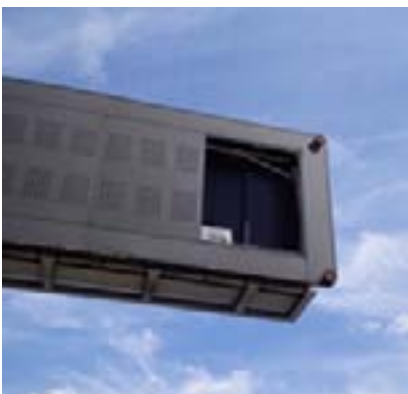
These assets are up to 22 years old and are obsolete awaiting renewal works and have unique lightweight cantilever structures. The modules that make up the sign are installed from the front and riveted in place. Investigations are continuing but it is expected that bad weather was a significant factor along with the age of the asset.

These assets are installed on accessible structures making it possible to check the signs using the rear access panels.

There are no spares available for these units, if you have a non-functioning unit it is advisable to disconnect power and consider further safeguarding or removal.

- Please ensure that area records are checked to confirm whether you have any of these assets
- If you do find a Dambach Cantilever 2x12 an inspection of the sign should be carried out as soon as possible looking for any signs of wear/separation on the front face of the sign
- Out of Service/Non-functioning assets should have power disconnected and works to safeguard or remove the asset considered.
- Where appropriate structures records should be checked to ensure inspection records are up to date for the cantilever structure.
