Cutting Slope Failure & Bridge Undermining

SafetyAlert

March 2016

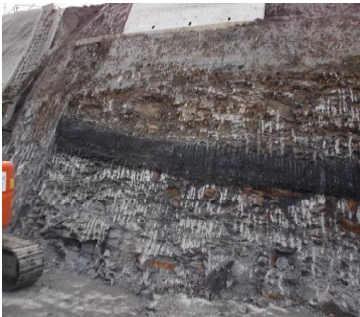
Excavated Cutting Slope

(Note bridge foundation at the top of slope before failure of cutting)

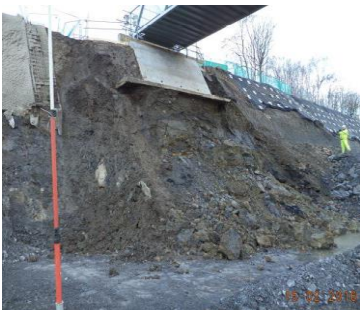
Shortly after the slope was steepened and the footbridge installed the slope and ground immediately in-front of the bridge foundation slipped, undermining the new foundation.

Steepened Cutting Slope Failure

(Bridge foundation undermined by slope failure.)

Initial findings are that the 'rock' supporting the new bridge foundation was significantly weaker than anticipated by the Designer with potential fault zones.

The site has now been made safe with temporary slope stabilisation and bridge propping, whilst a permanent solution is determined.
