SAFETY FLYER TO FISHING INDUSTRY

Fishing vessel *Saint Christophe 1*, accident leading to flooding of a vessel at its berth, 10 March 2016

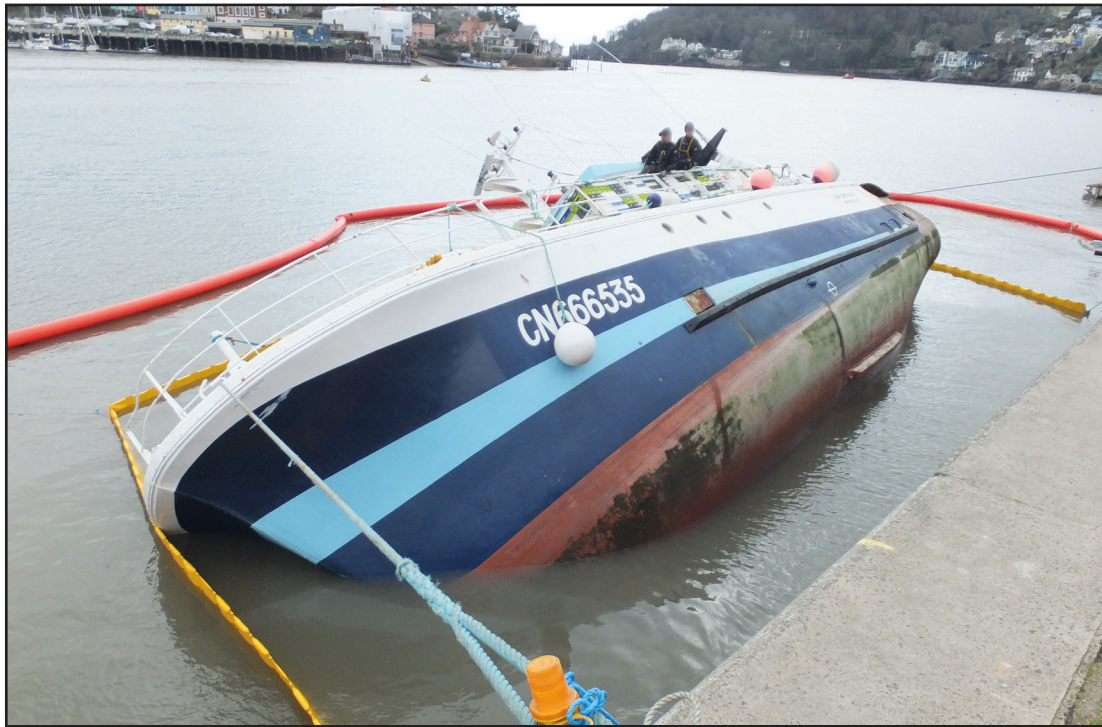
At about 2300 on 9 March 2016, the French fishing vessels *Saint Christophe 1* and *Sagittaire* grounded and started to list on the falling tide while they were berthed alongside in Dartmouth harbour, where they had taken refuge from bad weather. *Sagittaire*'s crew raised the alarm and rigged chains to support the vessel as the tide fell, but *Saint Christophe 1* rolled onto its side and started to flood. *Sagittaire* re-floated as the tide rose, but *Saint Christophe 1* continued to flood and was almost fully submerged at high water. Both crews were evacuated from their vessels without incident, and there was minimal pollution.

Saint Christophe 1 was salvaged on 2 April but was declared a constructive total loss by its insurance company.

Fishing vessel owners and skippers should always ensure that they are fully aware of the tidal range and the amount of water that will be under their vessel's keel at low water. If they intend their vessel to take the ground, procedures should be in place, and actions taken, to ensure their vessel remains upright or leans onto the quay wall when aground. When intending to take the ground at an unfamiliar berth the fishing vessel crew should:

- Consult with the harbour authority when assessing the suitability of the berth for taking the ground.
- Be aware of the condition of the ground their vessel will sit on.
- Ensure the vessel lists towards the quay prior to taking the ground.
- Close all watertight openings and monitor bilge levels and alarms.
- Tend the vessel's mooring lines and monitor its attitude and position as the tide falls.
- Where necessary, rig extra lines (possibly from outboard cleats) or beaching legs, to arrest the vessel's roll as the berth dries out.
