High Speed Rail
(London-West Midlands)

Air Quality and Dust Monitoring
Monthly Report - January 2018

London Borough of Camden

February 2018

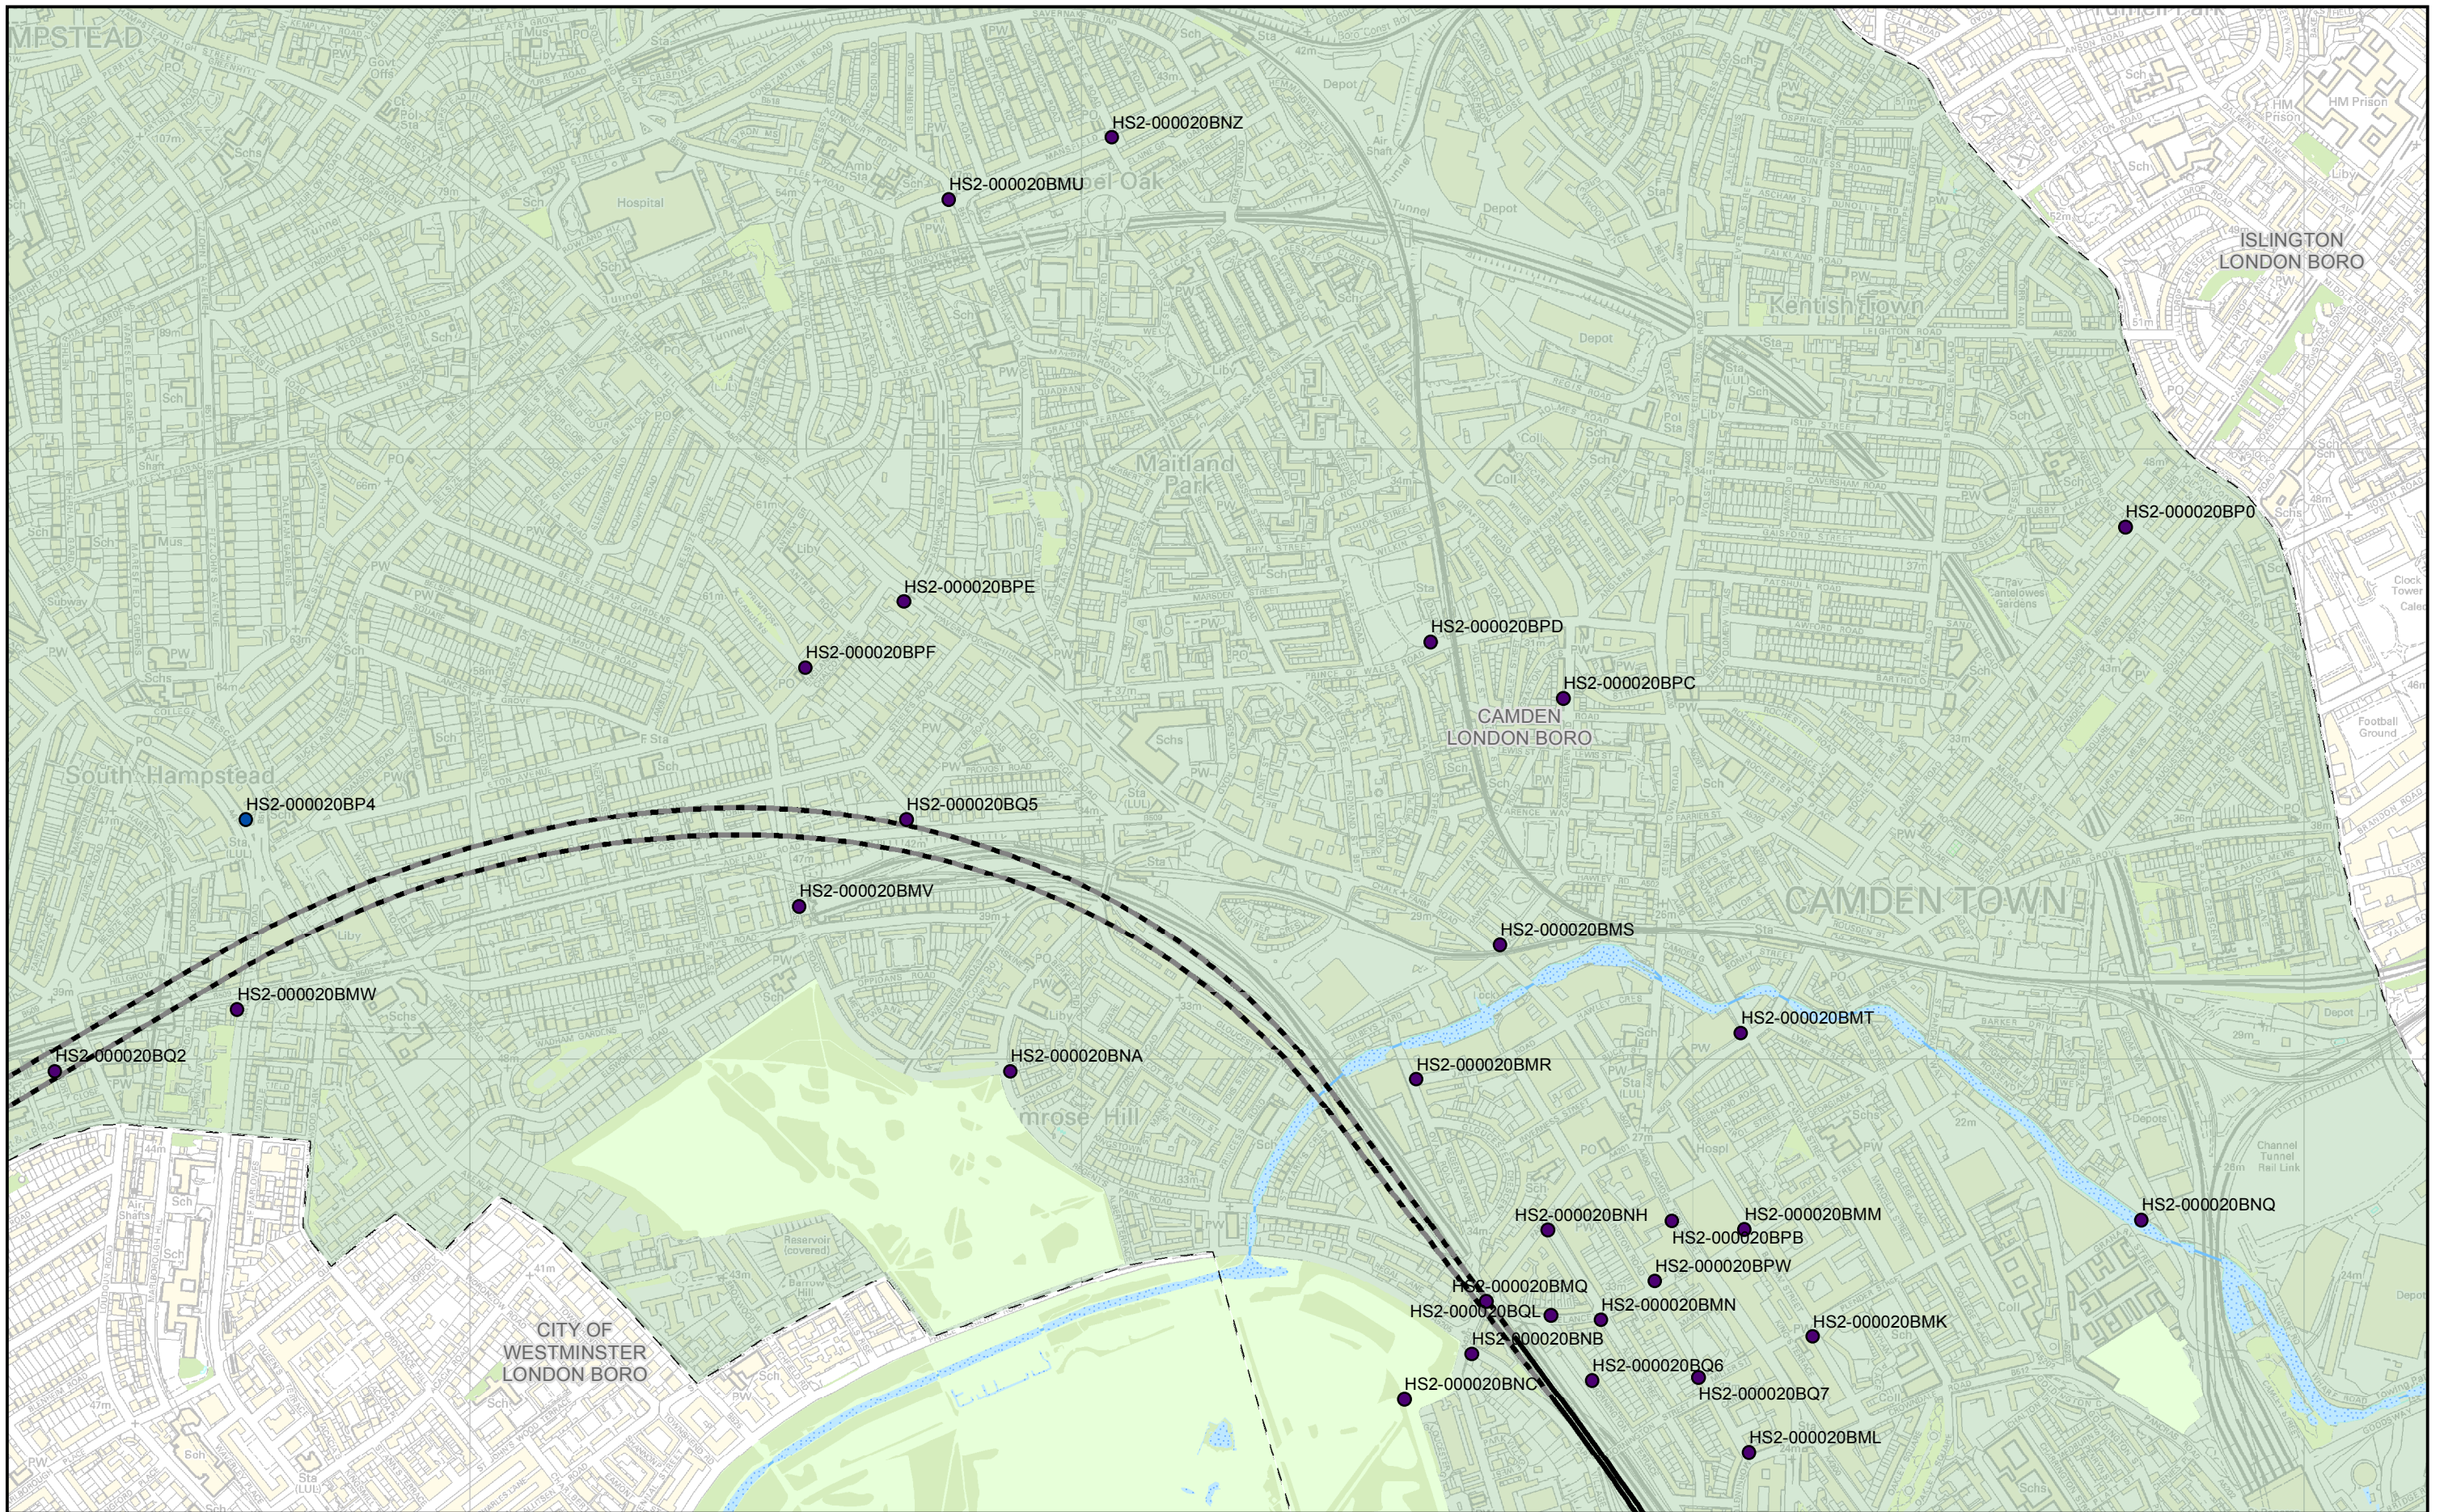
Figure Number

3.2.2 Table 3 lists the HS2 diffusion tube locations in Camden. Figure 3 in Appendix B shows the location of the diffusion tubes.
