## ACCIDENT

<b>Aircraft Type and Registration:</b>	Robinson R22 Beta, G-CTRL
<b>No &amp; Type of Engines:</b>	1 Lycoming O-360-J2A piston engine
<b>Year of Manufacture:</b>	2004 (Serial no: 3601)
<b>Date &amp; Time (UTC):</b>	30 January 2018 at 1045 hrs
<b>Location:</b>	Nottingham Heliport
<b>Type of Flight:</b>	Training
<b>Persons on Board:</b>	Crew - 1                      Passengers - None
<b>Injuries:</b>	Crew - 1 (Minor)          Passengers - N/A
<b>Nature of Damage:</b>	Extensive damage, beyond economic repair
<b>Commander's Licence:</b>	Student
<b>Commander's Age:</b>	62 years
<b>Commander's Flying Experience:</b>	41 hours (of which 41 were on type) Last 90 days - 9 hours Last 28 days - 3 hours
<b>Information Source:</b>	Aircraft Accident Report Form submitted by the pilot

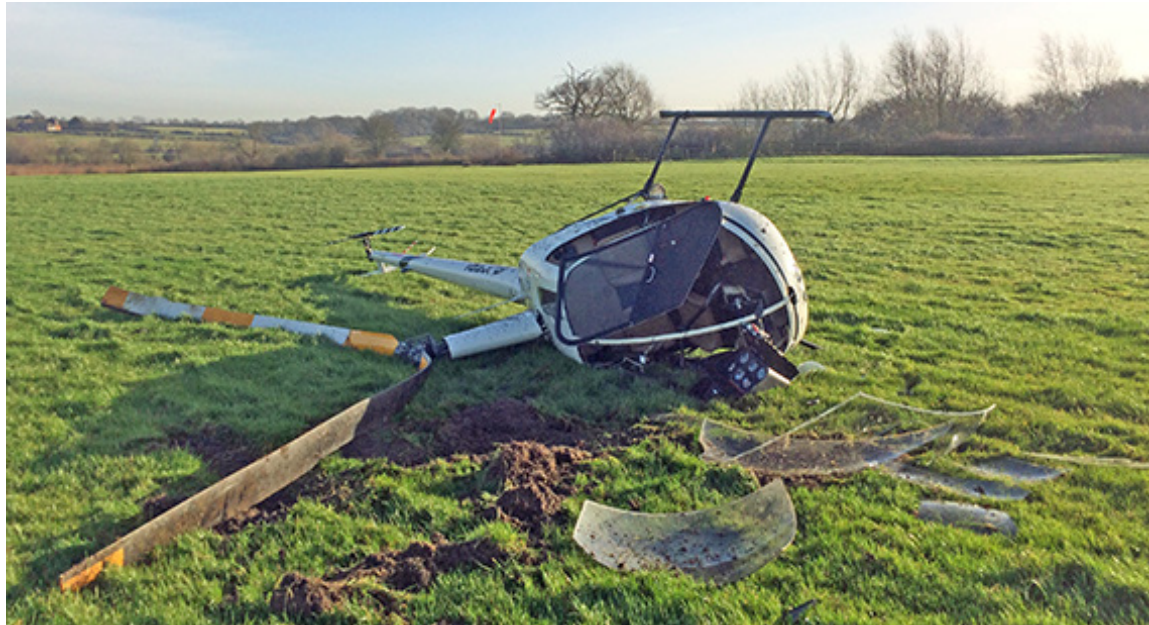
**Figure 1**

The helicopter rolled onto its right side when the student pilot attempted to lift into the hover to make his first solo flight. The instructor was watching from nearby and witnessed the helicopter rotate around the right skid and fall on its side due to dynamic rollover.

The instructor moved away to a safe distance before signalling the pilot to lift off. When the pilot saw this signal, he adjusted the cyclic stick to what he thought was the correct position and raised the collective lever. He stated that he used the available visual cues and made appropriate control adjustments, but was unable to prevent the helicopter rolling quickly onto its right side. The instructor reported that the pilot kept the helicopter straight through correct use of the yaw pedals but did not apply sufficient left cyclic control to compensate for the change of CG. He saw the helicopter roll onto its right side with the rotor blades stopping when they hit the grass (Figure 1).

G-CTRL after the accident with the front transparencies broken and the left door open

The instructor approached the helicopter and found the pilot trapped in his seat with minor injuries to his hands, so he helped him climb out through the left doorway, prior to arrival of the heliport rescue service. The instructor then switched off the fuel and electric supplies to the helicopter. His assessment was that the accident occurred as a result of dynamic rollover; a phenomenon the pilot had been briefed about in the classroom and pre-flight.

*'Always use a two-step liftoff. Pull in just enough collective to be light on the skids and feel for equilibrium, then gently lift the helicopter into the air.'*
