ACCIDENT

Aircraft Type and Registration: Jodel D117, G-BBPS

Location: Shempstons Farm, Lossiemouth

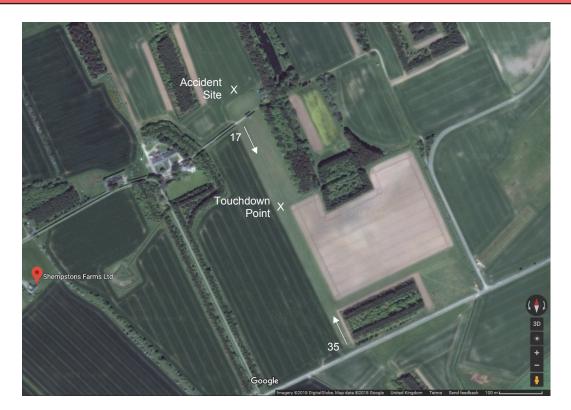
Figure 1
Accident site - Shempstons Field, near Lossiemouth

During the flight the wind increased to about 13 kt and the pilot made three approaches followed by go-arounds. The touchdown on the fourth approach was later than normal (Figure 1) and at 60 KIAS which, combined with the tailwind component, resulted in a high ground-speed. The aircraft wheel brakes are not normally used for landing deceleration and the pilot was unable to stop before running off the end of the runway. The aircraft entered a rough ploughed field causing the main landing gear to dig in and it came to rest inverted. The pilot required assistance to vacate the aircraft and suffered a minor back injury. The engine and propeller suffered shock loading and the structure of the canopy, upper fuselage and right main landing gear was damaged.
