**ACCIDENT**

<b>Aircraft Type and Registration:</b>	Gulfstream AA-5B Tiger, G-BJAJ	
<b>No &amp; Type of Engines:</b>	1 Lycoming O-360-A4K piston engine	
<b>Year of Manufacture:</b>	1979 (Serial no: AA5B-1177)	
<b>Date &amp; Time (UTC):</b>	19 April 2018 at 1200 hrs	
<b>Location:</b>	Thrupton Airfield, Hampshire	
<b>Type of Flight:</b>	Private	
<b>Persons on Board:</b>	Crew - 1	Passengers - 1
<b>Injuries:</b>	Crew - None	Passengers - None
<b>Nature of Damage:</b>	Nose leg bent; propeller damaged and engine possibly shock-loaded	
<b>Commander's Licence:</b>	Private Pilot's Licence	
<b>Commander's Age:</b>	63 years	
<b>Commander's Flying Experience:</b>	375 hours (of which 231 were on type) Last 90 days - 4 hours Last 28 days - 1 hour	
<b>Information Source:</b>	Aircraft Accident Report Form submitted by the pilot

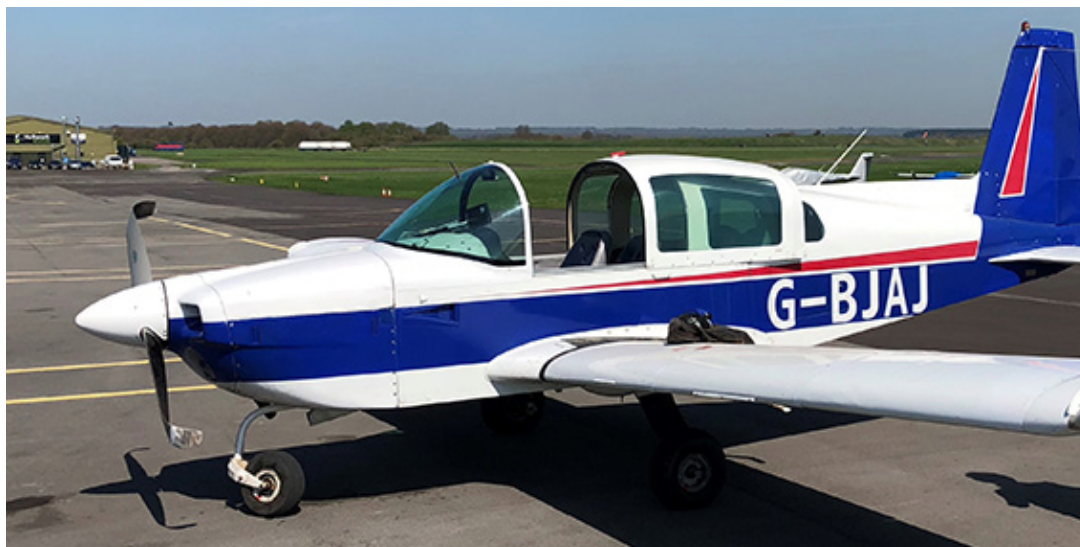
**Figure 1**

On the final approach to Runway 25 at Thrupton, both occupants considered the flightpath was correct. However, the pilot was distracted by manipulating the control column with his right hand, rather than his left, and he experienced difficulty monitoring the airspeed indicator. As they crossed the threshold, he realised he was slow, so he lowered the nose and increased power, but the nosewheel and the propeller unexpectedly struck the runway. The aircraft bounced before the pilot regained control. He completed the landing and then taxied to the apron (Figure 1).

G-BJAJ with damage to the propeller and the nose leg

As a result of the accident, the pilot realised that he should have sought assistance from a qualified instructor before flying the aircraft from the right seat.
